**Report on
Industrial Accident on G/F, Sludge Dewatering House,
Stonecutters Island Sewage Treatment Works
on 7 May 2010**

Drainage Services Department
June 2010

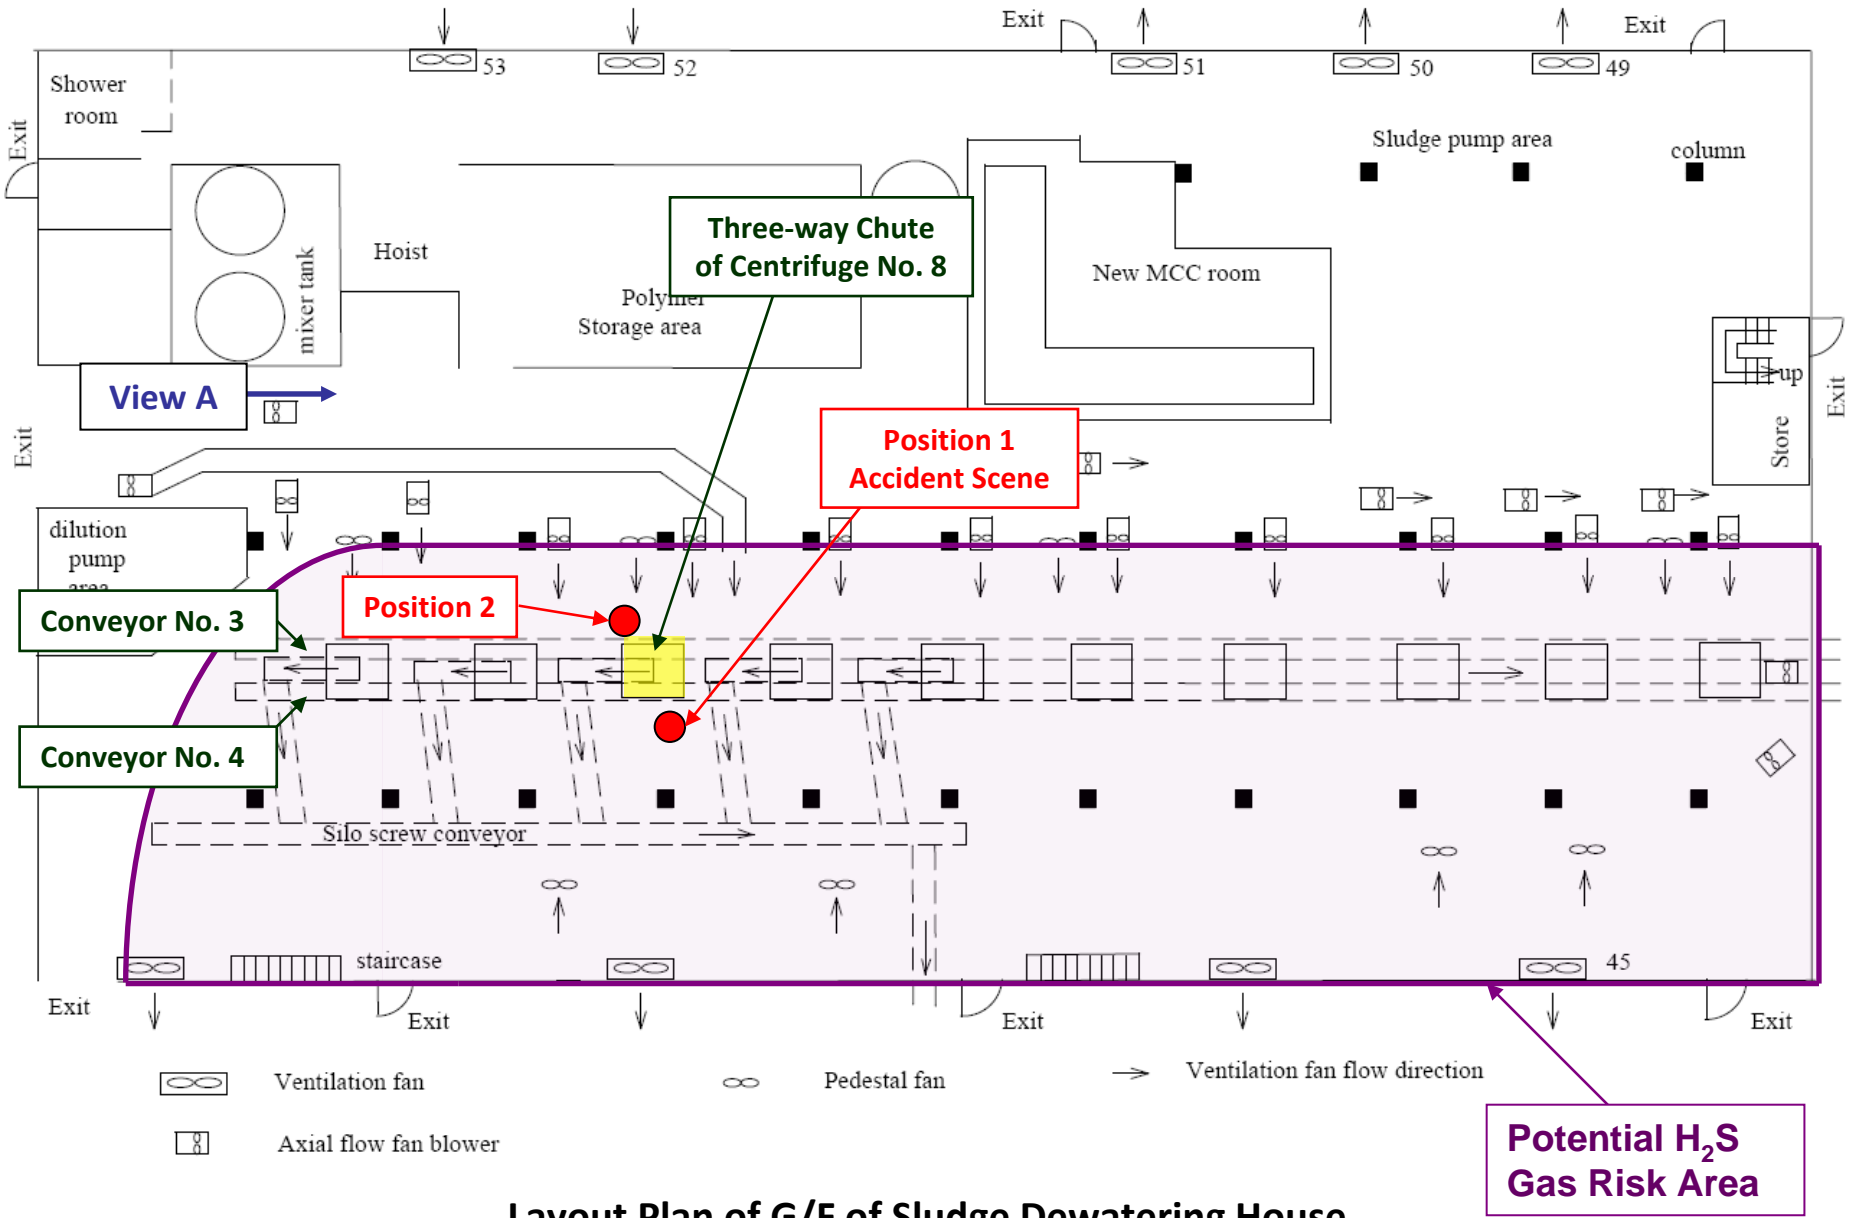
Layout Plan of G/F of Sludge Dewatering House, Stonecutters Island Sewage Treatment Works

At around 2:25 p.m., the team was approaching the discharge of Centrifuge No. 8 for work. Worker B and Worker C were at Position 1, and Worker A and Worker D at Position 2 as shown in Appendix 1. Upon arriving at the accident scene (Position 1), Worker B at first did not experience any discomfort. However, when he crouched down for inspection, he suddenly felt dizzy and then collapsed.

- f. The area where the accident occurred and the vicinity of it in the equipment hall had been designated as a potential H₂S gas risk area (see purple area in Appendix 1) and was clearly fenced off by rails and chains. Staff working in that area was required to observe the specific safety instructions for working in the area. Investigation found that the working team had followed the safety instructions by notifying the operator of the SDH before work; not to work alone by forming a team to work within that area; paying attention to the H₂S concentration in the work environment; and monitoring the air quality continually during work. However, they did not bring with them and put on any respirator masks or other breathing apparatus as stipulated in the safety instructions posted at the entrance to the works area.

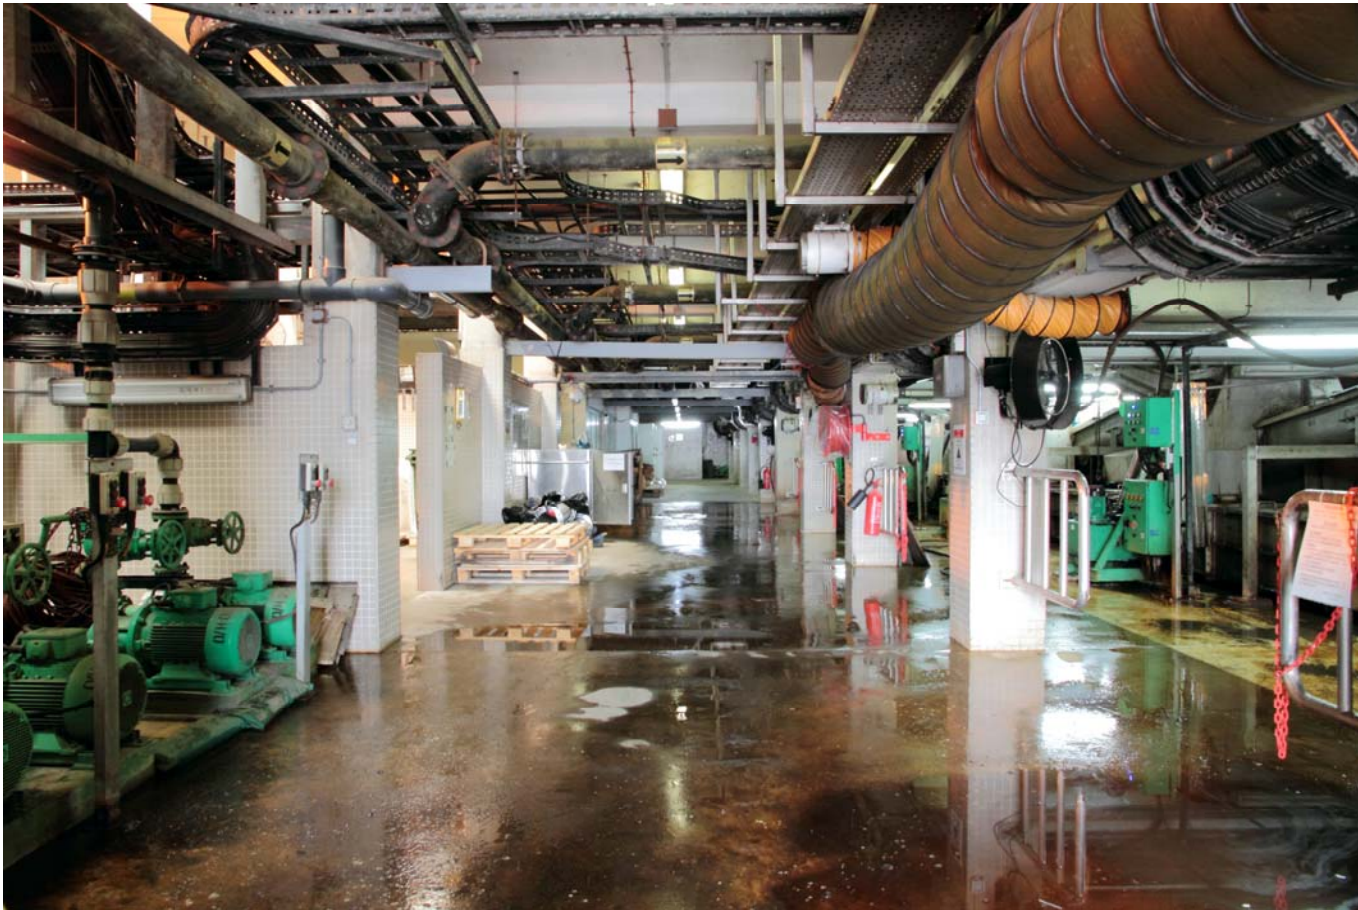
- a. The accident occurred at the equipment hall on the G/F of the SDH that housed the sludge conveyors and other equipment. The equipment hall measured about 50 m (L) x 30 m (W) x 2.5 m (H) (Photo 1) and was not a confined space. Mechanical ventilation was provided for the equipment hall by using 9 nos. of wall-mounted ventilation fans (Photo 2), 8 nos. of wall-mounted pedestal fans, and 19 nos. of wall-mounted blower fans. At the material time, the mechanical ventilation system was operating normally.

Photo 1: Sludge Dewatering House Equipment Hall (View A)

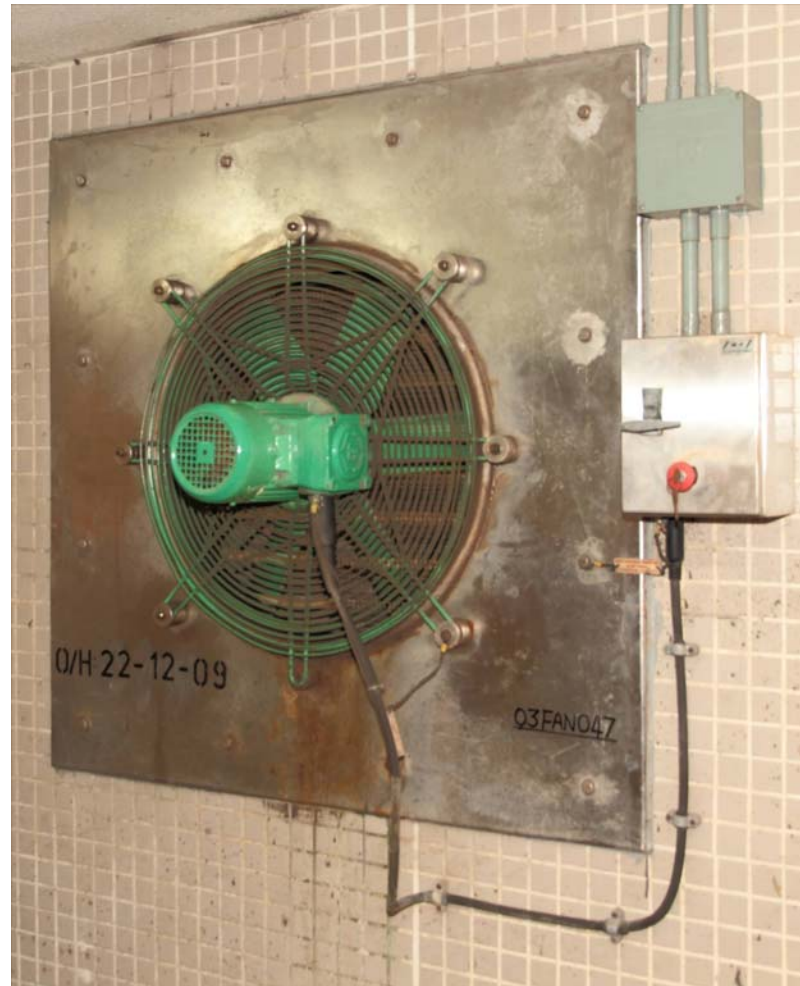
Photo 2: Wall-mounted Ventilation Fan (9 nos.)

- b. The existing mechanical ventilation system for the workplace will be further enhanced to prevent accumulation of gas at low level. Mobile ventilation fans will also be provided.

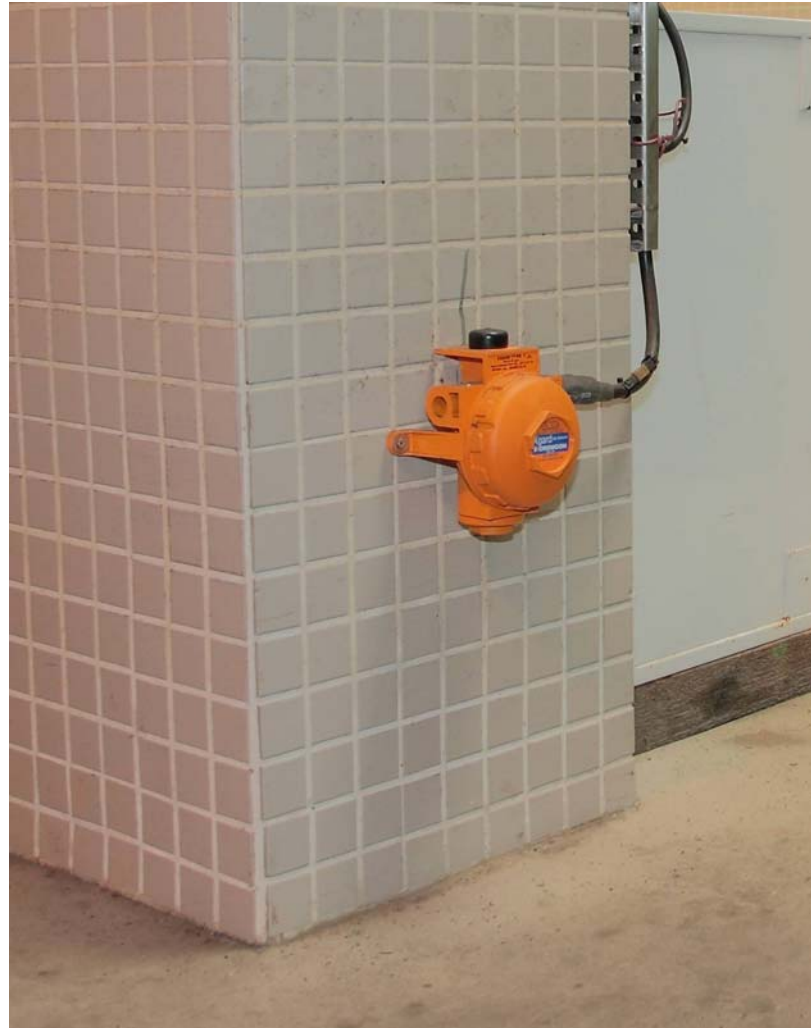
- b. The equipment hall on the G/F of the SDH was equipped with 7 nos. of fixed type H₂S sensors at low level at approx. 0.35 m above floor level (Photo 3). The sensors were under periodic calibration, with the most recent calibration carried out in April 2010. Based on records, between 2:00 p.m. to 3:00 p.m. on 7 May 2010, the H₂S gas level registered by the H₂S sensor installed nearest to the accident scene had exceeded 50 ppm. As for the other six H₂S sensors installed within the hall, they did not register any abnormal levels of H₂S. To confirm the proper function of the sensors, they were tested again on 12 May 2010 and found to be operating normally.

Photo 3: Fixed Type H₂S Sensor (7 nos.)

- c. The existing fixed type H₂S monitoring system at the workplace will be enhanced to provide local audible and visual alarms. Additional sensors will be provided.

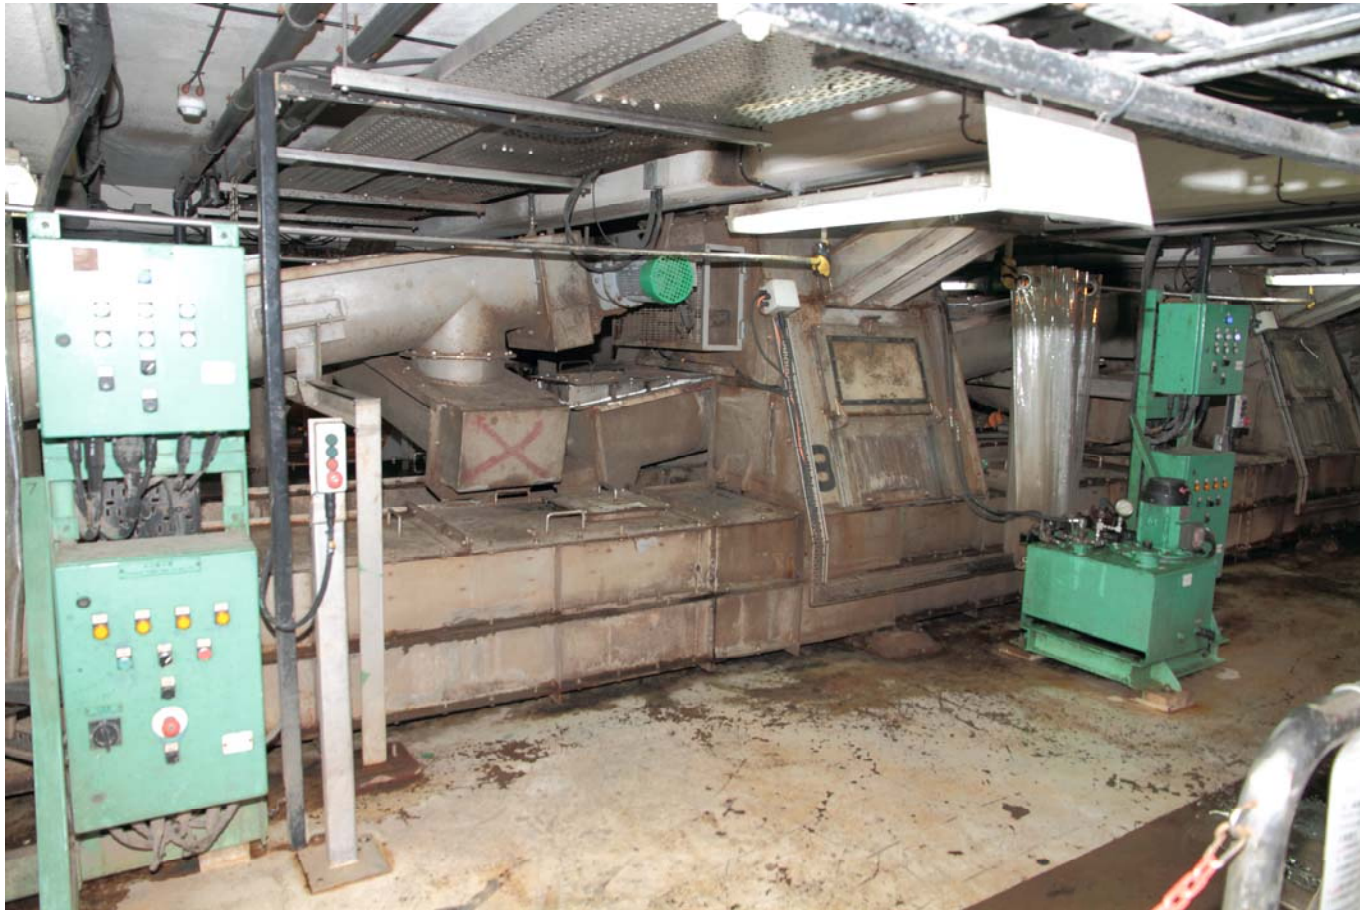
- c. The portable H₂S monitor Worker A brought with him to the workplace was also tested and found to function normally.
- d. Upon investigation, it was found that the inspection door fixed at the lower end of the inclined screw conveyor located next to the three-way chute at Centrifuge No. 8 (Photo 4) was not in place. The inspection door had been removed and put aside. That made the enclosed sludge conveyor not airtight. H₂S gas emanating from the sludge could escape from the enclosed conveyor through the inspection door opening into the atmosphere.

- e. Based on records, the involved Centrifuge No. 8 was tripped and needed to be resumed operation very urgently earlier in the morning on the accident date by various work teams. It might be that one of the teams had forgotten to replace the inspection door after the urgent resumption work. The exact details however could not be identified. The situation that the inspection door has not been put back in place was considered rare as it had never happened before.

It was believed that high concentration of H₂S gas escaped from the enclosed conveyor system, through the inspection door opening, into the atmosphere in the vicinity. As H₂S is 1.2 times heavier than air, the H₂S gas sank and accumulated at low level at the accident scene. When Worker B crouched down at the spot, he inhaled the H₂S gas and collapsed. When Worker C and Worker D rescued Worker B from the low position, they also inhaled the H₂S gas and collapsed.

Photo 4: Three-way Chute of Centrifuge No. 8

- a. The existing working procedures and guidelines to work on the sludge conveyors will be reviewed and amended to prevent unintended opening of the conveyor inspection doors.
