**沙埔仔村水浸事件調查報告**

**Investigation Report on the Flooding in  
Sha Po Tsai Village, Tai Po  
on 22 July 2010**

**行政摘要**

**Executive Summary**

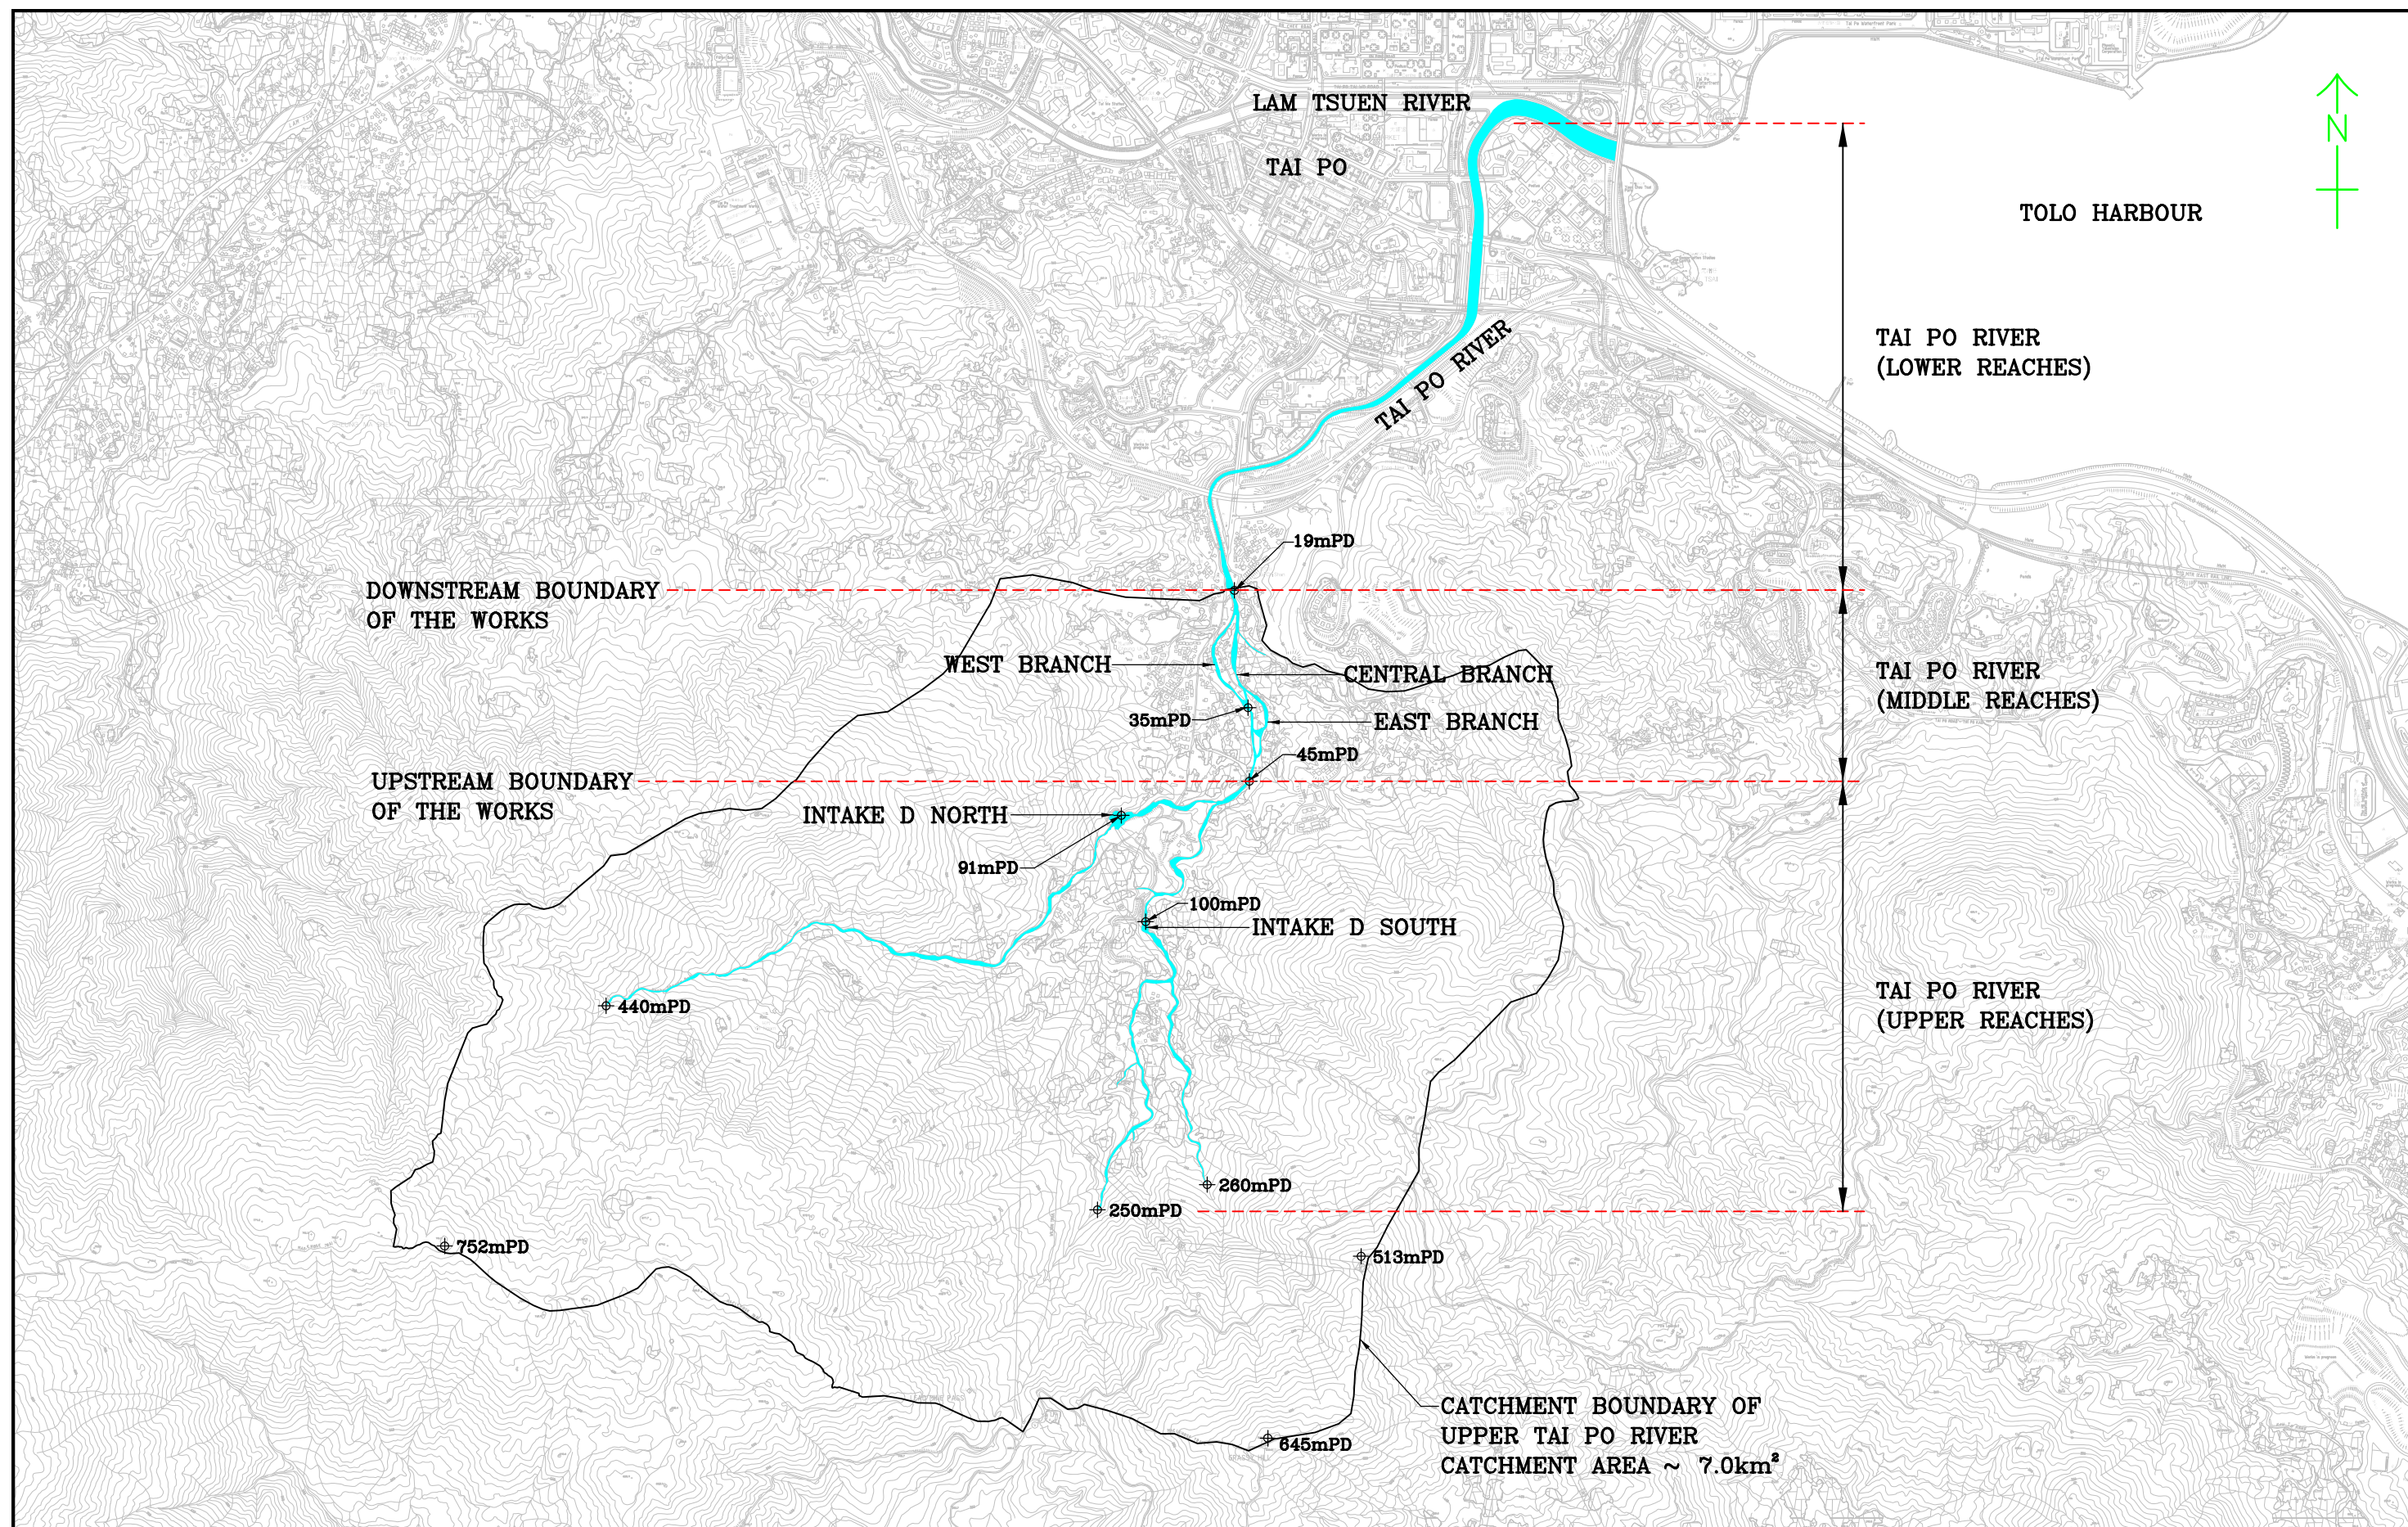
| DRAWING No. | FIG 2 | | REV<br>A |

大埔河全長約 6.7 公里，流域約 7 平方公里，由位於水準基準 752 米的最高點，流至吐露港（如圖號 2 所示）。大埔河河道陡峭，上游地區的坡度約 1 比 5，隨後逐步緩降，於中游段下降至約 1 比 23。根據過往的洪水記錄及當地居民憶述，大埔河中游段，即河道改善工程所在的河段，時有洪水為患，造成水浸。

The overall length of Tai Po River is about 6.7km with a catchment of 7km<sup>2</sup> descending from 752mPD to sea level at Tolo Harbour (**Fig. 2**). The gradients are steep (about 1 on 5) at Tai Po River (Upper Reaches) and gradually decrease to moderate (about 1 on 23) at Tai Po River (Middle Reaches). Based on previous flood records and verbal accounts
