**Investigation Report on the Flooding in  
Sha Po Tsai Village, Tai Po  
on 22 July 2010**

**Executive Summary**

**August 2010**

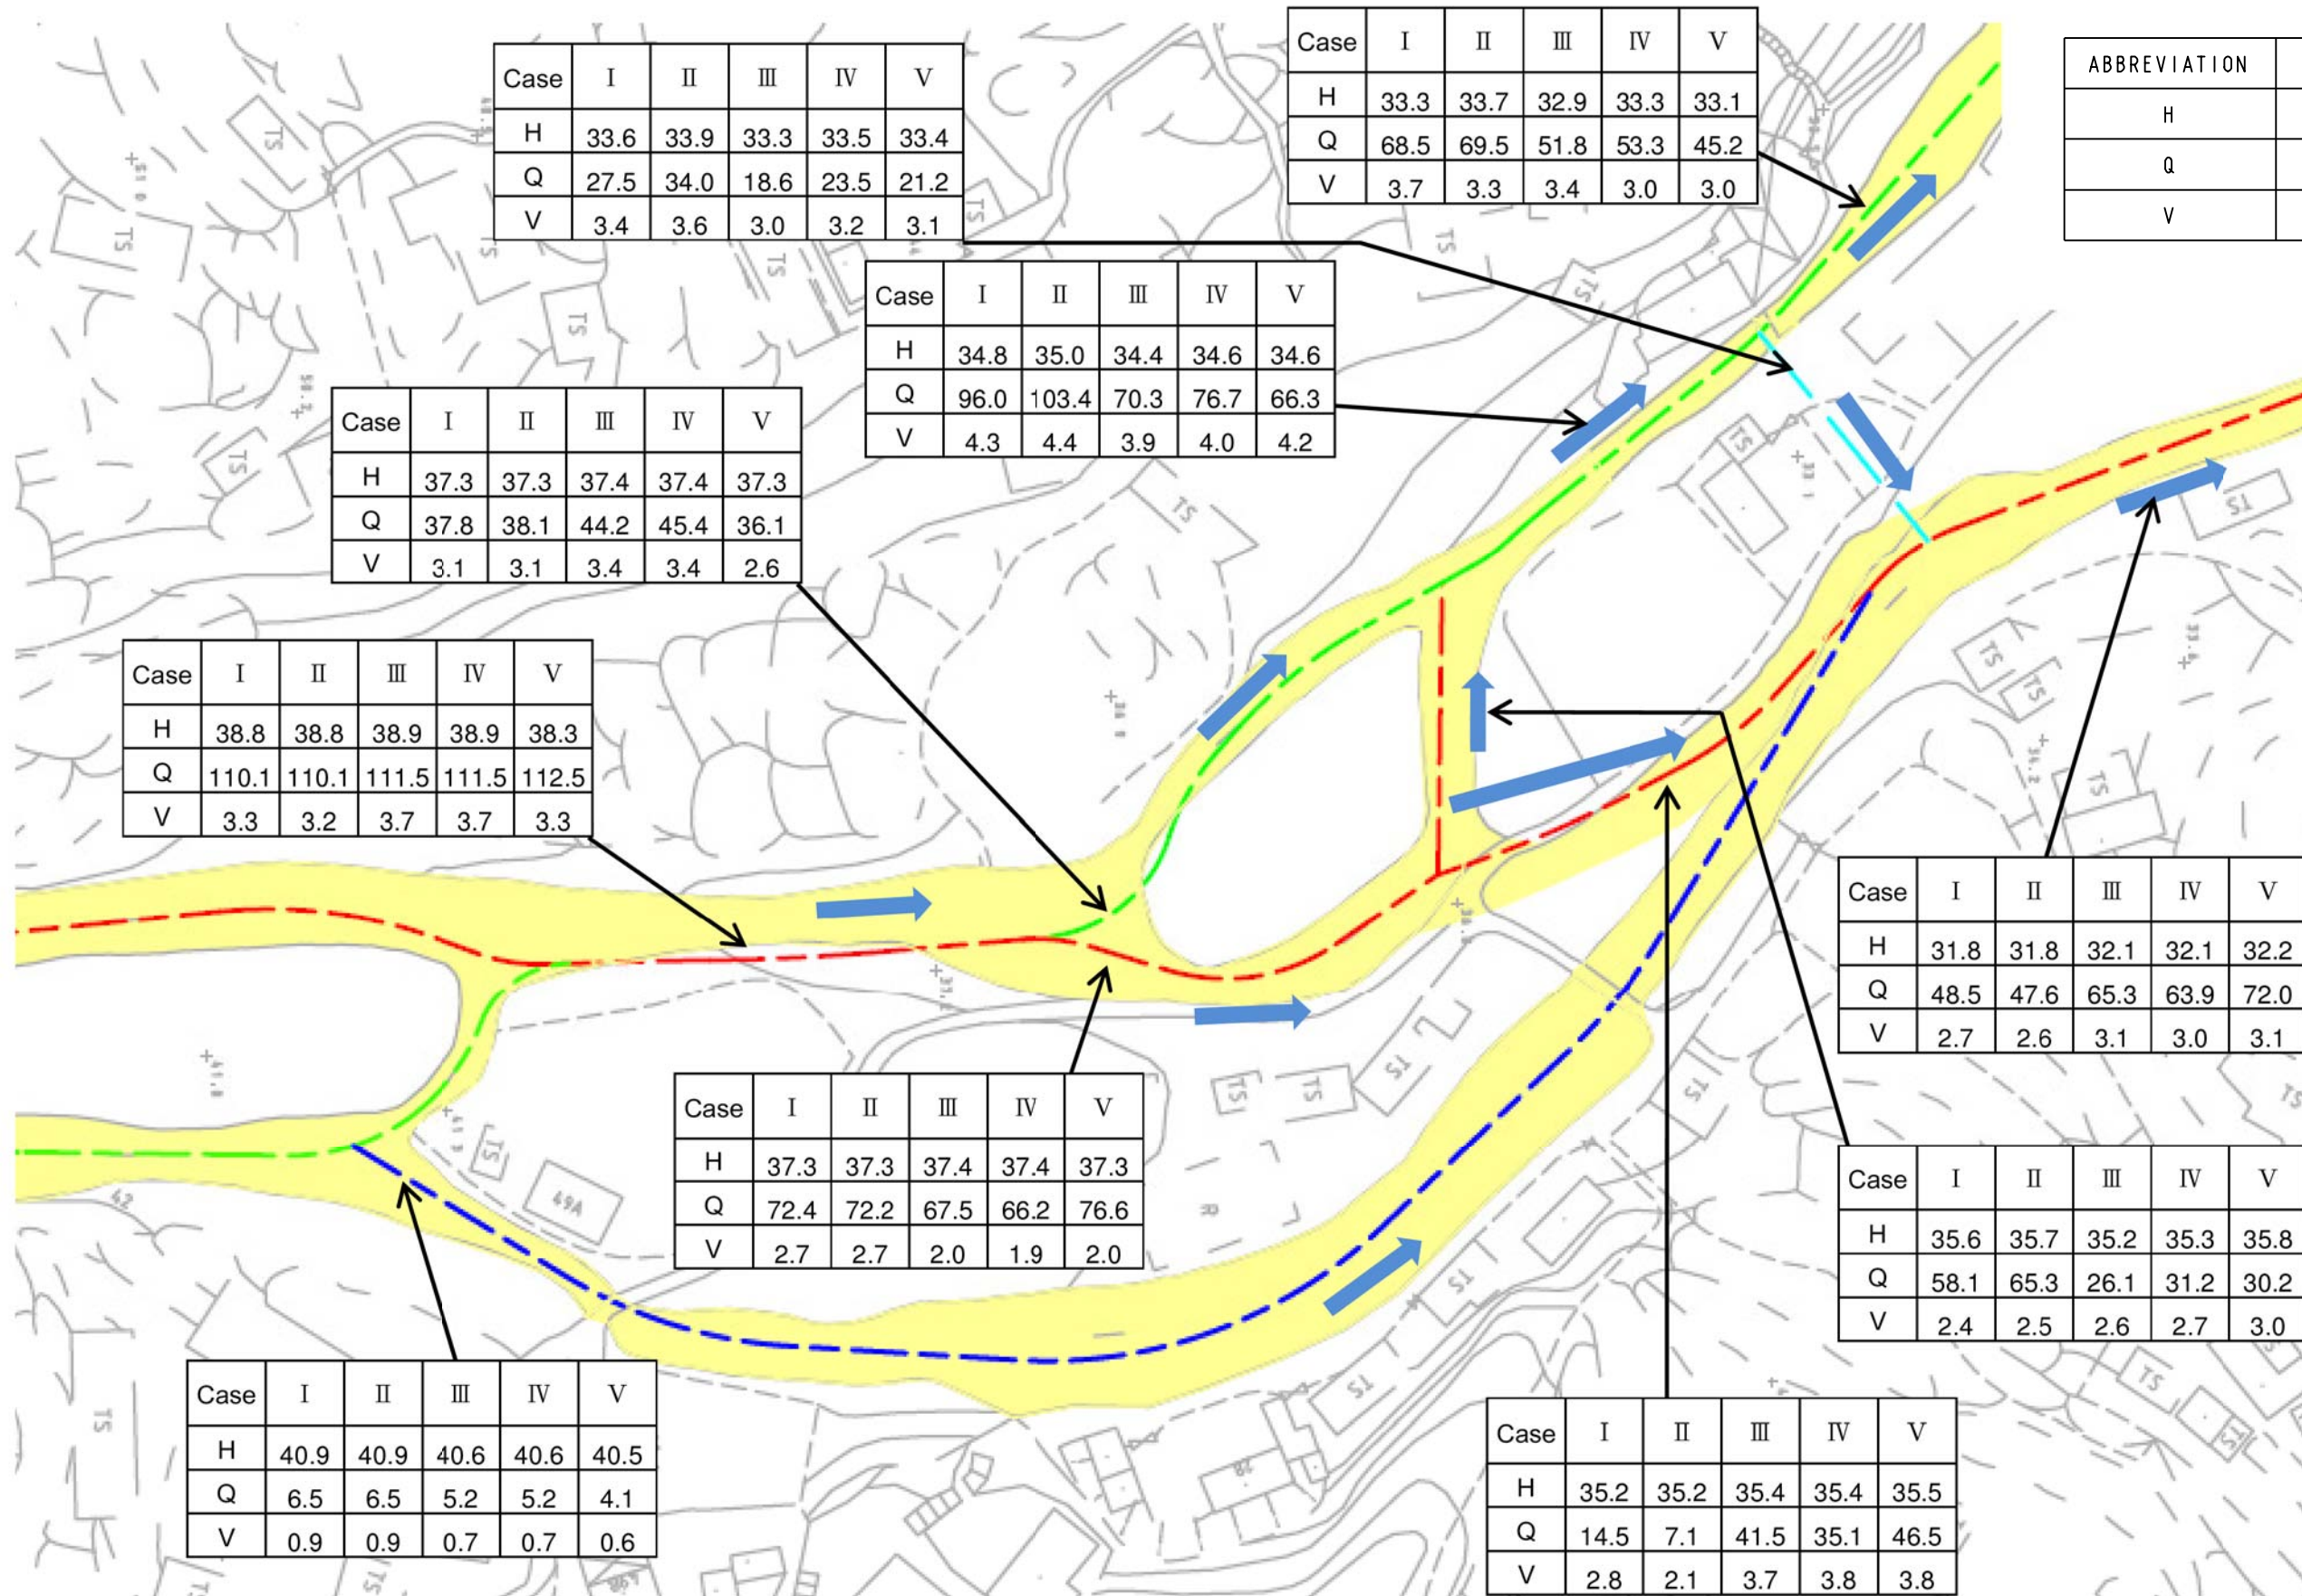
數學模型水力分析的結果，顯示 5 個模擬工況中的水流狀態均十分相似，特別是位於分流 2 處 (CH\_C 180 to 240) 的水流狀態，如圖號 3 所顯示。

Upon analyses of the modelling results, it is noted that the flow pattern for all 5 scenarios are similar, especially at Split Flow 2 location (CH\_C 180 to CH\_C 240) as shown in **Fig. 3**.

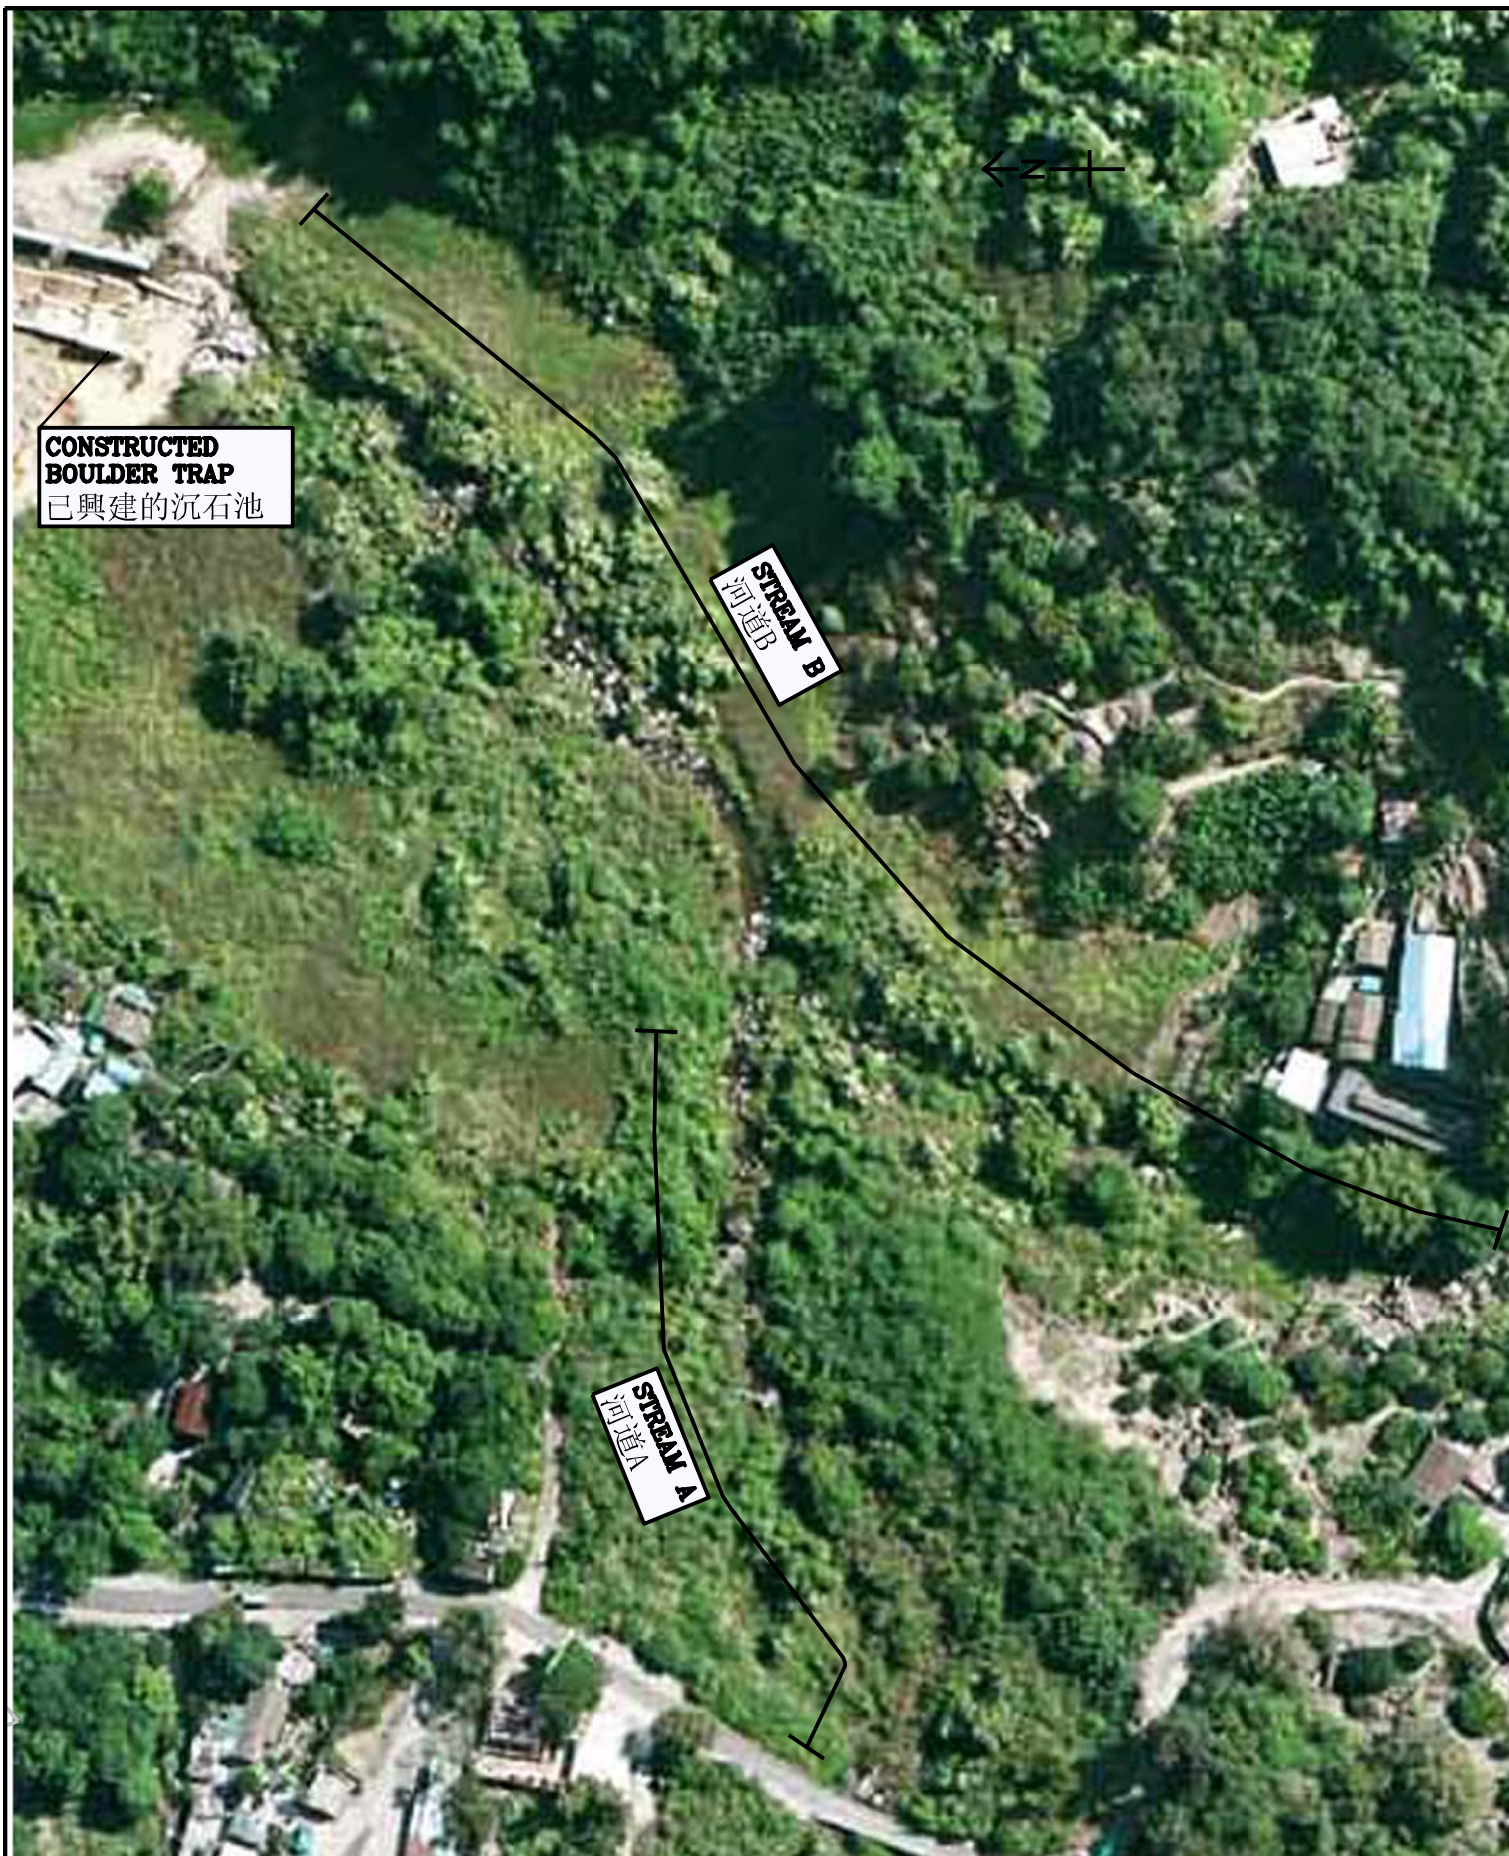
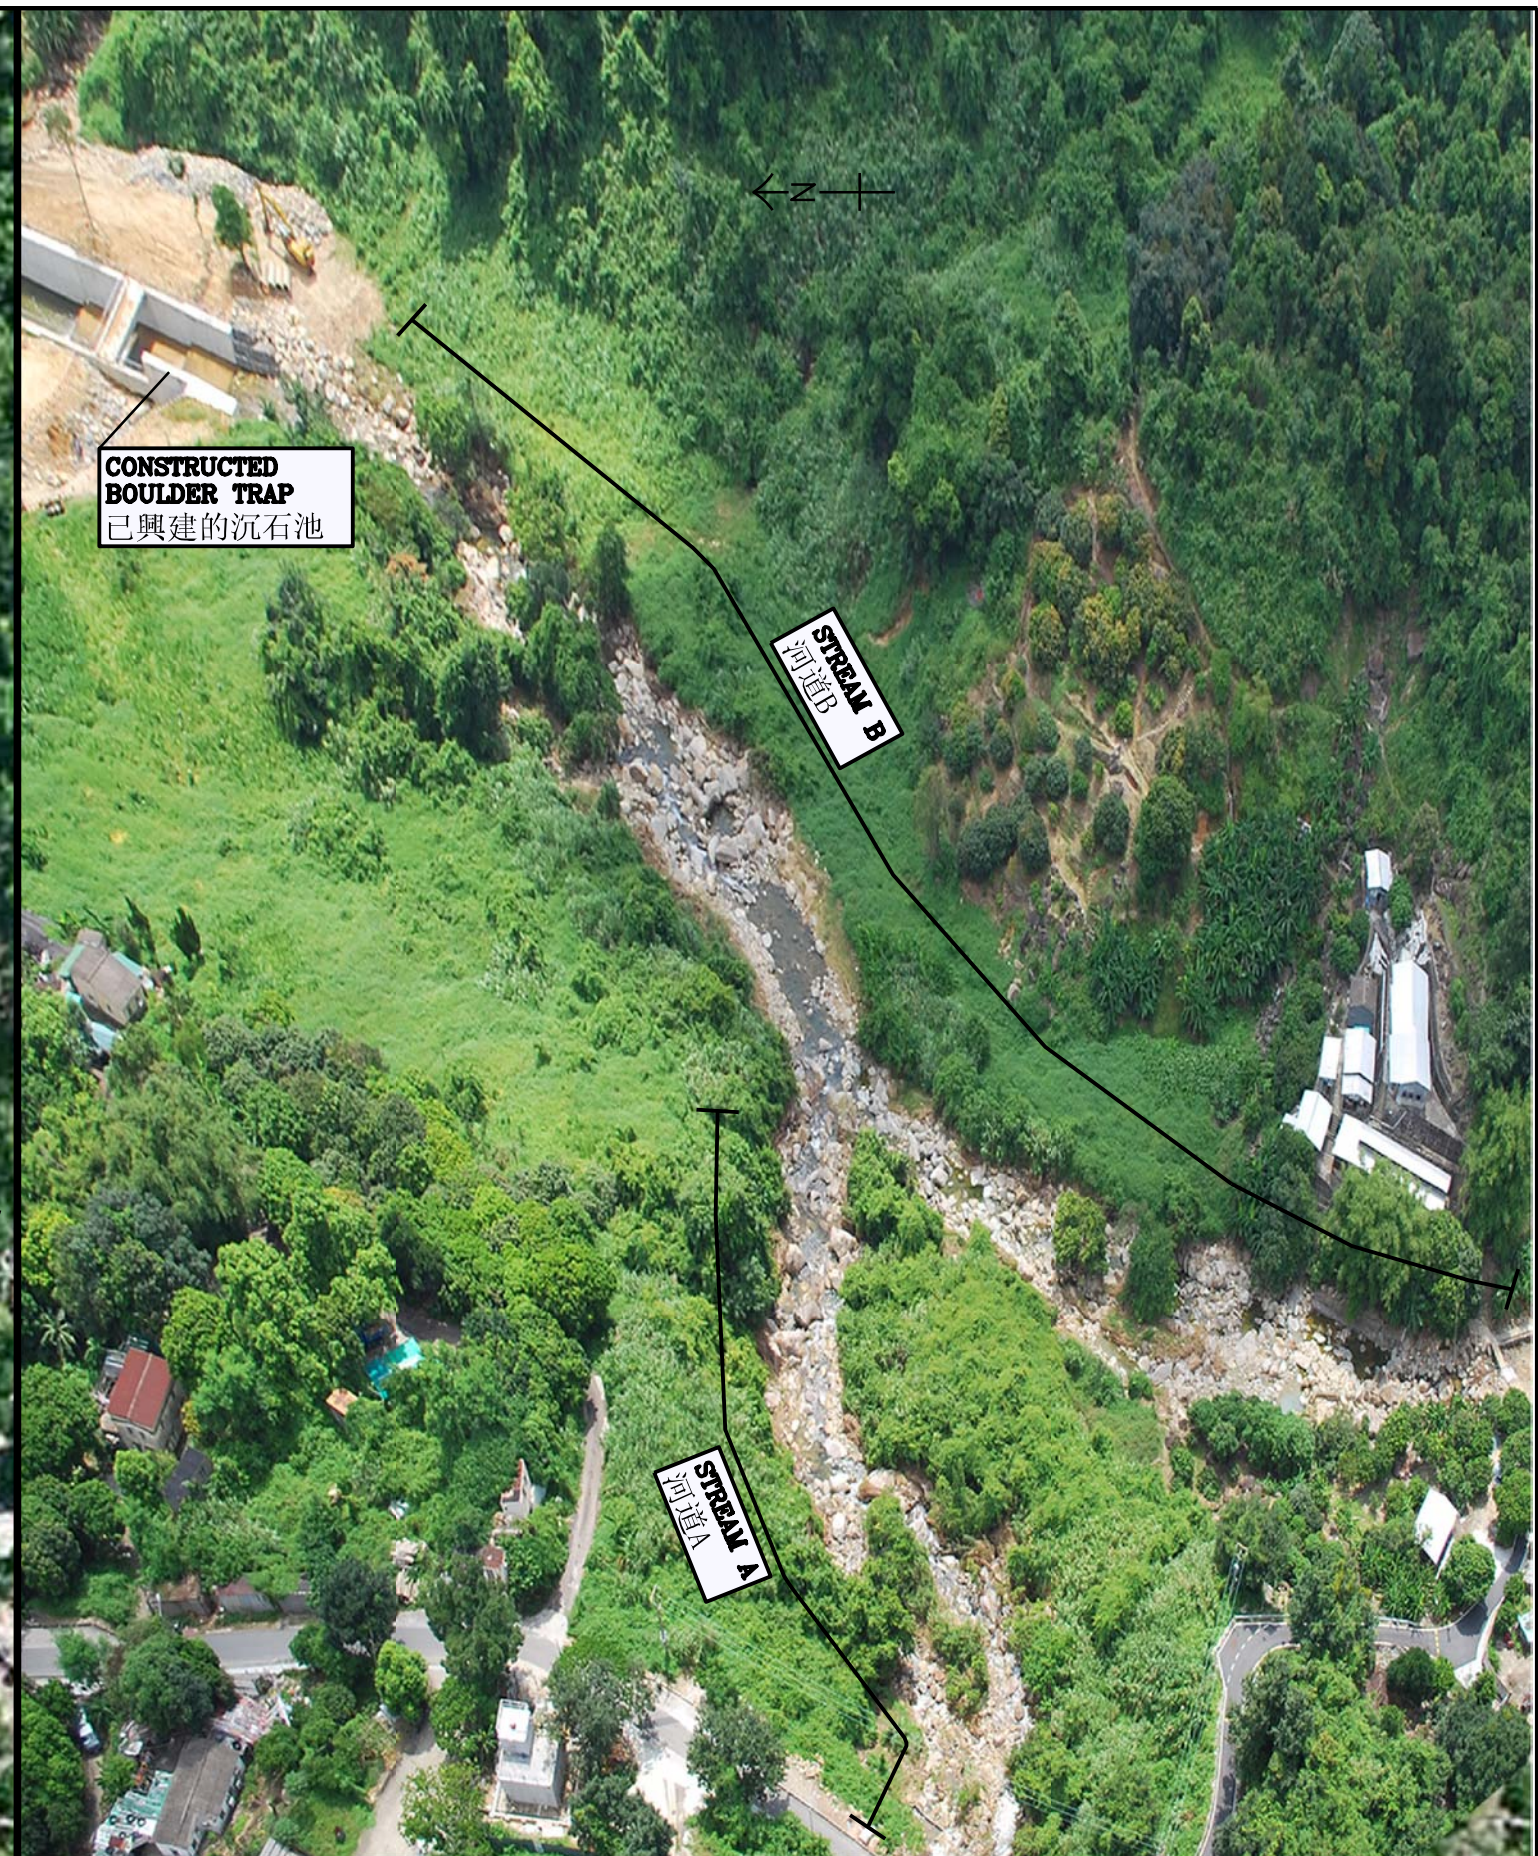
INVESTIGATION REPORT ON THE FLOODING IN  
SHA PO TSAI VILLAGE, TAI PO ON 22 JULY 2010  
COMPARISON OF RIVER CONDITION AT STREAM A AND STREAM B BEFORE AND AFTER THE RAINSTORM ON 22 JULY 2010  
河道A與河道B於二零一零年七月二十二日暴雨前及暴雨後的狀況比較圖

若將 2009 年 11 月與 2010 年 8 月的高空照片作一比對，可以見到沿大埔河上游的河道 A 及河道 B 出現明顯的沖刷現象（如圖號 4 所示），相信是由高速的水流和陡峭的河道所引致的。在施工範圍內之中游段亦發現多處河床及河岸的沖刷；同時，河道內其他地方亦發現有泥沙和大石積聚，主要分佈於西支流與中支流各橋樑的上游處。根據定量分析，這場特大暴雨對河道 A 和河道 B 的河床及河岸造成了嚴重的沖刷，沖走了大量的泥沙和大石（約 5,400 立方米），其中部分沉積於大埔河中游段，餘下部分則被沖至更下游及吐露港。據估算，於大埔河中游段，約 1,800 立方米的泥石被沖刷，另有約 4,000 立方米的泥石積聚，換言之，從上游段沖來的淨沉積量約為 2,200 立方米。

There were clear signs of erosion along Stream A and Stream B of Tai Po River (Upper Reaches) as shown by a comparison of the aerial photos of Nov 2009 and Aug 2010 (**Fig. 4**). The erosion and movement of sizeable boulders and cobbles were caused by the high flow velocities and the steep gradients of these two streams. Within the Tai Po River (Middle Reaches), erosion of sections of river bed and banks was found, whereas there was also deposition of sediments and boulders along other sections of the Tai Po River (Middle Reaches), mainly immediately upstream of the bridges crossing the West Branch and the Central Branch. Based on quantitative analyses of the volume of sediments and boulders transported by erosion and deposition, it is estimated that the erosion of the river bed and banks in Stream A and Stream B during this rainstorm event

yielded a significant amount of sediments and boulders (about 5,400m<sup>3</sup>), part of which was deposited within the Tai Po River (Middle Reaches), and the remainder washed further downstream to Tai Po River (Lower Reaches) and to Tolo Harbour. Within the Tai Po River (Middle Reaches), an erosion of about 1,800 m<sup>3</sup> was identified, and a deposition of about 4,000 m<sup>3</sup> was found, suggesting that a net deposition of about 2,200m<sup>3</sup> was originated from the Tai Po River (Upper Reaches).

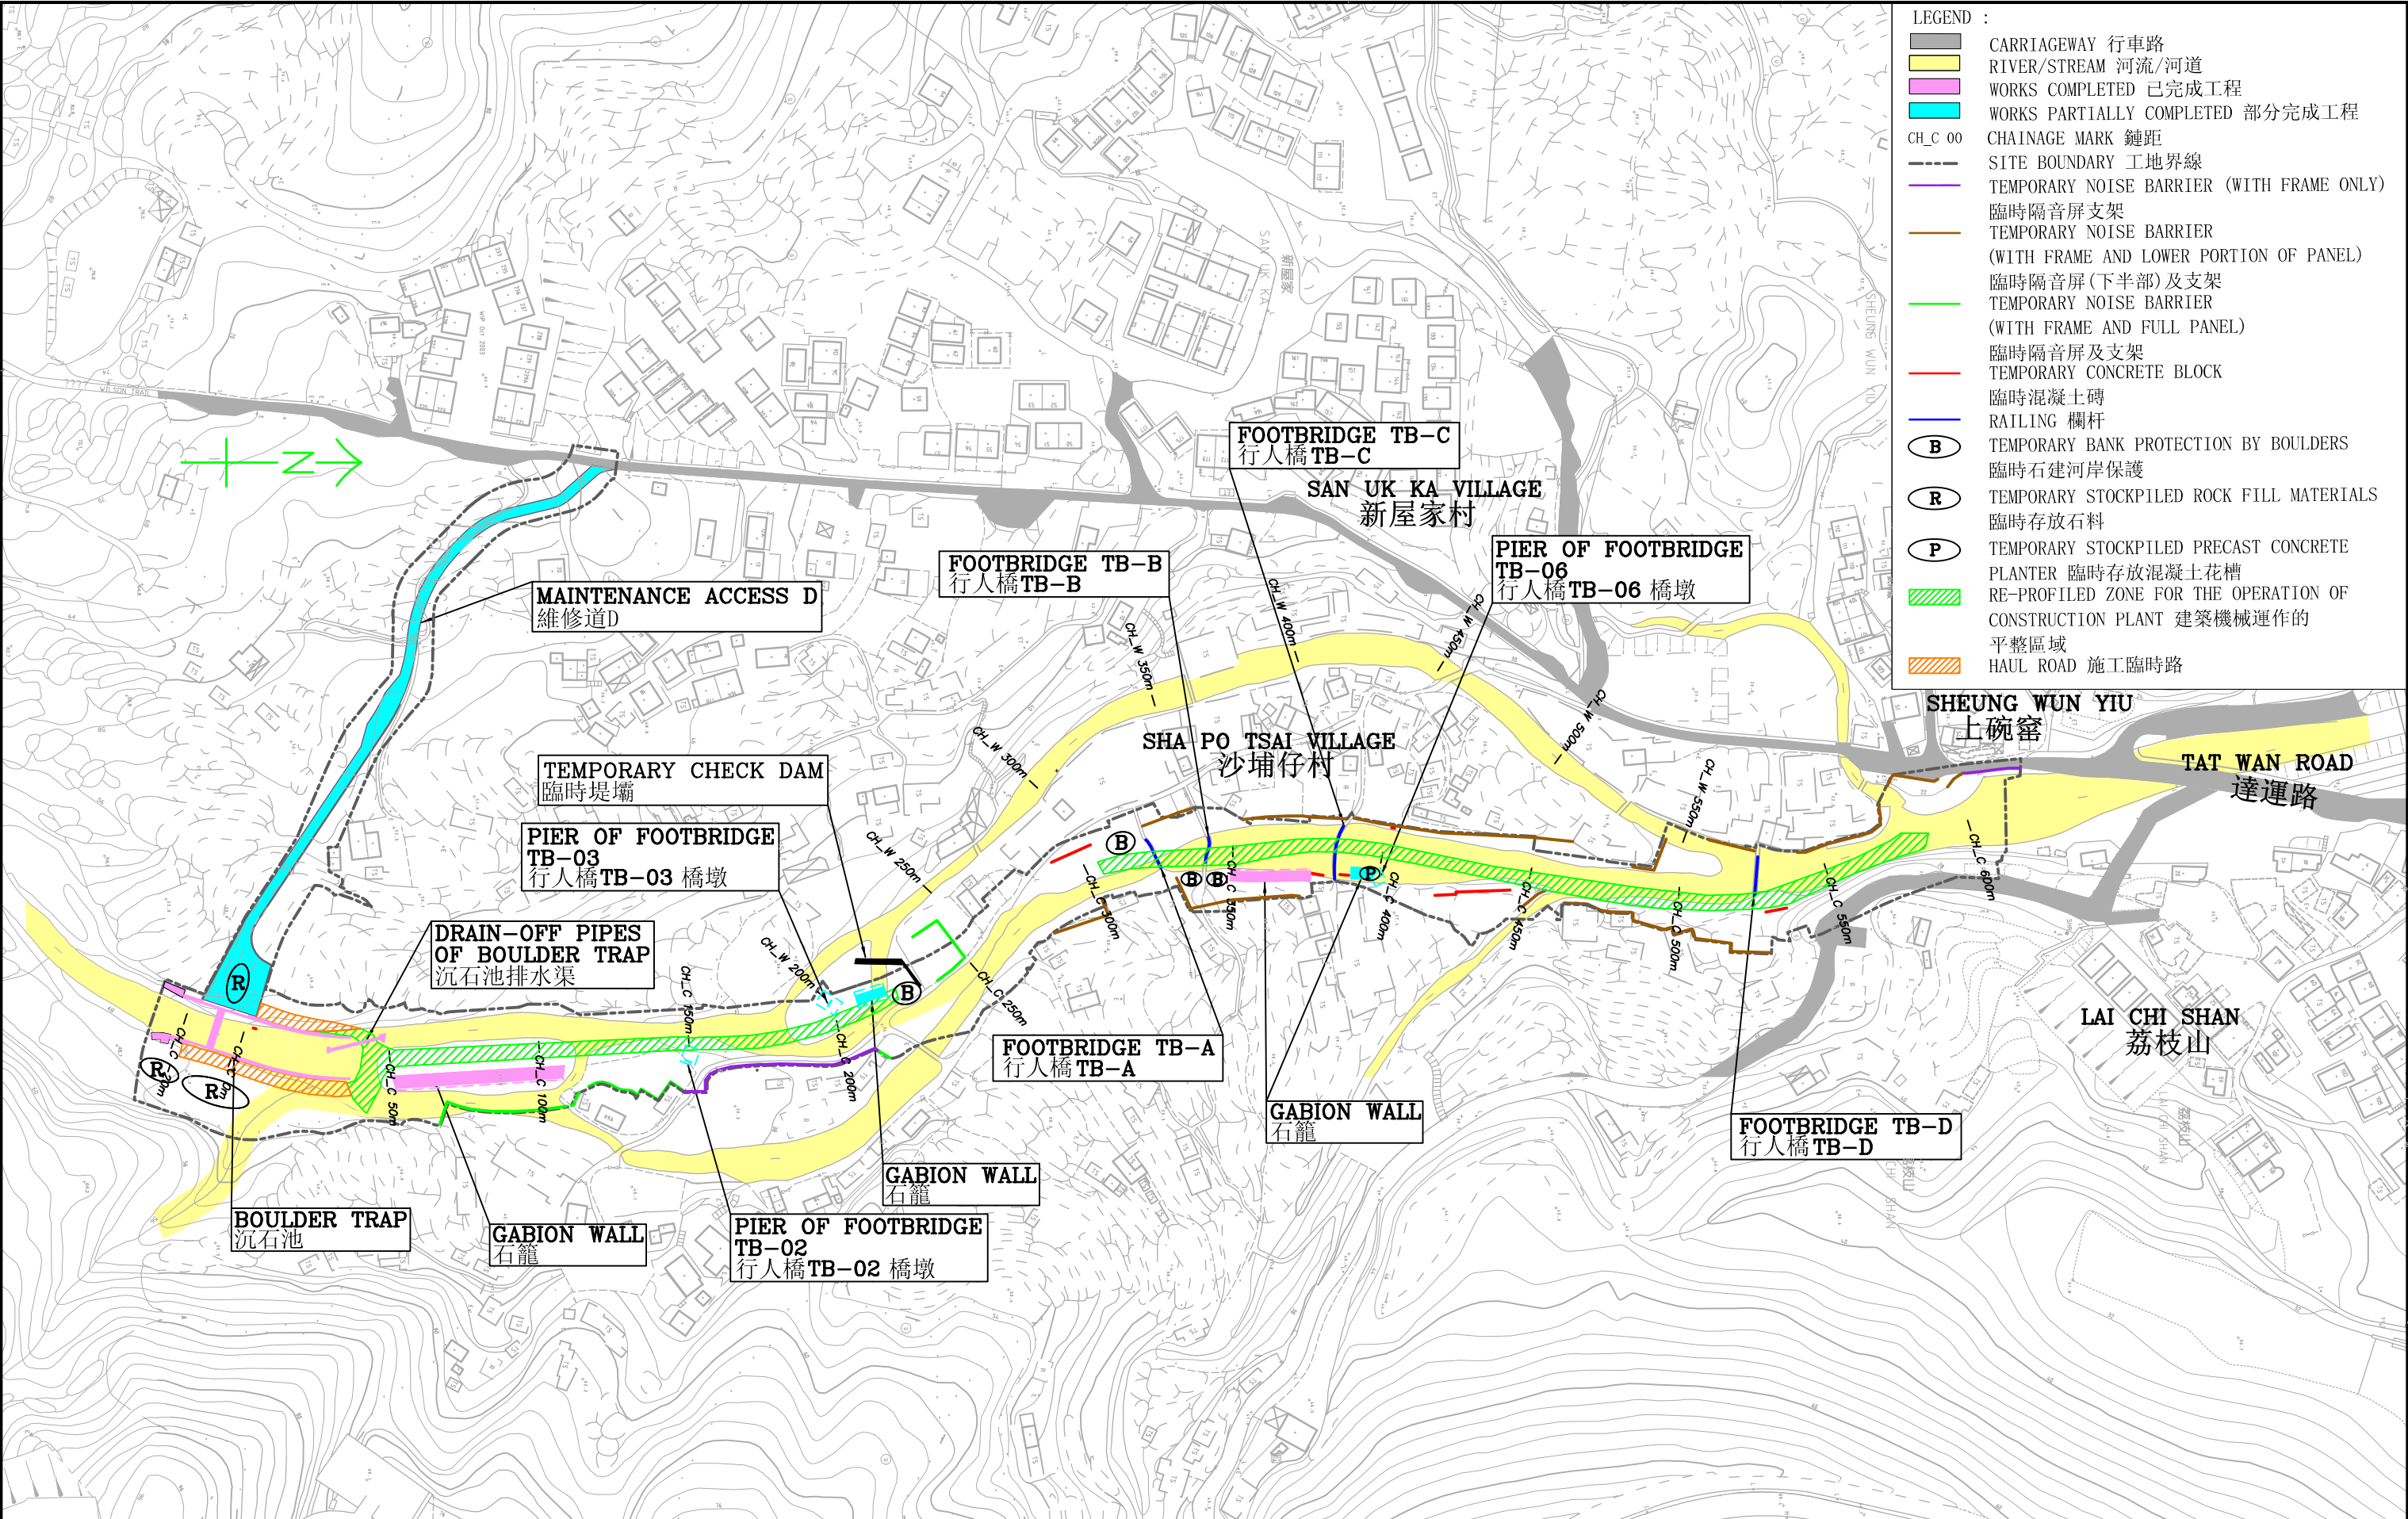
上述數學模型的水力分析結果顯示，整體來說，已建成工程沒有加劇這次水浸的程度。本調查亦對每一項已建成的工程(包括臨時建造工程)的影響，再作進一步的獨立分析研究。水浸發生前的已建成工程有沉石池、數段石籠、行人橋橋墩及一些臨時工程，包括臨時堤壩、隔音屏障、河岸穩固工程、臨時石料貯存堆和河床的平整，如圖號 5 所示。洪水發生後，雖然大部分永久工程均保持原貌，但有一部份臨時工程結構物被沖走或偏離原位；如圖號 6 所示：

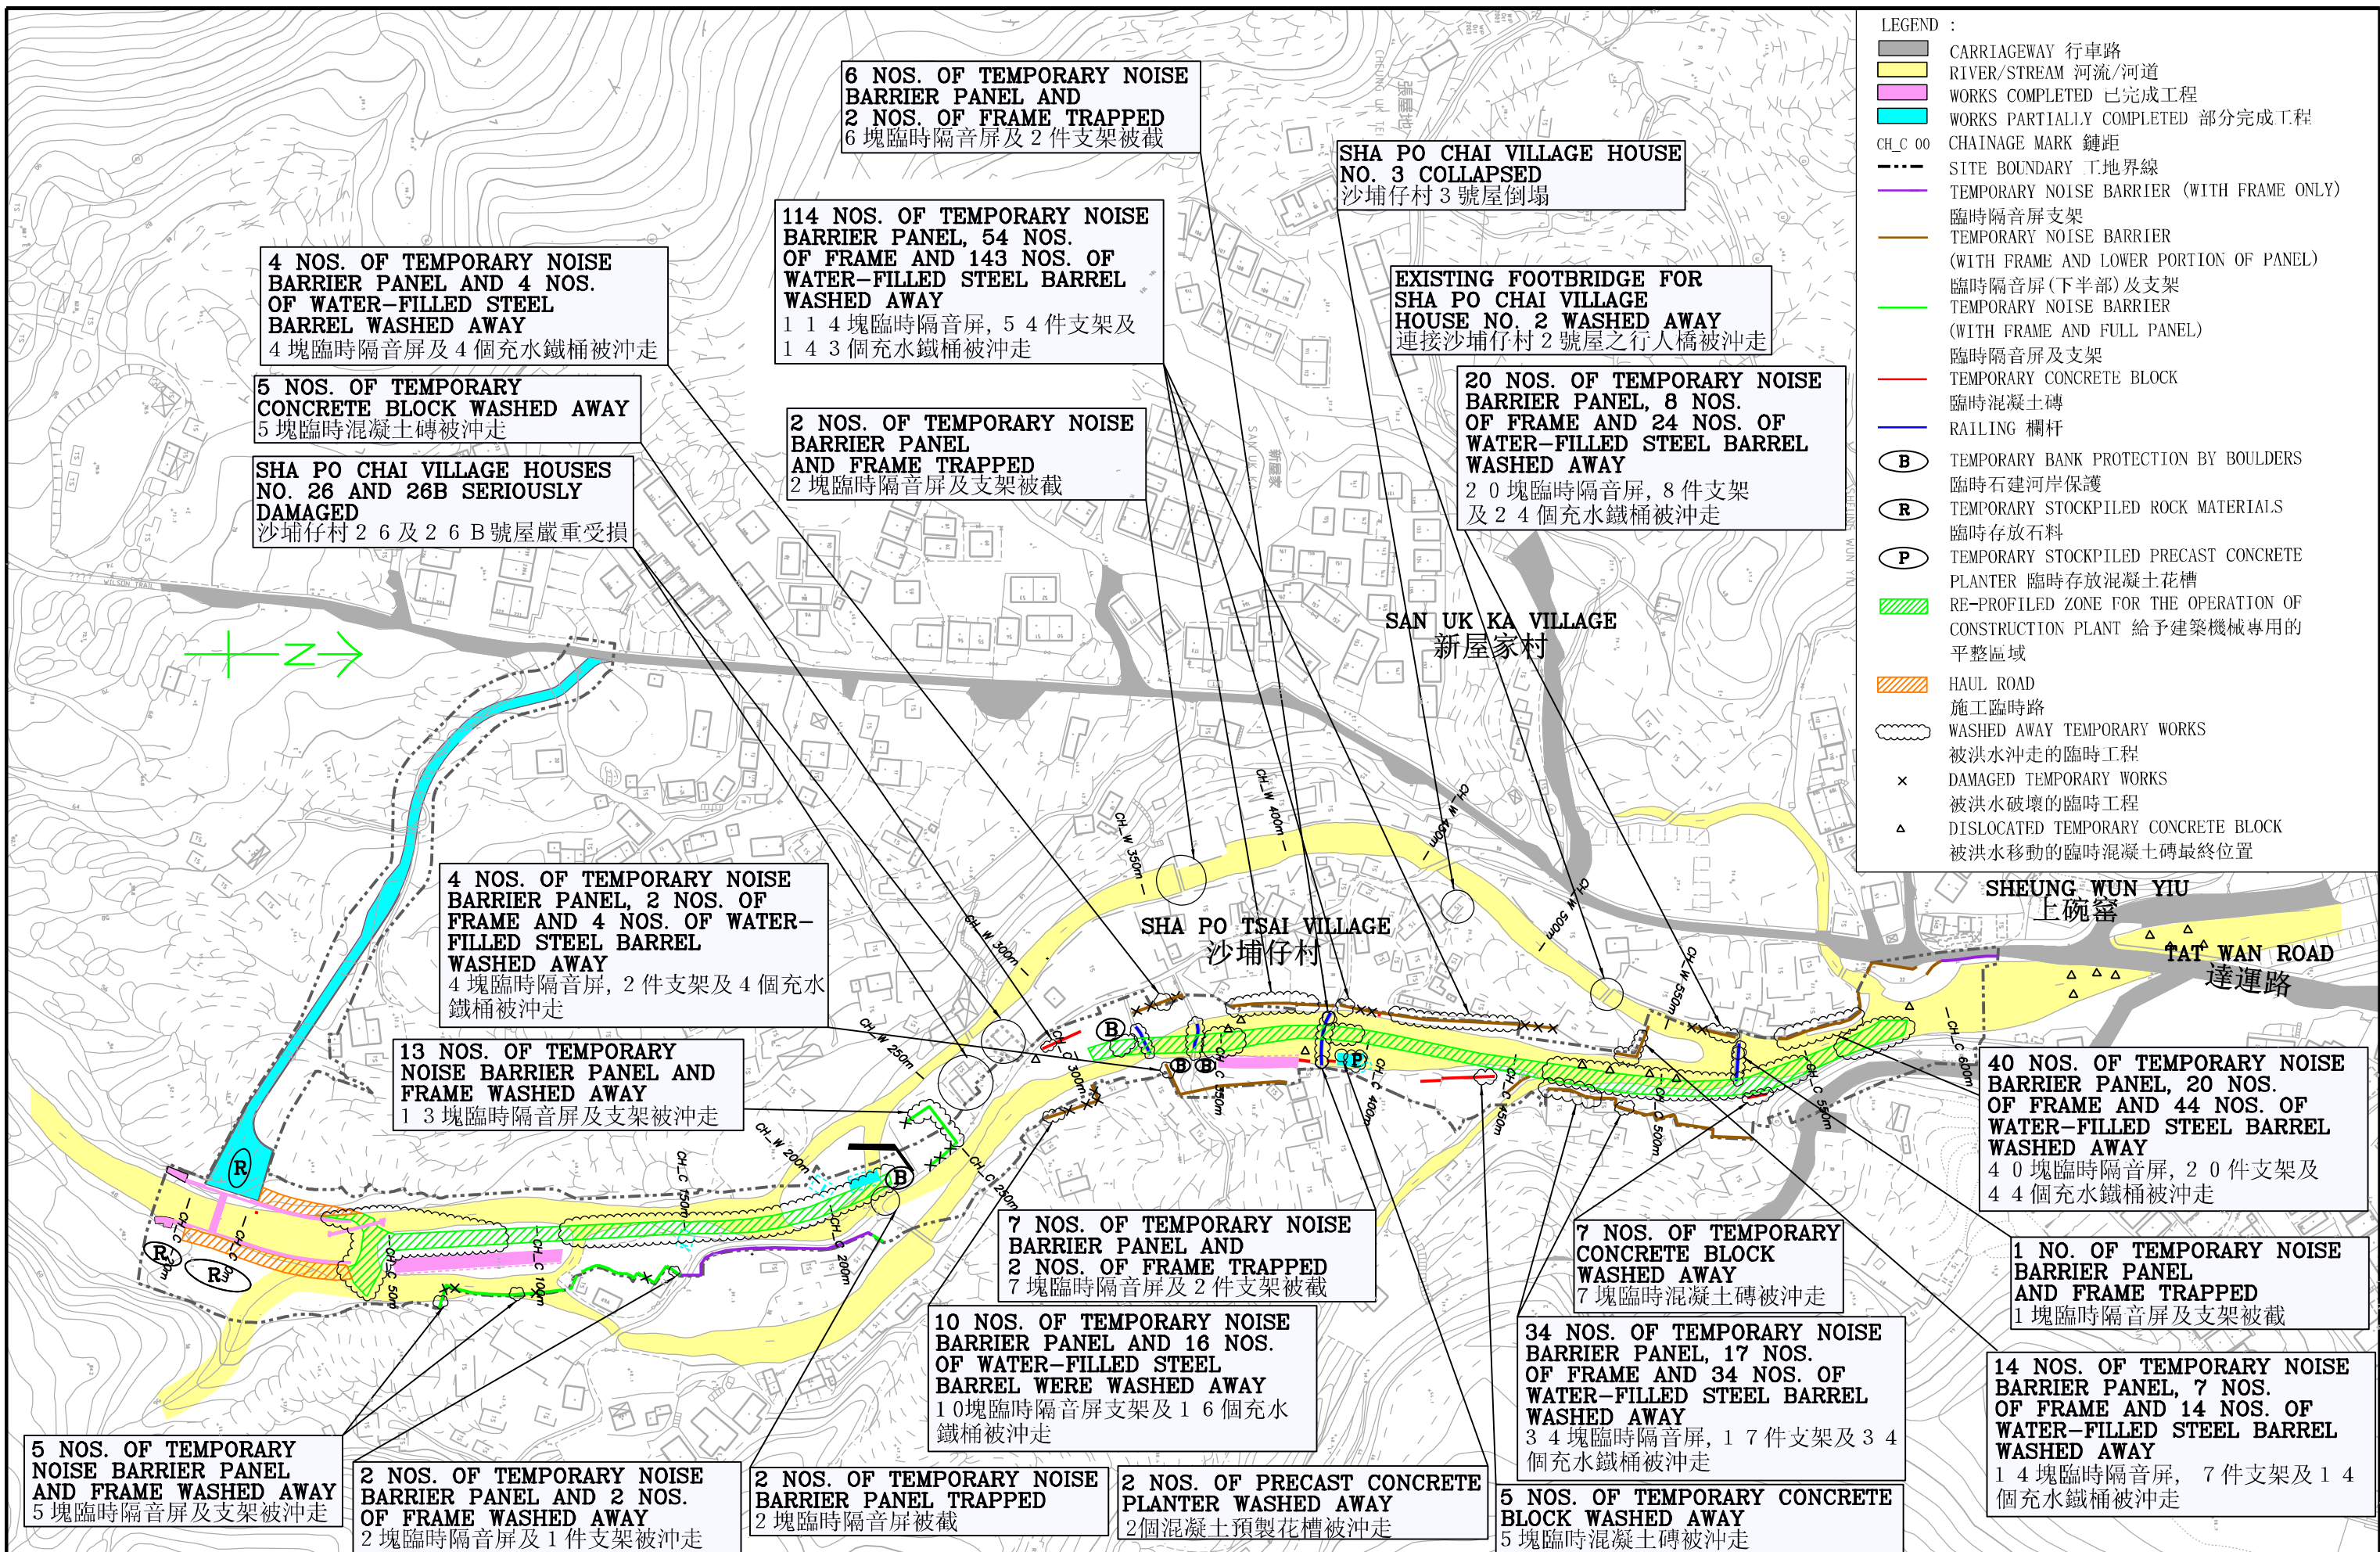
STATUS OF SITE IN TAI PO RIVER (MIDDLE REACHES) ON 23 JULY 2010 (AFTER FLOODING)  
二零一零年七月二十三日(水浸後)大埔河中游段工地狀況

- 臨時河岸穩固物料 – 承建商在中支流河岸擺放了一些大石及混凝土預製磚，作臨時河岸穩固之用。洪水過後，大石仍然保持原位，但如圖號 6 所示，有 17 塊混凝土磚被高速的洪水沖至中支流下游，直至洪水速度減緩方沉積於河道。由於整個過程發生於沙埔仔村下游，這些混凝土磚不應使沙埔仔村的洪水情況惡化。
- 河床的平整區域 – 原有河床有一些不平坦部分，承建商將該部分河床表面修平，以便施工機械操作，但仍然維持該段河道的整體斷面面積，確保不會對水流構成負面影響。洪水過後，重整過的河床部分出現沖刷跡象，主要分佈於交錯分流 2 處下游的中支流處。

While the overall effect of the interim drainage works was assessed in the hydraulic analyses by mathematical modelling to be not adverse, each item of the interim drainage including temporary construction works is studied in more detail. The interim drainage works completed before the flooding event included the Boulder Trap, sections of Gabion Wall and footbridge abutments. The temporary construction works completed before the flooding event included the Check Dam, noise barriers, bank protection, temporary rock fill stockpiles, and river bed re-profiling. Details are shown in **Fig. 5**. All permanent works remained intact after the flooding event. However, some temporary works had been washed away or displaced. Details are shown in **Fig. 6**.

- 
- Temporary Bank Protection – boulders and precast concrete blocks were placed along the bank of the Central Branch as temporary bank protection. The boulders remained in place but 17 precast concrete blocks were displaced and were found deposited at the downstream reaches of the Central Branch as shown in **Fig. 6**. These blocks were moved by the high velocity flow and deposited when the flow subsided. As the process took place on the downstream of the Sha Po Tsai Village, the blocks should not have aggravated the flooding situation there.
