Installation of Grouted Jacket to Protect Existing Major Water Pipes for Trenchless Construction in Hong Kong

Ir. Maurice W. W. Lee^a, Ir. Quentin K. T. Yau^a,
Ir. K. W. Mak^b, Ir. S. S. Lam^b and Ir. F. C. Lui^b

ABSTRACT

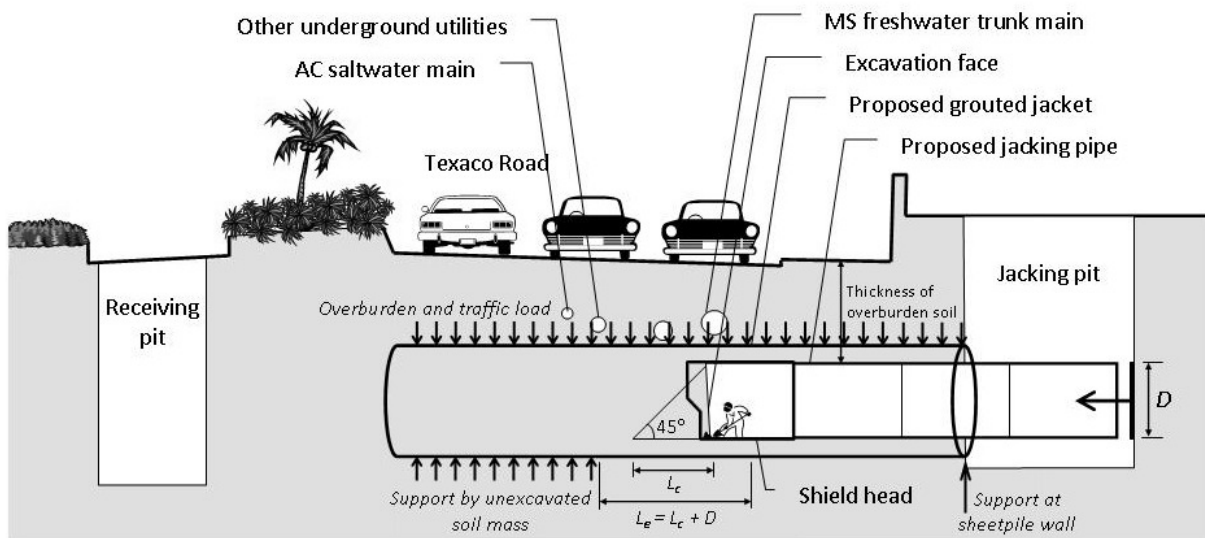
Such situation was faced by the project team for urban drainage improvement project in Tsuen Wan and Kwai Chung of Hong Kong during the construction of a 1800mm diameter stormwater pipe across Texaco Road near Tsuen Wing Street, Tsuen Wan. The Employer of the project was Drainage Services Department (DSD) of the Government of Hong Kong SAR, the Engineer of the project was Maurice Lee & Associates Ltd. and the Contractor was Shanghai Urban Construction (Group) Corporation. The overburden soil of the stormwater pipe was around 2.6m which was less than two times of the pipe diameter (1800mm) necessary to utilize the soil arching effect according to normal practice. Further, among other underground utilities, there were a 750mm diameter mild steel (MS) freshwater trunk main and a 450mm diameter asbestos cement (AC) saltwater main. The latter was laid in 1970s particularly attracted concerns because it was brittle. It was found only 890mm above the external circumference of the proposed jacking pipe. See Figure 1.

Figure 1 Longitudinal profile of Texaco Road and effective span of the grouted jacket

When considering the hollow tubular section as a beam, the composite action of the grouted jacket would be spanning between supports on two sides, with effective span (L_e) supporting the design loading, see Figure 1.

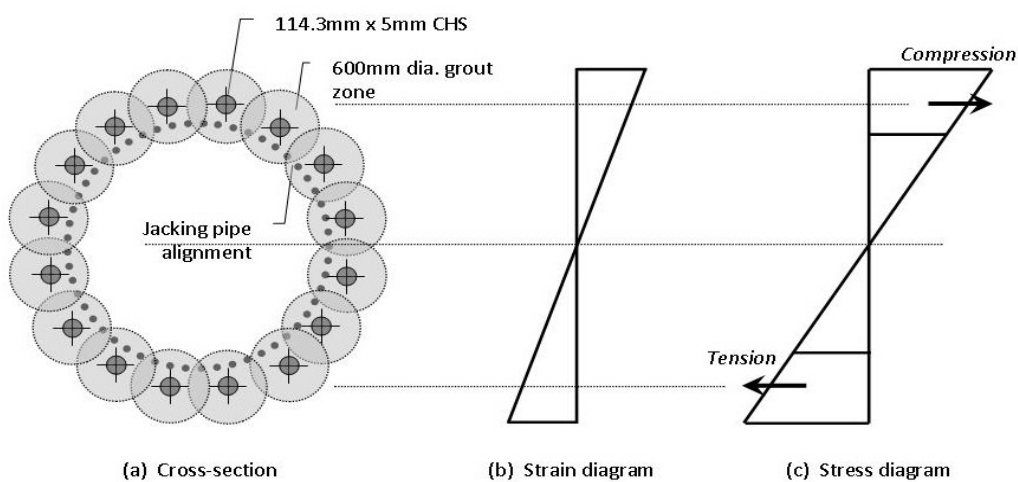
The obvious critical modes of failure would be bending and shear. Bending failure was assumed to be resisted by composite action of the steel tubular section and the grouted soil, see Figure 2.

Figure 2 Structural arrangement and effective span

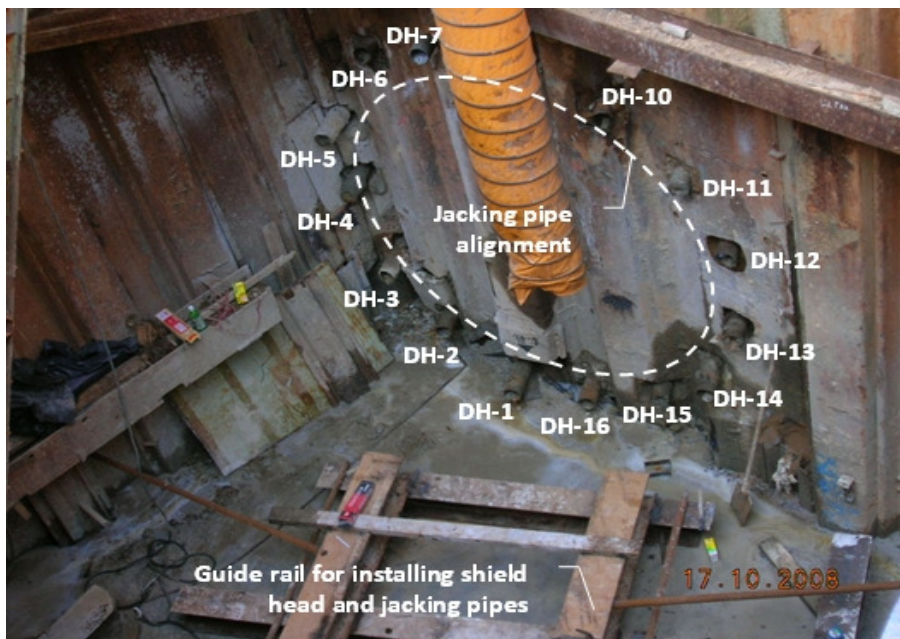
The grouted jacket construction commenced on 20 August 2008 and completed on 4 October 2008. A total of 16 holes were drilled and grouted. The left hand side of the bottom two pairs of holes was numbered as DH-1, while the other holes were numbered from DH-2 to DH-16 in a clockwise sequence. See Figure 5.

Figure 5 Completion of the grouted jacket (DH-8 and DH-9 were behind the vent pipe)

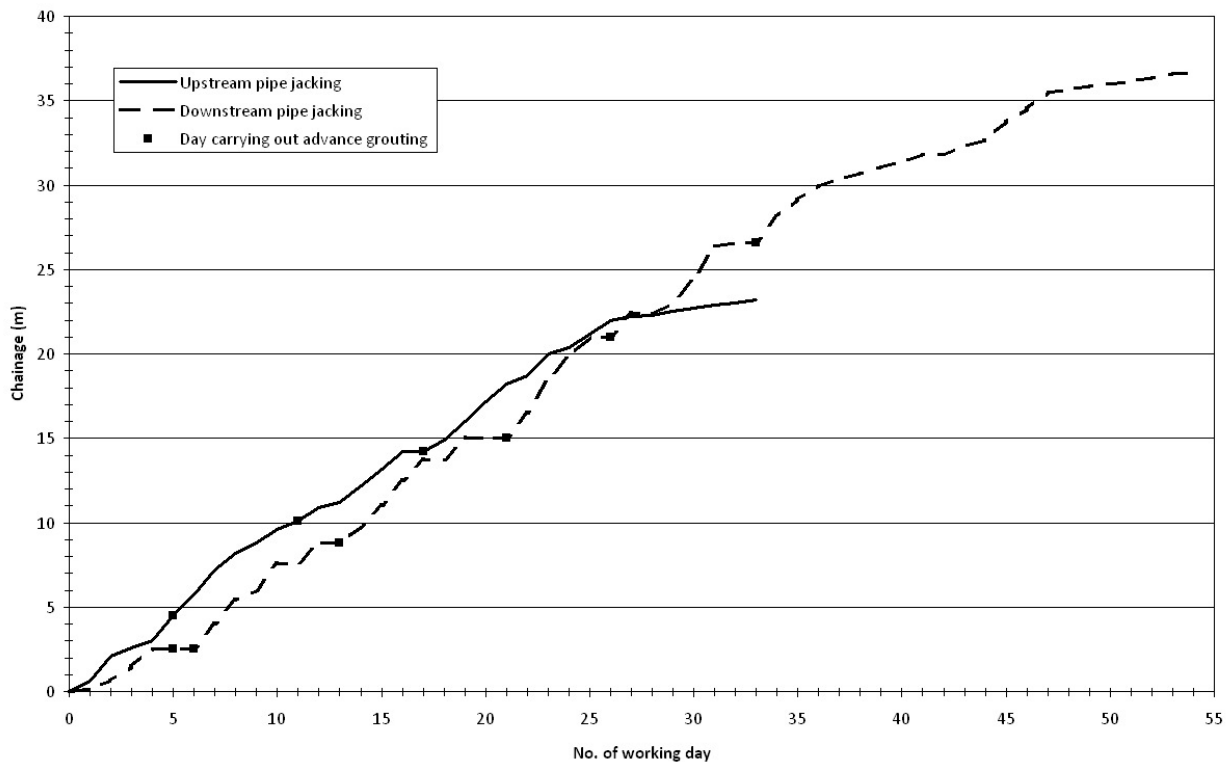
The pipe would be jacked 6m before another stage of grouting was carried out to ensure that all excavations were within the grouted soil. Therefore, for a 23.2m long pipe jacking works, a total of 4 stages of advance grouting were carried out. The rate of pipe jacking was shown in Figure 6 below. Due to the accurate installation of the CHS of the grouted jacket, the shield head never ran into any CHS.

Figure 6 Rate of pipe jacking

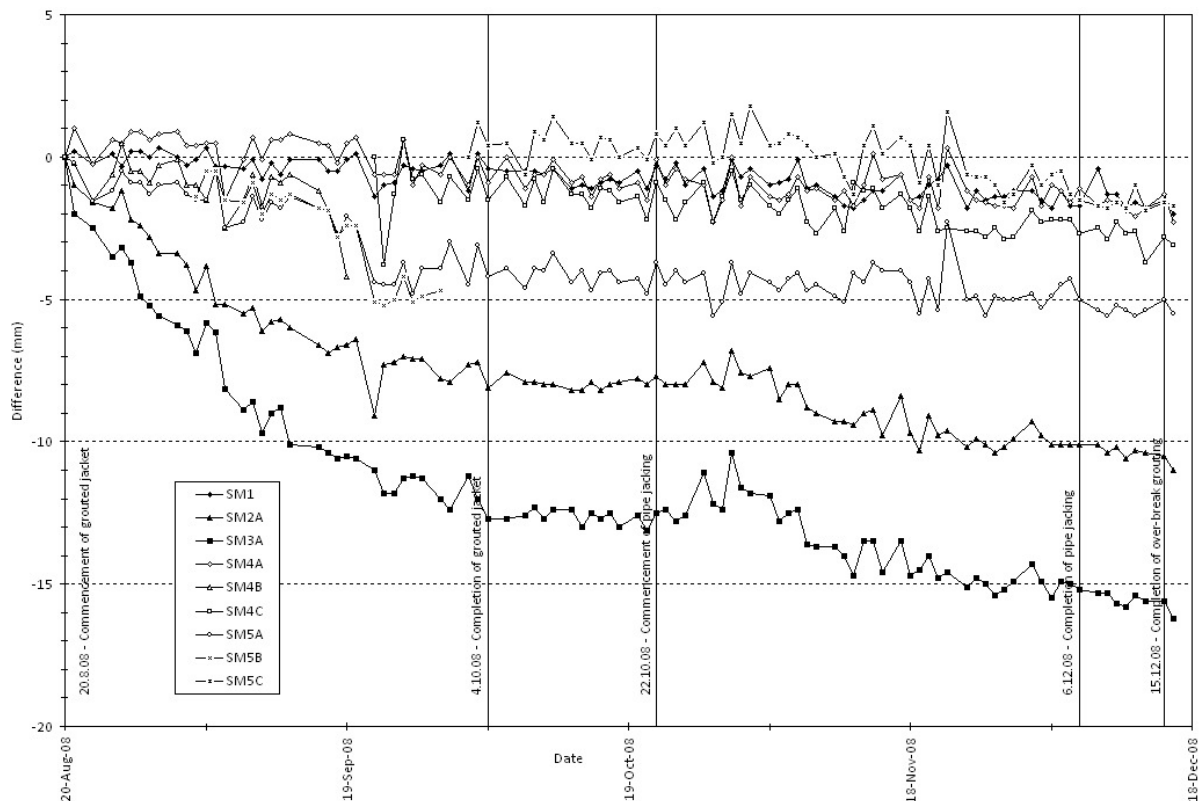
The grouted jacket construction was commenced on 20 August 2008. A settlement check point SM3A on the footpath near the jacking pit soon recorded substantial settlement, which eventually reached 13mm when the grouted jacket was completely constructed on 4 October 2008. Another check point SM2A adjacent to SM3A also recorded maximum 8mm settlement. The other markers recorded negligible settlements. See Figure 7.

Figure 7 Settlement due to construction of the grouted jacket and pipe jacking operation

The noticeable settlement was investigated before commencement of the pipe jacking works. Since no settlement was visually observed on the concrete kerb line and bituminous road surfacing, it was deduced with confidence that the settlement recorded was a local one restricted near the jacking pit and had not extended to the carriageway nor the AC water main.

The footpath where the check points SM2A and SM3A were located was covered by light duty bricks. A crater-like settlement of the bricks around the check points and a slight tilting parallel to the face of the adjacent 2m high concrete partition wall were observed. It was suspected that there was localized loss of underground soil near the jacking pit, probably brought into the jacking pit by groundwater through the local gaps in the sheet pile wall. This was later confirmed when the jacking pit was backfilled and the sheet pile wall removed. A cavity of around 1m³ was found under the concrete cover behind the top end of the sheet pile wall.
