COMPLAINT LOG

Noise Mitigation Measures

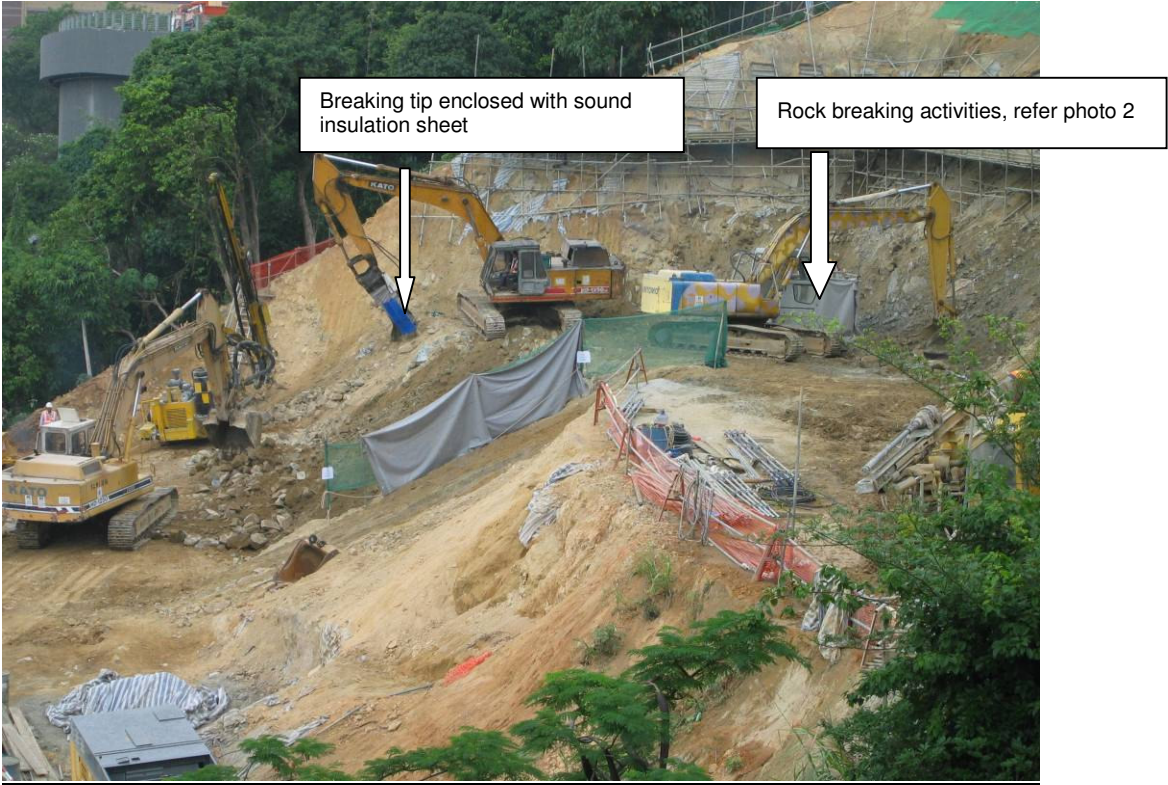
1. Sound insulation sheet erected with the green net.

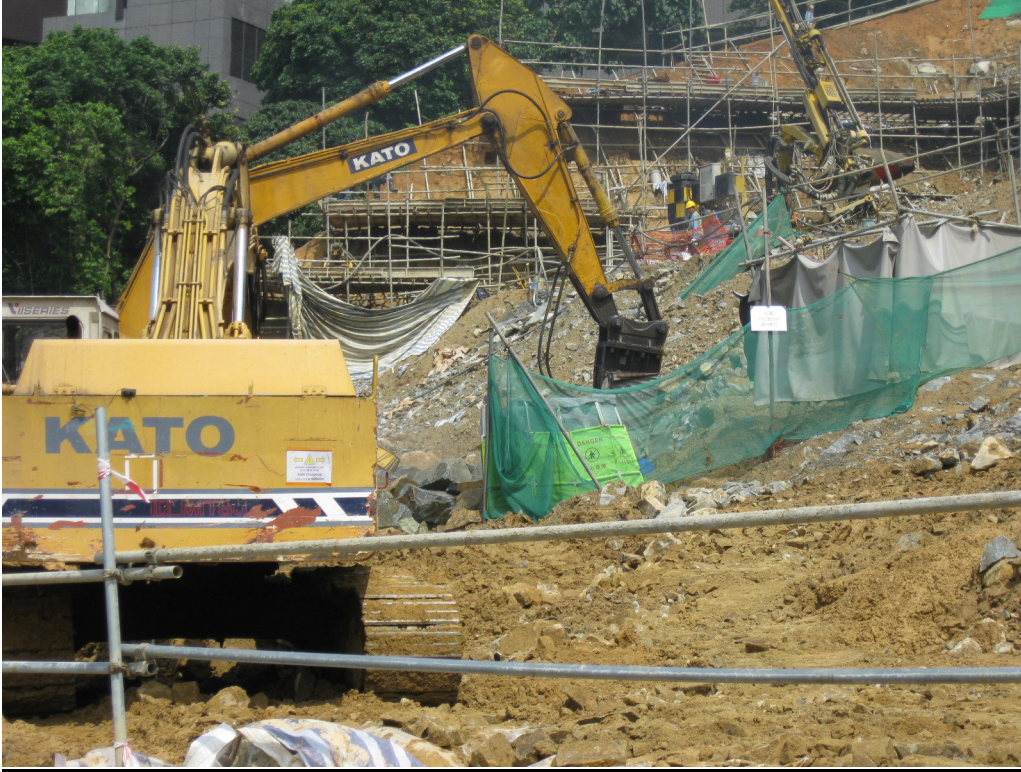
3. Noise insulation material for rock breaking.

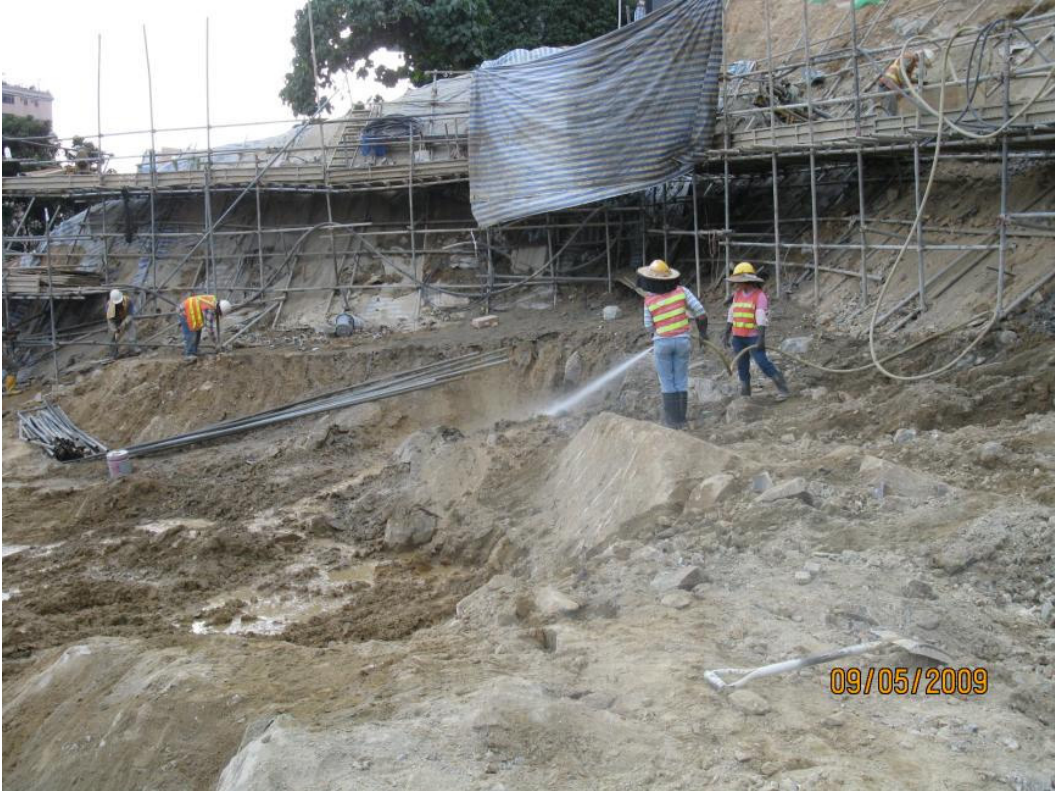
1. Water spraying for the exposed area.

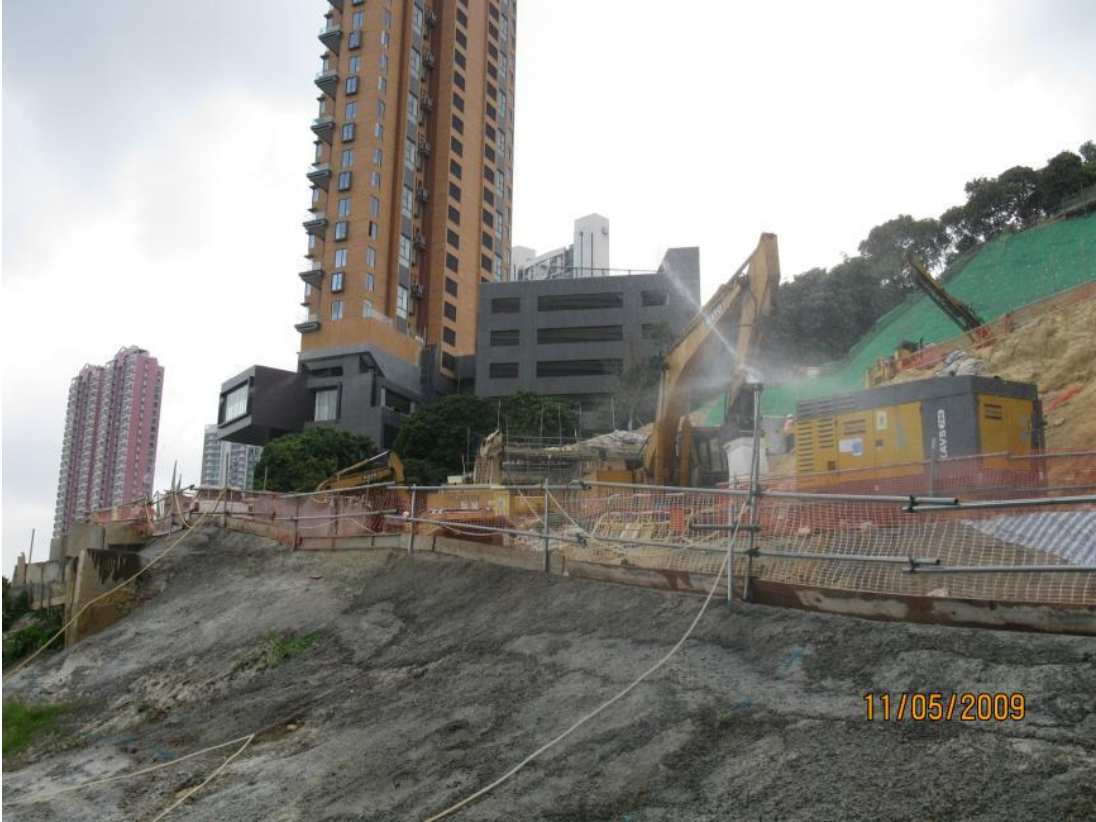
2. Automatic sprinkler spraying the haul road.

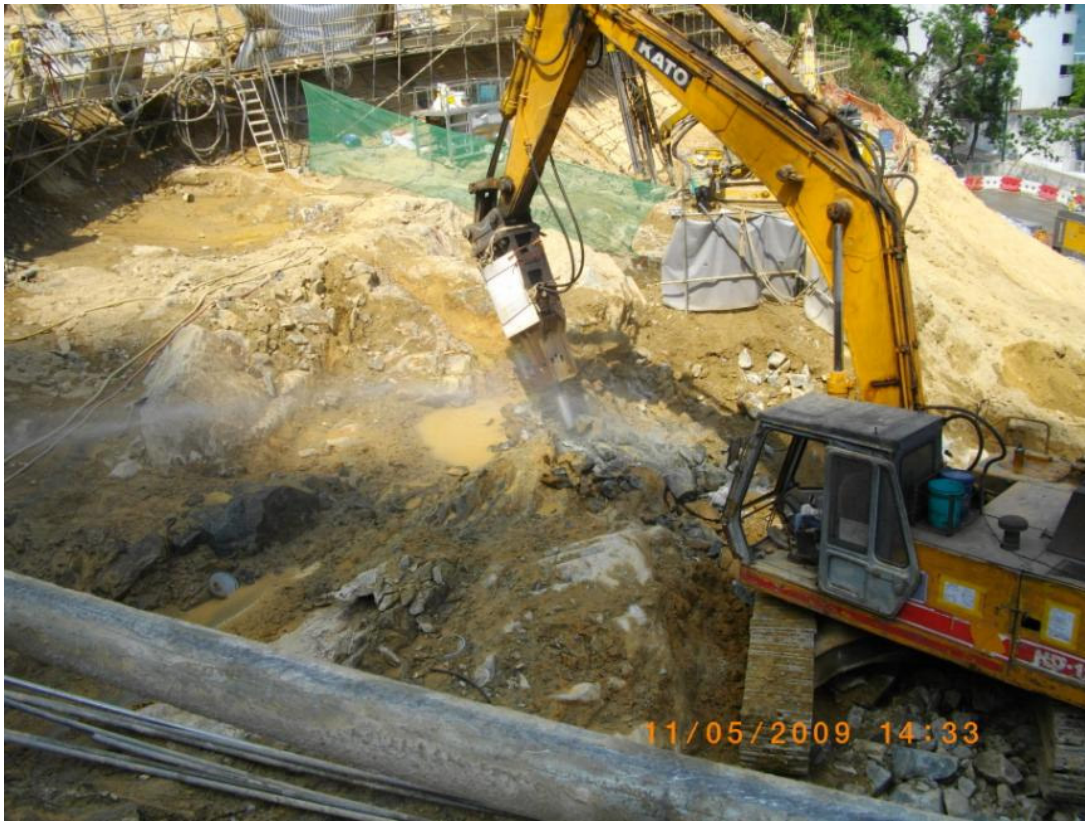
3. Water spraying during rock breaking.

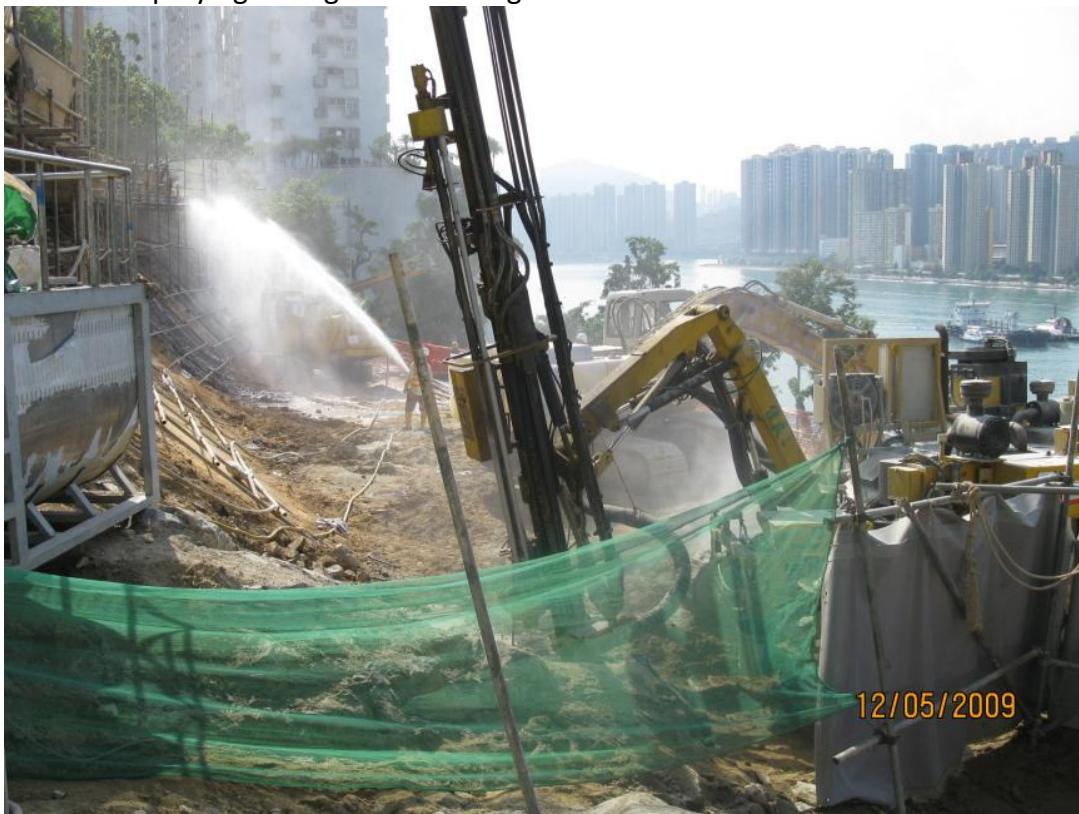
4. Water Spraying for soil nail work.
