**Interim Notifications of Environmental Quality Limits Exceedances**

Incident Report on Action Level or Limit Level Non-compliance

Project	Tsuen Wan Drainage Tunnel
Date	11-Sep-09
Time	9:40 AM
Monitoring Location	Sik Sik Yuen Ho Fung College (I-1)
Parameter	Suspended Solid
Action & Limit Levels	8.85 / 10.17
Measured Level	4.9 (higher than 130% of control station's SS)
Possible reason for Action or Limit Level Non-compliance	A low SS level of 2.2 is recorded at Control Station (I-1-C)
Actions taken / to be taken	The measured SS level was below baseline Action / Limit Level and was within the range of baseline SS concentration (1-10.5mg/L). Only water pumping work was undertaken during the measurement and no direct disturbance was observed from the site. Thus, the exceedance is considered to be contributed by natural variation and no action should be required.
Remarks	Following mitigation measures were provided: (1) sandbags were used at the gap of the bridge to avoid wastewater from site activities directly running down to the channel of I-1. (2) The working site was segregated with a wall and no wastewater was observed down to the channel-I1. (3) Sand/silts removal facilities wa

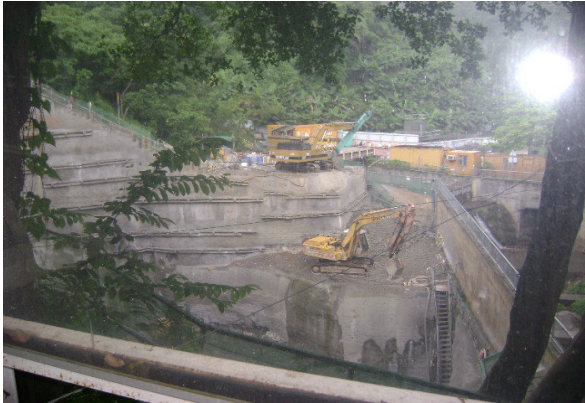
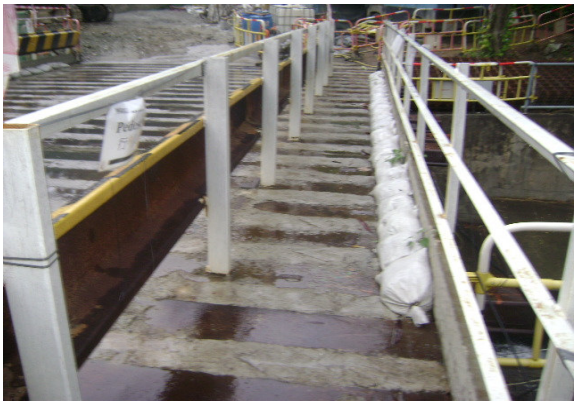
Site photo

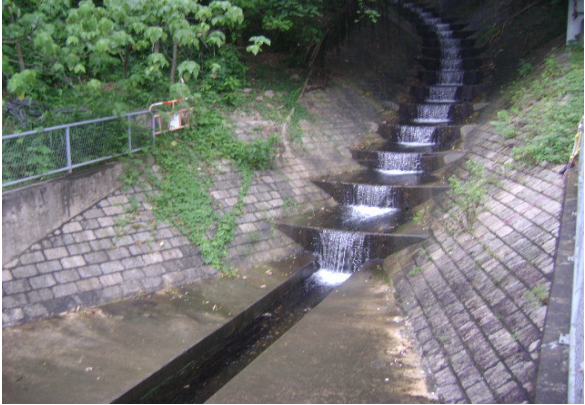
Photo taken at I-1

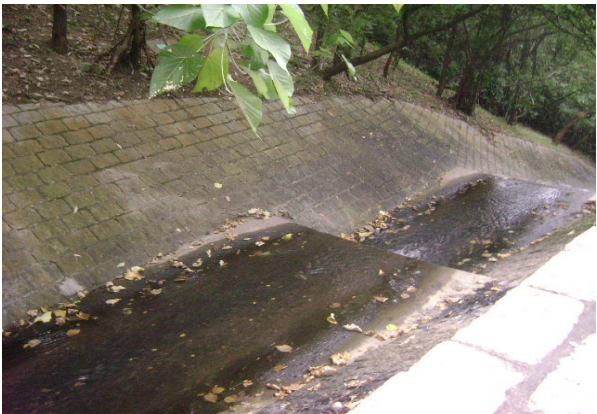
Photo taken at I-1-C

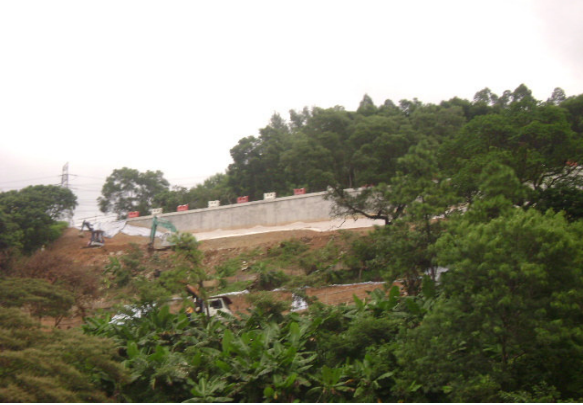
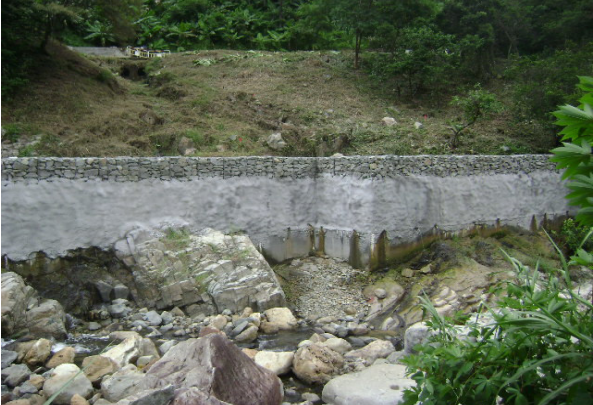
Site photo

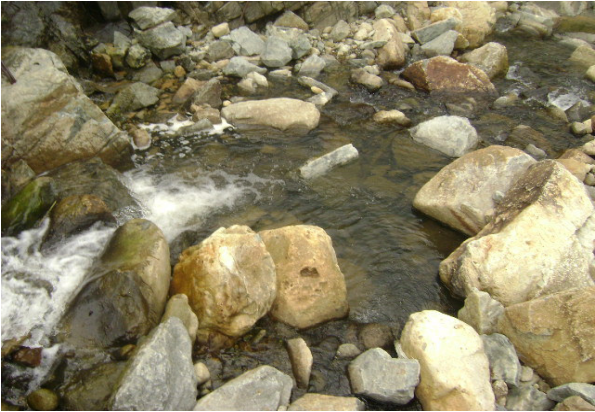
Photo taken at I-3

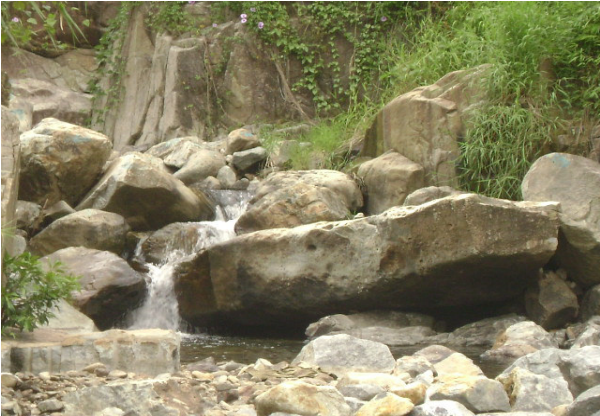
Photo taken at I-3-C

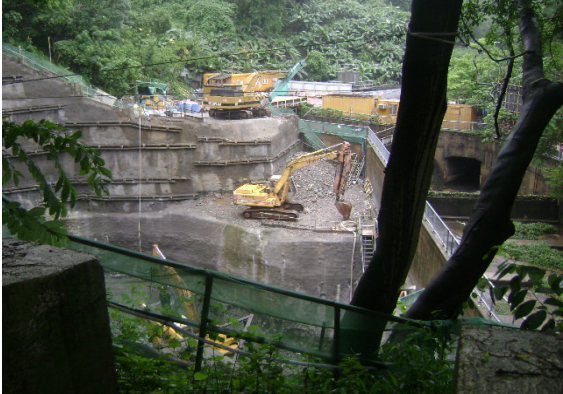
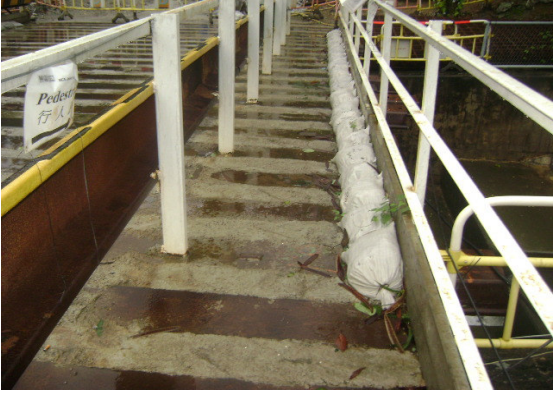
Site photo

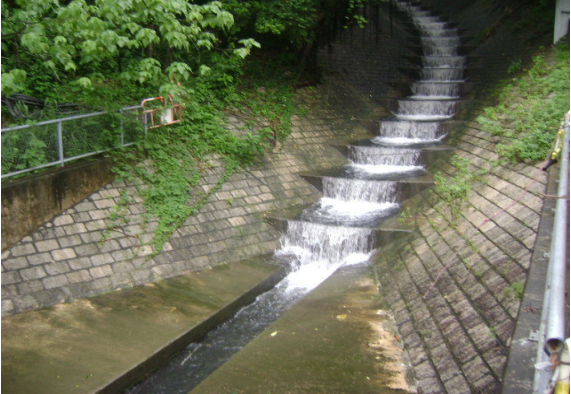
Photo taken at I-1

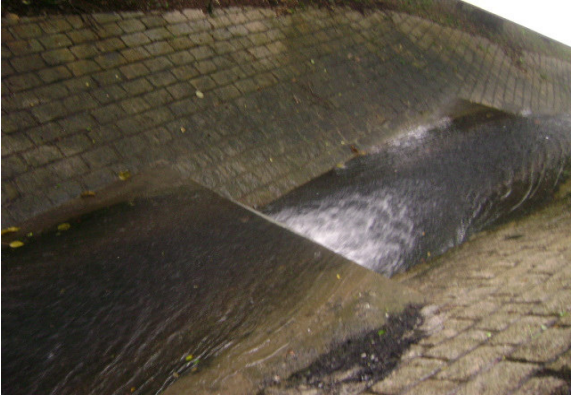
Photo taken at I-1-C
