Interim Notifications of Environmental Quality Limits Exceedances

Incident Report on Action Level or Limit Level Non-compliance

Project	Tsuen Wan Drainage Tunnel
Date	04-Nov-09
Time	10:00 AM
Monitoring Location	Sik Sik Yuen Ho Fung College (I-1)
Parameter	Turbidity
Action & Limit Levels	9.75 / 12.47
Measured Level	13.68
Possible reason for Action or Limit Level Non-compliance	A high turbidity level of 14.11 is recorded at Control Station (I-1-C)
Actions taken / to be taken	The measured turbidity level was above baseline Action and Limit Levels as well as the range of baseline turbidity concentration (3.13 - 13.15 NTU). Construction activities, such as rock breaking, rock dowel and mucking out, were undertaken during the measurement and no direct disturbance was observed from the site. Thus, the exceedance is considered to be contributed by the high turbidity level of control station (I-1-C) and no action should be required.
Remarks	Following mitigation measures were provided: (1) sandbags were used at the gap of the bridge to avoid wastewater from site activities directly running down to the channel of I-1. (2) The working site was segregated with a wall and no wastewater was obs

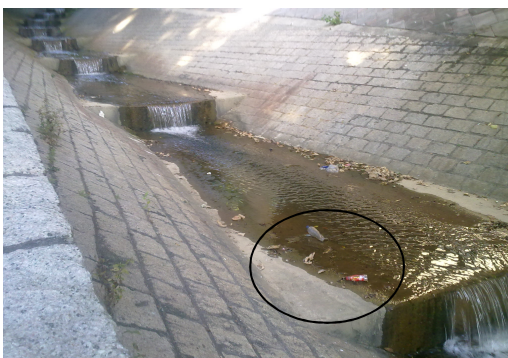
Rubbish was observed at I-1-C

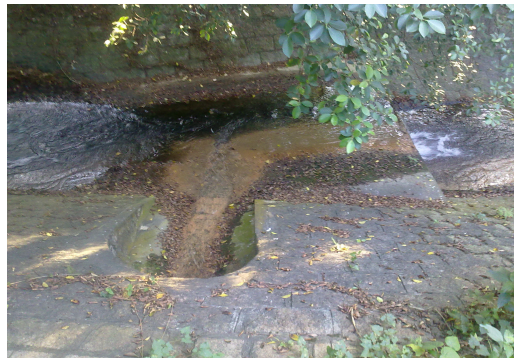
Muddy stain was observed at the exit of the closed channel at upstream near Shing Mun Lane.

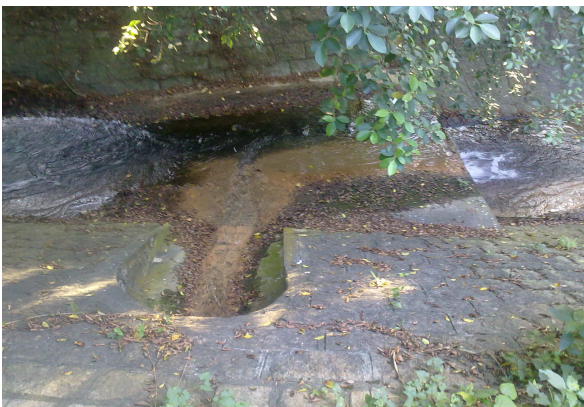
Muddy stain was observed at the exit of the closed channel at upstream near Shing Mun Lane.

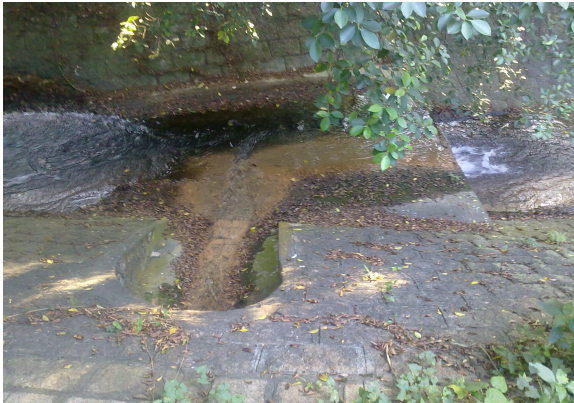
Muddy stain was observed at the exit of the closed channel at upstream near Shing Mun Lane.

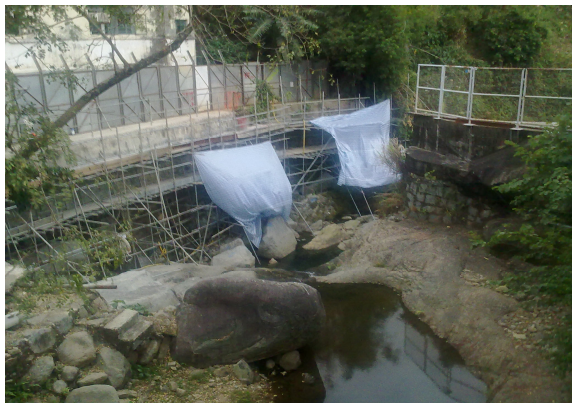
Construction activities at I-2-C.

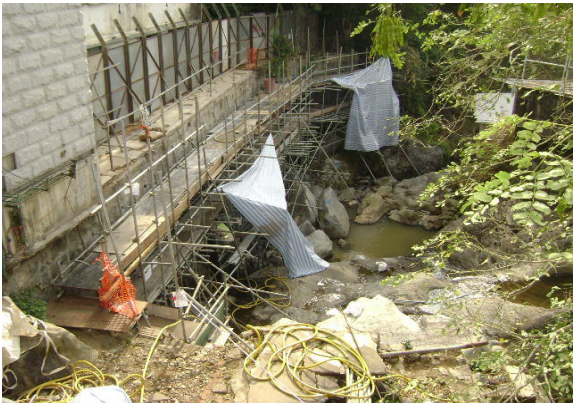
Construction activities at I-2-C.

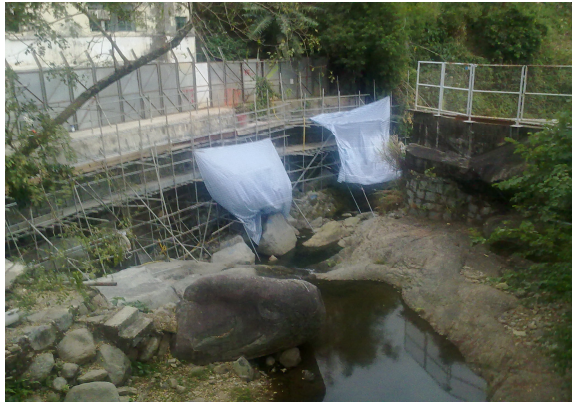
Construction activities at I-2-C.

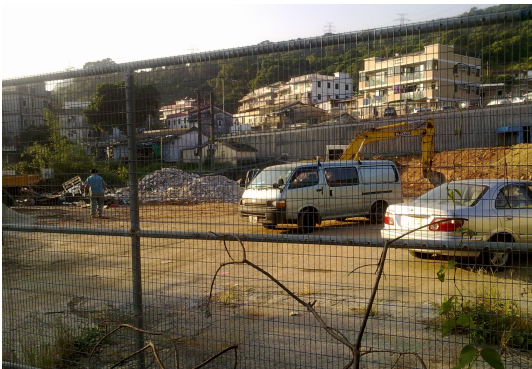
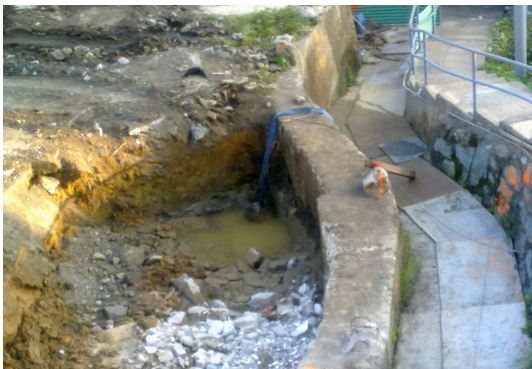
Construction activities at Wo Yi Hop Village near I-1-C

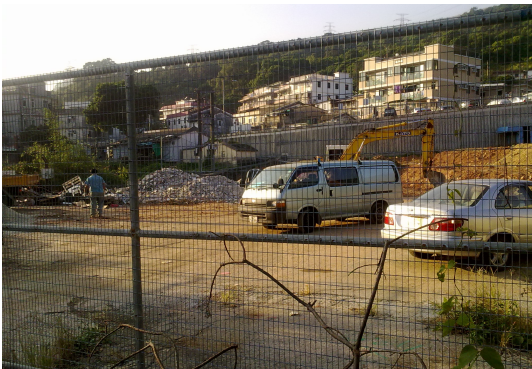
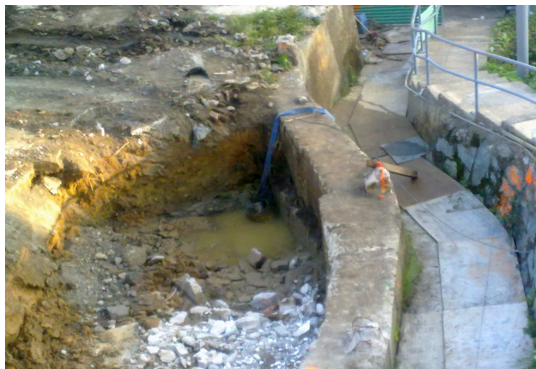
Construction activities at Wo Yi Hop Village near I-1-C

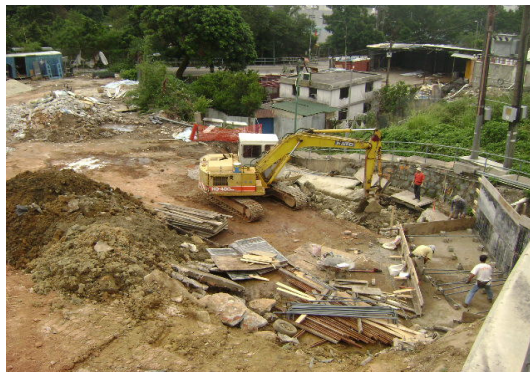
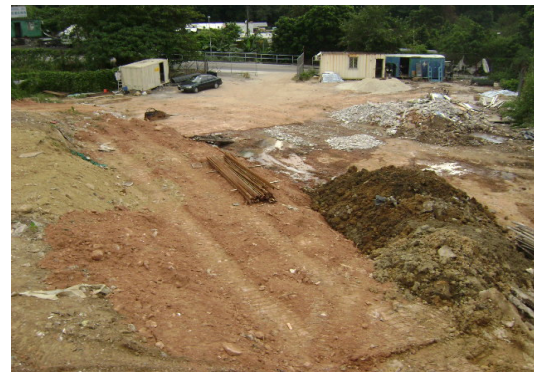
Construction activities at Wo Yi Hop Village near I-1-C

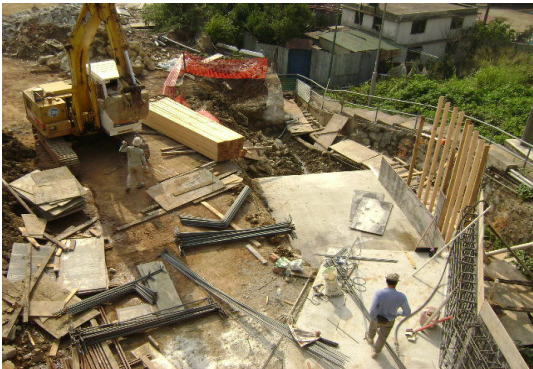
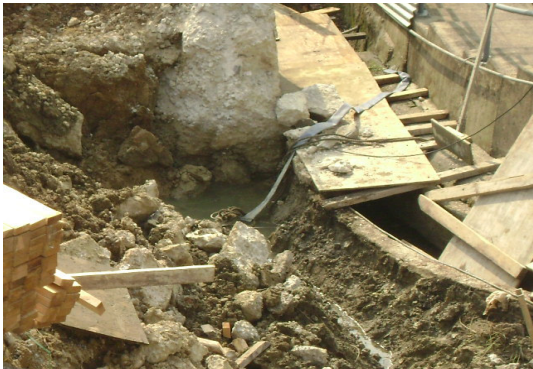
Construction activities at Wo Yi Hop Village near I-1-C
