Interim Notifications of Environmental Quality Limits Exceedances

Incident Report on Action Level or Limit Level Non-compliance

Project	Tsuen Wan Drainage Tunnel
Date	06-Jan-10
Time	10:30 AM
Monitoring Location	Sik Sik Yuen Ho Fung College (I-1)
Parameter	Turbidity
Action & Limit Levels	9.75 / 12.47
Measured Level	19.47
Possible reason for Action or Limit Level Non-compliance	A high turbidity level of 19.67 is recorded at Control Station (I-1-C). Other construction activities were carried out at control station during the measurement. (Refer to the photos below).
Actions taken / to be taken	The measured turbidity level was above baseline Action/Limit Levels as well as higher the range of baseline turbidity concentration (3.13-13.5 NTU). Construction activities, such as disposal of C&D materials, site cleaning and tidying as well as shotcrete to shaft wall, were undertaken during the measurement and no direct disturbance was observed from the site. Thus, the exceedance is considered to be contributed by the high turbidity level of control station (I-1-C) and no action should be taken as the turbidity result at monitoring station was below the action and limit level of control stat

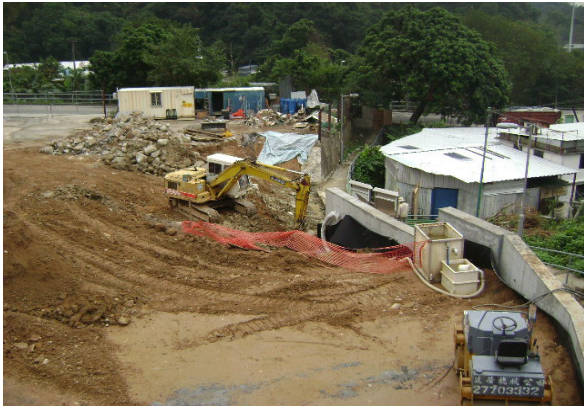
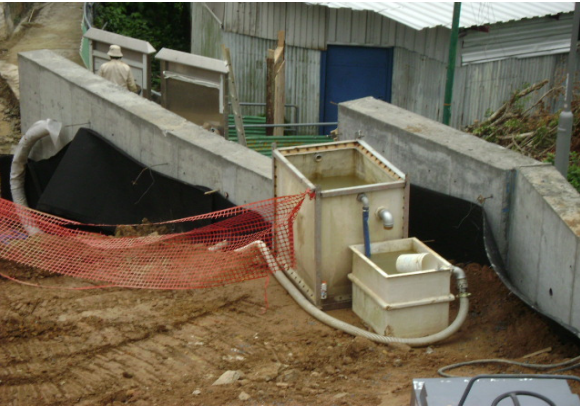
Construction activities at I-1-C

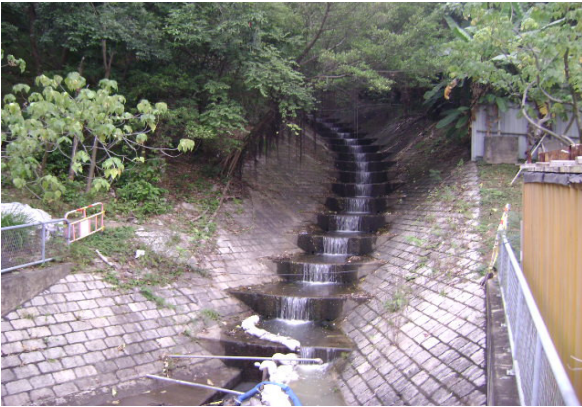
Photo taken at I-1

Project	Tsuen Wan Drainage Tunnel
Date	06-Jan-10
Time	10:30 AM
Monitoring Location	Sik Sik Yuen Ho Fung College (I-1)
Parameter	Suspended Solid
Action & Limit Levels	8.85 / 10.17
Measured Level	13.6
Possible reason for Action or Limit Level Non-compliance	A high SS level of 16.3 is recorded at Control Station (I-1-C). Other construction activities were carried out at control station during the measurement. (Refer to the photos below).
Actions taken / to be taken	The measured SS level was above baseline Action/Limit Levels as well as higher than the range of baseline SS concentration (1-10.5mg/L). Construction activities, such as disposal of C&D materials, site cleaning and tidying as well as shotcrete to shaft wall, were undertaken during the measurement and no direct disturbance was observed from the site. Thus, the exceedance is considered to be contributed by the high SS level of control station (I-1-C) and no action should be taken as the SS result at monitoring station was below the action and limit level of control station.

Remarks	Following mitigation measures were provided: (1) sandbags were used at the gap of the bridge to avoid wastewater from site activities directly running down to the channel of I-1. (2) Water quality mitigation measures were implemented at working area and no wastewater was observed down to the channel-I1. (3) Sand/silts removal facilities was installed at the location of I-1.

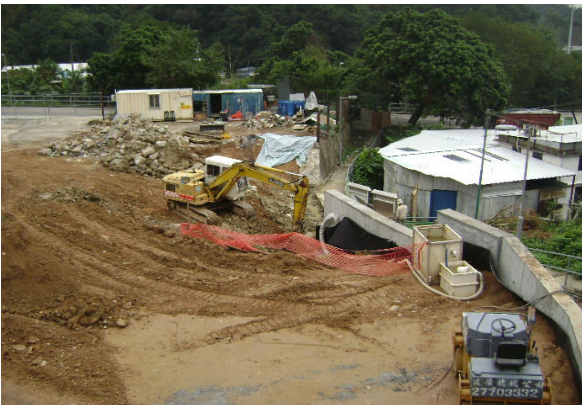
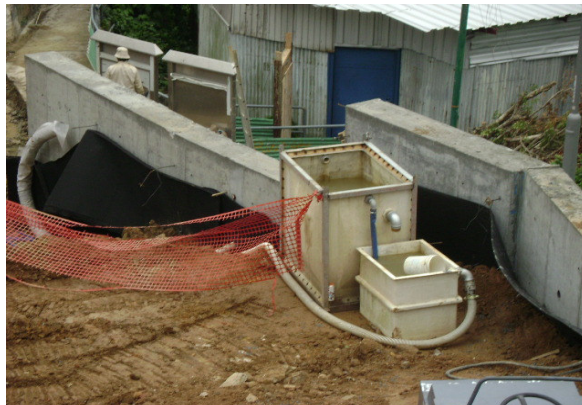
Construction activities at I-1-C

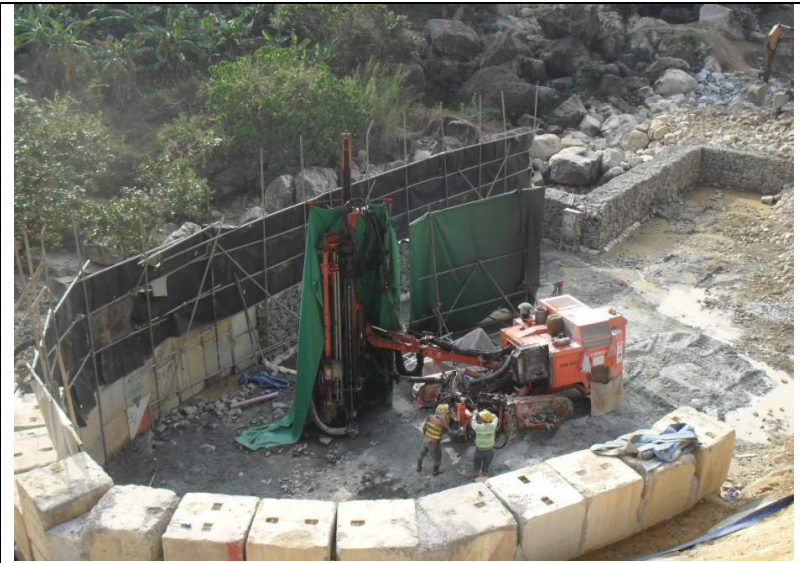
Noise Mitigation Measures at I3

A resident raised a complaint at intake I-3 regarding the noise generated by rock breaker and drilling rig on 19-Jan-2010 and 21-Jan-10.

Sound insulation sheets were installed covering the working area during rock drilling in order to block the line of sight to the NSR.
