**Interim Notification of Environmental Quality Limit Exceedance**

Project	Tsuen Wan Drainage Tunnel
Date	07-May-11
Time	8:45 AM
Monitoring Location	O-1(FT)
Parameter	Dissolved Oxygen (marine surface)
Action & Limit Levels (mg/L)	6.84 / 6.81
Measured Level (mg/L)	6.81
Control Station	O-1-C(FT)
Measured Level at the Control Station (mg/L)	6.99
Possible reason for Action or Limit Level Non-compliance	The measured DO level (marine surface) was below the baseline action level but was within the ranges of 3-year (2007 - 2009) marine surface DO records between 4.3 and 9.4 mg/L at EPD WM4 marine water quality monitoring station near Ma Wan and between 4.2 and 8.6 mg/L at EPD VM14 marine water quality monitoring station towards the north of Rambler Channel. Adjusting level of installed seawall blocks and survey check on installed seawall blocks were conducted at the Outfall basin (Portion E) during monitoring. Since there was no other marine works conducted during the monitoring, the exceedance was considered to be contributed by natural variation and no further action was required.

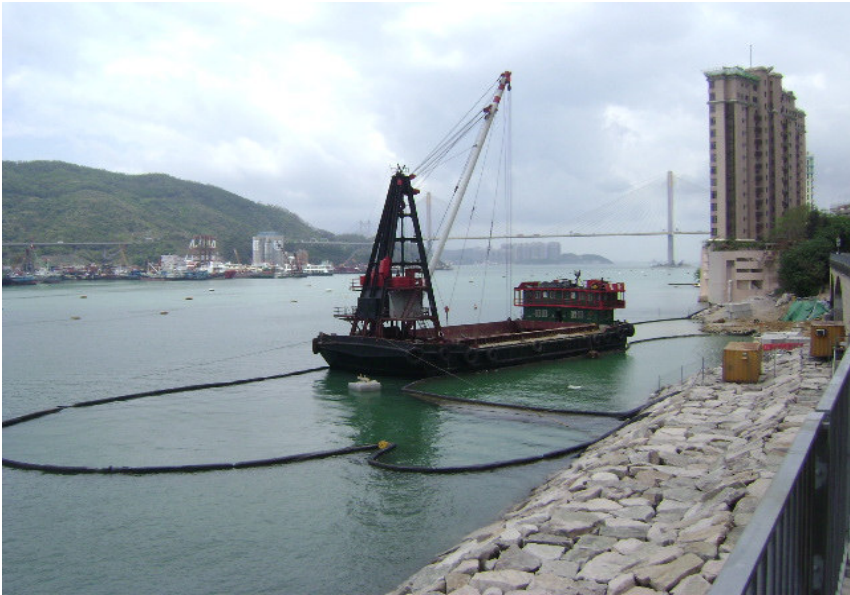
**Photographic record for exceedance of Dissolved Oxygen (marine mid-depth) recorded at O-1(FT) on 07-May-11**

Project	Tsuen Wan Drainage Tunnel
Date	07-May-11
Time	8:45 AM
Monitoring Location	O-1(FT)
Parameter	Dissolved Oxygen (marine mid-depth)
Action & Limit Levels (mg/L)	6.84 / 6.81
Measured Level (mg/L)	6.79
Control Station	O-1-C(FT)
Measured Level at the Control Station (mg/L)	6.91
Possible reason for Action or Limit Level Non-compliance	The measured DO level (marine mid-depth) was below the baseline limit level but was within the ranges of 3-year (2007 - 2009) marine mid-depth DO records between 2.6 and 9.1 mg/L at EPD WM4 marine water quality monitoring station near Ma Wan and between 3.9 and 8.5 mg/L at EPD VM14 marine water quality monitoring station towards the north of Rambler Channel. Adjusting level of installed seawall blocks and survey check on installed seawall blocks were conducted at the Outfall basin (Portion E) during monitoring. Since there was no other marine works conducted during the monitoring, the exceedance was considered to be contributed by natural variation and no further action was required.

Actions taken / to be taken	(1) Silt curtain was provided along the Portion E boundary line and extended from seawater level to the bottom of seabed; (2) floating type silt curtain was employed at the inner side; (3) sufficient slack of silt curtain was allowed to cope with the wave and tidal action to ensure the curtains (outer and inner) were rested on seabed; (4) condition of silt curtains was checked by the supervisor daily; and (5) seawall blocks installation was undertaken within the inner silt curtain area only.
Remarks	None

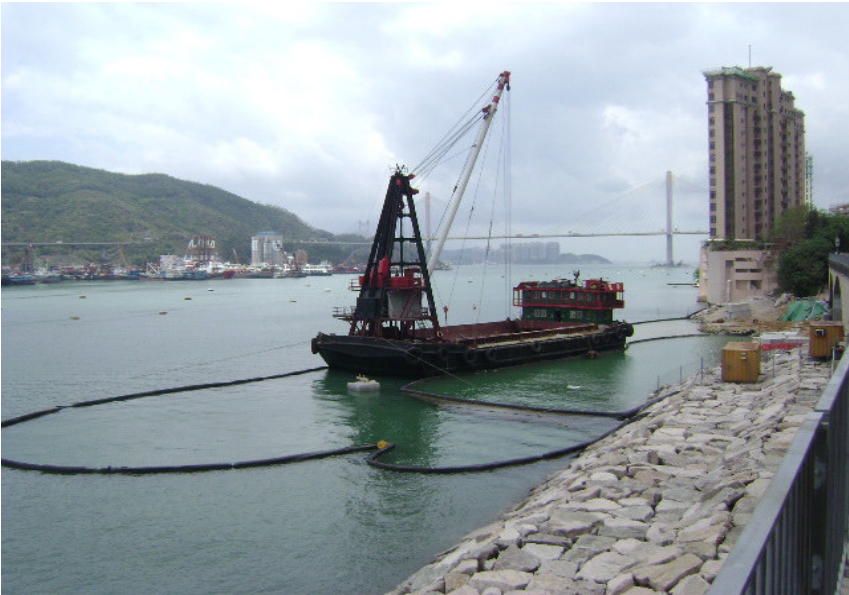
**Photographic record for exceedance of Dissolved Oxygen (marine bottom) recorded at O-1(FT) on 07-May-11**

Project	Tsuen Wan Drainage Tunnel
Date	07-May-11
Time	8:45 AM
Monitoring Location	O-1(FT)
Parameter	Dissolved Oxygen (marine bottom)
Action & Limit Levels (mg/L)	6.99 / 6.96
Measured Level (mg/L)	6.91
Control Station	O-1-C(FT)
Measured Level at the Control Station (mg/L)	6.78
Possible reason for Action or Limit Level Non-compliance	The measured DO level (marine bottom) was below the baseline limit level but was within the ranges of 3-year (2007 - 2009) marine bottom DO records between 2.2 and 8.8 mg/L at EPD WM4 marine water quality monitoring station near Ma Wan and between 3.4 and 8.6 mg/L at EPD VM14 marine water quality monitoring station towards the north of Rambler Channel. Adjusting level of installed seawall blocks and survey check on installed seawall blocks were conducted at the Outfall basin (Portion E) during monitoring. Since there was no other marine works conducted during the monitoring, the exceedance was considered to be contributed by natural variation and no further action was required.

Actions taken / to be taken	(1) Silt curtain was provided along the Portion E boundary line and extended from seawater level to the bottom of seabed; (2) floating type silt curtain was employed at the inner side; (3) sufficient slack of silt curtain was allowed to cope with the wave and tidal action to ensure the curtains (outer and inner) were rested on seabed; (4) condition of silt curtains was checked by the supervisor daily; and (5) seawall blocks installation was undertaken within the inner silt curtain area only.
Remarks	None

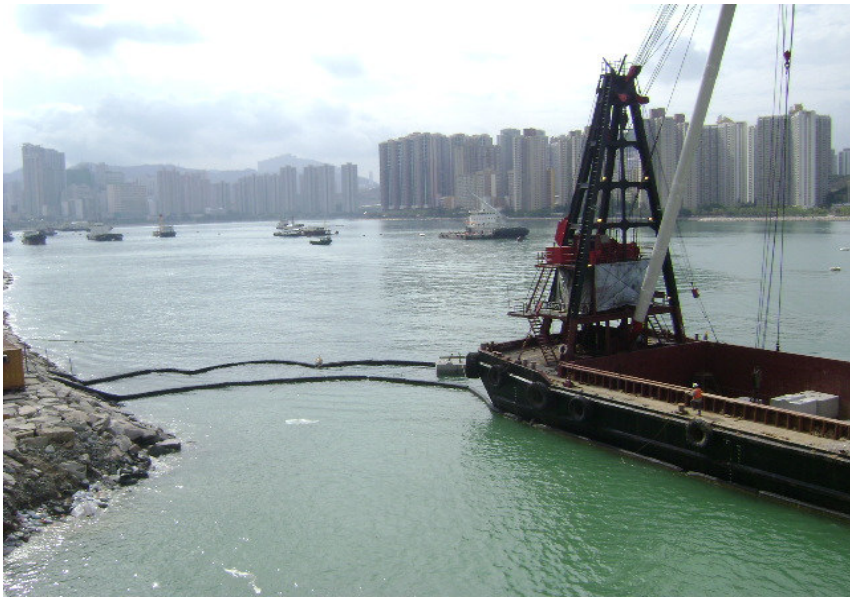
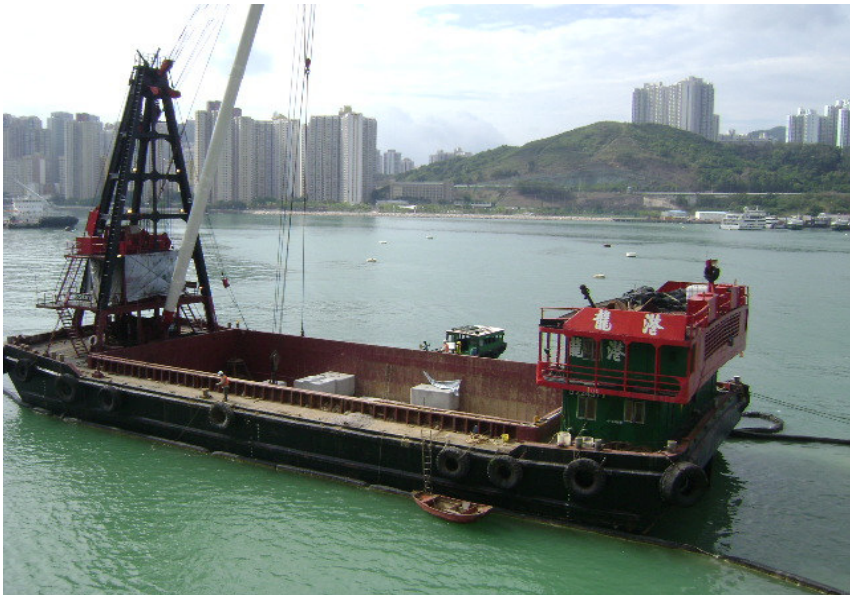
**Photographic record for exceedance of Dissolved Oxygen (marine surface) recorded at O-1(ET) on 07-May-11**

Project	Tsuen Wan Drainage Tunnel
Date	07-May-11
Time	12:28 PM
Monitoring Location	O-1(ET)
Parameter	Dissolved Oxygen (marine surface)
Action & Limit Levels (mg/L)	7.02 / 6.94
Measured Level (mg/L)	6.90
Control Station	O-1-C(ET)
Measured Level at the Control Station (mg/L)	6.88
Possible reason for Action or Limit Level Non-compliance	The measured DO level (marine surface) was below the baseline limit level but was within the ranges of 3-year (2007 - 2009) marine surface DO records between 4.3 and 9.4 mg/L at EPD WM4 marine water quality monitoring station near Ma Wan and between 4.2 and 8.6 mg/L at EPD VM14 marine water quality monitoring station towards the north of Rambler Channel. Adjusting level of installed seawall blocks and survey check on installed seawall blocks were conducted at the Outfall basin (Portion E) during monitoring. Since there was no other marine works conducted during the monitoring, the exceedance was considered to be contributed by natural variation and no further action was required.

Actions taken / to be taken	(1) Silt curtain was provided along the Portion E boundary line and extended from seawater level to the bottom of seabed; (2) floating type silt curtain was employed at the inner side; (3) sufficient slack of silt curtain was allowed to cope with the wave and tidal action to ensure the curtains (outer and inner) were rested on seabed; (4) condition of silt curtains was checked by the supervisor daily; and (5) seawall blocks installation was undertaken within the inner silt curtain area only.
Remarks	None

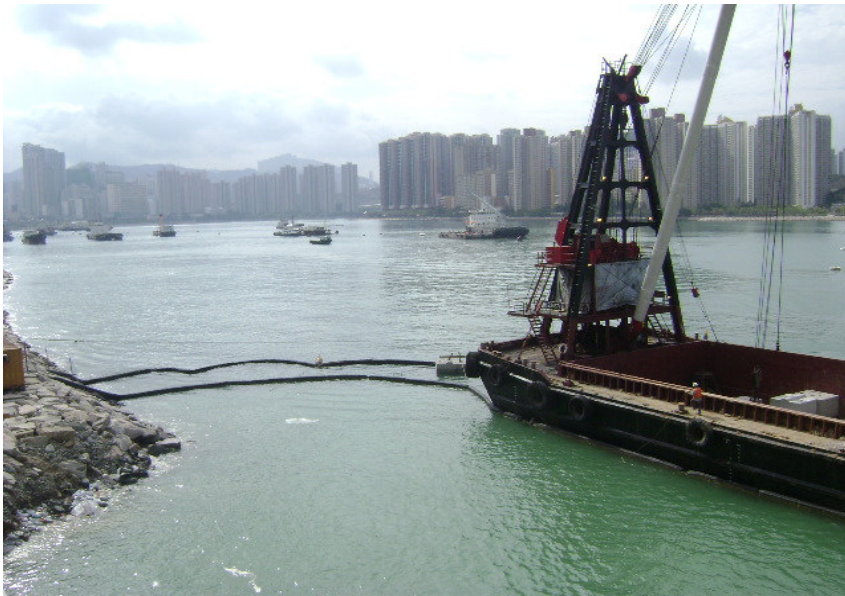
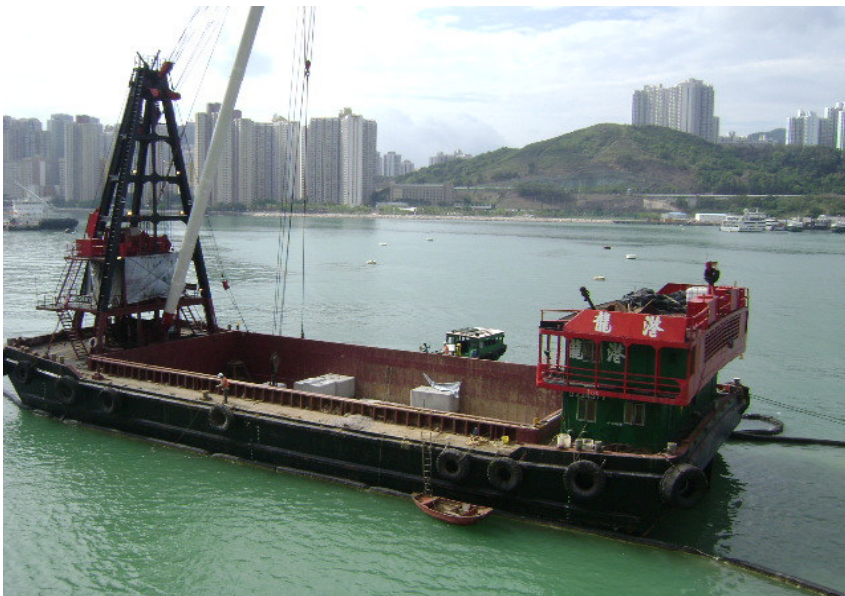
**Photographic record for exceedance of Dissolved Oxygen (marine mid-depth) recorded at O-1(ET) on 07-May-11**

Project	Tsuen Wan Drainage Tunnel
Date	07-May-11
Time	12:28 PM
Monitoring Location	O-1(ET)
Parameter	Dissolved Oxygen (marine mid-depth)
Action & Limit Levels (mg/L)	7.02 / 6.94
Measured Level (mg/L)	6.84
Control Station	O-1-C(ET)
Measured Level at the Control Station (mg/L)	6.76
Possible reason for Action or Limit Level Non-compliance	The measured DO level (marine mid-depth) was below the baseline limit level but was within the ranges of 3-year (2007 - 2009) marine mid-depth DO records between 2.6 and 9.1 mg/L at EPD WM4 marine water quality monitoring station near Ma Wan and between 3.9 and 8.5 mg/L at EPD VM14 marine water quality monitoring station towards the north of Rambler Channel. Adjusting level of installed seawall blocks and survey check on installed seawall blocks were conducted at the Outfall basin (Portion E) during monitoring. Since there was no other marine works conducted during the monitoring, the exceedance was considered to be contributed by natural variation and no further action was required.

Actions taken / to be taken	(1) Silt curtain was provided along the Portion E boundary line and extended from seawater level to the bottom of seabed; (2) floating type silt curtain was employed at the inner side; (3) sufficient slack of silt curtain was allowed to cope with the wave and tidal action to ensure the curtains (outer and inner) were rested on seabed; (4) condition of silt curtains was checked by the supervisor daily; and (5) seawall blocks installation was undertaken within the inner silt curtain area only.
Remarks	None

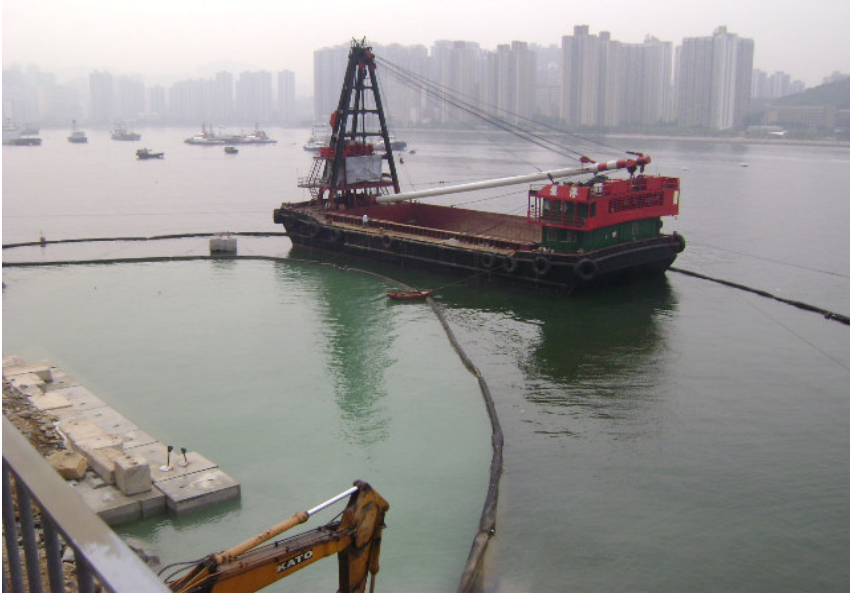
**Photographic record for exceedance of Suspended Solids (SS) recorded at O-1(FT) on 03-May-11**

Project	Tsuen Wan Drainage Tunnel
Date	03-May-11
Time	5:35 PM
Monitoring Location	O-1(FT)
Parameter	Suspended Solids (SS)
Action & Limit Levels (mg/L)	14.10 / 18.08 (derived from the baseline monitoring data)
Measured Level (depth-averaged) at Monitoring Location (mg/L)	8.45
Control Station	O-1-C(FT)
Measured Level (depth averaged) at Control Station (mg/L)	6.97
Possible reason for Action or Limit Level Non-compliance	The measured SS level (depth-averaged) at O-1(FT) was below the baseline action/limit level but was higher than 120% of the control station's SS level (O-1-C(FT)) at the same tide of the same day. Only placing seawall blocks was undertaken and there was no other marine works conducted during the monitoring. Silt curtain was deployed along the Portion E boundary line and extended from seawater level to seabed. Floating type silt curtain was also employed at the inner side. As such, the exceedance was considered to be contributed by natural variation and no further action was required.

Actions taken / to be taken	(1) Silt curtain was provided along the Portion E boundary line and extended from seawater level to the bottom of seabed; (2) floating type silt curtain was employed at the inner side; (3) sufficient slack of silt curtain was allowed to cope with the wave and tidal action to ensure the curtains (outer and inner) were rested on seabed; (4) condition of silt curtains was checked by the supervisor daily; and (5) seawall blocks installation was undertaken within the inner silt curtain area only.
Remarks	None

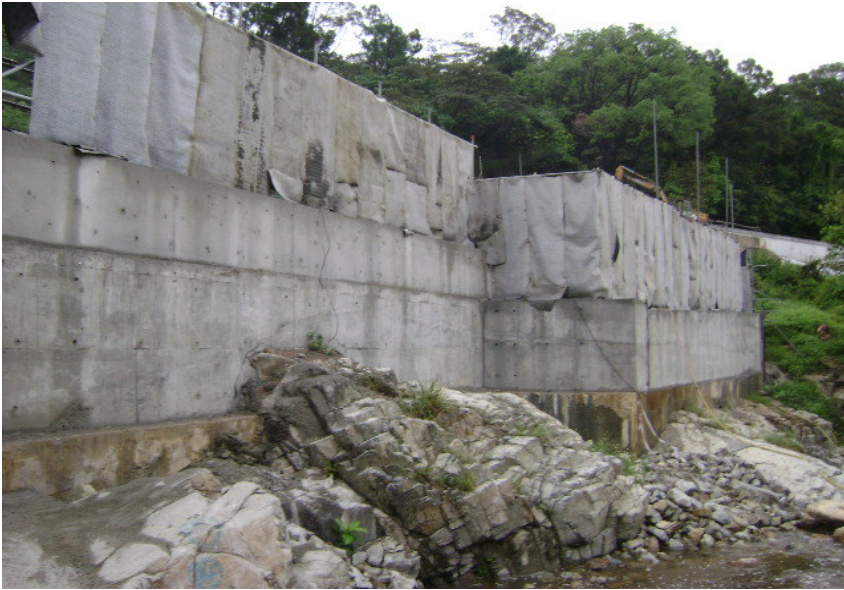
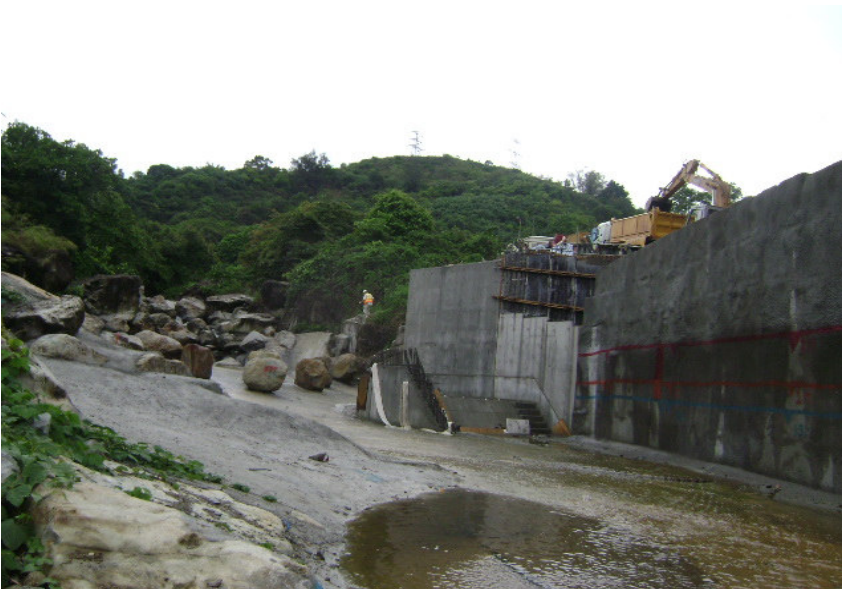
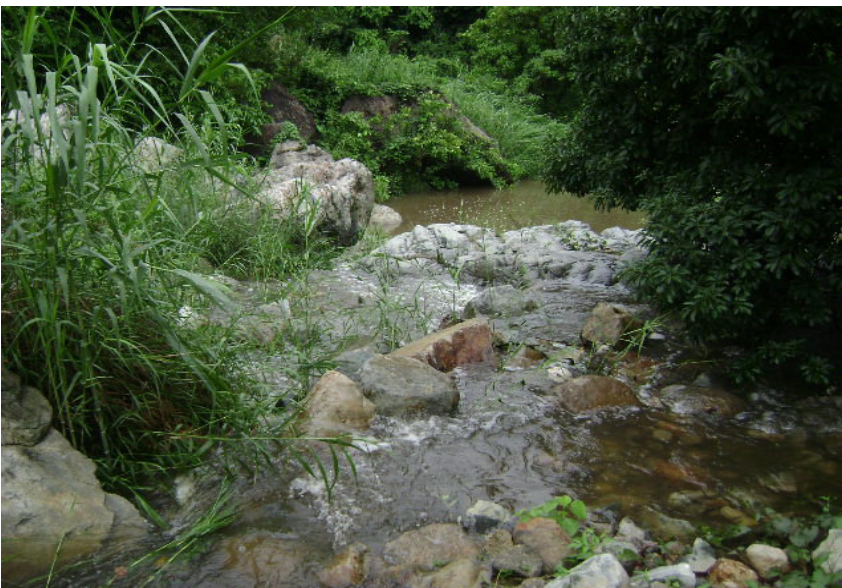
Photographic record for exceedance of Turbidity recorded at Squatters (I-3) on 13-May-11

Project	Tsuen Wan Drainage Tunnel
Date	13-May-11
Time	10:20 AM
Monitoring Location	Squatters (I-3)
Parameter	Turbidity
Action & Limit Levels (NTU)	3.99 / 4.18
Measured Level (NTU)	19.08
Control Station	I-3-C
Measured Level at the Control Station (NTU)	19.19
Possible reason for Action or Limit Level Non-compliance	The measured turbidity level was higher than baseline limit level, but lower than the turbidity level of the control station (I-3-C). General site cleaning and housekeeping, monitoring of deformation monitoring point (DMP), drilling and rock breaking in shaft, installation of concrete blocks in shaft, digging trail pit and breaking of blinding layer at PB wall were undertaken during measurement. No direct disturbance was observed from the site and 33.5 mm rainfall was recorded on the same day. The exceedance was considered to be contributed by high turbidity level at upstream location and rainfall. Since the exceedance was non-projected related, no further action was required.

Actions taken / to be taken	The following mitigation measures were provided on-site during monitoring: (1) All waste water were collected and diverted to waste water treatment plant prior to discharge; (2) Existing stream was diverted and banded by sealed concrete block wall; and (3) Excavated area had been banded and sealed by concrete block wall to prevent any excavated material runoff from working area.
Remarks	None

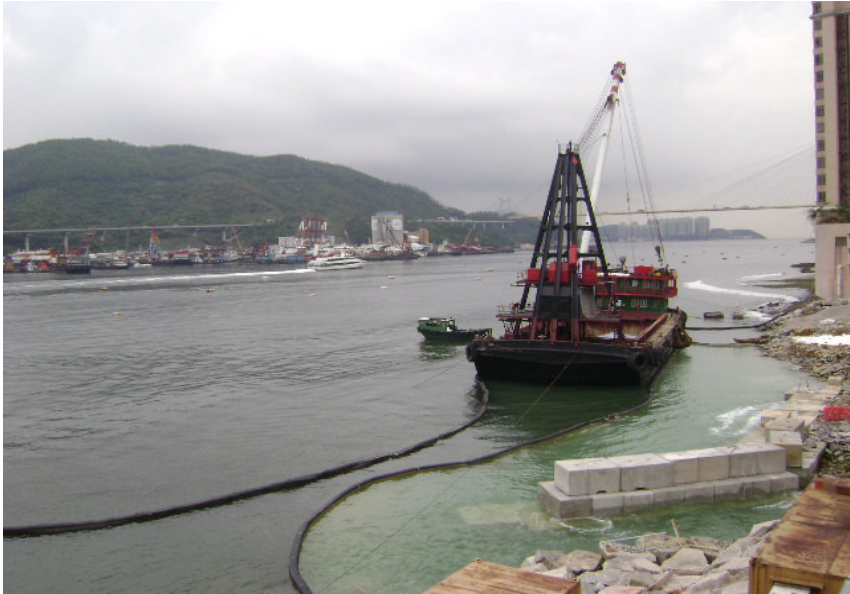
**Photographic record for exceedance of Dissolved Oxygen (marine bottom) recorded at O-1(FT) on 13-May-11**

Project	Tsuen Wan Drainage Tunnel
Date	13-May-11
Time	2:32 PM
Monitoring Location	O-1(FT)
Parameter	Dissolved Oxygen (marine bottom)
Action & Limit Levels (mg/L)	6.99 / 6.96
Measured Level (mg/L)	6.83
Control Station	O-1-C(FT)
Measured Level at the Control Station (mg/L)	6.89
Possible reason for Action or Limit Level Non-compliance	The measured DO level (marine bottom) was below the baseline limit level but was within the ranges of 3-year (2007 - 2009) marine bottom DO records between 2.2 and 8.8 mg/L at EPD WM4 marine water quality monitoring station near Ma Wan and between 3.4 and 8.6 mg/L at EPD VM14 marine water quality monitoring station towards the north of Rambler Channel. Loading seawall blocks onto installed seawall blocks and preparation work for geotextile were conducted at the Outfall basin (Portion E) during monitoring. Since there was no other marine works conducted during the monitoring, the exceedance was considered to be contributed by natural variation and no further action was required.

Actions taken / to be taken	(1) Silt curtain was provided along the Portion E boundary line and extended from seawater level to the bottom of seabed; (2) floating type silt curtain was employed at the inner side; (3) sufficient slack of silt curtain was allowed to cope with the wave and tidal action to ensure the curtains (outer and inner) were rested on seabed; (4) condition of silt curtains was checked by the supervisor daily; and (5) seawall blocks installation was undertaken within the inner silt curtain area only.
Remarks	None

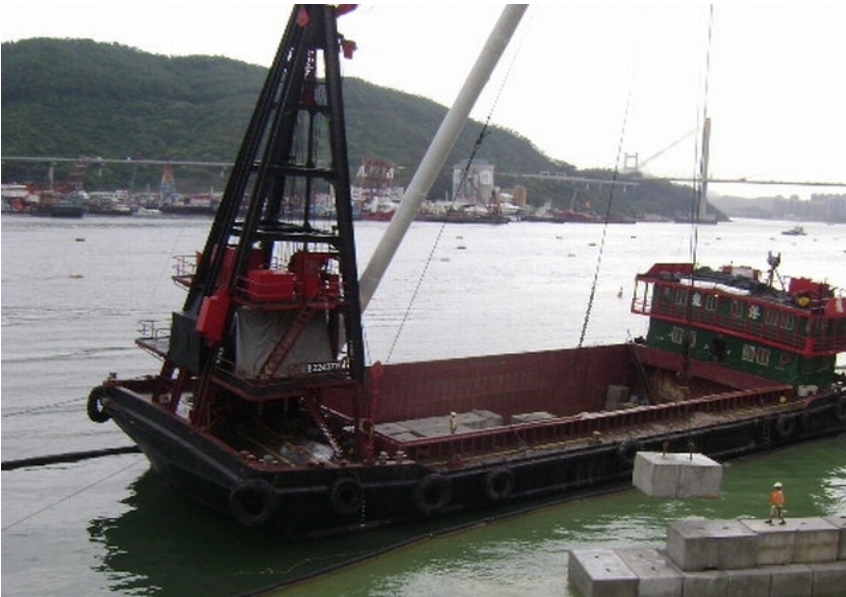
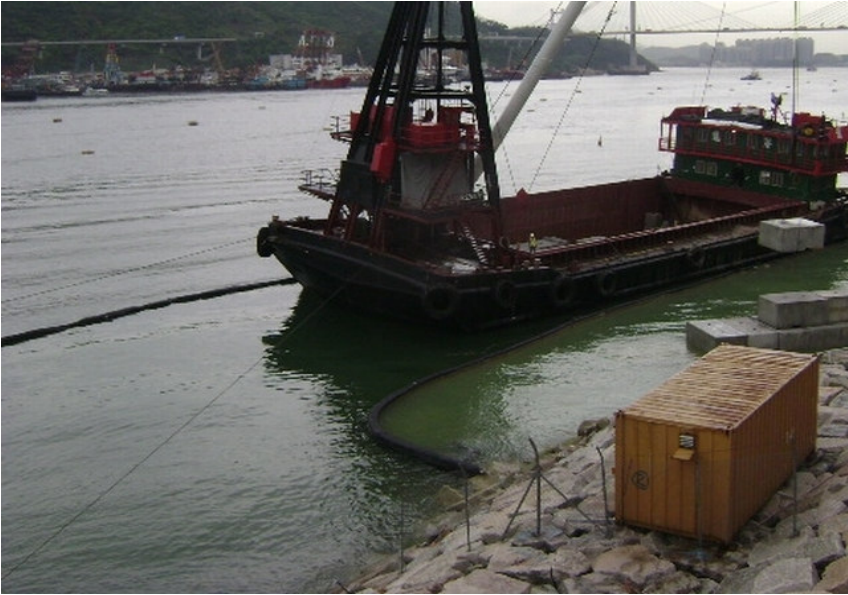
**Photographic record for exceedance of Dissolved Oxygen (marine surface) recorded at O-1(ET) on 13-May-11**

Project	Tsuen Wan Drainage Tunnel
Date	13-May-11
Time	9:40 AM
Monitoring Location	O-1(ET)
Parameter	Dissolved Oxygen (marine surface)
Action & Limit Levels (mg/L)	7.02 / 6.94
Measured Level (mg/L)	6.90
Control Station	O-1-C(ET)
Measured Level at the Control Station (mg/L)	7.08
Possible reason for Action or Limit Level Non-compliance	The measured DO level (marine surface) was below the baseline limit level but was within the ranges of 3-year (2007 - 2009) marine surface DO records between 4.3 and 9.4 mg/L at EPD WM4 marine water quality monitoring station near Ma Wan and between 4.2 and 8.6 mg/L at EPD VM14 marine water quality monitoring station towards the north of Rambler Channel. Loading seawall blocks onto installed seawall blocks and preparation work for geotextile were conducted at the Outfall basin (Portion E) during monitoring. Since there was no other marine works conducted during the monitoring, the exceedance was considered to be contributed by natural variation and no further action was required.

Actions taken / to be taken	(1) Silt curtain was provided along the Portion E boundary line and extended from seawater level to the bottom of seabed; (2) floating type silt curtain was employed at the inner side; (3) sufficient slack of silt curtain was allowed to cope with the wave and tidal action to ensure the curtains (outer and inner) were rested on seabed; (4) condition of silt curtains was checked by the supervisor daily; and (5) seawall blocks installation was undertaken within the inner silt curtain area only.
Remarks	None

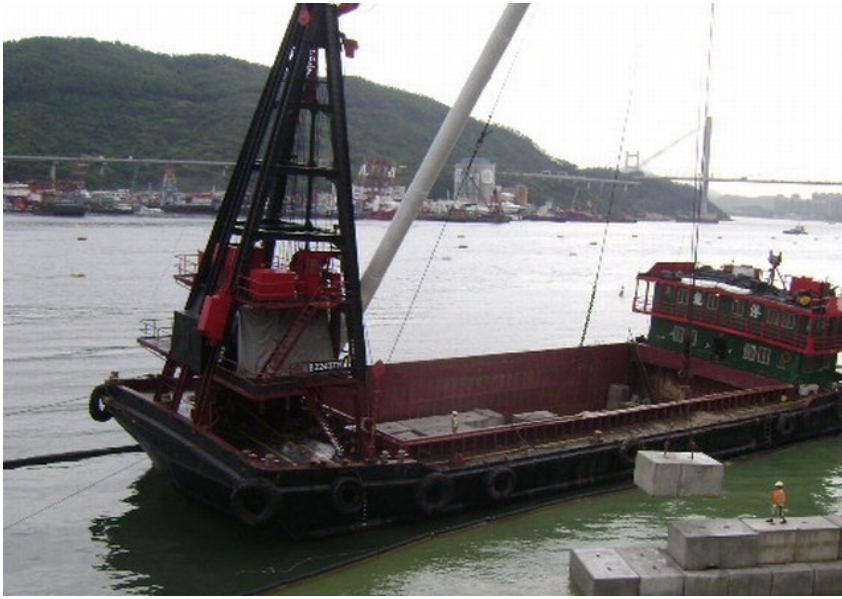
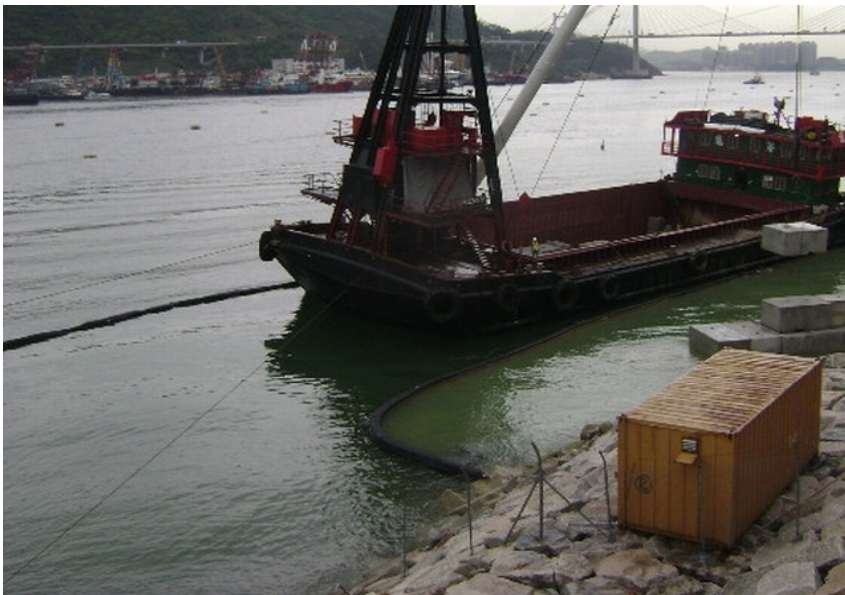
**Photographic record for exceedance of Dissolved Oxygen (marine mid-depth) recorded at O-1(ET) on 13-May-11**

Project	Tsuen Wan Drainage Tunnel
Date	13-May-11
Time	9:40 AM
Monitoring Location	O-1(ET)
Parameter	Dissolved Oxygen (marine mid-depth)
Action & Limit Levels (mg/L)	7.02 / 6.94
Measured Level (mg/L)	6.85
Control Station	O-1-C(ET)
Measured Level at the Control Station (mg/L)	7.01
Possible reason for Action or Limit Level Non-compliance	The measured DO level (marine mid-depth) was below the baseline limit level but was within the ranges of 3-year (2007 - 2009) marine mid-depth DO records between 2.6 and 9.1 mg/L at EPD WM4 marine water quality monitoring station near Ma Wan and between 3.9 and 8.5 mg/L at EPD VM14 marine water quality monitoring station towards the north of Rambler Channel. Loading seawall blocks onto installed seawall blocks and preparation work for geotextile were conducted at the Outfall basin (Portion E) during monitoring. Since there was no other marine works conducted during the monitoring, the exceedance was considered to be contributed by natural variation and no further action was required.

Actions taken / to be taken	(1) Silt curtain was provided along the Portion E boundary line and extended from seawater level to the bottom of seabed; (2) floating type silt curtain was employed at the inner side; (3) sufficient slack of silt curtain was allowed to cope with the wave and tidal action to ensure the curtains (outer and inner) were rested on seabed; (4) condition of silt curtains was checked by the supervisor daily; and (5) seawall blocks installation was undertaken within the inner silt curtain area only.
Remarks	None

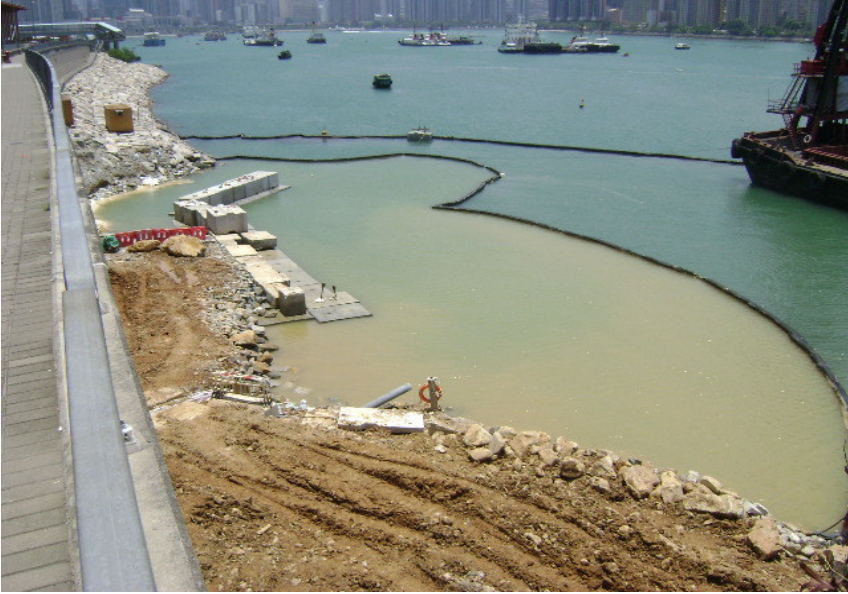
**Photographic record for exceedance of Dissolved Oxygen (marine surface) recorded at O-1(FT) on 18-May-11**

Project	Tsuen Wan Drainage Tunnel
Date	18-May-11
Time	5:30 PM
Monitoring Location	O-1(FT)
Parameter	Dissolved Oxygen (marine surface)
Action & Limit Levels (mg/L)	6.84 / 6.81
Measured Level (mg/L)	6.81
Control Station	O-1-C(FT)
Measured Level at the Control Station (mg/L)	6.90
Possible reason for Action or Limit Level Non-compliance	The measured DO level (marine surface) was below the baseline action level but was within the ranges of 3-year (2007 - 2009) marine surface DO records between 4.3 and 9.4 mg/L at EPD WM4 marine water quality monitoring station near Ma Wan and between 4.2 and 8.6 mg/L at EPD VM14 marine water quality monitoring station towards the north of Rambler Channel. Adjusting level of installed seawall blocks was conducted at the Outfall basin (Portion E) during monitoring and there was no other marine works conducted. Since the difference between DO level at impact and control station was around 1.3% and the DO level at impact station was only 0.03 mg/L lower than the baseline action level, the exceedance was considered to be contributed by natural variation and no further action was required.

Actions taken / to be taken	(1) Silt curtain was provided along the Portion E boundary line and extended from seawater level to the bottom of seabed; (2) floating type silt curtain was employed at the inner side; (3) sufficient slack of silt curtain was allowed to cope with the wave and tidal action to ensure the curtains (outer and inner) were rested on seabed; (4) condition of silt curtains was checked by the supervisor daily; and (5) seawall blocks installation was undertaken within the inner silt curtain area only.
Remarks	None

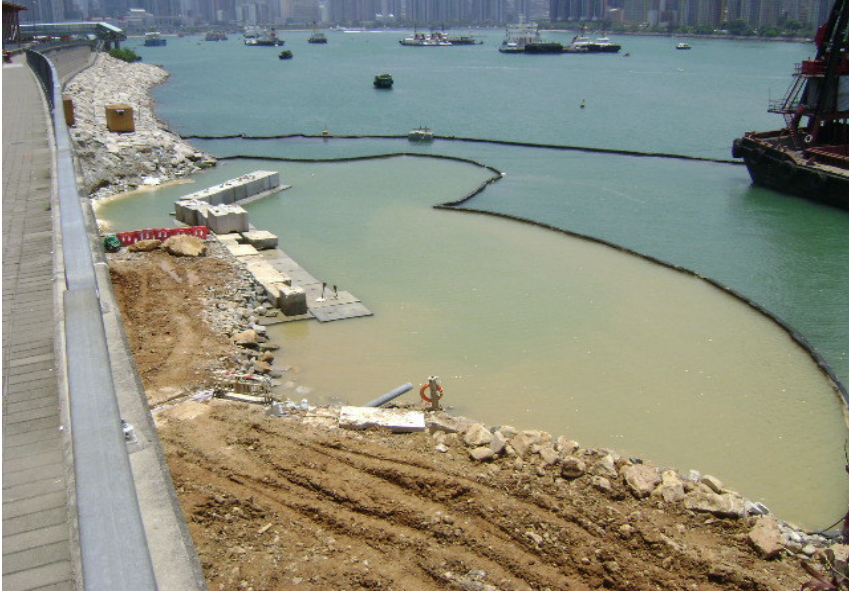
**Photographic record for exceedance of Dissolved Oxygen (marine mid-depth) recorded at O-1(FT) on 18-May-11**

Project	Tsuen Wan Drainage Tunnel
Date	18-May-11
Time	5:30 PM
Monitoring Location	O-1(FT)
Parameter	Dissolved Oxygen (marine mid-depth)
Action & Limit Levels (mg/L)	6.84 / 6.81
Measured Level (mg/L)	6.78
Control Station	O-1-C(FT)
Measured Level at the Control Station (mg/L)	6.79
Possible reason for Action or Limit Level Non-compliance	The measured DO level (marine mid-depth) was below the baseline limit level but was within the ranges of 3-year (2007 - 2009) marine mid-depth DO records between 2.6 and 9.1 mg/L at EPD WM4 marine water quality monitoring station near Ma Wan and between 3.9 and 8.5 mg/L at EPD VM14 marine water quality monitoring station towards the north of Rambler Channel. Adjusting level of installed seawall blocks was conducted at the Outfall basin (Portion E) during monitoring and there was no other marine works conducted. Since both DO levels at impact station and control station were just below the baseline limit level and the difference between them was only 0.01 mg/L, the exceedance was considered to be contributed by natural variation and no further action was required.

Actions taken / to be taken	(1) Silt curtain was provided along the Portion E boundary line and extended from seawater level to the bottom of seabed; (2) floating type silt curtain was employed at the inner side; (3) sufficient slack of silt curtain was allowed to cope with the wave and tidal action to ensure the curtains (outer and inner) were rested on seabed; (4) condition of silt curtains was checked by the supervisor daily; and (5) seawall blocks installation was undertaken within the inner silt curtain area only.
Remarks	None

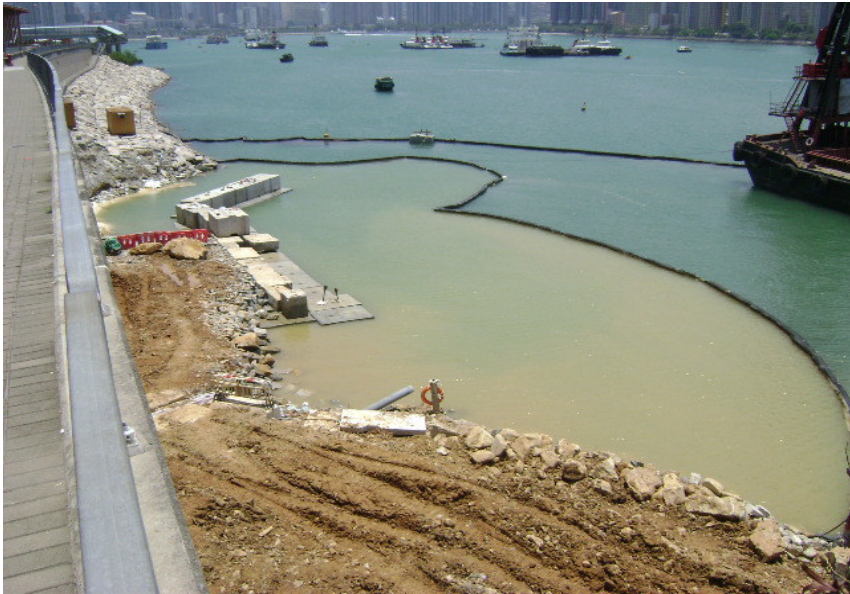
**Photographic record for exceedance of Dissolved Oxygen (marine bottom) recorded at O-1(FT) on 18-May-11**

Project	Tsuen Wan Drainage Tunnel
Date	18-May-11
Time	5:30 PM
Monitoring Location	O-1(FT)
Parameter	Dissolved Oxygen (marine bottom)
Action & Limit Levels (mg/L)	6.99 / 6.96
Measured Level (mg/L)	6.98
Control Station	O-1-C(FT)
Measured Level at the Control Station (mg/L)	6.74
Possible reason for Action or Limit Level Non-compliance	The measured DO level (marine bottom) was below the baseline action level but was within the ranges of 3-year (2007 - 2009) marine bottom DO records between 2.2 and 8.8 mg/L at EPD WM4 marine water quality monitoring station near Ma Wan and between 3.4 and 8.6 mg/L at EPD VM14 marine water quality monitoring station towards the north of Rambler Channel. Adjusting level of installed seawall blocks was conducted at the Outfall basin (Portion E) during monitoring and there was no other marine works conducted. Since the DO level at impact station was just below the baseline action level and the DO level at impact station was higher than that at control station, the exceedance was considered to be contributed by natural variation and no further action was required.

Actions taken / to be taken	(1) Silt curtain was provided along the Portion E boundary line and extended from seawater level to the bottom of seabed; (2) floating type silt curtain was employed at the inner side; (3) sufficient slack of silt curtain was allowed to cope with the wave and tidal action to ensure the curtains (outer and inner) were rested on seabed; (4) condition of silt curtains was checked by the supervisor daily; and (5) seawall blocks installation was undertaken within the inner silt curtain area only.
Remarks	None

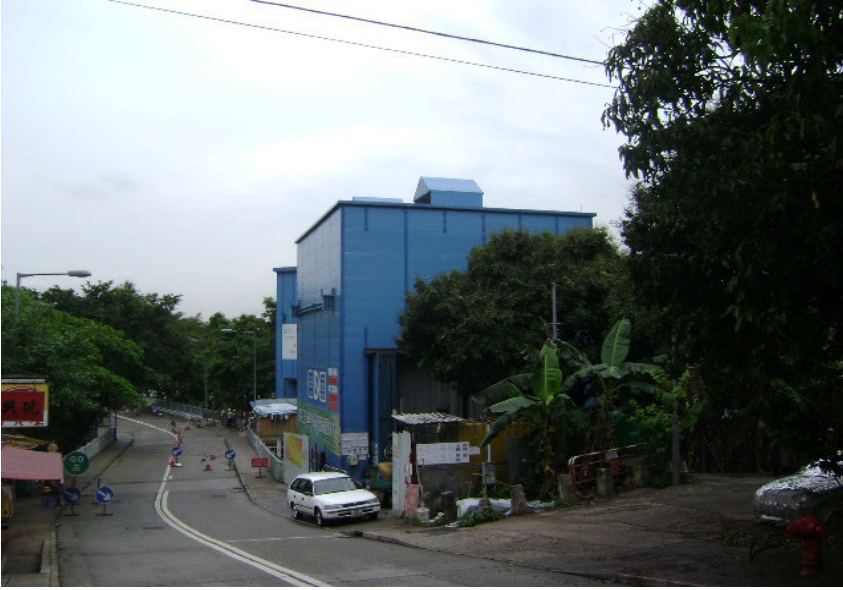
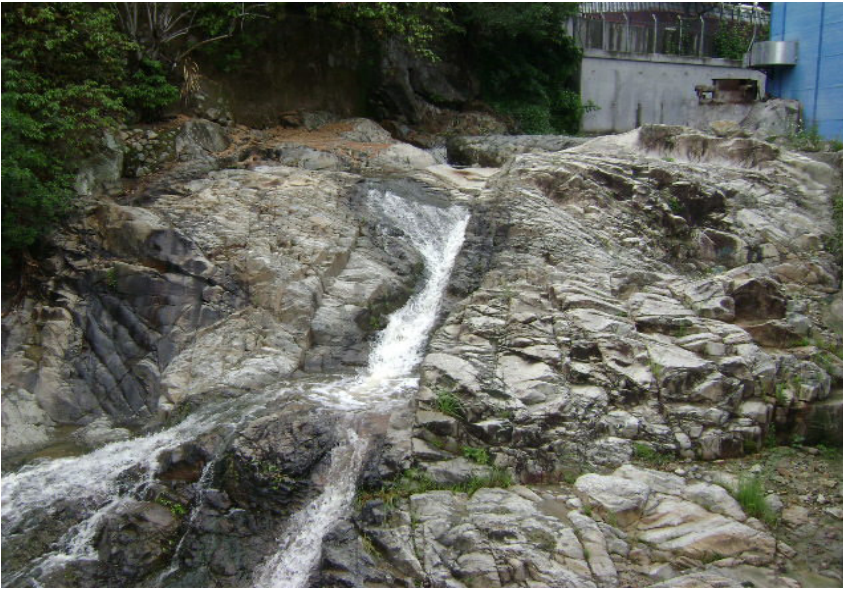
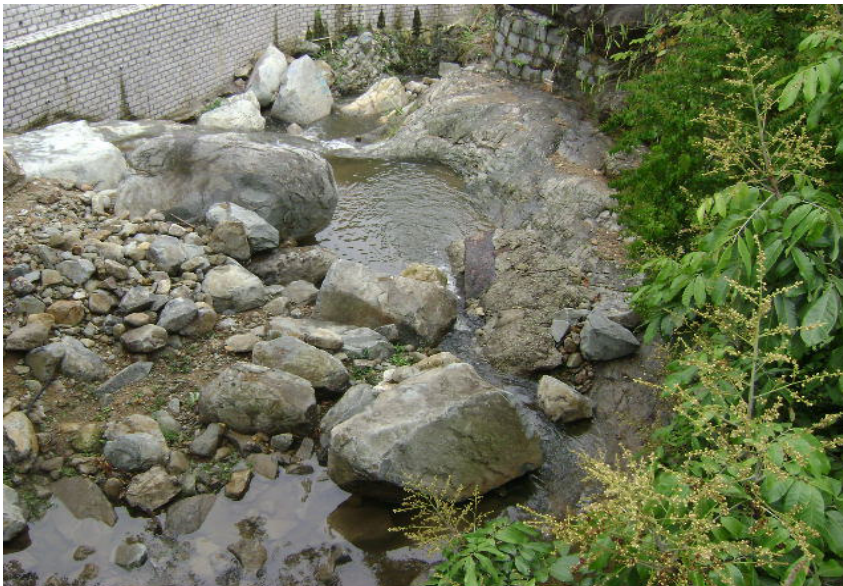
Photographic record for exceedance of Suspended Solid recorded at Hong Hoi Chee Hong Temple (I-2) on 13-May-11

Project	Tsuen Wan Drainage Tunnel
Date	13-May-11
Time	10:55 AM
Monitoring Location	Hong Hoi Chee Hong Temple (I-2)
Parameter	Suspended Solid
Action & Limit Levels (mg/L)	7.68 / 8.34
Measured Level (mg/L)	6.30
Control Station	I-2-C
Measured Level at the Control Station (mg/L)	4.10
Possible reason for Action or Limit Level Non-compliance	The measured SS level was below than baseline action level, but higher than 130% of the SS level of the control station (I-2-C). General site cleaning, housekeeping and temporary traffic arrangement, rock splitting and mucking at vortex drop shaft, drilling holes for rock splitting, construction of H-pile and excavation for pipe jacking at Portion G were undertaken during measurement. No direct disturbance was observed from the site and about 33.5 mm rainfall was recorded on the same day. The exceedance was considered to be contributed by natural variation and high rainfall. Since the exceedance was non-projected related, no further action was required.

Actions taken / to be taken	The following mitigation measures were provided on-site during monitoring: (1) All waste water were collected and diverted to waste water treatment plant prior to discharge; (2) Existing stream was diverted and bunded by sealed concrete block wall; and (3) Existing stream was bunded off by sand bags to prevent any excavated material washing out from working area.
Remarks	None

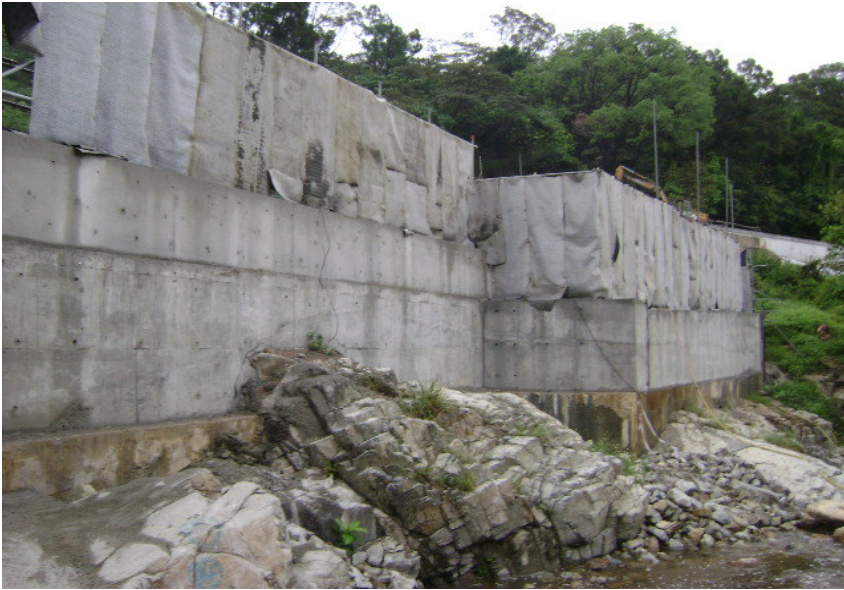
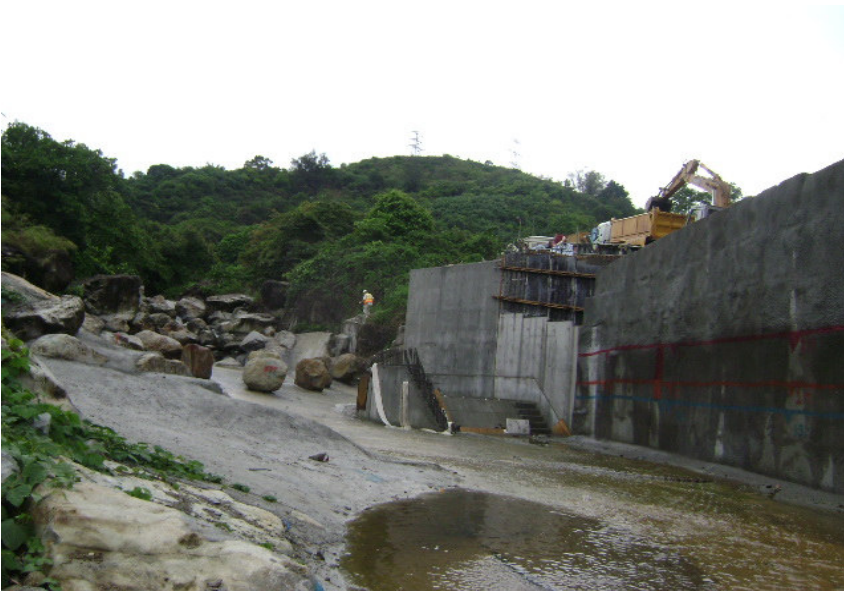
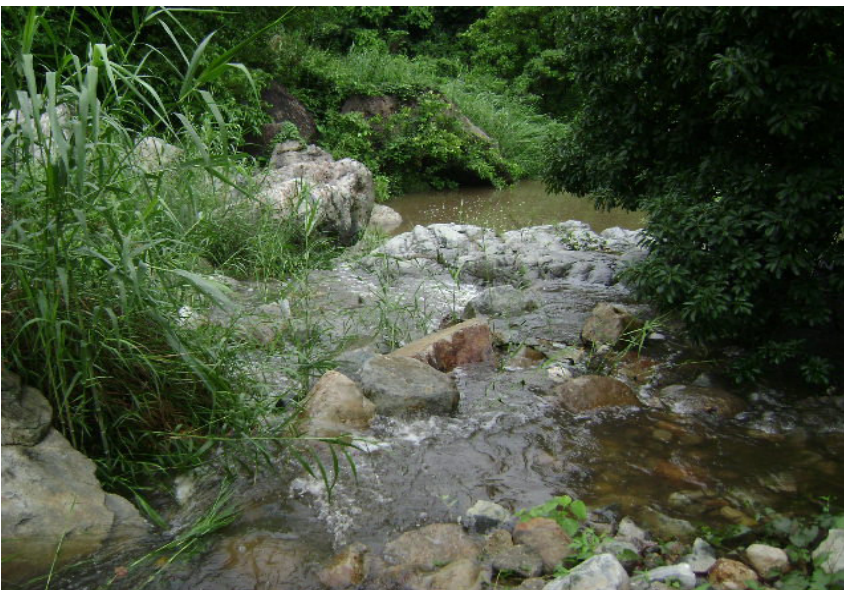
Photographic record for exceedance of Suspended Solid recorded at Squatters (I-3) on 13-May-11

Project	Tsuen Wan Drainage Tunnel
Date	13-May-11
Time	10:20 AM
Monitoring Location	Squatters (I-3)
Parameter	Suspended Solid
Action & Limit Levels (mg/L)	6.13 / 7.23
Measured Level (mg/L)	21.50
Control Station	I-3-C
Measured Level at the Control Station (mg/L)	22.15
Possible reason for Action or Limit Level Non-compliance	The measured SS level was higher than baseline limit level, but lower than the SS level of the control station (I-3-C). General site cleaning and housekeeping, monitoring of deformation monitoring point (DMP), drilling and rock breaking in shaft, installation of concrete blocks in shaft, digging trail pit and breaking of blinding layer at PB wall were undertaken during measurement. No direct disturbance was observed from the site and about 33.5 mm rainfall was recorded on the same day. The exceedance was considered to be contributed by high SS level at upstream location and rainfall. Since the exceedance was non-projected related, no further action was required.

Actions taken / to be taken	The following mitigation measures were provided on-site during monitoring: (1) All waste water were collected and diverted to waste water treatment plant prior to discharge; (2) Existing stream was diverted and bunded by sealed concrete block wall; and (3) Excavated area had been bunded and sealed by concrete block wall to prevent any excavated material runoff from working area.
Remarks	None

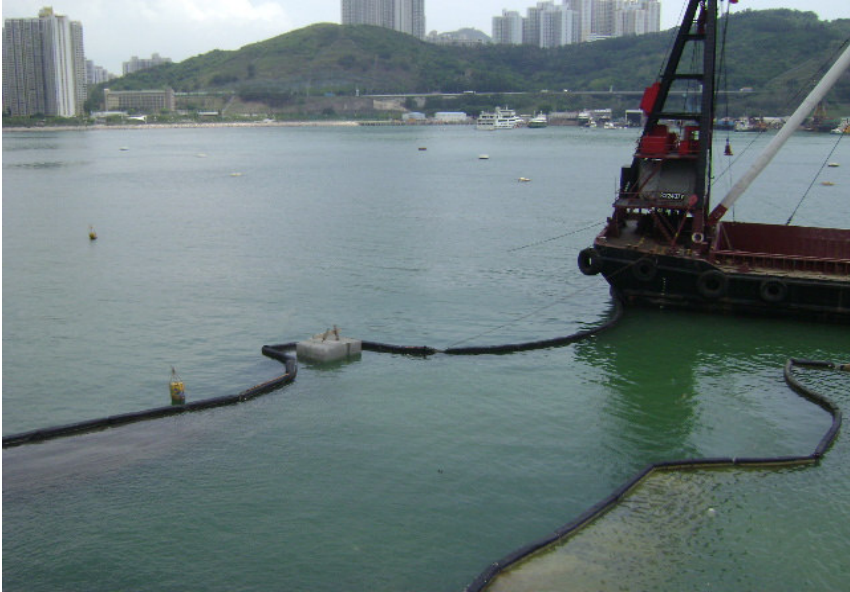
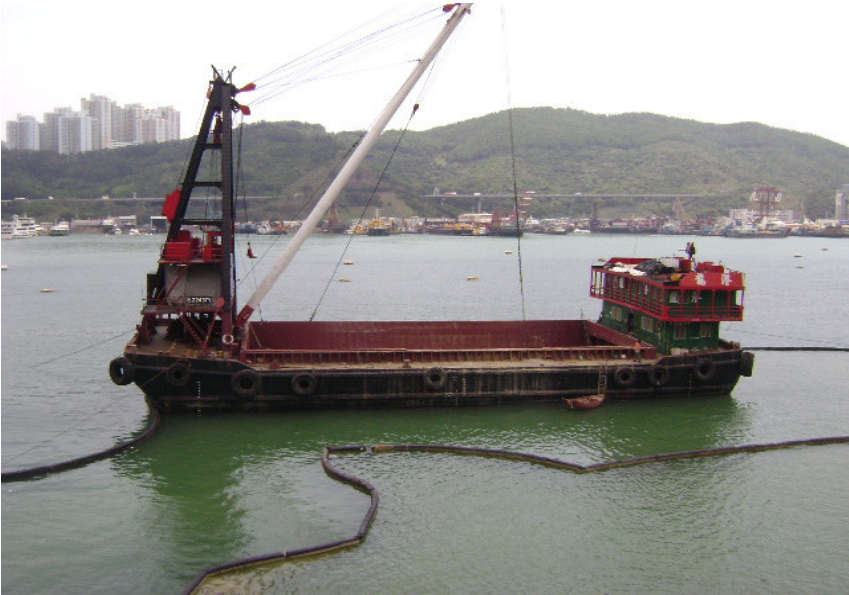
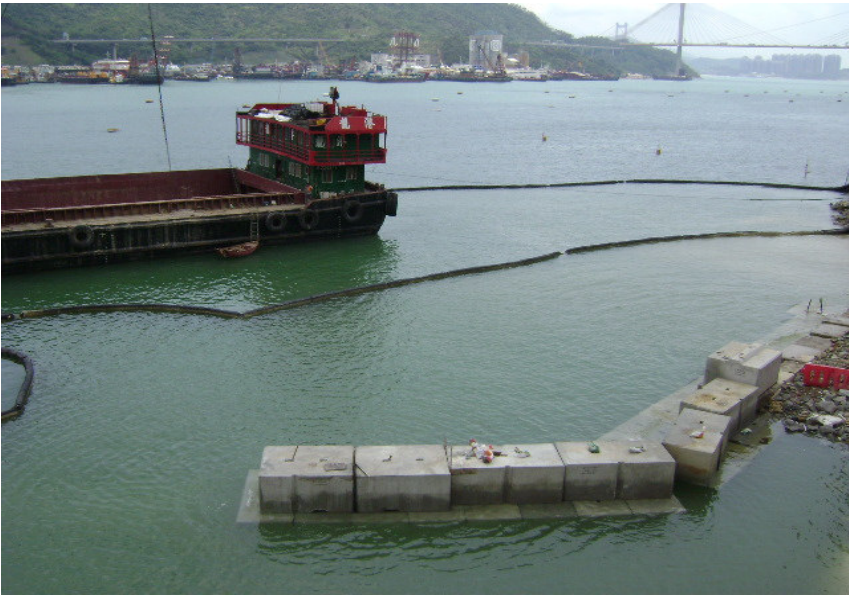
**Photographic record for exceedance of Dissolved Oxygen (marine surface) recorded at O-1(ET) on 20-May-11**

Project	Tsuen Wan Drainage Tunnel
Date	20-May-11
Time	1:07 PM
Monitoring Location	O-1(ET)
Parameter	Dissolved Oxygen (marine surface)
Action & Limit Levels (mg/L)	7.02 / 6.94
Measured Level (mg/L)	6.99
Control Station	O-1-C(ET)
Measured Level at the Control Station (mg/L)	6.96
Possible reason for Action or Limit Level Non-compliance	The measured DO level (marine surface) was below the baseline action level but higher than the marine surface DO level of the control station O-1-C(ET). Maintenance of the inner silt curtain was undertaken at the Outfall basin (Portion E) during monitoring and no other marine works was conducted. No direct disturbance from the site was observed. Therefore, the exceedance was considered to be contributed by natural variation and no further action was required.
Actions taken / to be taken	(1) Silt curtain was provided along the Portion E boundary line and extended from seawater level to the bottom of seabed; (2) floating type silt curtain was employed at the inner side; (3) sufficient slack of silt curtain was allowed to cope with the wave and tidal action to ensure the curtains (outer and inner) were rested on seabed; (4) condition of silt curtains was checked by the supervisor daily.

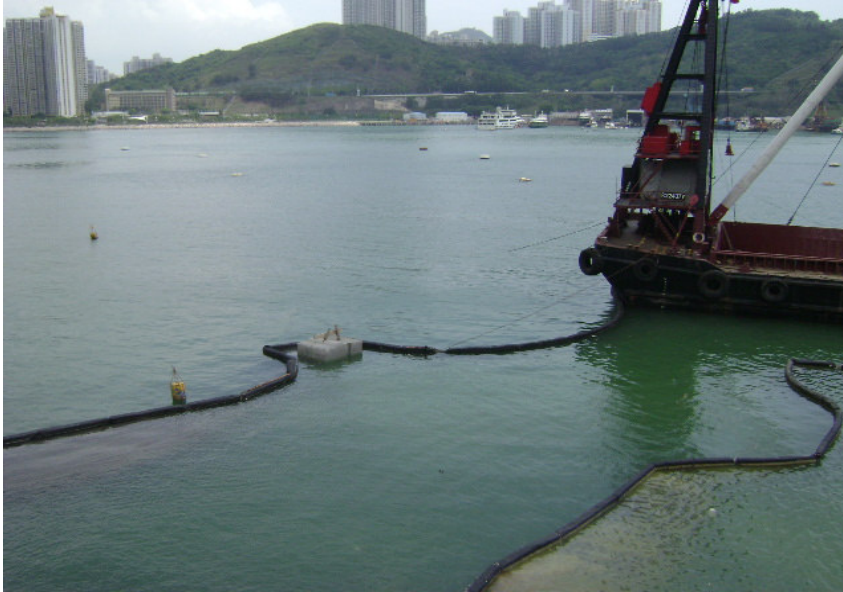
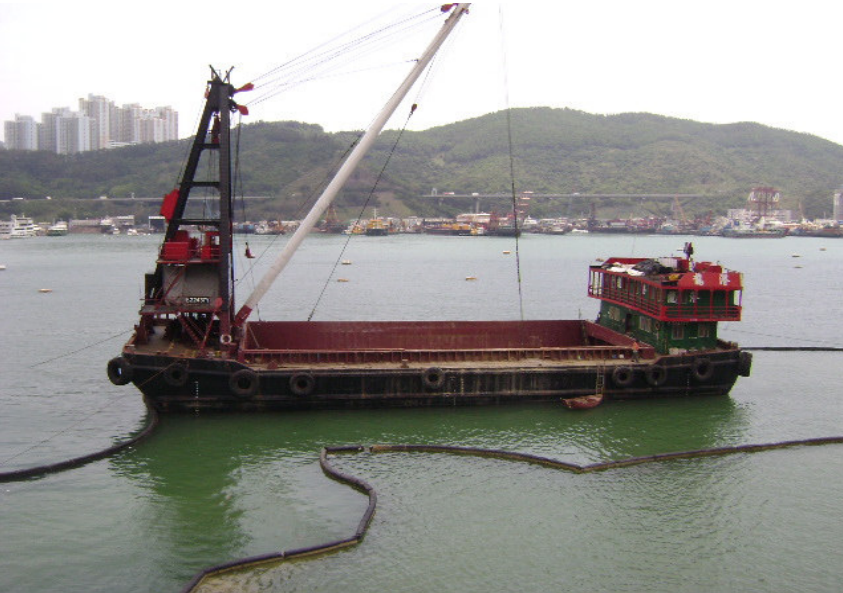
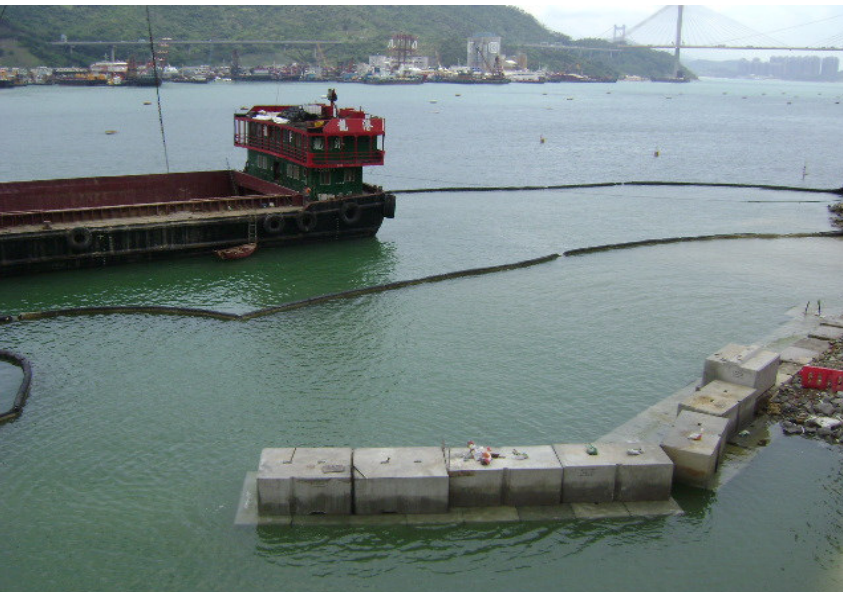
Photographic record for exceedance of Dissolved Oxygen (mid-depth) recorded at O-1(ET) on 20-May-11

Project	Tsuen Wan Drainage Tunnel
Date	20-May-11
Time	1:07 PM
Monitoring Location	O-1(ET)
Parameter	Dissolved Oxygen (mid-depth)
Action & Limit Levels (mg/L)	7.02 / 6.94
Measured Level (mg/L)	6.92
Control Station	O-1-C(ET)
Measured Level at the Control Station (mg/L)	7.07
Possible reason for Action or Limit Level Non-compliance	The measured DO level (marine mid-depth) was below the baseline limit level and the DO level of the corresponding control station (O-1-C(ET)). Maintenance of the inner silt curtain was undertaken at the Outfall basin (Portion E) during monitoring and no other marine works was conducted. No direct disturbance from the site was observed during monitoring. Therefore, the exceedance was considered to be contributed by natural variation and no further action was required.
Actions taken / to be taken	(1) Silt curtain was provided along the Portion E boundary line and extended from seawater level to the bottom of seabed; (2) floating type silt curtain was employed at the inner side; (3) sufficient slack of silt curtain was allowed to cope with the wave and tidal action to ensure the curtains (outer and inner) were rested on seabed; (4) condition of silt curtains was checked by the supervisor daily.
