**Interim Notification of Environmental Quality Limit Exceedance**

Project	Tsuen Wan Drainage Tunnel
Date	07-May-11
Time	8:45 AM
Monitoring Location	O-1(FT)
Parameter	Dissolved Oxygen (marine surface)
Action & Limit Levels (mg/L)	6.84 / 6.81
Measured Level (mg/L)	6.81
Control Station	O-1-C(FT)
Measured Level at the Control Station (mg/L)	6.99
Possible reason for Action or Limit Level Non-compliance	The measured DO level (marine surface) was below the baseline action level but was within the ranges of 3-year (2007 - 2009) marine surface DO records between 4.3 and 9.4 mg/L at EPD WM4 marine water quality monitoring station near Ma Wan and between 4.2 and 8.6 mg/L at EPD VM14 marine water quality monitoring station towards the north of Rambler Channel. Adjusting level of installed seawall blocks and survey check on installed seawall blocks were conducted at the Outfall basin (Portion E) during monitoring. Since there was no other marine works conducted during the monitoring, the exceedance was considered to be contributed by natural variation and no further action was required.

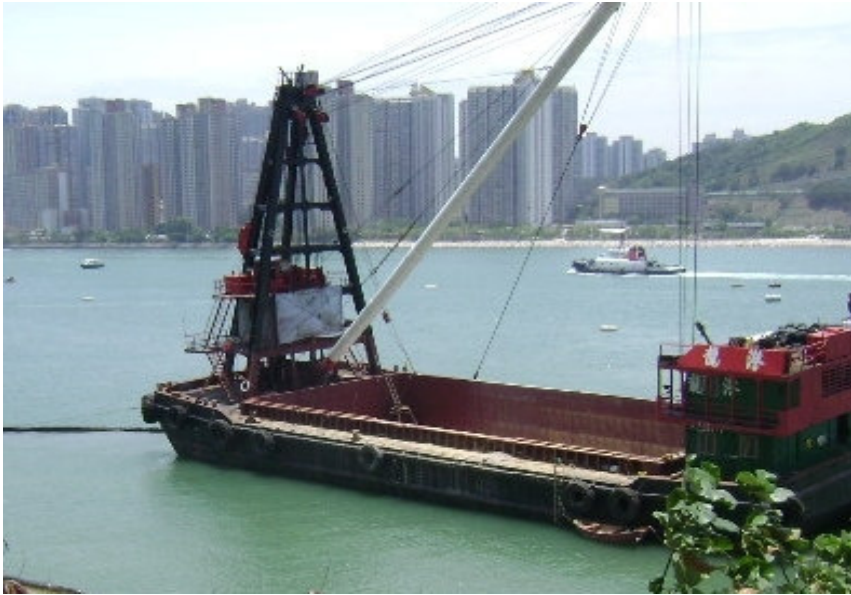
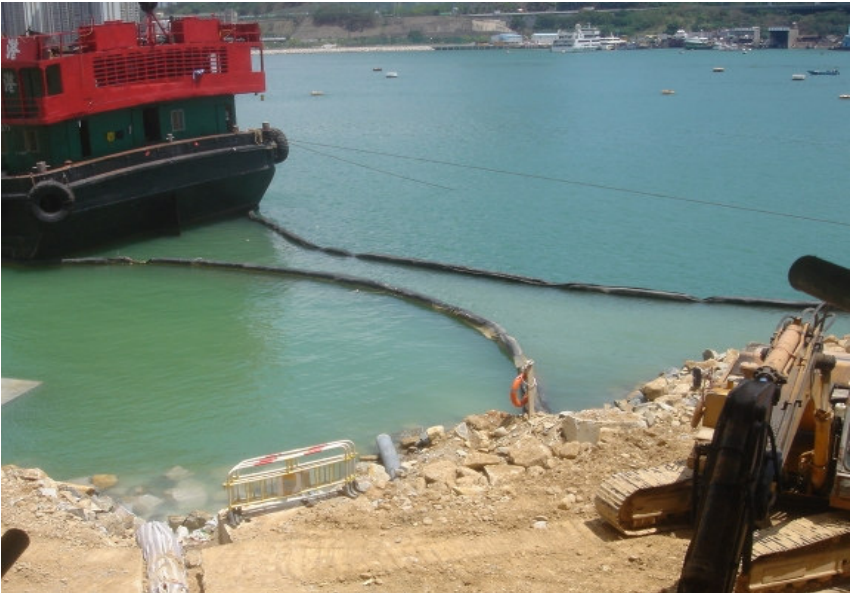
Photographic record for exceedance of Suspended Solids recorded at O-1(ET) on 18-May-11

Project	Tsuen Wan Drainage Tunnel
Date	18-May-11
Time	12:28 PM
Monitoring Location	O-1(ET)
Parameter	Suspended Solids
Action & Limit Levels (mg/L)	13.25 / 14.39
Measured Level (mg/L)	7.02
Control Station	O-1-C(ET)
Measured Level at the Control Station (mg/L)	5.78
Possible reason for Action or Limit Level Non-compliance	The measured SS level was below the baseline action level but was slightly higher than 120% of that of the control station (O-1-C(ET)). Adjusting level of installed seawall blocks was conducted at the Outfall basin (Portion E) during monitoring and there was no other marine works conducted. As no direct disturbance from the site was observed and the measured SS level was relatively low comparing with the baseline action level, the exceedance was considered to be contributed by natural variation and non-project related. Therefore, no further action was required.
Actions taken / to be taken	(1) Silt curtain was provided along the Portion E boundary line and extended from seawater level to the bottom of seabed; (2) floating type silt curtain was employed at the inner side; (3) sufficient slack of silt curtain was allowed to cope with the wave and tidal action to ensure the curtains (outer and inner) were rested on seabed; (4) condition of silt curtains was checked by the supervisor daily; and (5) seawall blocks installation was undertaken within the inner silt curtain area only.

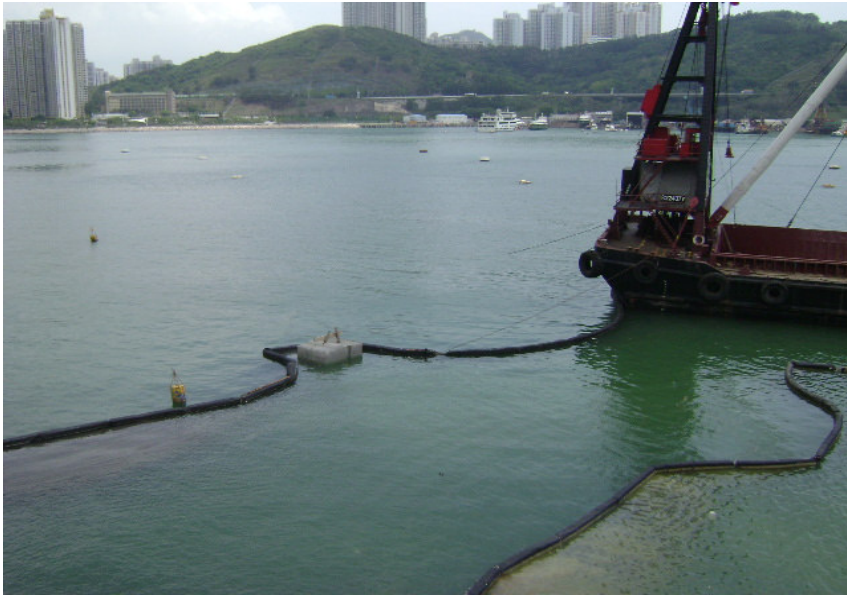
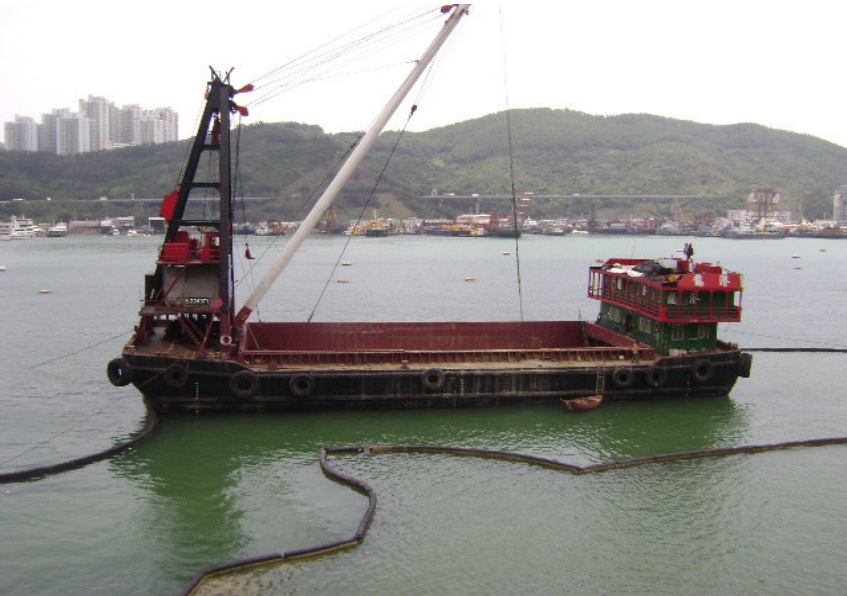
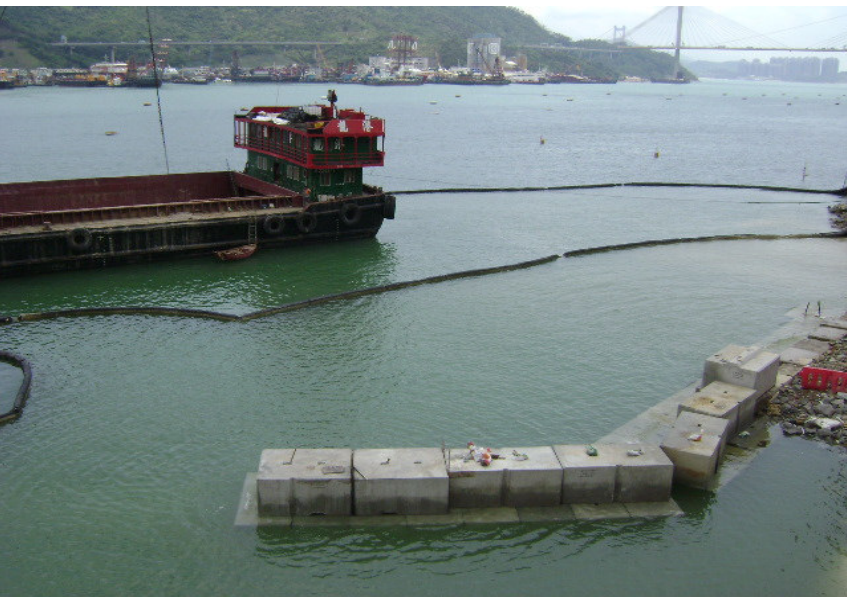
Photographic record for exceedance of Suspended Solids recorded at O-1(ET) on 20-May-11

Project	Tsuen Wan Drainage Tunnel
Date	20-May-11
Time	1:07 PM
Monitoring Location	O-1(ET)
Parameter	Suspended Solids
Action & Limit Levels (mg/L)	13.25 / 14.39
Measured Level (mg/L)	5.75
Control Station	O-1-C(ET)
Measured Level at the Control Station (mg/L)	4.27
Possible reason for Action or Limit Level Non-compliance	The measured SS level at the monitoring station was well below the baseline action level but higher than the 130% of the SS level measured at the control station. Only maintenance of the inner silt curtain was undertaken at the Outfall basin (Portion E) during monitoring and no other marine works was conducted. No direct disturbance from the site was observed. Therefore, the exceedance was considered to be contributed by natural variation and relatively low SS level at the control station. Since the exceedance was non-project related, no further action was required.
Actions taken / to be taken	(1) Silt curtain was provided along the Portion E boundary line and extended from seawater level to the bottom of seabed; (2) floating type silt curtain was employed at the inner side; (3) sufficient slack of silt curtain was allowed to cope with the wave and tidal action to ensure the curtains (outer and inner) were rested on seabed; (4) condition of silt curtains was checked by the supervisor daily.

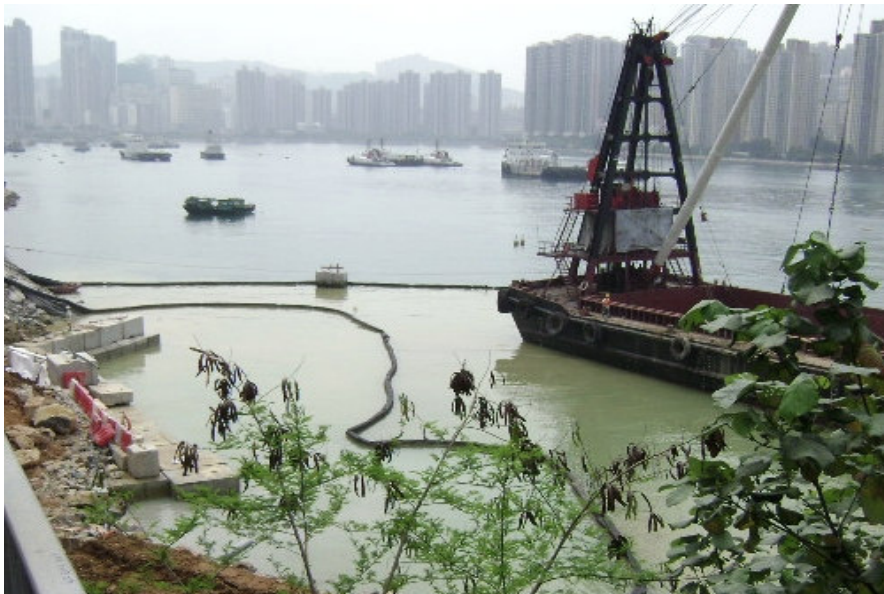
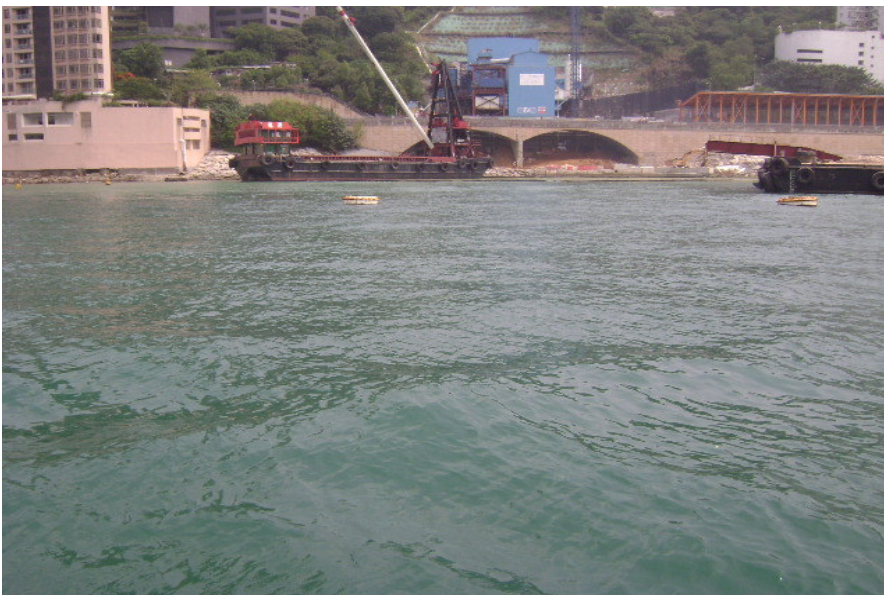
**Photographic record for exceedance of Dissolved Oxygen (mid-depth) recorded at O-1(ET) on 27-May-11**

Project	Tsuen Wan Drainage Tunnel
Date	27-May-11
Time	10:40 AM
Monitoring Location	O-1(ET)
Parameter	Dissolved Oxygen (mid-depth)
Action & Limit Levels (mg/L)	7.02 / 6.94
Measured Level (mg/L)	6.98
Control Station	O-1-C(ET)
Measured Level at the Control Station (mg/L)	7.19
Possible reason for Action or Limit Level Non-compliance	The measured DO level (marine mid-depth) was only 0.04 mg/L (about 0.6%) below the baseline action level and was below the DO level of the corresponding control station (O-1-C(ET)). Backfilling grade 700 rockfill and type II armour behind seawall blocks was undertaken at the Outfall basin (Portion E) during monitoring. No other marine works was conducted. No direct disturbance from the site was observed during monitoring. Therefore, the exceedance was considered to be contributed by natural variation and no further action was required.
Actions taken / to be taken	(1) Silt curtain was provided along the Portion E boundary line and extended from seawater level to the bottom of seabed; (2) floating type silt curtain was employed at the inner side; (3) sufficient slack of silt curtain was allowed to cope with the wave and tidal action to ensure the curtains (outer and inner) were rested on seabed; (4) condition of silt curtains was checked by the supervisor daily; and (5) seawall blocks installation was only undertaken within the inner silt curtain area.

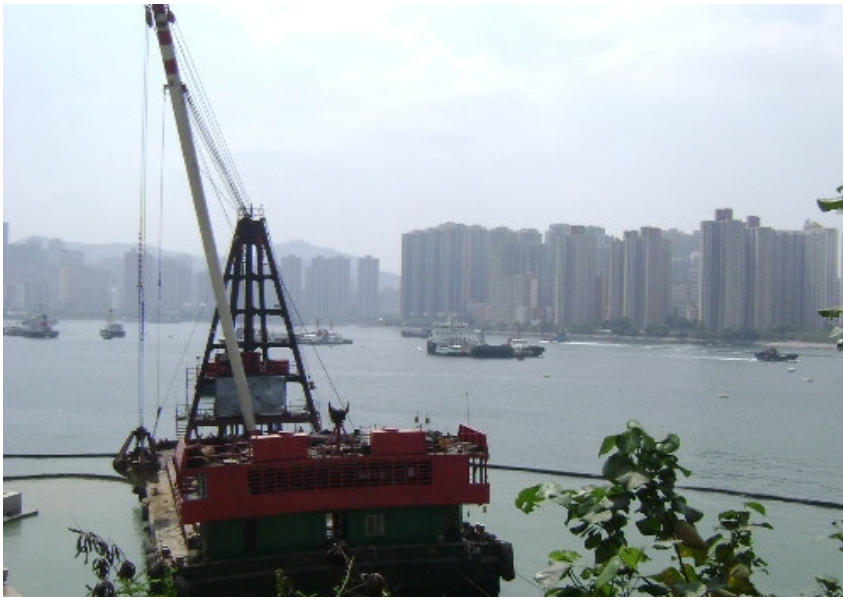
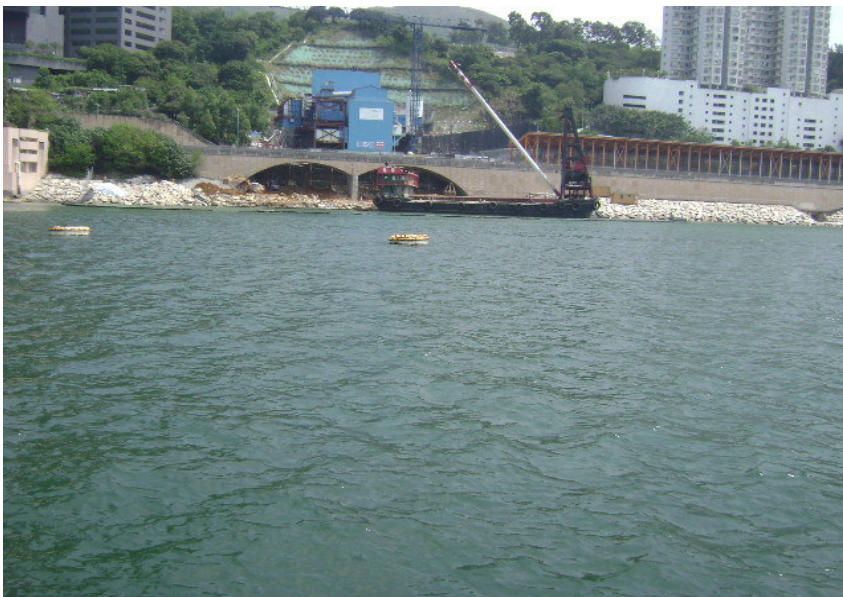
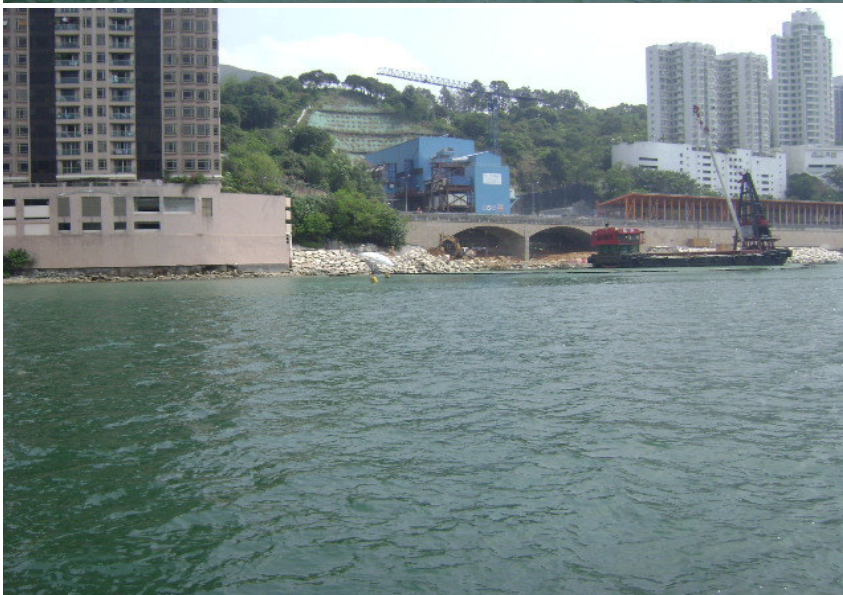
**Photographic record for exceedance of Dissolved Oxygen (Surface) recorded at O-1(ET) on 30-May-11**

Project	Tsuen Wan Drainage Tunnel
Date	30-May-11
Time	9:42 AM
Monitoring Location	O-1(ET)
Parameter	Dissolved Oxygen (Surface)
Action & Limit Levels (mg/L)	7.02 / 6.94
Measured Level (mg/L)	6.97
Control Station	O-1-C(ET)
Measured Level at the Control Station (mg/L)	7.09
Possible reason for Action or Limit Level Non-compliance	The measured DO level (marine surface) at the monitoring station was only 0.05 mg/L (about 0.7%) below the baseline action level and was below the DO level of the corresponding control station. Backfilling type II armour behind seawall blocks at the eastern side was undertaken at the Outfall basin (Portion E) during monitoring. No other marine works was conducted. No direct disturbance from the site was observed during monitoring. Therefore, the exceedance was considered to be contributed by natural variation and no further action was required.
Actions taken / to be taken	(1) Silt curtain was provided along the Portion E boundary line and extended from seawater level to the bottom of seabed; (2) floating type silt curtain was employed at the inner side; (3) sufficient slack of silt curtain was allowed to cope with the wave and tidal action to ensure the curtains (outer and inner) were rested on seabed; (4) condition of silt curtains was checked by the supervisor daily; and (5) seawall blocks installation was only undertaken within the inner silt curtain area.

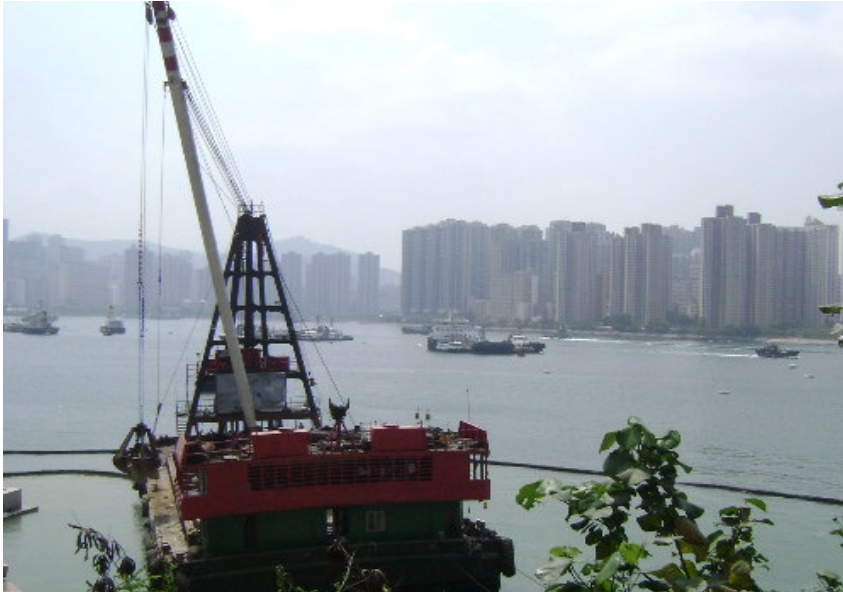
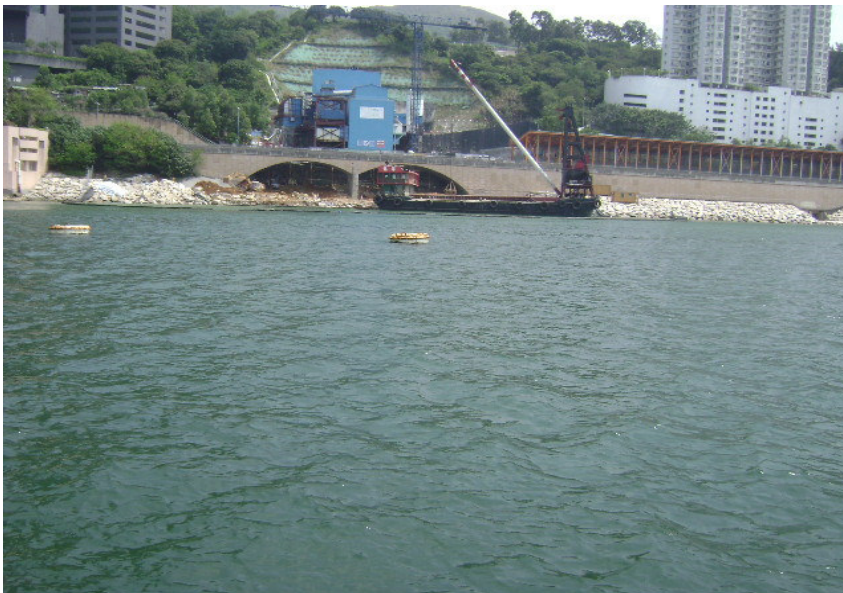
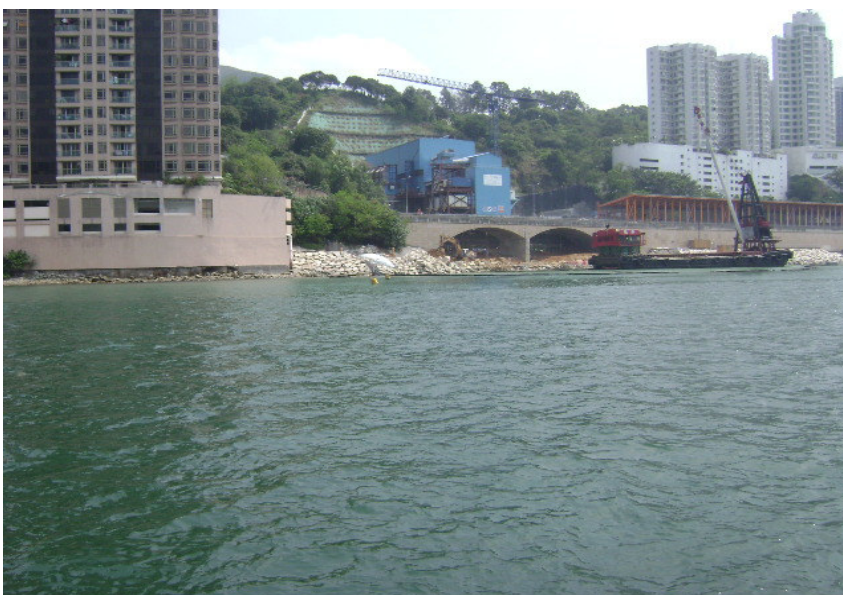
**Photographic record for exceedance of Dissolved Oxygen (Mid-depth) recorded at O-1(ET) on 30-May-11**

Project	Tsuen Wan Drainage Tunnel
Date	30-May-11
Time	9:42 AM
Monitoring Location	O-1(ET)
Parameter	Dissolved Oxygen (Mid-depth)
Action & Limit Levels (mg/L)	7.02 / 6.94
Measured Level (mg/L)	6.94
Control Station	O-1-C(ET)
Measured Level at the Control Station (mg/L)	6.98
Possible reason for Action or Limit Level Non-compliance	The measured DO level (marine mid-depth) at the monitoring station was below the baseline action level and slightly below than the DO level of the corresponding control station. Backfilling type II armour behind seawall blocks at the eastern side was undertaken at the Outfall basin (Portion E) during monitoring. No other marine works was conducted. No direct disturbance from the site was observed during monitoring. Therefore, the exceedance was considered to be contributed by natural variation and no further action was required.
Actions taken / to be taken	(1) Silt curtain was provided along the Portion E boundary line and extended from seawater level to the bottom of seabed; (2) floating type silt curtain was employed at the inner side; (3) sufficient slack of silt curtain was allowed to cope with the wave and tidal action to ensure the curtains (outer and inner) were rested on seabed; (4) condition of silt curtains was checked by the supervisor daily; and (5) seawall blocks installation was only undertaken within the inner silt curtain area.

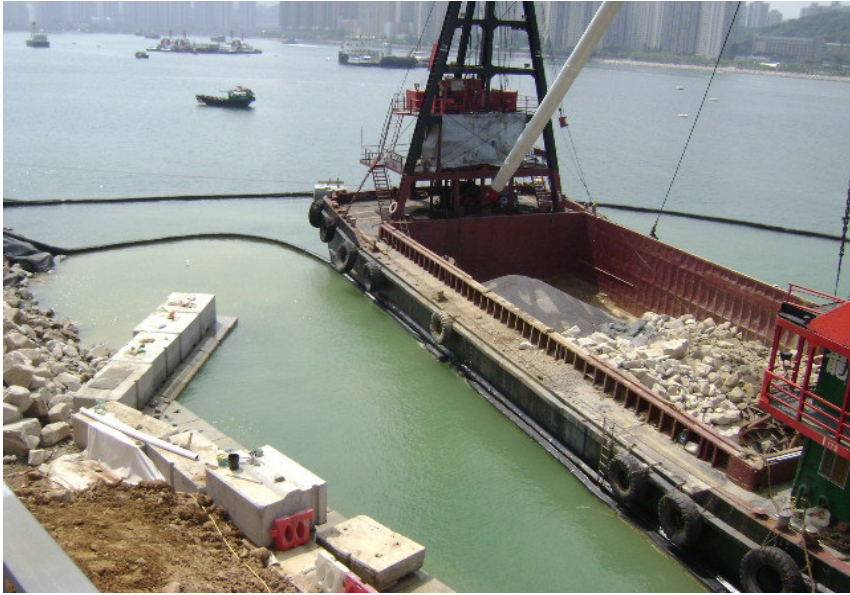
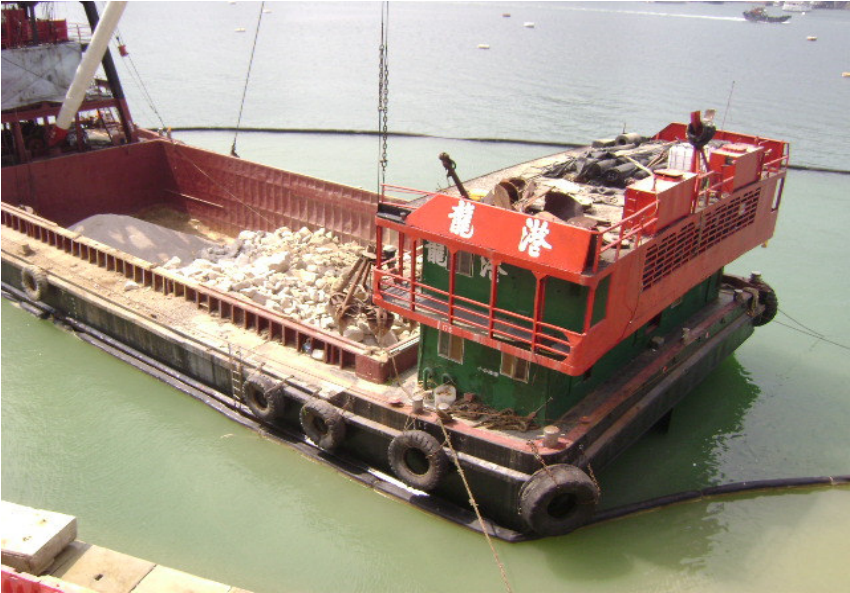
**Photographic record for exceedance of Dissolved Oxygen (marine bottom) recorded at O-1(FT) on 30-May-11**

Project	Tsuen Wan Drainage Tunnel
Date	30-May-11
Time	5:30 PM
Monitoring Location	O-1(FT)
Parameter	Dissolved Oxygen (marine bottom)
Action & Limit Levels (mg/L)	6.99 / 6.96
Measured Level (mg/L)	6.95
Control Station	O-1-C(FT)
Measured Level at the Control Station (mg/L)	6.92
Possible reason for Action or Limit Level Non-compliance	The measured DO level (marine bottom) at the monitoring station was below the baseline limit level but higher than the DO level of the corresponding control station. Backfilling type II armour behind seawall blocks at eastern side was undertaken at the Outfall basin (Portion E) during monitoring. No other marine works was conducted. No direct disturbance from the site was observed during monitoring. Therefore, the exceedance was considered to be contributed by natural variation and no further action was required.
Actions taken / to be taken	(1) Silt curtain was provided along the Portion E boundary line and extended from seawater level to the bottom of seabed; (2) floating type silt curtain was employed at the inner side; (3) sufficient slack of silt curtain was allowed to cope with the wave and tidal action to ensure the curtains (outer and inner) were rested on seabed; (4) condition of silt curtains was checked by the supervisor daily; and (5) seawall blocks installation was undertaken within the inner silt curtain area only.

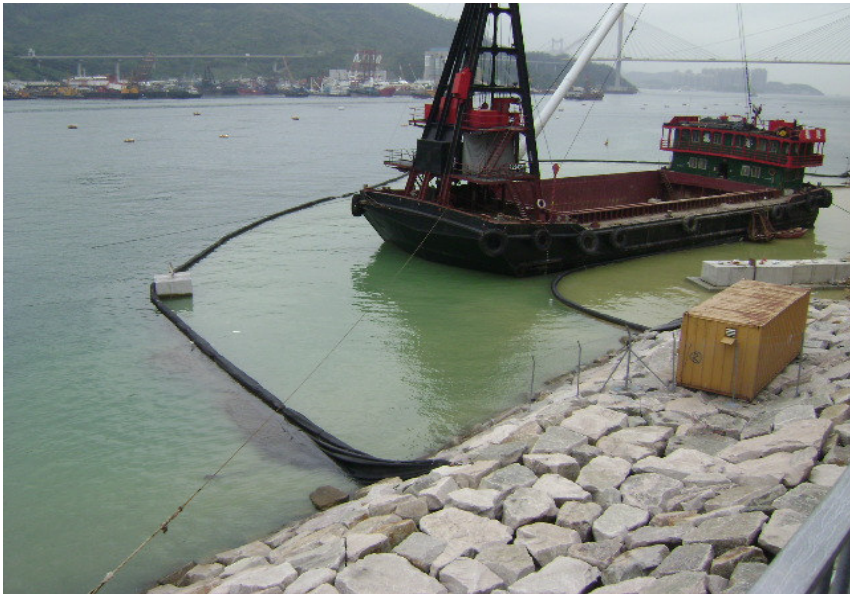
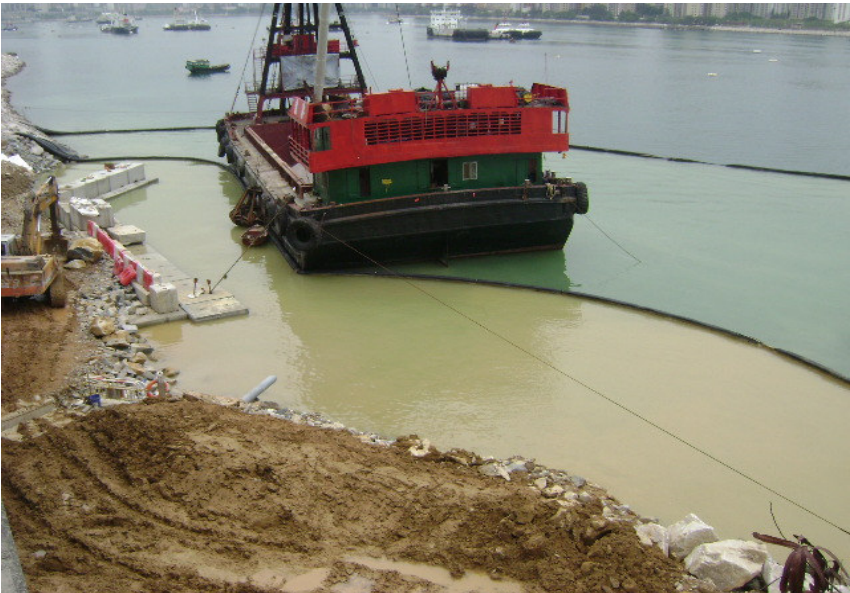
Photographic record for exceedance of Suspended Solids recorded at O-1(FT) on 27-May-11

Project	Tsuen Wan Drainage Tunnel
Date	27-May-11
Time	3:28 PM
Monitoring Location	O-1(FT)
Parameter	Suspended Solids
Action & Limit Levels (mg/L)	14.10 / 18.08
Measured Level (mg/L)	3.10
Control Station	O-1-C(FT)
Measured Level at the Control Station (mg/L)	2.33
Possible reason for Action or Limit Level Non-compliance	The measured SS level at the monitoring station was well below the baseline action/limit level but slightly higher than 130% of the SS level of the control station. Backfilling grade 700 rockfill and type II armour behind seawall blocks was undertaken at the Outfall basin (Portion E) during monitoring. No other marine works was conducted. No direct disturbance from the site was observed during monitoring. Therefore, the exceedance was considered to be contributed by low SS level of the control station and natural variation. Since the exceedance was non-project related, no further action was required.

Actions taken / to be taken	(1) Silt curtain was provided along the Portion E boundary line and extended from seawater level to the bottom of seabed; (2) floating type silt curtain was employed at the inner side; (3) sufficient slack of silt curtain was allowed to cope with the wave and tidal action to ensure the curtains (outer and inner) were rested on seabed; (4) condition of silt curtains was checked by the supervisor daily; and (5) seawall blocks installation was only undertaken within the inner silt curtain area.
Remarks	None
