Interim Notification of Environmental Quality Limit Exceedance

Project	Tsuen Wan Drainage Tunnel
Date	01-Jun-11
Time	11:40 AM
Monitoring Location	O-1(ET)
Parameter	Dissolved Oxygen (marine mid-depth)
Action & Limit Levels (mg/L)	7.02 / 6.94
Measured Level (mg/L)	6.93
Control Station	O-1-C(ET)
Measured Level at the Control Station (mg/L)	7.00
Possible reason for Action or Limit Level Non-compliance	The measured DO level (marine mid-depth) of the monitoring station was slightly below the baseline limit level and the DO level at the corresponding control station. Relocation of C&D material to derrick barge was undertaken during monitoring and there was no other marine works conducted. Since the difference between the control station and impact monitoring was only 1%, the exceedance was considered contributed by natural variation and non-project related. Therefore, no further action was required.
Actions taken / to be taken	(1) Silt curtain was provided along the Portion E boundary line and extended from seawater level to the bottom of seabed; (2) floating type silt curtain was employed at the inner side; (3) sufficient slack of silt curtain was allowed to cope with the wave and tidal

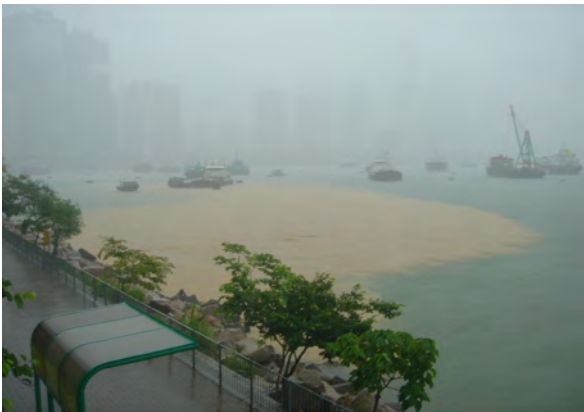
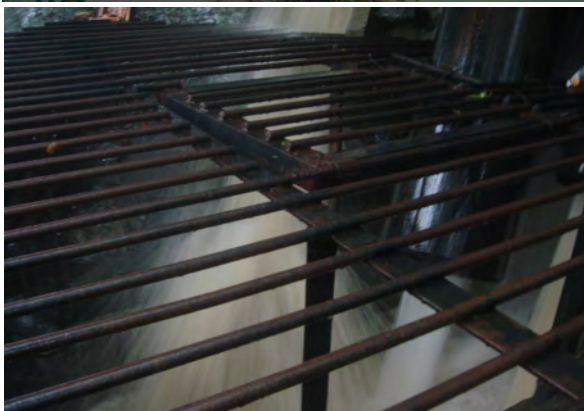
Photos of drainage outfall near the Belvedere Garden

On 29 June 2011, 76.5 mm heavy rainfall was recorded. Huge amount of muddy water discharged from streams and drainage outfalls among the coast into marine water body was observed during afternoon on the monitoring day and caused turbid sea surface.

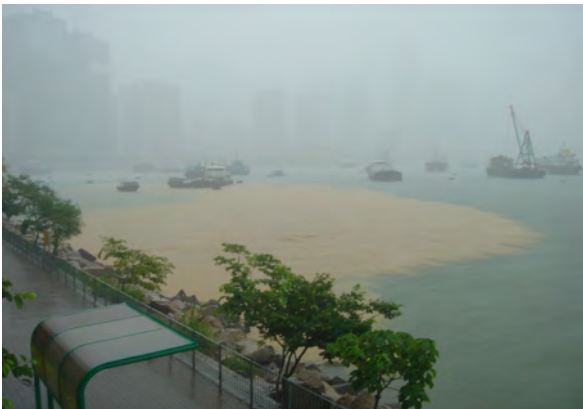
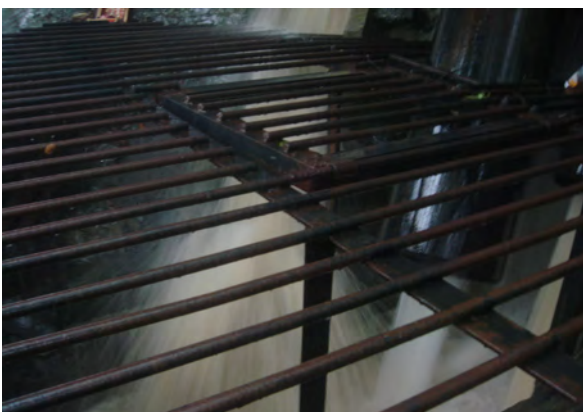
Photos of drainage outfall near the Belvedere Garden

On 29 June 2011, 76.5 mm heavy rainfall was recorded. Huge amount of muddy water discharged from streams and drainage outfalls among the coast into marine water body was observed during afternoon on the monitoring day and caused turbid sea surface.

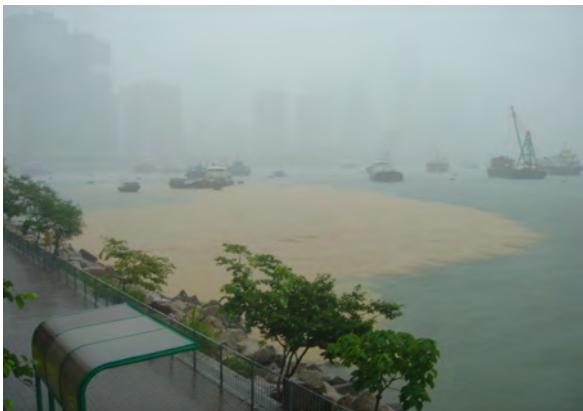
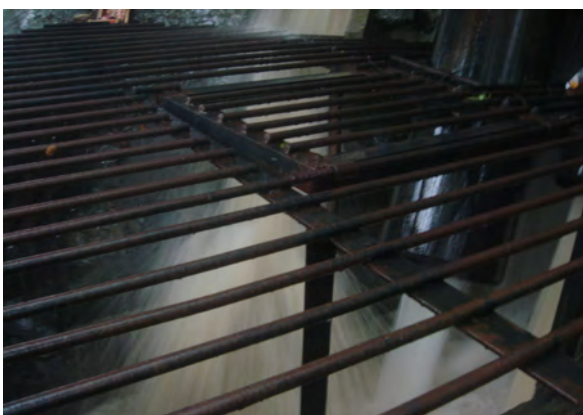
Photos of drainage outfall near the Belvedere Garden

On 29 June 2011, 76.5 mm heavy rainfall was recorded. Huge amount of muddy water discharged from streams and drainage outfalls among the coast into marine water body was observed during afternoon on the monitoring day and caused turbid sea surface.

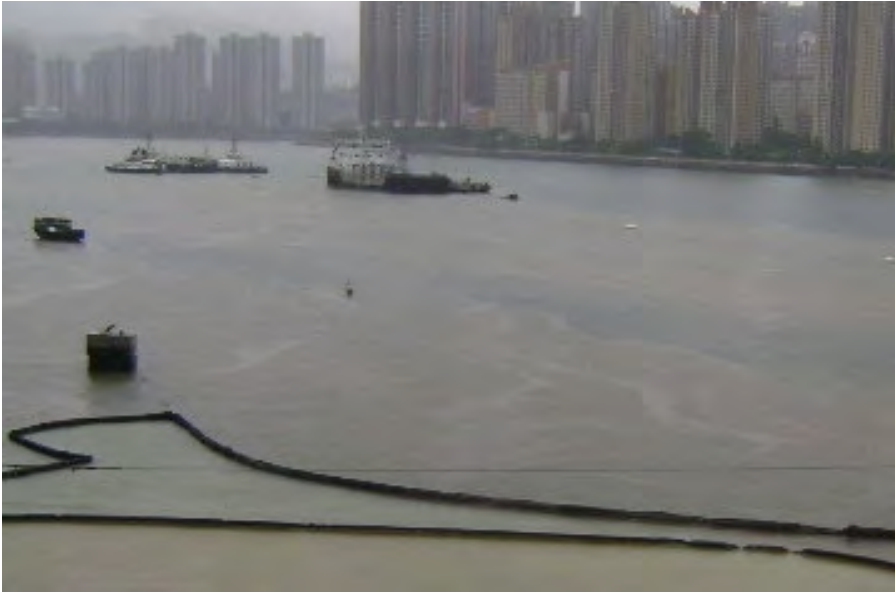
Site photo
(The marine water between the inner and outer silt curtain was clearer than the marine water outside the construction site. No leakage of silt curtain was observed.)

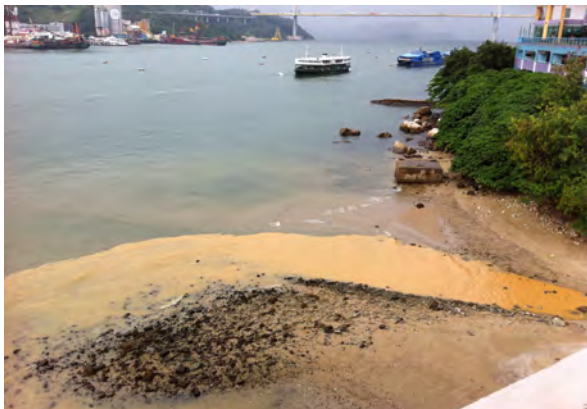
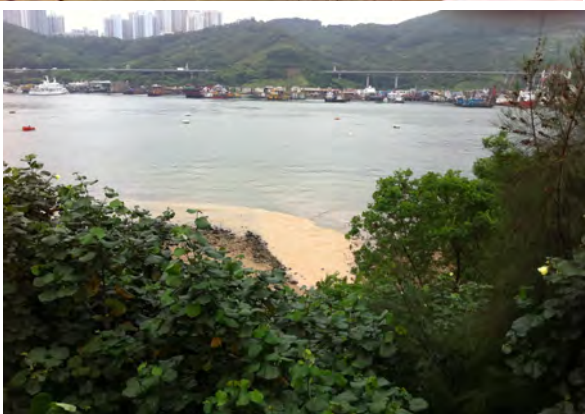
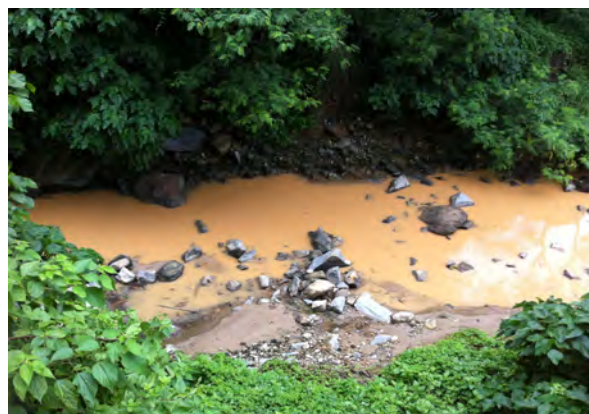
Photos of a stream between The Bay Bridge and Long Beach Garden

On 29 June 2011, 76.5 mm heavy rainfall was recorded. Huge amount of muddy water discharged from streams and drainage outfalls among the coast into marine water body was observed during monitoring and caused turbid sea surface.

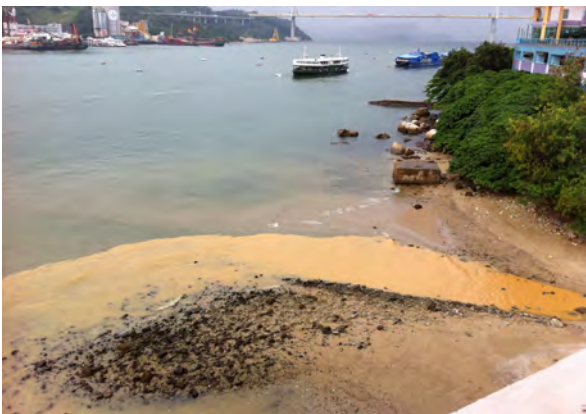
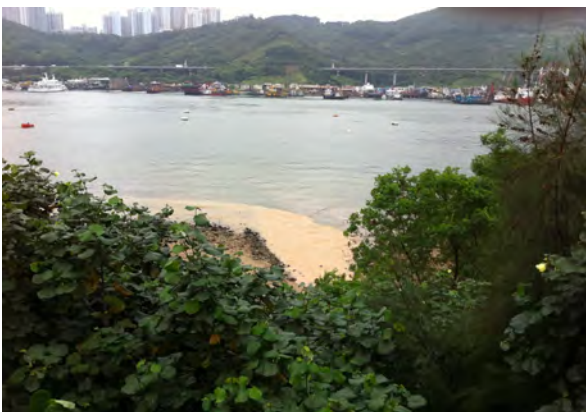
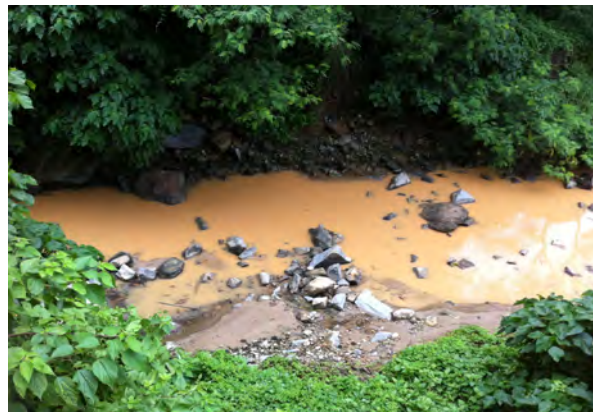
Photos of a stream between The Bay Bridge and Long Beach Garden

On 29 June 2011, 76.5 mm heavy rainfall was recorded. Huge amount of muddy water discharged from streams and drainage outfalls among the coast into marine water body was observed during monitoring and caused turbid sea surface.
