**Interim Notification of Environmental Quality Limit Exceedance**

Incident Report on Action Level Non-compliance

Project	Tsuen Wan Drainage Tunnel
Date	04-Nov-11
Time	3:13 PM
Monitoring Location	O-1(ET)
Parameter	Dissolved Oxygen (marine surface)
Action & Limit Levels (mg/L)	7.02 / 6.94
Measured Level (mg/L)	6.95
Control Station	O-1-C(ET)
Measured Level at the Control Station (mg/L)	6.91
Possible reason for Action or Limit Level Non-compliance	The measured DO level (marine surface) at the monitoring station was below the baseline action level, but higher than the DO level of the corresponding control station. Only relocation of grade 200 rockfill and trimming formation for precast concrete panel were undertaken at the Outfall basin (Portion E) on the monitoring day. No other marine works was conducted. No direct disturbance was observed from the site. The exceedance was considered to be contributed by natural variation and non-project related. Therefore, no further action was required.
Actions taken / to be taken	(1) Silt curtain was provided along the Portion E boundary line and extended from the seawater level to the bottom of seabed; (2) floating type silt curtain was employe

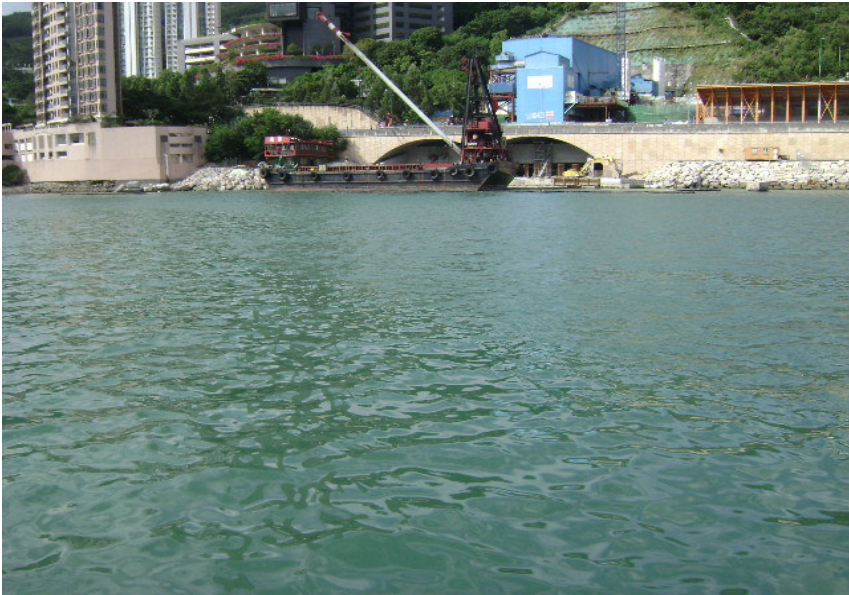
Site photo

**Photographic record for exceedance of Dissolved Oxygen (marine surface) recorded at O-1(ET) on 04-Nov-11**

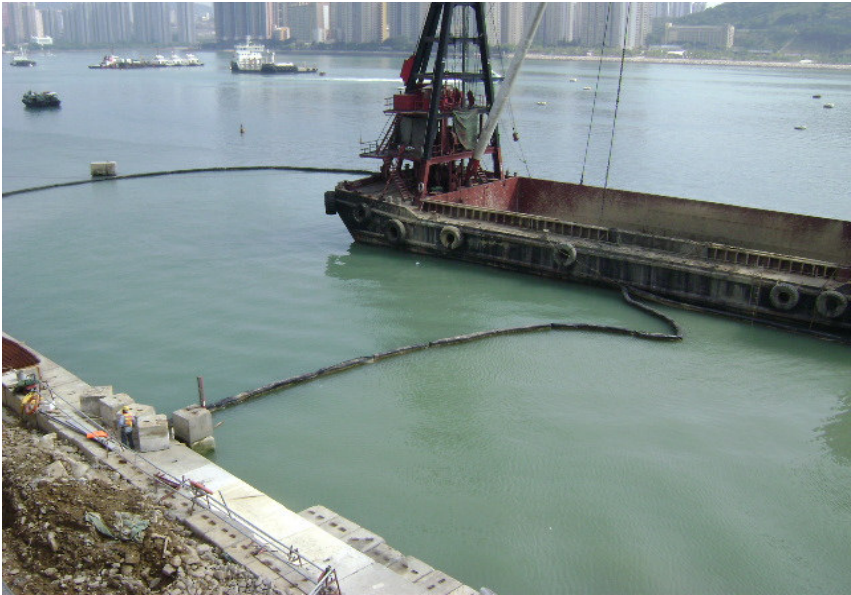
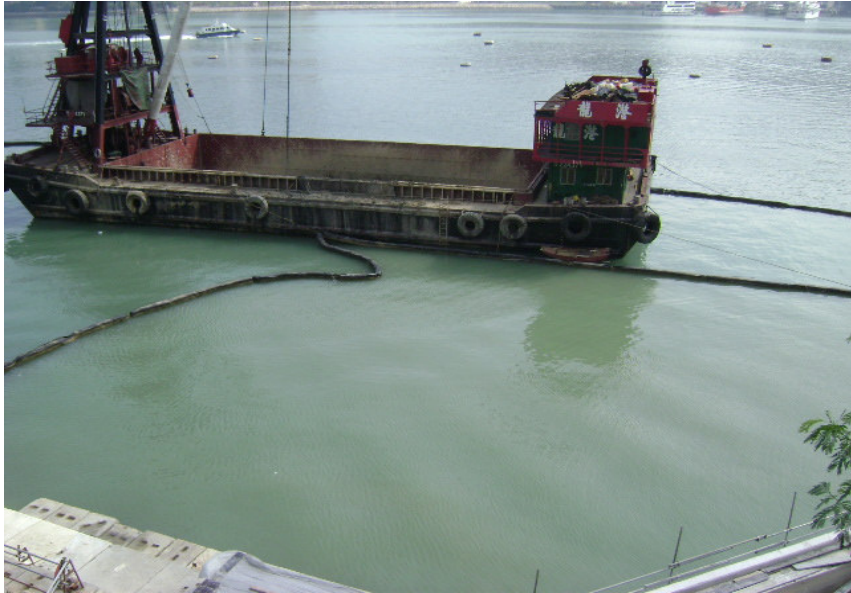
Site photo

Project	Tsuen Wan Drainage Tunnel
Date	02-Nov-11
Time	1:38 PM
Monitoring Location	O-1(ET)
Parameter	Suspended Solids (SS)
Action & Limit Levels (mg/L)	13.25 / 14.39
Measured Level (mg/L)	9.23
Control Station	O-1-C(ET)
Measured Level at the Control Station (mg/L)	7.50
Possible reason for Action or Limit Level Non-compliance	The measured SS level at the monitoring station was below the baseline action/limit level, but higher than 120% of the SS level of the corresponding control station. Only trimming formation for precast concrete panel was undertaken at the Outfall basin (Portion E) on the monitoring day. No other marine works was conducted. No direct disturbance was observed from the site. The exceedance was considered to be contributed by natural variation and non-project related. Therefore, no further action was required.
Actions taken / to be taken	(1) Silt curtain was provided along the Portion E boundary line and extended from the seawater level to the bottom of seabed; (2) floating type silt curtain was employed at the inner side; (3) sufficient slack of silt curtain was allowed to cope with the wave and tidal action to ensure the curtains (outer and inner) were rested on seabed; and (4) condition of silt curtains was checked by the supervisor daily before undertaking any marine works.

Photographic record for exceedance of Suspended Solids (SS) recorded at O-1(ET) on 02-Nov-11

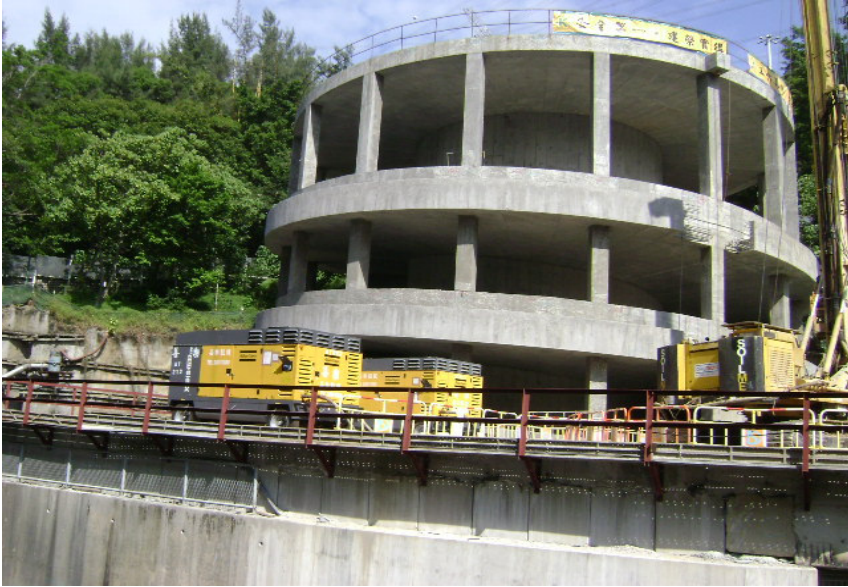
Site photo

Project	Tsuen Wan Drainage Tunnel
Date	02-Nov-11
Time	11:50 AM
Monitoring Location	Sik Sik Yuen Ho Fung College (I-1)
Parameter	Suspended Solids (SS)
Action & Limit Levels (mg/L)	8.85 / 10.17
Measured Level (mg/L)	7.05
Control Station	I-1-C
Measured Level at the Control Station (mg/L)	5.60
Possible reason for Action or Limit Level Non-compliance	The measured SS level was below the baseline action/limit level, but higher than 120% of the SS level of the control station (I-1-C). General cleaning and housekeeping, geotechnical instrumentation monitoring, making good spiral ramp concrete surface and cleaning, and drilling H-pile for PA wall were undertaken at the site during the monitoring day. No direct disturbance was observed from the site. The exceedance was considered to be contributed by natural variation and non-project related. Therefore, no further action was required.
Actions taken / to be taken	The following mitigation measures were provided on-site during monitoring: (1) wastewater was collected and diverted to waste water treatment plant prior to discharge; and (2) nullah and site area were separated by sealed concrete blocks.

Photographic record for exceedance of Suspended Solids (SS) recorded at Sik Sik Yuen Ho Fung College (I-1) on 02-Nov-11

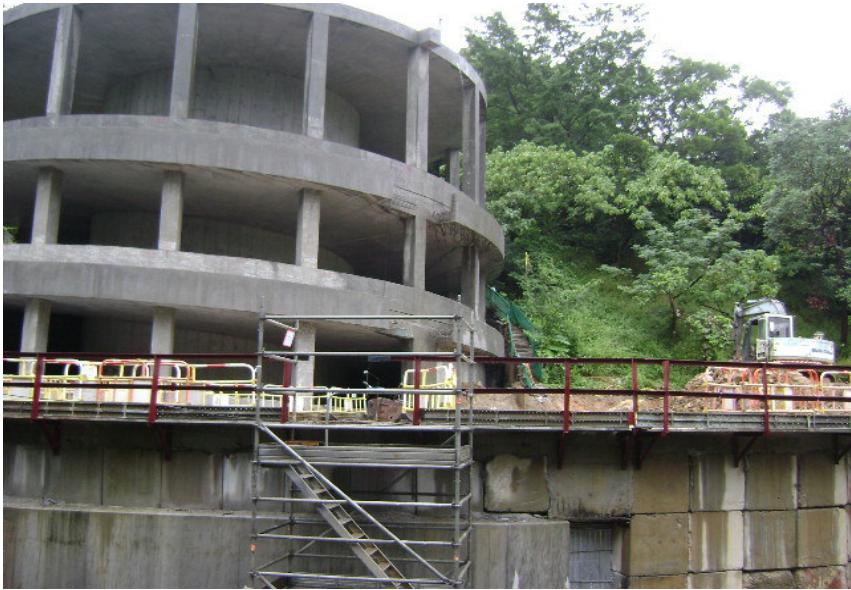
Site photo

Project	Tsuen Wan Drainage Tunnel
Date	09-Nov-11
Time	11:40 AM
Monitoring Location	Sik Sik Yuen Ho Fung College (I-1)
Parameter	Turbidity
Action & Limit Levels (NTU)	9.75 / 12.47
Measured Level (NTU)	15.06
Control Station	I-1-C
Measured Level at the Control Station (NTU)	15.42
Possible reason for Action or Limit Level Non-compliance	The measured turbidity level was higher than the baseline limit level, but lower than the turbidity level of the control station (I-1-C). General cleaning and housekeeping, monitoring of de-formation monitoring point (DMP), making good of concrete face and cleaning at spiral ramp, weir footing steel bar drilling and inserting steel bars, and site clearance at PA wall were undertaken during the monitoring day. No direct disturbance was observed from the site. About 44.2 mm rainfall was recorded by the Hong Kong Observatory on the monitoring day. Therefore, the exceedance was considered to be contributed by high turbidity level at upstream location and rainfall. Since the exceedance was non-project related, no further action was required.

Photographic record for exceedance of Turbidity recorded at Sik Sik Yuen Ho Fung College (I-1) on 09-Nov-11

Actions taken / to be taken	The following mitigation measures were provided on-site during monitoring: (1) wastewater was collected and diverted to waste water treatment plant prior to discharge; and (2) nullah and site area were separated by sealed concrete blocks.
Remarks	None

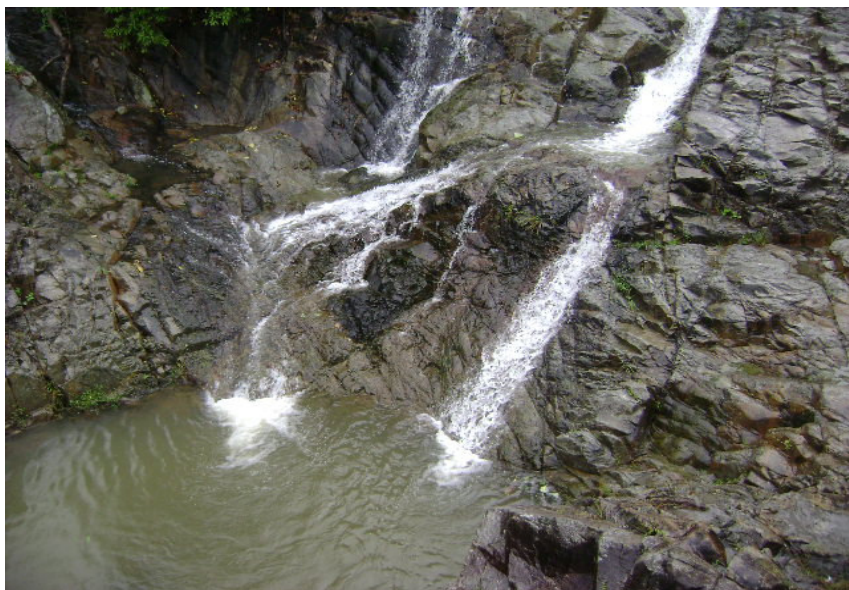
Photo taken at I-2

Project	Tsuen Wan Drainage Tunnel
Date	09-Nov-11
Time	11:10 AM
Monitoring Location	Hong Hoi Chee Hong Temple (I-2)
Parameter	Turbidity
Action & Limit Levels (NTU)	6.63 / 6.99
Measured Level (NTU)	19.50
Control Station	I-2-C
Measured Level at the Control Station (NTU)	19.40
Possible reason for Action or Limit Level Non-compliance	The measured turbidity level was higher than the baseline limit level, but lower than 120% of turbidity level of the control station (I-2-C). General site cleaning, housekeeping and temporary traffic arrangement (TTA), mucking, drilling blast holes and shotcreting, excavation for soil nailing at L-shape wall, backfilling for 1.5 m diameter drainage pipe next to catchpit WS1, breaking concrete buttress at Bay 2, removing formwork and curing for capping beam at Bay 1, closing formwork for capping beam Bay 5, trimming slope between 300 U-channel at mid-level of slope, and erection of formwork for 300 step channel and catchpit 7 were undertaken during the monitoring day. No direct disturbance was observed from the site. About 44.2 mm rainfall was recorded by the Hong Kong Observatory on the monitoring day. Therefore, the exceedance was considered to be contributed by high turbidity level at upstream location and rainfall. Since the exceedance was non-project related, no further action was required.

Photographic record for exceedance of Turbidity recorded at Hong Hoi Chee Hong Temple (I-2)  
on 09-Nov-11

Actions taken / to be taken	The following mitigation measures were provided on-site during monitoring: (1) Wastewater was collected and diverted to waste water treatment plant prior to discharge; (2) existing stream was diverted and bunded by sealed concrete block wall; and (3) existing stream was bunded off by sand bag to prevent any excavated material washing out from working area.
Remarks	None

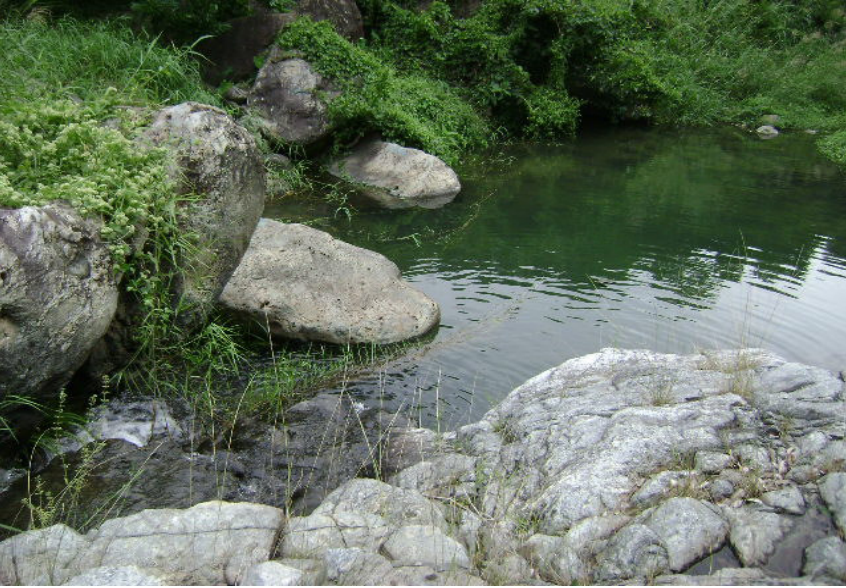
Photo taken at I-3

Project	Tsuen Wan Drainage Tunnel
Date	09-Nov-11
Time	10:25 AM
Monitoring Location	Squatters (I-3)
Parameter	Turbidity
Action & Limit Levels (NTU)	3.99 / 4.18
Measured Level (NTU)	4.09
Control Station	I-3-C
Measured Level at the Control Station (NTU)	4.17
Possible reason for Action or Limit Level Non-compliance	The measured turbidity level was higher than the baseline action level, but lower than the turbidity level of the control station (I-3-C). General site cleaning and housekeeping, monitoring of de-formation monitoring point (DMP), drilling hole for rock splitting, rock breaking and mucking out, lowering down of permanent access road at PB wall, and dismantling of concrete bund wall at approach channel were undertaken during the monitoring day. No direct disturbance was observed from the site. Therefore, the exceedance was considered to be contributed by high turbidity level at upstream location. Since the exceedance was non-project related, no further action was required.

Photographic record for exceedance of Turbidity recorded at Squatters (I-3) on 09-Nov-11

Actions taken / to be taken	The following mitigation measures were provided on-site during monitoring: (1) wastewater was collected and diverted to waste water treatment plant prior to discharge; (2) existing stream was diverted and banded by sealed concrete block wall; (3) excavated area was banded and sealed by concrete block wall to prevent any excavated material runoff from the working area.
Remarks	None

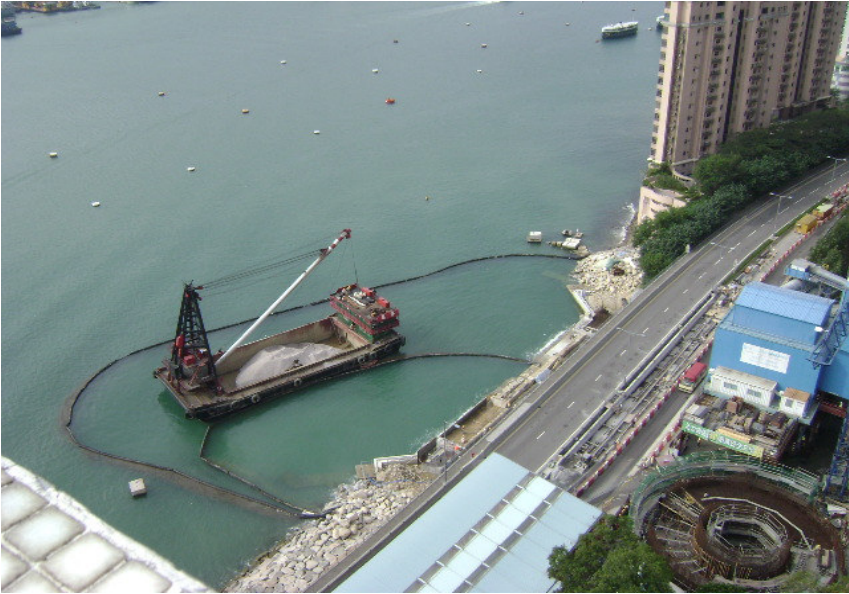
Site photo

Project	Tsuen Wan Drainage Tunnel
Date	07-Nov-11
Time	12:50 PM
Monitoring Location	O-1(FT)
Parameter	Suspended Solids (SS)
Action & Limit Levels (mg/L)	14.10 / 18.08
Measured Level (mg/L)	5.28
Control Station	O-1-C(FT)
Measured Level at the Control Station (mg/L)	3.87
Possible reason for Action or Limit Level Non-compliance	The measured SS level at the monitoring station was well below the baseline action/limit level, but slightly higher than 130% of the SS level of the corresponding control station. Only placing level stone for formation of precast panels was undertaken at the Outfall basin (Portion E) on the monitoring day. No other marine works was conducted. No direct disturbance was observed from the site. The exceedance was considered to be contributed by natural variation and non-project related. Therefore, no further action was required.
Actions taken / to be taken	(1) Silt curtain was provided along the Portion E boundary line and extended from the seawater level to the bottom of seabed; (2) floating type silt curtain was employed at the inner side; (3) sufficient slack of silt curtain was allowed to cope with the wave and tidal action to ensure the curtains (outer and inner) were rested on seabed; and (4) condition of silt curtains was checked by the supervisor daily before undertaking any marine works.

**Photographic record for exceedance of Suspended Solids (SS) recorded at O-1(FT) on 07-Nov-11**

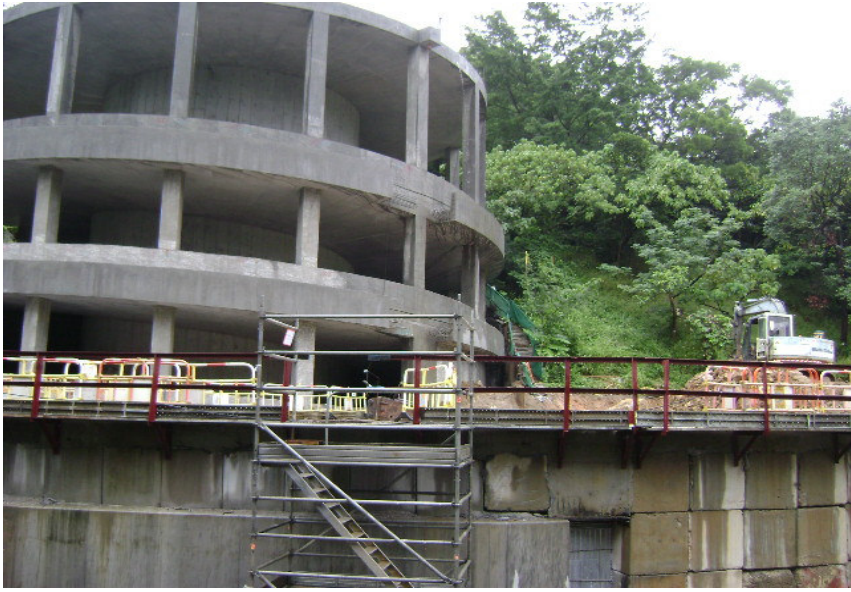
Site photo

Project	Tsuen Wan Drainage Tunnel
Date	09-Nov-11
Time	11:40 AM
Monitoring Location	Sik Sik Yuen Ho Fung College (I-1)
Parameter	Suspended Solids (SS)
Action & Limit Levels (mg/L)	8.85 / 10.17
Measured Level (mg/L)	12.70
Control Station	I-1-C
Measured Level at the Control Station (mg/L)	12.90
Possible reason for Action or Limit Level Non-compliance	The measured SS level was higher than the baseline limit level, but lower than the SS level of the control station (I-1-C). General cleaning and housekeeping, monitoring of de-deformation monitoring point (DMP), making good of concrete face and cleaning at spiral ramp, weir footing steel bar drilling and inserting steel bars, and site clearance at PA wall were undertaken during the monitoring day. No direct disturbance was observed from the site. About 44.2 mm rainfall was recorded by the Hong Kong Observatory on the monitoring day. Therefore, the exceedance was considered to be contributed by high SS level at upstream location and rainfall. Since the exceedance was non-project related, no further action was required.

Photographic record for exceedance of Suspended Solids (SS) recorded at Sik Sik Yuen Ho Fung College (I-1) on 09-Nov-11

Actions taken / to be taken	The following mitigation measures were provided on-site during monitoring: (1) wastewater was collected and diverted to waste water treatment plant prior to discharge; and (2) nullah and site area were separated by sealed concrete blocks.
Remarks	None

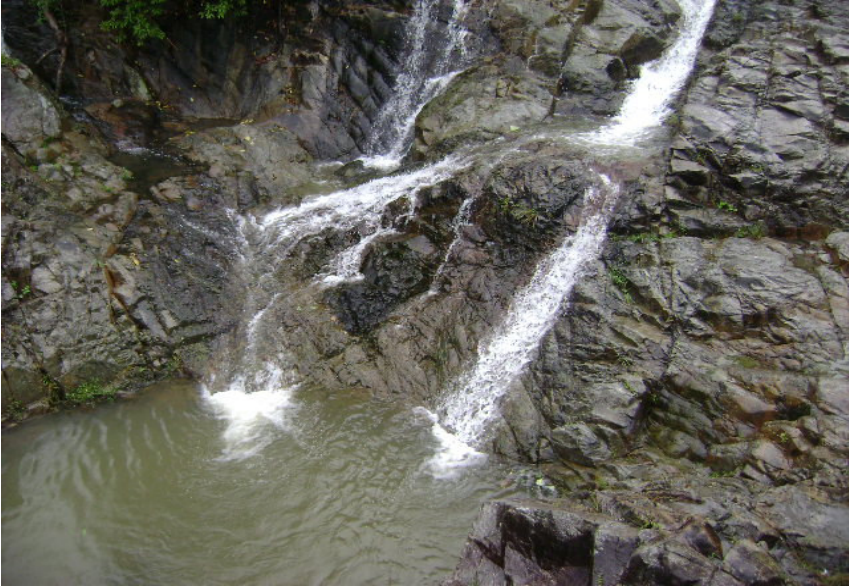
Photo taken at I-2

Project	Tsuen Wan Drainage Tunnel
Date	09-Nov-11
Time	11:10 AM
Monitoring Location	Hong Hoi Chee Hong Temple (I-2)
Parameter	Suspended Solids (SS)
Action & Limit Levels (mg/L)	7.68 / 8.34
Measured Level (mg/L)	18.00
Control Station	I-2-C
Measured Level at the Control Station (mg/L)	18.20
Possible reason for Action or Limit Level Non-compliance	The measured SS level was higher than the baseline limit level, but lower than the SS level of the control station (I-2-C). General site cleaning, housekeeping and temporary traffic arrangement (TTA), mucking, drilling blast holes and shotcreting, excavation for soil nailing at L-shaped wall, backfilling for 1.5 m diameter drainage pipe next to catchpit WS1, breaking concrete buttress at Bay 2, removing formwork and curing for capping beam at Bay 1, closing formwork for capping beam Bay 5, trimming slope between 300 U-channel at mid-level of slope, and erection of formwork for 300 step channel and catchpit 7 were undertaken during the monitoring day. No direct disturbance was observed from the site. About 44.2 mm rainfall was recorded by the Hong Kong Observatory on the monitoring day. Therefore, the exceedance was considered to be contributed by high SS level at upstream location and rainfall. Since the exceedance was non-project related, no further action was required.

Photographic record for exceedance of Suspended Solids (SS) recorded at Hong Hoi Chee Hong Temple (I-2) on 09-Nov-11

Actions taken / to be taken	The following mitigation measures were provided on-site during monitoring: (1) Wastewater was collected and diverted to waste water treatment plant prior to discharge; (2) existing stream was diverted and bunded by sealed concrete block wall; and (3) existing stream was bunded off by sand bag to prevent any excavated material washing out from working area.
Remarks	None

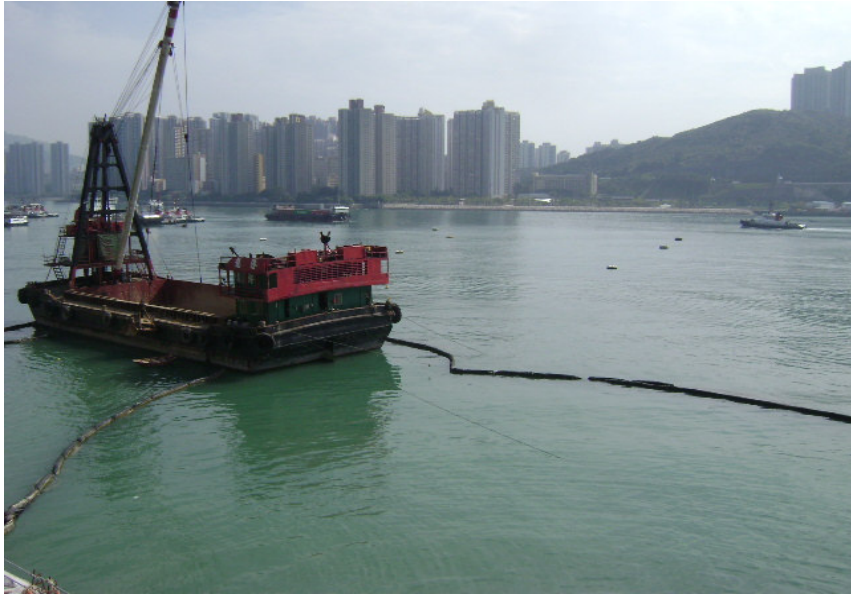
Site photo

Project	Tsuen Wan Drainage Tunnel
Date	23-Nov-11
Time	2:35 PM
Monitoring Location	O-1(FT)
Parameter	Suspended Solids (SS)
Action & Limit Levels (mg/L)	14.10 / 18.08
Measured Level (mg/L)	5.97
Control Station	O-1-C(FT)
Measured Level at the Control Station (mg/L)	4.78
Possible reason for Action or Limit Level Non-compliance	The measured SS level at the monitoring station was well below the baseline action/limit level, but slightly higher than 120% of the SS level of the corresponding control station. Only erection of formwork at open channel, and placing level stone and checking the formation for precast panels were undertaken at the Outfall basin (Portion E) on the monitoring day. No other marine works was conducted. No direct disturbance was observed from the site. The exceedance was considered to be contributed by natural variation and non-project related. Therefore, no further action was required.

**Photographic record for exceedance of Suspended Solids (SS) recorded at O-1(FT) on 23-Nov-11**

Actions taken / to be taken	(1) Silt curtain was provided along the Portion E boundary line and extended from the seawater level to the bottom of seabed; (2) floating type silt curtain was employed at the inner side; (3) sufficient slack of silt curtain was allowed to cope with the wave and tidal action to ensure the curtains (outer and inner) were rested on seabed; and (4) condition of silt curtains was checked by the supervisor daily before undertaking any marine works.
Remarks	None

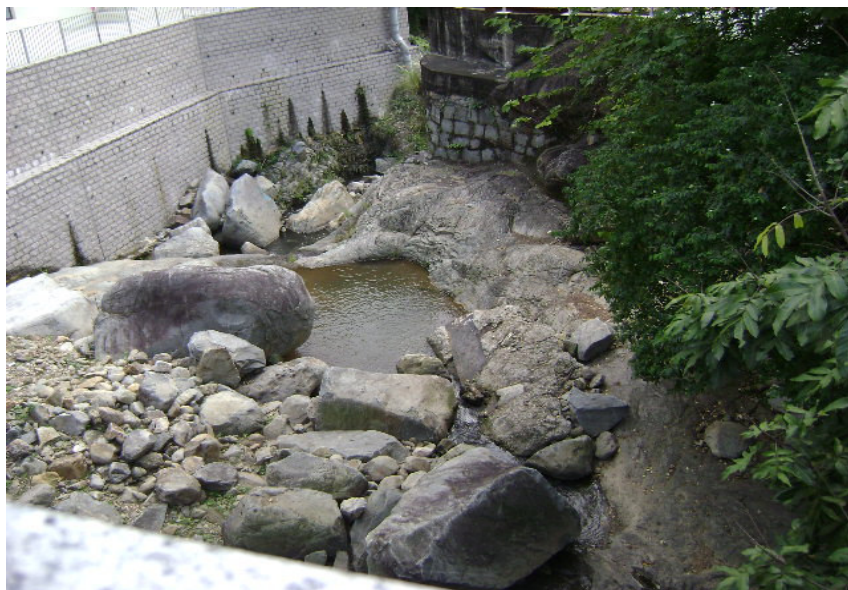
Photo taken at I-2

Project	Tsuen Wan Drainage Tunnel
Date	23-Nov-11
Time	3:40 PM
Monitoring Location	Hong Hoi Chee Hong Temple (I-2)
Parameter	Suspended Solids (SS)
Action & Limit Levels (mg/L)	7.68 / 8.34
Measured Level (mg/L)	2.60
Control Station	I-2-C
Measured Level at the Control Station (mg/L)	<2.00
Possible reason for Action or Limit Level Non-compliance	The measured SS level was well below the baseline action/limit level and same as 130% of the SS level of the control station (I-2-C). General site cleaning, housekeeping and temporary traffic arrangement (TTA); mucking out, drilling blast holes, survey check and rock mapping; drilling holes and grouting for soil nails at L-shape wall; formation of layer at trench, installation of cut pipe and fixing rebar for WS2; preparation works for demobilizing the mobile crane; erecting formwork for CP7 at 300 stepped channel; casting concrete for capping beam bay 6 and apron of 1500 stepped channel; and trimming final slope profile beside West Monastery were undertaken during the monitoring day. No direct disturbance was observed from the site. The exceedance was considered to be contributed by natural variation and non-project related. Therefore, no further action was required.

Photographic record for exceedance of Suspended Solids (SS) recorded at Hong Hoi Chee Hong Temple (I-2) on 23-Nov-11

Actions taken / to be taken	The following mitigation measures were provided on-site during monitoring: (1) Wastewater was collected and diverted to waste water treatment plant prior to discharge; (2) existing stream was diverted and bunded by sealed concrete block wall; and (3) existing stream was bunded off by sand bag to prevent any excavated material washing out from working area.
Remarks	None

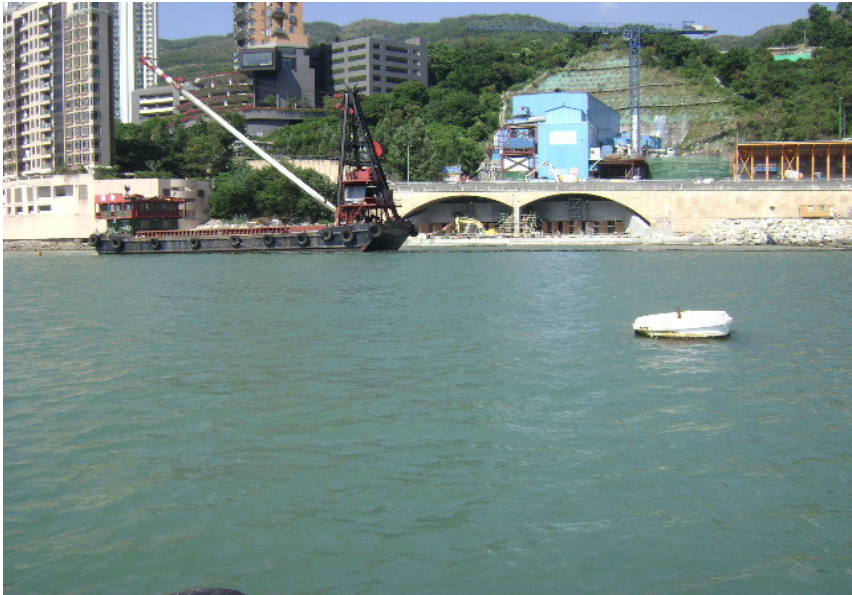
Site photo

Project	Tsuen Wan Drainage Tunnel
Date	28-Nov-11
Time	7:50 AM
Monitoring Location	O-1(FT)
Parameter	Suspended Solids (SS)
Action & Limit Levels (mg/L)	14.10 / 18.08
Measured Level (mg/L)	8.33
Control Station	O-1-C(FT)
Measured Level at the Control Station (mg/L)	6.42
Possible reason for Action or Limit Level Non-compliance	The measured SS level at the monitoring station was below the baseline action/limit level, but higher than 120% of the SS level of the corresponding control station. Only maintenance of the outer silt curtain and shifting the type II armour storage at the eastern seawall were undertaken at the Outfall basin (Portion E) on the monitoring day. No other marine works was conducted. No direct disturbance was observed from the site. The exceedance was considered to be contributed by natural variation and non-project related. Therefore, no further action was required.
Actions taken / to be taken	(1) Silt curtain was provided along the Portion E boundary line and extended from the seawater level to the bottom of seabed; (2) floating type silt curtain was employed at the inner side; (3) sufficient slack of silt curtain was allowed to cope with the wave and tidal action to ensure the curtains (outer and inner) were rested on seabed; and (4) condition of silt curtains was checked by the supervisor daily before undertaking any marine works.

**Photographic record for exceedance of Suspended Solids (SS) recorded at O-1(FT) on 28-Nov-11**
