Interim Notification of Environmental Quality Limit Exceedance

Incident Report on Limit Level Non-compliance

Project	Tsuen Wan Drainage Tunnel
Date	02-Mar-12
Time	1:32 PM
Monitoring Location	O-1(FT)
Parameter	Dissolved Oxygen (marine mid-depth)
Action & Limit Levels (mg/L)	6.84 / 6.81
Measured Level (mg/L)	6.70
Control Station	O-1-C(FT)
Measured Level at the Control Station (mg/L)	6.66
Possible reason for Action or Limit Level Non-compliance	The measured DO level (marine mid-depth) at the monitoring station was below the baseline limit level, but higher than the DO level of the corresponding control station. Only trimming type II rock slope at west side was undertaken at the Outfall basin (Portion E) on the monitoring day. No other marine works was conducted. No direct disturbance was observed from the site. The exceedance was considered to be contributed by natural variation and non-project related. Therefore, no further action was required.
Actions taken / to be taken	(1) Silt curtain was provided along the Portion E boundary line and extended from the seawater level to the bottom of seabed; (2) sufficient slack of silt curtain was allowed to cope with the wave and tidal action

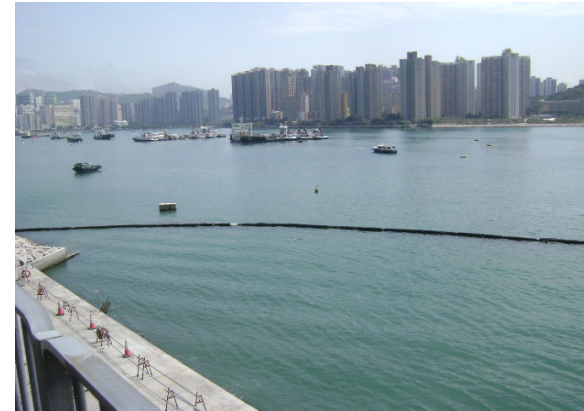
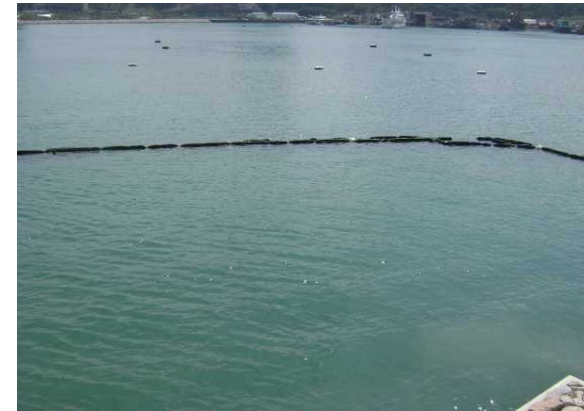
Photographic record for exceedance of Dissolved Oxygen (marine mid-depth) recorded at O-1(FT) on 02-Mar-12

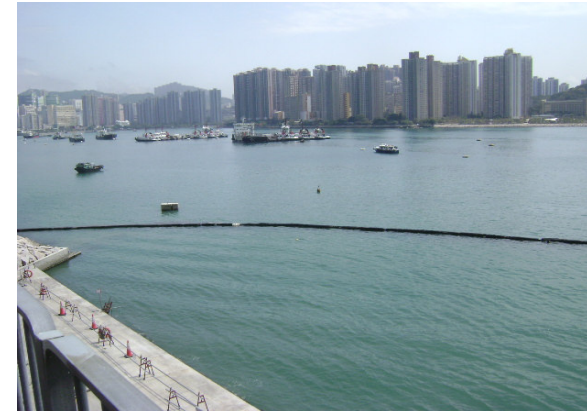
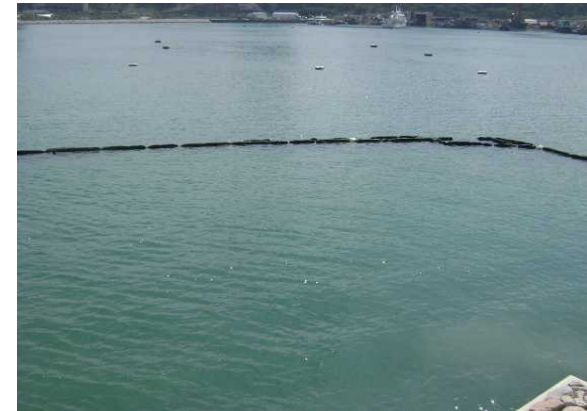
Project	Tsuen Wan Drainage Tunnel
Date	02-Mar-12
Time	1:32 PM
Monitoring Location	O-1(FT)
Parameter	Dissolved Oxygen (marine bottom)
Action & Limit Levels (mg/L)	6.99 / 6.96
Measured Level (mg/L)	6.59
Control Station	O-1-C(FT)
Measured Level at the Control Station (mg/L)	6.61
Possible reason for Action or Limit Level Non-compliance	The measured DO level (marine bottom) at the monitoring station was below the baseline limit level and lower than the DO level of the corresponding control station (about 0.3%). Only trimming type II rock slope at west side was undertaken at the Outfall basin (Portion E) on the monitoring day. No other marine works was conducted. No direct disturbance was observed from the site. The exceedance was considered to be contributed by natural variation and non-project related. Therefore, no further action was required.
Actions taken / to be taken	(1) Silt curtain was provided along the Portion E boundary line and extended from the seawater level to the bottom of seabed; (2) sufficient slack of silt curtain was allowed to cope with the wave and tidal action to ensure the curtain was rested on seabed; and (3) condition of silt curtain was checked by the supervisor daily before undertaking any marine works.

Photographic record for exceedance of Dissolved Oxygen (marine bottom) recorded at O-1(FT) on 02-Mar-12

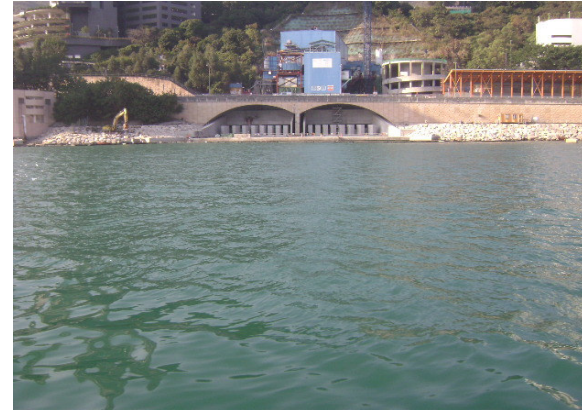
Project	Tsuen Wan Drainage Tunnel
Date	02-Mar-12
Time	5:27 PM
Monitoring Location	O-1(ET)
Parameter	Dissolved Oxygen (marine surface)
Action & Limit Levels (mg/L)	7.02 / 6.94
Measured Level (mg/L)	6.75
Control Station	O-1-C(ET)
Measured Level at the Control Station (mg/L)	6.80
Possible reason for Action or Limit Level Non-compliance	The measured DO level (marine surface) at the monitoring station was below the baseline limit level and lower than the DO level of the corresponding control station (about 0.7%). Only trimming type II rock slope at west side was undertaken at the Outfall basin (Portion E) on the monitoring day. No other marine works was conducted. No direct disturbance was observed from the site. The exceedance was considered to be contributed by natural variation and non-project related. Therefore, no further action was required.
Actions taken / to be taken	(1) Silt curtain was provided along the Portion E boundary line and extended from the seawater level to the bottom of seabed; (2) sufficient slack of silt curtain was allowed to cope with the wave and tidal action to ensure the curtain was rested on seabed; and (3) condition of silt curtain was checked by the supervisor daily before undertaking any marine works.

Photographic record for exceedance of Dissolved Oxygen (marine surface) recorded at O-1(ET) on 02-Mar-12

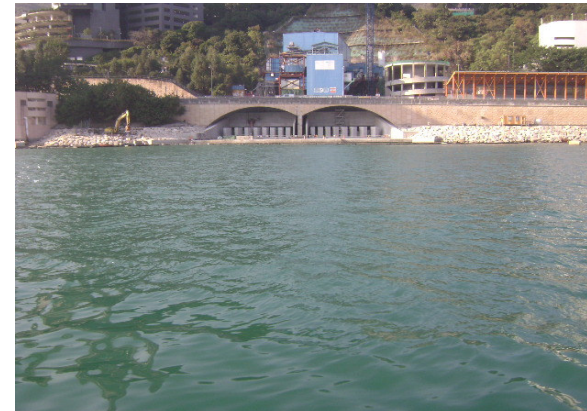
Project	Tsuen Wan Drainage Tunnel
Date	02-Mar-12
Time	5:27 PM
Monitoring Location	O-1(ET)
Parameter	Dissolved Oxygen (marine mid-depth)
Action & Limit Levels (mg/L)	7.02 / 6.94
Measured Level (mg/L)	6.64
Control Station	O-1-C(ET)
Measured Level at the Control Station (mg/L)	6.71
Possible reason for Action or Limit Level Non-compliance	The measured DO level (marine mid-depth) at the monitoring station was below the baseline limit level and lower than the DO level of the corresponding control station (about 1.0%). Only trimming type II rock slope at west side was undertaken at the Outfall basin (Portion E) on the monitoring day. No other marine works was conducted. No direct disturbance was observed from the site. The exceedance was considered to be contributed by natural variation and non-project related. Therefore, no further action was required.
Actions taken / to be taken	(1) Silt curtain was provided along the Portion E boundary line and extended from the seawater level to the bottom of seabed; (2) sufficient slack of silt curtain was allowed to cope with the wave and tidal action to ensure the curtain was rested on seabed; and (3) condition of silt curtain was checked by the supervisor daily before undertaking any marine works.

Photographic record for exceedance of Dissolved Oxygen (marine mid-depth) recorded at O-1(ET) on 02-Mar-12

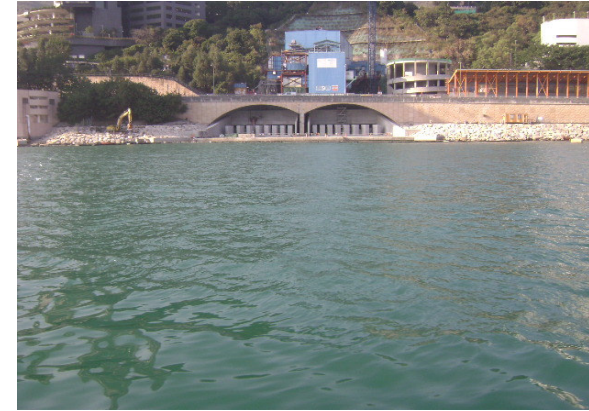
Project	Tsuen Wan Drainage Tunnel
Date	02-Mar-12
Time	5:27 PM
Monitoring Location	O-1(ET)
Parameter	Dissolved Oxygen (marine bottom)
Action & Limit Levels (mg/L)	6.70 / 6.48
Measured Level (mg/L)	6.55
Control Station	O-1-C(ET)
Measured Level at the Control Station (mg/L)	6.56
Possible reason for Action or Limit Level Non-compliance	The measured DO level (marine bottom) at the monitoring station was below the baseline action level and lower than the DO level of the corresponding control station (about 0.2%). Only trimming type II rock slope at west side was undertaken at the Outfall basin (Portion E) on the monitoring day. No other marine works was conducted. No direct disturbance was observed from the site. The exceedance was considered to be contributed by natural variation and non-project related. Therefore, no further action was required.
Actions taken / to be taken	(1) Silt curtain was provided along the Portion E boundary line and extended from the seawater level to the bottom of seabed; (2) sufficient slack of silt curtain was allowed to cope with the wave and tidal action to ensure the curtain was rested on seabed; and (3) condition of silt curtain was checked by the supervisor daily before undertaking any marine works.

Photographic record for exceedance of Dissolved Oxygen (marine bottom) recorded at O-1(ET) on 02-Mar-12

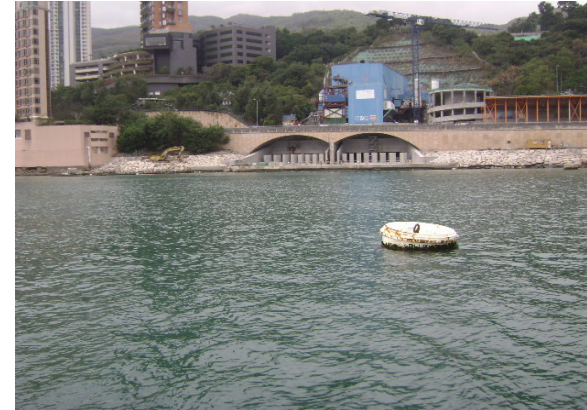
Project	Tsuen Wan Drainage Tunnel
Date	05-Mar-12
Time	3:30 PM
Monitoring Location	O-1(FT)
Parameter	Dissolved Oxygen (marine surface)
Action & Limit Levels (mg/L)	6.84 / 6.81
Measured Level (mg/L)	6.70
Control Station	O-1-C(FT)
Measured Level at the Control Station (mg/L)	6.84
Possible reason for Action or Limit Level Non-compliance	The measured DO level (marine surface) at the monitoring station was below the baseline limit level and lower than the DO level of the corresponding control station (about 2.0%). Only trimming type II rock slope at west side was undertaken at the Outfall basin (Portion E) on the monitoring day. No other marine works was conducted. No direct disturbance was observed from the site. The exceedance was considered to be contributed by natural variation and non-project related. Therefore, no further action was required.
Actions taken / to be taken	(1) Silt curtain was provided along the Portion E boundary line and extended from the seawater level to the bottom of seabed; (2) sufficient slack of silt curtain was allowed to cope with the wave and tidal action to ensure the curtain was rested on seabed; and (3) condition of silt curtain was checked by the supervisor daily before undertaking any marine works.

Photographic record for exceedance of Dissolved Oxygen (marine surface) recorded at O-1(FT) on 05-Mar-12

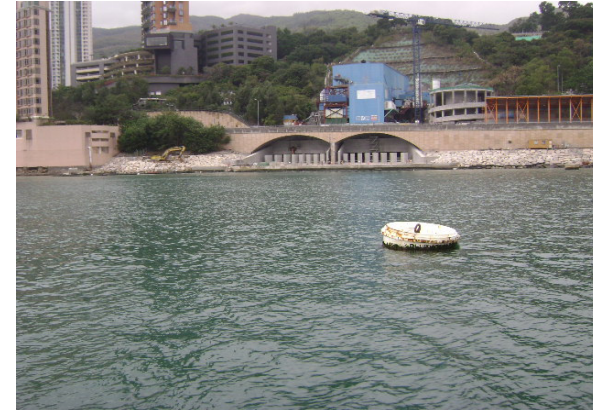
Project	Tsuen Wan Drainage Tunnel
Date	05-Mar-12
Time	3:30 PM
Monitoring Location	O-1(FT)
Parameter	Dissolved Oxygen (marine mid-depth)
Action & Limit Levels (mg/L)	6.84 / 6.81
Measured Level (mg/L)	6.61
Control Station	O-1-C(FT)
Measured Level at the Control Station (mg/L)	6.68
Possible reason for Action or Limit Level Non-compliance	The measured DO level (marine mid-depth) at the monitoring station was below the baseline limit level and lower than the DO level of the corresponding control station (about 1.0%). Only trimming type II rock slope at west side was undertaken at the Outfall basin (Portion E) on the monitoring day. No other marine works was conducted. No direct disturbance was observed from the site. The exceedance was considered to be contributed by natural variation and non-project related. Therefore, no further action was required.
Actions taken / to be taken	(1) Silt curtain was provided along the Portion E boundary line and extended from the seawater level to the bottom of seabed; (2) sufficient slack of silt curtain was allowed to cope with the wave and tidal action to ensure the curtain was rested on seabed; and (3) condition of silt curtain was checked by the supervisor daily before undertaking any marine works.

Photographic record for exceedance of Dissolved Oxygen (marine mid-depth) recorded at O-1(FT) on 05-Mar-12

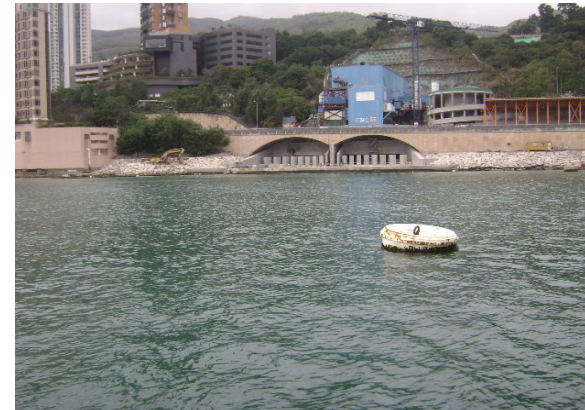
Project	Tsuen Wan Drainage Tunnel
Date	05-Mar-12
Time	3:30 PM
Monitoring Location	O-1(FT)
Parameter	Dissolved Oxygen (marine bottom)
Action & Limit Levels (mg/L)	6.99 / 6.96
Measured Level (mg/L)	6.61
Control Station	O-1-C(FT)
Measured Level at the Control Station (mg/L)	6.60
Possible reason for Action or Limit Level Non-compliance	The measured DO level (marine bottom) at the monitoring station was below the baseline limit level, but higher than the DO level of the corresponding control station. Only trimming type II rock slope at west side was undertaken at the Outfall basin (Portion E) on the monitoring day. No other marine works was conducted. No direct disturbance was observed from the site. The exceedance was considered to be contributed by natural variation and non-project related. Therefore, no further action was required.
Actions taken / to be taken	(1) Silt curtain was provided along the Portion E boundary line and extended from the seawater level to the bottom of seabed; (2) sufficient slack of silt curtain was allowed to cope with the wave and tidal action to ensure the curtain was rested on seabed; and (3) condition of silt curtain was checked by the supervisor daily before undertaking any marine works.

Photographic record for exceedance of Dissolved Oxygen (marine bottom) recorded at O-1(FT) on 05-Mar-12

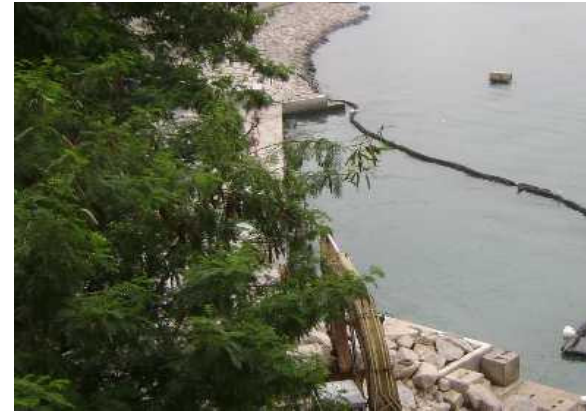
Project	Tsuen Wan Drainage Tunnel
Date	05-Mar-12
Time	10:33 AM
Monitoring Location	O-1(ET)
Parameter	Dissolved Oxygen (marine surface)
Action & Limit Levels (mg/L)	7.02 / 6.94
Measured Level (mg/L)	6.91
Control Station	O-1-C(ET)
Measured Level at the Control Station (mg/L)	7.04
Possible reason for Action or Limit Level Non-compliance	The measured DO level (marine surface) at the monitoring station was below the baseline limit level and lower than the DO level of the corresponding control station (about 1.8%). Only trimming type II rock slope at west side was undertaken at the Outfall basin (Portion E) on the monitoring day. No other marine works was conducted. No direct disturbance was observed from the site. The exceedance was considered to be contributed by natural variation and non-project related. Therefore, no further action was required.
Actions taken / to be taken	(1) Silt curtain was provided along the Portion E boundary line and extended from the seawater level to the bottom of seabed; (2) sufficient slack of silt curtain was allowed to cope with the wave and tidal action to ensure the curtain was rested on seabed; and (3) condition of silt curtain was checked by the supervisor daily before undertaking any marine works.

Photographic record for exceedance of Dissolved Oxygen (marine surface) recorded at O-1(ET) on 05-Mar-12

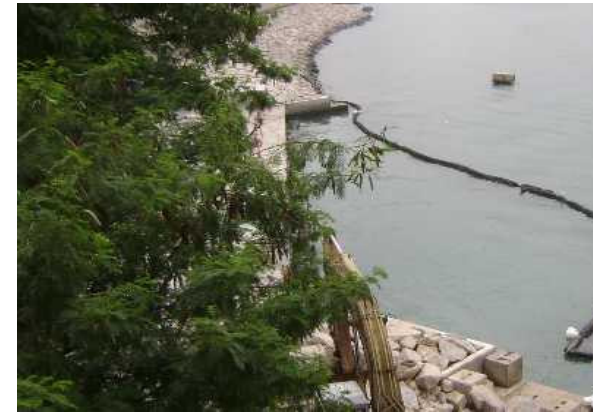
Project	Tsuen Wan Drainage Tunnel
Date	05-Mar-12
Time	10:33 AM
Monitoring Location	O-1(ET)
Parameter	Dissolved Oxygen (marine mid-depth)
Action & Limit Levels (mg/L)	7.02 / 6.94
Measured Level (mg/L)	6.59
Control Station	O-1-C(ET)
Measured Level at the Control Station (mg/L)	6.71
Possible reason for Action or Limit Level Non-compliance	The measured DO level (marine mid-depth) at the monitoring station was below the baseline limit level and lower than the DO level of the corresponding control station (about 1.8%). Only trimming type II rock slope at west side was undertaken at the Outfall basin (Portion E) on the monitoring day. No other marine works was conducted. No direct disturbance was observed from the site. The exceedance was considered to be contributed by natural variation and non-project related. Therefore, no further action was required.
Actions taken / to be taken	(1) Silt curtain was provided along the Portion E boundary line and extended from the seawater level to the bottom of seabed; (2) sufficient slack of silt curtain was allowed to cope with the wave and tidal action to ensure the curtain was rested on seabed; and (3) condition of silt curtain was checked by the supervisor daily before undertaking any marine works.

Photographic record for exceedance of Dissolved Oxygen (marine mid-depth) recorded at O-1(ET) on 05-Mar-12

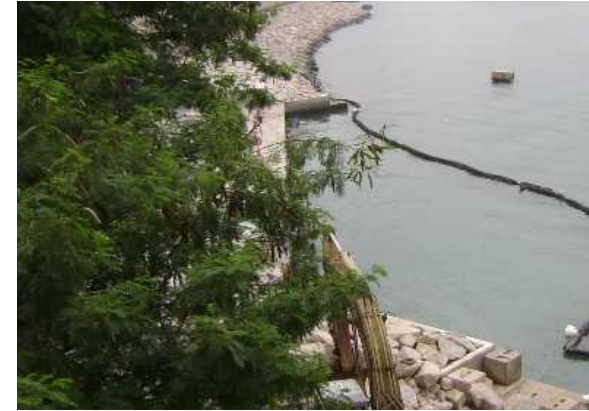
Project	Tsuen Wan Drainage Tunnel
Date	05-Mar-12
Time	10:33 AM
Monitoring Location	O-1(ET)
Parameter	Dissolved Oxygen (marine bottom)
Action & Limit Levels (mg/L)	6.70 / 6.48
Measured Level (mg/L)	6.63
Control Station	O-1-C(ET)
Measured Level at the Control Station (mg/L)	6.54
Possible reason for Action or Limit Level Non-compliance	The measured DO level (marine bottom) at the monitoring station was below the baseline action level, but higher than the DO level of the corresponding control station. Only trimming type II rock slope at west side was undertaken at the Outfall basin (Portion E) on the monitoring day. No other marine works was conducted. No direct disturbance was observed from the site. The exceedance was considered to be contributed by natural variation and non-project related. Therefore, no further action was required.
Actions taken / to be taken	(1) Silt curtain was provided along the Portion E boundary line and extended from the seawater level to the bottom of seabed; (2) sufficient slack of silt curtain was allowed to cope with the wave and tidal action to ensure the curtain was rested on seabed; and (3) condition of silt curtain was checked by the supervisor daily before undertaking any marine works.

Photographic record for exceedance of Dissolved Oxygen (marine bottom) recorded at O-1(ET) on 05-Mar-12

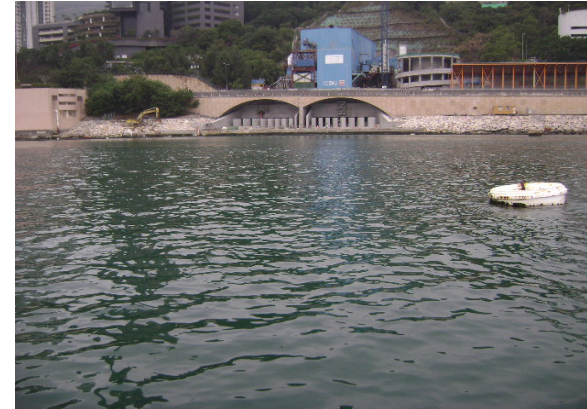
Project	Tsuen Wan Drainage Tunnel
Date	07-Mar-12
Time	12:50 PM
Monitoring Location	O-1(ET)
Parameter	Dissolved Oxygen (marine mid-depth)
Action & Limit Levels (mg/L)	7.02 / 6.94
Measured Level (mg/L)	7.01
Control Station	O-1-C(ET)
Measured Level at the Control Station (mg/L)	7.08
Possible reason for Action or Limit Level Non-compliance	The measured DO level (marine mid-depth) at the monitoring station was below the baseline action level and lower than the DO level of the corresponding control station (about 1.0%). Only trimming type II rock slope at west side was undertaken at the Outfall basin (Portion E) on the monitoring day. No other marine works was conducted. No direct disturbance was observed from the site. The exceedance was considered to be contributed by natural variation and non-project related. Therefore, no further action was required.
Actions taken / to be taken	(1) Silt curtain was provided along the Portion E boundary line and extended from the seawater level to the bottom of seabed; (2) sufficient slack of silt curtain was allowed to cope with the wave and tidal action to ensure the curtain was rested on seabed; and (3) condition of silt curtain was checked by the supervisor daily before undertaking any marine works.

Photographic record for exceedance of Dissolved Oxygen (marine mid-depth) recorded at O-1(ET) on 07-Mar-12

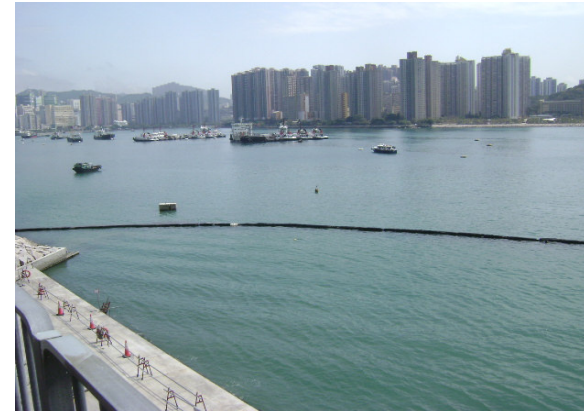
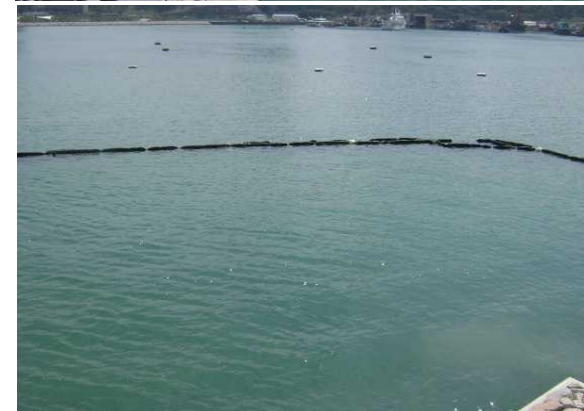
Project	Tsuen Wan Drainage Tunnel
Date	02-Mar-12
Time	1:32 PM
Monitoring Location	O-1(FT)
Parameter	Suspended Solids (SS)
Action & Limit Levels (mg/L)	14.10 / 18.08
Measured Level (mg/L)	2.78
Control Station	O-1-C(FT)
Measured Level at the Control Station (mg/L)	2.17
Possible reason for Action or Limit Level Non-compliance	The measured SS level at the monitoring station was well below the baseline action/limit level, but higher than the 120% of the SS level of the corresponding control station. Only trimming type II rock slope at west side was undertaken at the Outfall basin (Portion E) on the monitoring day. No other marine works was conducted. No direct disturbance was observed from the site. The exceedance was considered to be contributed by natural variation and non-project related. Therefore, no further action was required.
Actions taken / to be taken	(1) Silt curtain was provided along the Portion E boundary line and extended from the seawater level to the bottom of seabed; (2) sufficient slack of silt curtain was allowed to cope with the wave and tidal action to ensure the curtain was rested on seabed; and (3) condition of silt curtain was checked by the supervisor daily before undertaking any marine works.

Photographic record for exceedance of Suspended Solids (SS) recorded at O-1(FT) on 02-Mar-12

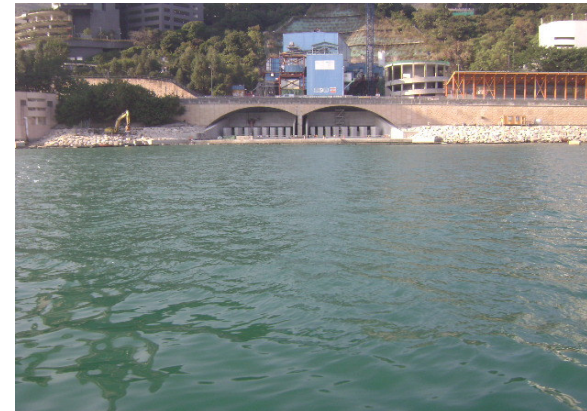
Project	Tsuen Wan Drainage Tunnel
Date	02-Mar-12
Time	5:27 PM
Monitoring Location	O-1(ET)
Parameter	Suspended Solids (SS)
Action & Limit Levels (mg/L)	13.25 / 14.39
Measured Level (mg/L)	3.86
Control Station	O-1-C(ET)
Measured Level at the Control Station (mg/L)	2.83
Possible reason for Action or Limit Level Non-compliance	The measured SS level at the monitoring station was well below the baseline action/limit level, but higher than 130% of the SS level of the corresponding control station. Only trimming type II rock slope at west side was undertaken at the Outfall basin (Portion E) on the monitoring day. No other marine works was conducted. No direct disturbance was observed from the site. The exceedance was considered to be contributed by natural variation and non-project related. Therefore, no further action was required.
Actions taken / to be taken	(1) Silt curtain was provided along the Portion E boundary line and extended from the seawater level to the bottom of seabed; (2) sufficient slack of silt curtain was allowed to cope with the wave and tidal action to ensure the curtain was rested on seabed; and (3) condition of silt curtain was checked by the supervisor daily before undertaking any marine works.

Photographic record for exceedance of Suspended Solids (SS) recorded at O-1(ET) on 02-Mar-12

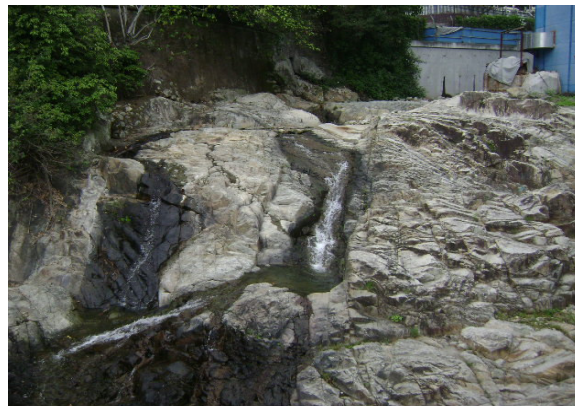
Photo taken at I-2

Project	Tsuen Wan Drainage Tunnel
Date	05-Mar-12
Time	1:27 PM
Monitoring Location	Hong Hoi Chee Hong Temple (I-2)
Parameter	Suspended Solids (SS)
Action & Limit Levels (mg/L)	7.68 / 8.34
Measured Level (mg/L)	2.80
Control Station	I-2-C
Measured Level at the Control Station (mg/L)	<2.00
Possible reason for Action or Limit Level Non-compliance	The measured SS level was well below the baseline action/limit level, but higher than 130% of the SS level of the control station (I-2-C). General site cleaning and housekeeping, mucking out and drilling holes for rock dowel and blast holes at main adit, mucking out drilled blast holes at lower man access shaft (LMAS), erection of formwork for dry weather flow channel (DWFC) and cast concrete for wall stem at L-shaped wall (type I), excavation, driving sheet pile and installing waling for trench of 1500 mm diameter drainage pipe from WS2 to SM1A (Stage 3) (construction area at Portion G next to the village house) at Portion G, and removing formwork for bedding of 1500 mm diameter drainage pipe at Bay 2 and 3 at Portion G were undertaken during the monitoring day. No direct disturbance was observed from the site. Therefore, the exceedance was considered to be contributed by natural variation. Since the exceedance was non-project related, no further action was required.

Photographic record for exceedance of Suspended Solids (SS) recorded at Hong Hoi Chee Hong Temple (I-2) on 05-Mar-12

Actions taken / to be taken	The following mitigation measures were provided on-site during monitoring: (1) wastewater was collected and diverted to waste water treatment plant prior to discharge; and (2) existing stream was diverted and banded by sand bags and sealed concrete block wall.
Remarks	None

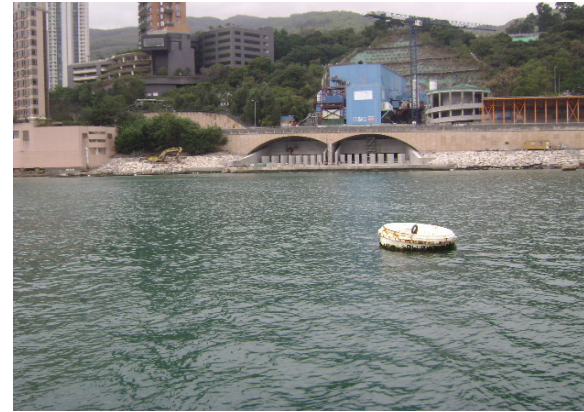
Project	Tsuen Wan Drainage Tunnel
Date	05-Mar-12
Time	3:30 PM
Monitoring Location	O-1(FT)
Parameter	Suspended Solids (SS)
Action & Limit Levels (mg/L)	14.10 / 18.08
Measured Level (mg/L)	4.32
Control Station	O-1-C(FT)
Measured Level at the Control Station (mg/L)	3.50
Possible reason for Action or Limit Level Non-compliance	The measured SS level at the monitoring station was well below the baseline action/limit level, but higher than 120% of the SS level of the corresponding control station. Only trimming type II rock slope at west side was undertaken at the Outfall basin (Portion E) on the monitoring day. No other marine works was conducted. No direct disturbance was observed from the site. The exceedance was considered to be contributed by natural variation and non-project related. Therefore, no further action was required.
Actions taken / to be taken	(1) Silt curtain was provided along the Portion E boundary line and extended from the seawater level to the bottom of seabed; (2) sufficient slack of silt curtain was allowed to cope with the wave and tidal action to ensure the curtain was rested on seabed; and (3) condition of silt curtain was checked by the supervisor daily before undertaking any marine works.

Photographic record for exceedance of Suspended Solids (SS) recorded at O-1(FT) on 05-Mar-12

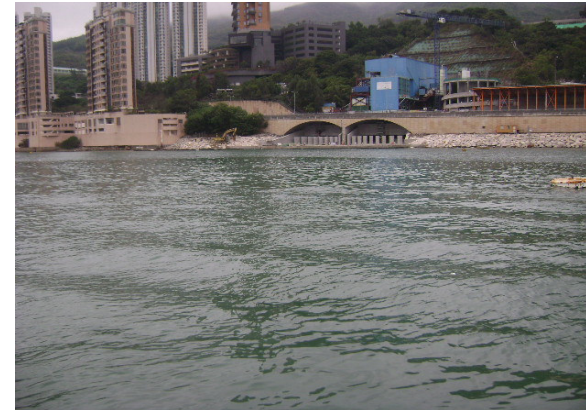
Project	Tsuen Wan Drainage Tunnel
Date	09-Mar-12
Time	8:55 AM
Monitoring Location	O-1(FT)
Parameter	Dissolved Oxygen (marine mid-depth)
Action & Limit Levels (mg/L)	6.84 / 6.81
Measured Level (mg/L)	6.79
Control Station	O-1-C(FT)
Measured Level at the Control Station (mg/L)	6.84
Possible reason for Action or Limit Level Non-compliance	The measured DO level (marine mid-depth) at the monitoring station was below the baseline limit level and lower than the DO level of the corresponding control station (about 0.7%). Only trimming type II rock slope at west side was undertaken at the Outfall basin (Portion E) on the monitoring day. No other marine works was conducted. No direct disturbance was observed from the site. The exceedance was considered to be contributed by natural variation and non-project related. Therefore, no further action was required.
Actions taken / to be taken	(1) Silt curtain was provided along the Portion E boundary line and extended from the seawater level to the bottom of seabed; (2) sufficient slack of silt curtain was allowed to cope with the wave and tidal action to ensure the curtain was rested on seabed; and (3) condition of silt curtain was checked by the supervisor daily before undertaking any marine works.

Photographic record for exceedance of Dissolved Oxygen (marine mid-depth) recorded at O-1(FT) on 09-Mar-12

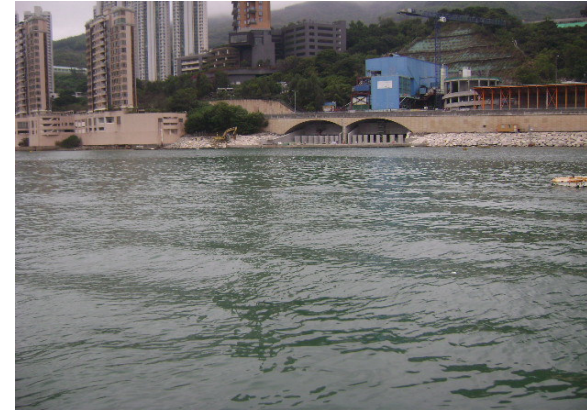
Project	Tsuen Wan Drainage Tunnel
Date	09-Mar-12
Time	8:55 AM
Monitoring Location	O-1(FT)
Parameter	Dissolved Oxygen (marine bottom)
Action & Limit Levels (mg/L)	6.99 / 6.96
Measured Level (mg/L)	6.88
Control Station	O-1-C(FT)
Measured Level at the Control Station (mg/L)	6.89
Possible reason for Action or Limit Level Non-compliance	The measured DO level (marine bottom) at the monitoring station was below the baseline limit level and lower than the DO level of the corresponding control station (about 0.1%). Only trimming type II rock slope at west side was undertaken at the Outfall basin (Portion E) on the monitoring day. No other marine works was conducted. No direct disturbance was observed from the site. The exceedance was considered to be contributed by natural variation and non-project related. Therefore, no further action was required.
Actions taken / to be taken	(1) Silt curtain was provided along the Portion E boundary line and extended from the seawater level to the bottom of seabed; (2) sufficient slack of silt curtain was allowed to cope with the wave and tidal action to ensure the curtain was rested on seabed; and (3) condition of silt curtain was checked by the supervisor daily before undertaking any marine works.

Photographic record for exceedance of Dissolved Oxygen (marine bottom) recorded at O-1(FT) on 09-Mar-12

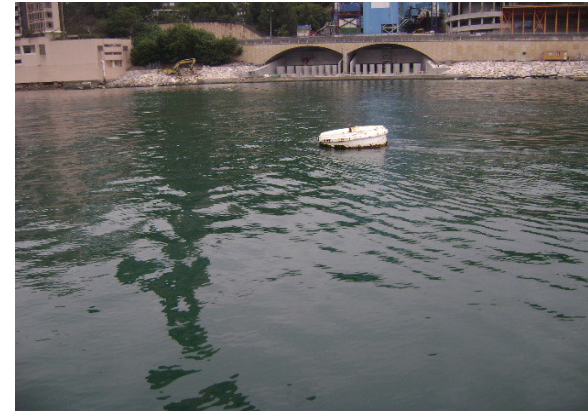
Project	Tsuen Wan Drainage Tunnel
Date	09-Mar-12
Time	12:30 PM
Monitoring Location	O-1(ET)
Parameter	Dissolved Oxygen (marine surface)
Action & Limit Levels (mg/L)	7.02 / 6.94
Measured Level (mg/L)	6.81
Control Station	O-1-C(ET)
Measured Level at the Control Station (mg/L)	6.89
Possible reason for Action or Limit Level Non-compliance	The measured DO level (marine surface) at the monitoring station was below the baseline limit level and lower than the DO level of the corresponding control station (about 1.2%). Only trimming type II rock slope at west side was undertaken at the Outfall basin (Portion E) on the monitoring day. No other marine works was conducted. No direct disturbance was observed from the site. The exceedance was considered to be contributed by natural variation and non-project related. Therefore, no further action was required.
Actions taken / to be taken	(1) Silt curtain was provided along the Portion E boundary line and extended from the seawater level to the bottom of seabed; (2) sufficient slack of silt curtain was allowed to cope with the wave and tidal action to ensure the curtain was rested on seabed; and (3) condition of silt curtain was checked by the supervisor daily before undertaking any marine works.

Photographic record for exceedance of Dissolved Oxygen (marine surface) recorded at O-1(ET) on 09-Mar-12

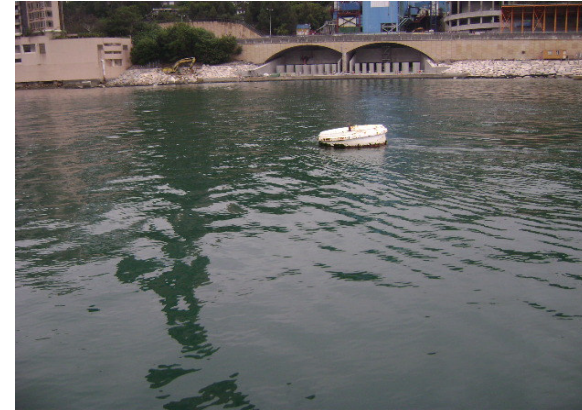
Project	Tsuen Wan Drainage Tunnel
Date	09-Mar-12
Time	12:30 PM
Monitoring Location	O-1(ET)
Parameter	Dissolved Oxygen (marine mid-depth)
Action & Limit Levels (mg/L)	7.02 / 6.94
Measured Level (mg/L)	6.82
Control Station	O-1-C(ET)
Measured Level at the Control Station (mg/L)	6.86
Possible reason for Action or Limit Level Non-compliance	The measured DO level (marine mid-depth) at the monitoring station was below the baseline limit level and lower than the DO level of the corresponding control station (about 0.6%). Only trimming type II rock slope at west side was undertaken at the Outfall basin (Portion E) on the monitoring day. No other marine works was conducted. No direct disturbance was observed from the site. The exceedance was considered to be contributed by natural variation and non-project related. Therefore, no further action was required.
Actions taken / to be taken	(1) Silt curtain was provided along the Portion E boundary line and extended from the seawater level to the bottom of seabed; (2) sufficient slack of silt curtain was allowed to cope with the wave and tidal action to ensure the curtain was rested on seabed; and (3) condition of silt curtain was checked by the supervisor daily before undertaking any marine works.

Photographic record for exceedance of Dissolved Oxygen (marine mid-depth) recorded at O-1(ET) on 09-Mar-12

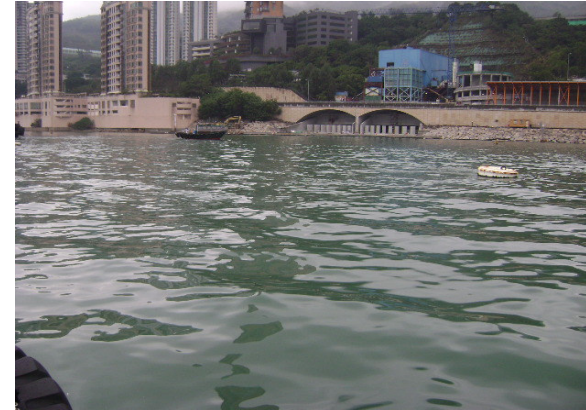
Project	Tsuen Wan Drainage Tunnel
Date	12-Mar-12
Time	9:50 AM
Monitoring Location	O-1(FT)
Parameter	Dissolved Oxygen (marine mid-depth)
Action & Limit Levels (mg/L)	6.84 / 6.81
Measured Level (mg/L)	6.55
Control Station	O-1-C(FT)
Measured Level at the Control Station (mg/L)	6.71
Possible reason for Action or Limit Level Non-compliance	The measured DO level (marine mid-depth) at the monitoring station was below the baseline limit level and lower than the DO level of the corresponding control station (about 2.4%). Only offloading rock material to Portion E west side and trimming type II rock slope at west side were undertaken at the Outfall basin (Portion E) on the monitoring day. No other marine works was conducted. No direct disturbance was observed from the site. The exceedance was considered to be contributed by natural variation and non-project related. Therefore, no further action was required.

Photographic record for exceedance of Dissolved Oxygen (marine mid-depth) recorded at O-1(FT) on 12-Mar-12

Actions taken / to be taken	(1) Silt curtain was provided along the Portion E boundary line and extended from the seawater level to the bottom of seabed; (2) sufficient slack of silt curtain was allowed to cope with the wave and tidal action to ensure the curtain was rested on seabed; and (3) condition of silt curtain was checked by the supervisor daily before undertaking any marine works.
Remarks	None

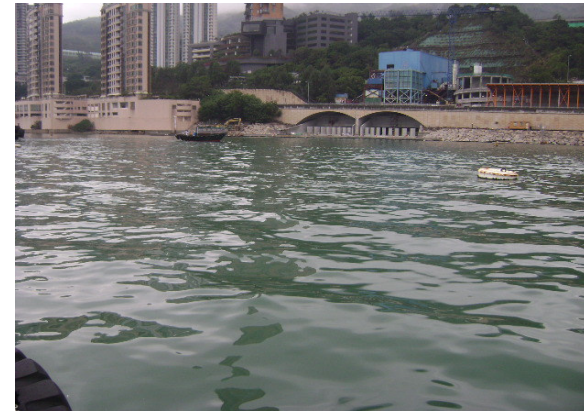
Project	Tsuen Wan Drainage Tunnel
Date	12-Mar-12
Time	9:50 AM
Monitoring Location	O-1(FT)
Parameter	Dissolved Oxygen (marine bottom)
Action & Limit Levels (mg/L)	6.99 / 6.96
Measured Level (mg/L)	6.78
Control Station	O-1-C(FT)
Measured Level at the Control Station (mg/L)	6.67
Possible reason for Action or Limit Level Non-compliance	The measured DO level (marine bottom) at the monitoring station was below the baseline limit level, but higher than the DO level of the corresponding control station. Only offloading rock material to Portion E west side and trimming type II rock slope at west side were undertaken at the Outfall basin (Portion E) on the monitoring day. No other marine works was conducted. No direct disturbance was observed from the site. The exceedance was considered to be contributed by natural variation and non-project related. Therefore, no further action was required.
Actions taken / to be taken	(1) Silt curtain was provided along the Portion E boundary line and extended from the seawater level to the bottom of seabed; (2) sufficient slack of silt curtain was allowed to cope with the wave and tidal action to ensure the curtain was rested on seabed; and (3) condition of silt curtain was checked by the supervisor daily before undertaking any marine works.

Photographic record for exceedance of Dissolved Oxygen (marine bottom) recorded at O-1(FT) on 12-Mar-12

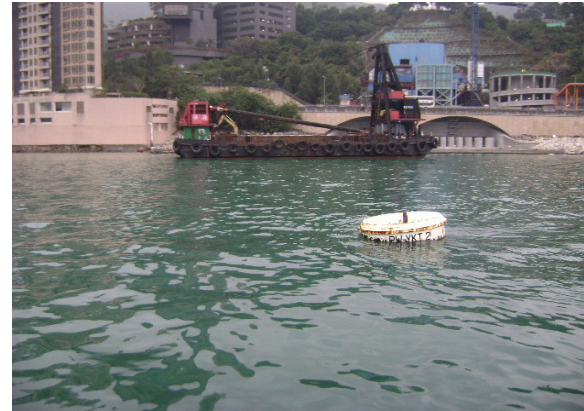
Project	Tsuen Wan Drainage Tunnel
Date	12-Mar-12
Time	3:00 PM
Monitoring Location	O-1(ET)
Parameter	Dissolved Oxygen (marine surface)
Action & Limit Levels (mg/L)	7.02 / 6.94
Measured Level (mg/L)	6.84
Control Station	O-1-C(ET)
Measured Level at the Control Station (mg/L)	6.89
Possible reason for Action or Limit Level Non-compliance	The measured DO level (marine surface) at the monitoring station was below the baseline limit level and lower than the DO level of the corresponding control station (about 0.7%). Only offloading rock material to Portion E west side and trimming type II rock slope at west side were undertaken at the Outfall basin (Portion E) on the monitoring day. No other marine works was conducted. No direct disturbance was observed from the site. The exceedance was considered to be contributed by natural variation and non-project related. Therefore, no further action was required.
Actions taken / to be taken	(1) Silt curtain was provided along the Portion E boundary line and extended from the seawater level to the bottom of seabed; (2) sufficient slack of silt curtain was allowed to cope with the wave and tidal action to ensure the curtain was rested on seabed; and (3) condition of silt curtain was checked by the supervisor daily before undertaking any marine works.

Photographic record for exceedance of Dissolved Oxygen (marine surface) recorded at O-1(ET) on 12-Mar-12

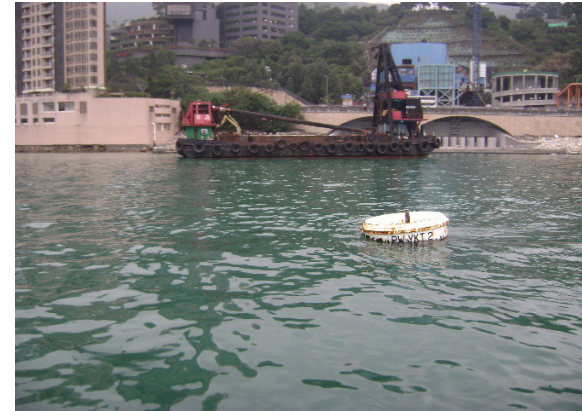
Project	Tsuen Wan Drainage Tunnel
Date	12-Mar-12
Time	3:00 PM
Monitoring Location	O-1(ET)
Parameter	Dissolved Oxygen (marine mid-depth)
Action & Limit Levels (mg/L)	7.02 / 6.94
Measured Level (mg/L)	6.73
Control Station	O-1-C(ET)
Measured Level at the Control Station (mg/L)	6.75
Possible reason for Action or Limit Level Non-compliance	The measured DO level (marine mid-depth) at the monitoring station was below the baseline limit level and lower than the DO level of the corresponding control station (about 0.3%). Only offloading rock material to Portion E west side and trimming type II rock slope at west side were undertaken at the Outfall basin (Portion E) on the monitoring day. No other marine works was conducted. No direct disturbance was observed from the site. The exceedance was considered to be contributed by natural variation and non-project related. Therefore, no further action was required.

Photographic record for exceedance of Dissolved Oxygen (marine mid-depth) recorded at O-1(ET) on 12-Mar-12

Actions taken / to be taken	(1) Silt curtain was provided along the Portion E boundary line and extended from the seawater level to the bottom of seabed; (2) sufficient slack of silt curtain was allowed to cope with the wave and tidal action to ensure the curtain was rested on seabed; and (3) condition of silt curtain was checked by the supervisor daily before undertaking any marine works.
Remarks	None

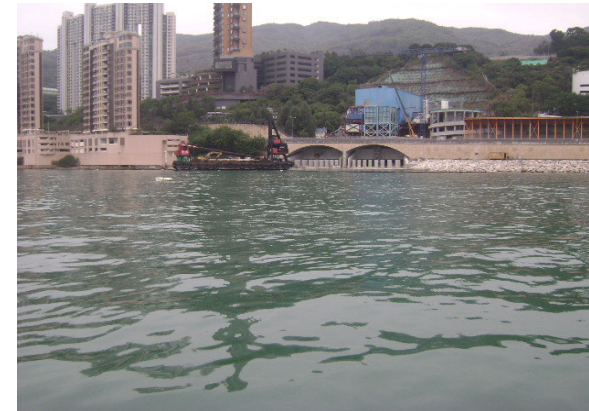
Project	Tsuen Wan Drainage Tunnel
Date	14-Mar-12
Time	10:55 AM
Monitoring Location	O-1(FT)
Parameter	Dissolved Oxygen (marine bottom)
Action & Limit Levels (mg/L)	6.99 / 6.96
Measured Level (mg/L)	6.80
Control Station	O-1-C(FT)
Measured Level at the Control Station (mg/L)	6.80
Possible reason for Action or Limit Level Non-compliance	The measured DO level (marine bottom) at the monitoring station was below the baseline limit level and same as the DO level of the corresponding control station. Only offloading type II rock material to Portion E west side and trimming type II rock slope at west side were undertaken at the Outfall basin (Portion E) on the monitoring day. No other marine works was conducted. No direct disturbance was observed from the site. The exceedance was considered to be contributed by natural variation and non-project related. Therefore, no further action was required.
Actions taken / to be taken	(1) Silt curtain was provided along the Portion E boundary line (outer silt curtain) and extended from the seawater level to the bottom of seabed; (2) floating type silt curtain was employed at the inner side; (3) sufficient slack of silt curtain was allowed to cope with the wave and tidal action to ensure the curtains (outer and inner) were rested on seabed; and (4) condition of silt curtains (outer and inner) were checked by the supervisor daily before undertaking any marine works.

Photographic record for exceedance of Dissolved Oxygen (marine bottom) recorded at O-1(FT) on 14-Mar-12

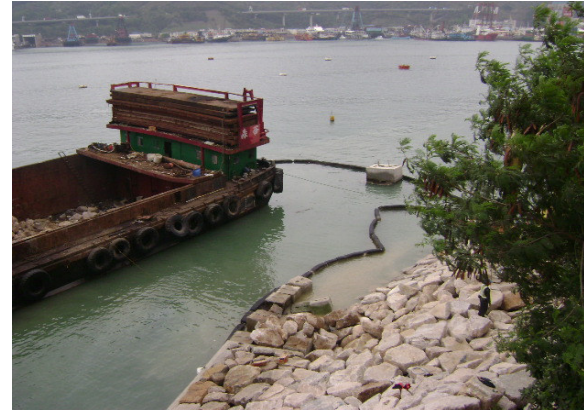
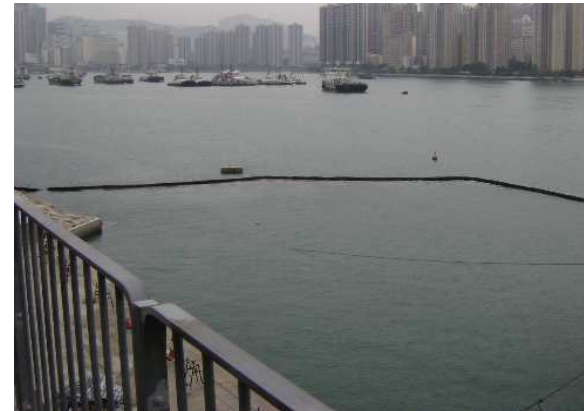
Project	Tsuen Wan Drainage Tunnel
Date	14-Mar-12
Time	04:30 PM
Monitoring Location	O-1(ET)
Parameter	Dissolved Oxygen (marine surface)
Action & Limit Levels (mg/L)	7.02 / 6.94
Measured Level (mg/L)	6.93
Control Station	O-1-C(ET)
Measured Level at the Control Station (mg/L)	6.97
Possible reason for Action or Limit Level Non-compliance	The measured DO level (marine surface) at the monitoring station was below the baseline limit level and lower than the DO level of the corresponding control station (about 0.6%). Only offloading type II rock material to Portion E west side and trimming type II rock slope at west side were undertaken at the Outfall basin (Portion E) on the monitoring day. No other marine works was conducted. No direct disturbance was observed from the site. The exceedance was considered to be contributed by natural variation and non-project related. Therefore, no further action was required.

Photographic record for exceedance of Dissolved Oxygen (marine surface) recorded at O-1(ET) on 14-Mar-12

Actions taken / to be taken	(1) Silt curtain was provided along the Portion E boundary line (outer silt curtain) and extended from the seawater level to the bottom of seabed; (2) floating type silt curtain was employed at the inner side; (3) sufficient slack of silt curtain was allowed to cope with the wave and tidal action to ensure the curtains (outer and inner) were rested on seabed; and (4) condition of silt curtains (outer and inner) were checked by the supervisor daily before undertaking any marine works.
Remarks	None

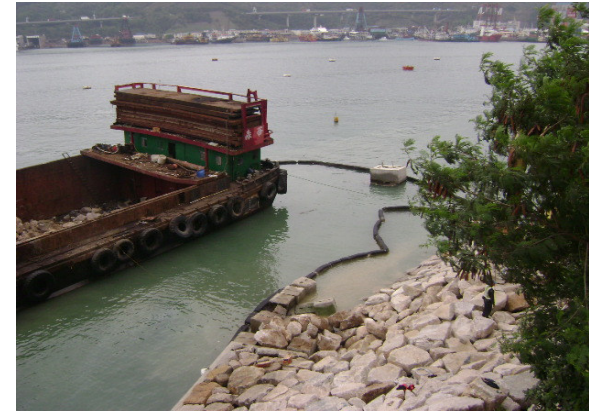
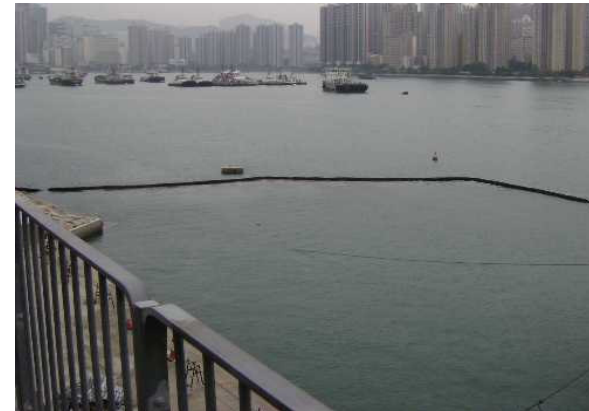
Project	Tsuen Wan Drainage Tunnel
Date	14-Mar-12
Time	04:30 PM
Monitoring Location	O-1(ET)
Parameter	Dissolved Oxygen (marine mid-depth)
Action & Limit Levels (mg/L)	7.02 / 6.94
Measured Level (mg/L)	6.74
Control Station	O-1-C(ET)
Measured Level at the Control Station (mg/L)	6.83
Possible reason for Action or Limit Level Non-compliance	The measured DO level (marine mid-depth) at the monitoring station was below the baseline limit level and lower than the DO level of the corresponding control station (about 1.3%). Only offloading type II rock material to Portion E west side and trimming type II rock slope at west side were undertaken at the Outfall basin (Portion E) on the monitoring day. No other marine works was conducted. No direct disturbance was observed from the site. The exceedance was considered to be contributed by natural variation and non-project related. Therefore, no further action was required.

Photographic record for exceedance of Dissolved Oxygen (marine mid-depth) recorded at O-1(ET) on 14-Mar-12

Actions taken / to be taken	(1) Silt curtain was provided along the Portion E boundary line (outer silt curtain) and extended from the seawater level to the bottom of seabed; (2) floating type silt curtain was employed at the inner side; (3) sufficient slack of silt curtain was allowed to cope with the wave and tidal action to ensure the curtains (outer and inner) were rested on seabed; and (4) condition of silt curtains (outer and inner) were checked by the supervisor daily before undertaking any marine works.
Remarks	None

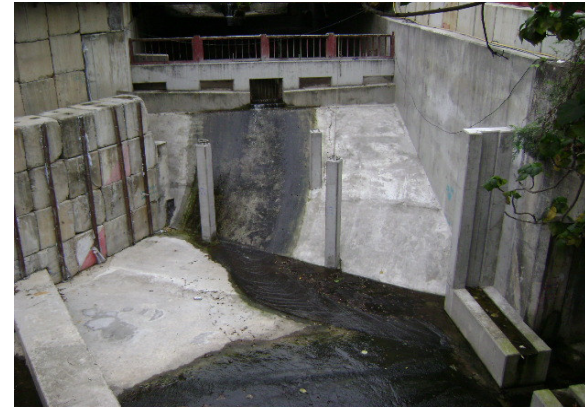
Photo taken at I-1

Project	Tsuen Wan Drainage Tunnel
Date	09-Mar-12
Time	10:55 AM
Monitoring Location	Sik Sik Yuen Ho Fung College (I-1)
Parameter	Suspended Solids (SS)
Action & Limit Levels (mg/L)	8.85 / 10.17
Measured Level (mg/L)	5.50
Control Station	I-1-C
Measured Level at the Control Station (mg/L)	4.40
Possible reason for Action or Limit Level Non-compliance	The measured SS level was below the baseline action/limit level, but higher than 120% of the SS level of the control station (I-1-C). Site tidying, clearing leaves at nullah and dismantling tunnel boring machine (TBM) head were undertaken during the monitoring day. No direct disturbance was observed from the site. Therefore, the exceedance was considered to be contributed by natural variation. Since the exceedance was non-project related, no further action was required.
Actions taken / to be taken	The following mitigation measures were provided on-site during monitoring: (1) wastewater was collected to waste water treatment plant for treatment before discharge; and (2) nullah and site area were separated by sealed concrete blocks.

Photographic record for exceedance of Suspended Solids (SS) recorded at Sik Sik Yuen Ho Fung College (I-1) on 09-Mar-12

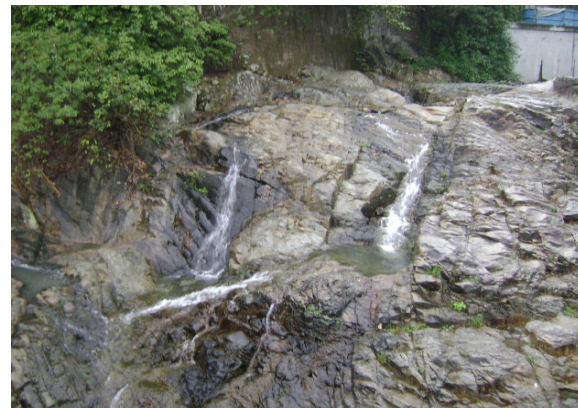
Photo taken at I-2

Photographic record for exceedance of Suspended Solids (SS) recorded at Hong Hoi Chee Hong Temple (I-2) on 12-Mar-12

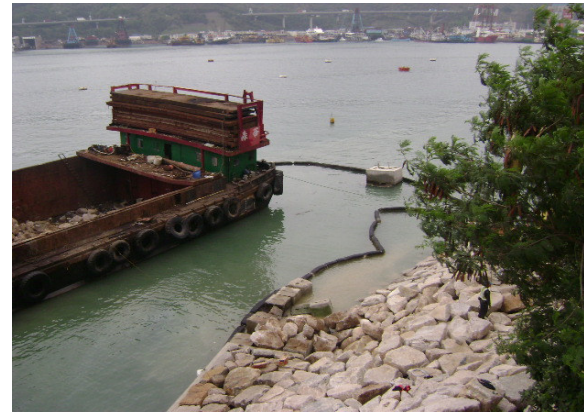
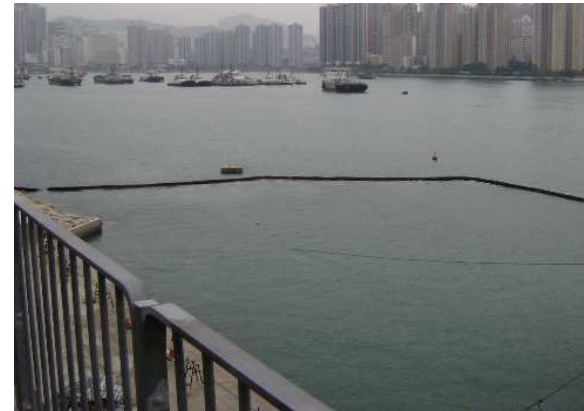
Photographic record for exceedance of Suspended Solids (SS) recorded at O-1(ET) on 14-Mar-12

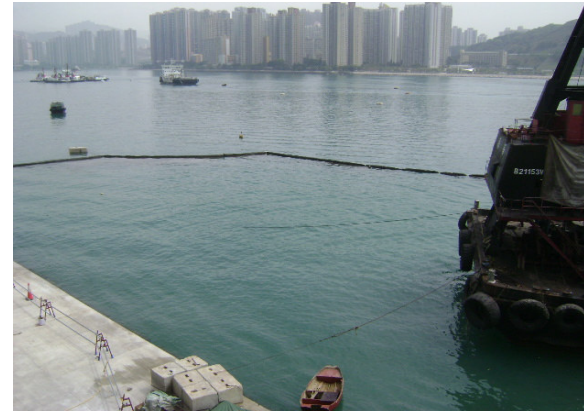
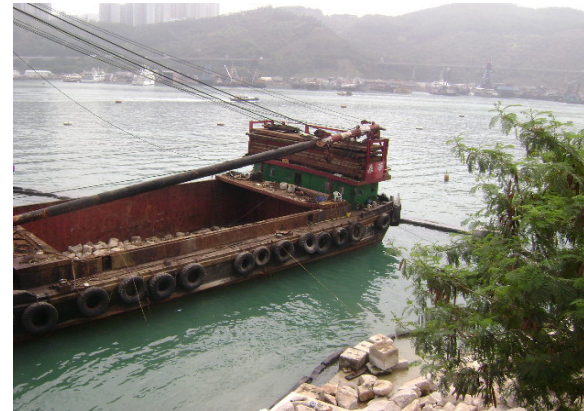
Photographic record for exceedance of Dissolved Oxygen (marine mid-depth) recorded at O-1(FT) on 16-Mar-12

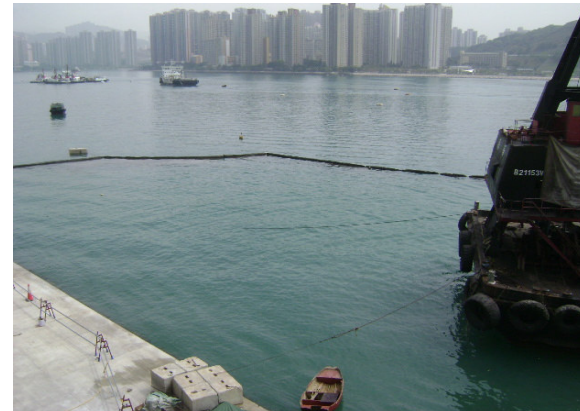
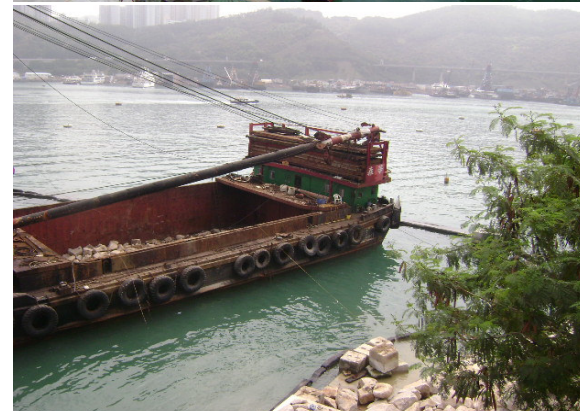
Photographic record for exceedance of Dissolved Oxygen (marine bottom) recorded at O-1(FT) on 16-Mar-12

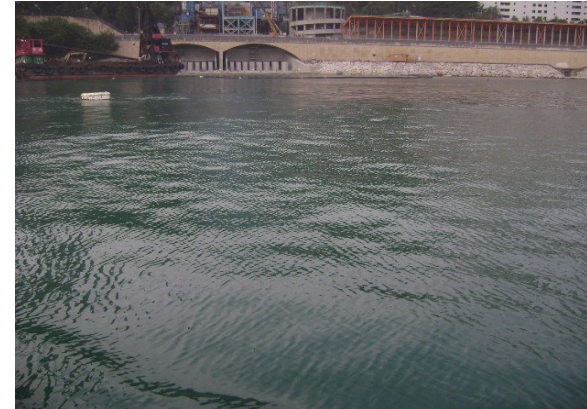
Photographic record for exceedance of Dissolved Oxygen (marine surface) recorded at O-1(ET) on 16-Mar-12

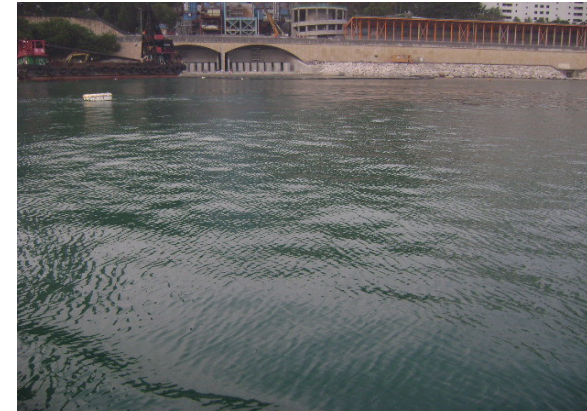
Photographic record for exceedance of Dissolved Oxygen (marine mid-depth) recorded at O-1(ET) on 16-Mar-12

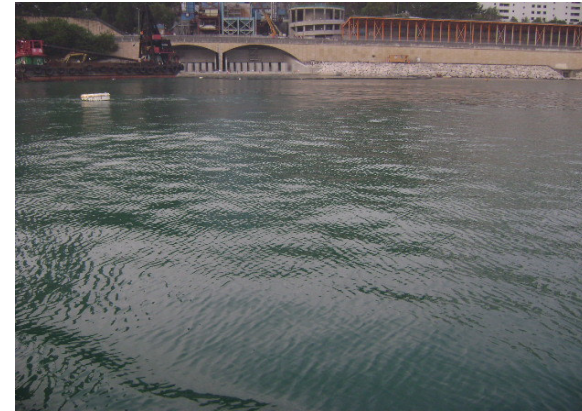
Photographic record for exceedance of Dissolved Oxygen (marine bottom) recorded at O-1(ET) on 16-Mar-12

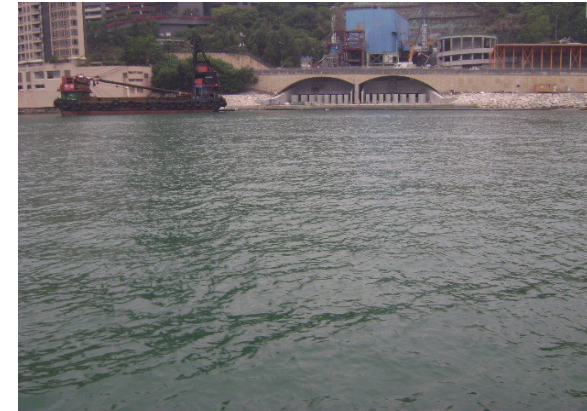
Photographic record for exceedance of Dissolved Oxygen (marine bottom) recorded at O-1(FT) on 23-Mar-12

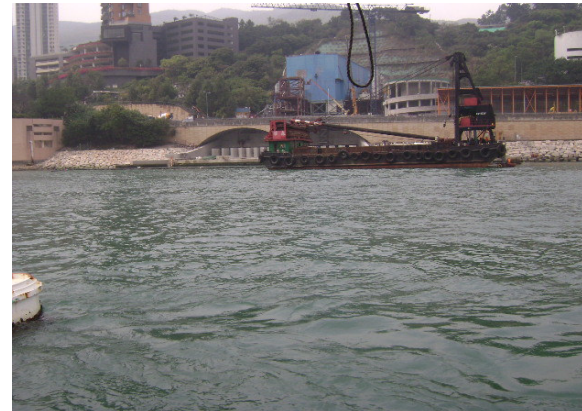
Photographic record for exceedance of Dissolved Oxygen (marine surface) recorded at O-1(ET) on 23-Mar-12
