Interim Notification of Environmental Quality Limit Exceedance

Incident Report on Limit Level Non-compliance

Project	Tsuen Wan Drainage Tunnel
Date	02-Mar-12
Time	1:32 PM
Monitoring Location	O-1(FT)
Parameter	Dissolved Oxygen (marine mid-depth)
Action & Limit Levels (mg/L)	6.84 / 6.81
Measured Level (mg/L)	6.70
Control Station	O-1-C(FT)
Measured Level at the Control Station (mg/L)	6.66
Possible reason for Action or Limit Level Non-compliance	The measured DO level (marine mid-depth) at the monitoring station was below the baseline limit level, but higher than the DO level of the corresponding control station. Only trimming type II rock slope at west side was undertaken at the Outfall basin (Portion E) on the monitoring day. No other marine works was conducted. No direct disturbance was observed from the site. The exceedance was considered to be contributed by natural variation and non-project related. Therefore, no further action was required.
Actions taken / to be taken	(1) Silt curtain was provided along the Portion E boundary line and extended from the seawater level to the bottom of seabed; (2) sufficient slack of silt curtain was allowed to cope with the wave and tidal action

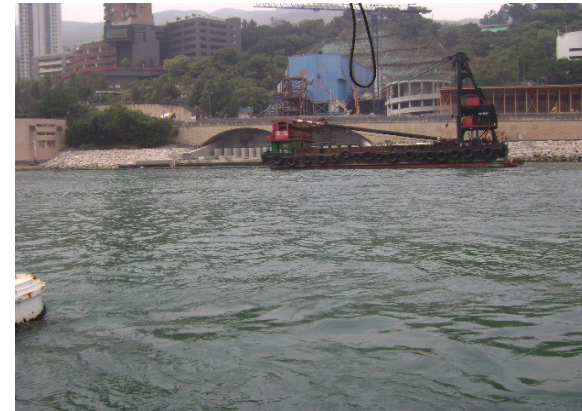
Photographic record for exceedance of Dissolved Oxygen (marine mid-depth) recorded at O-1(ET) on 23-Mar-12

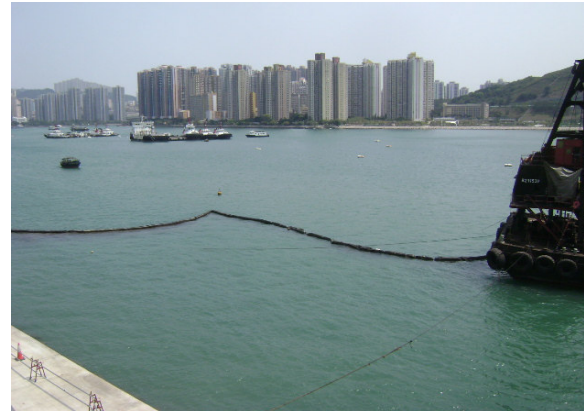
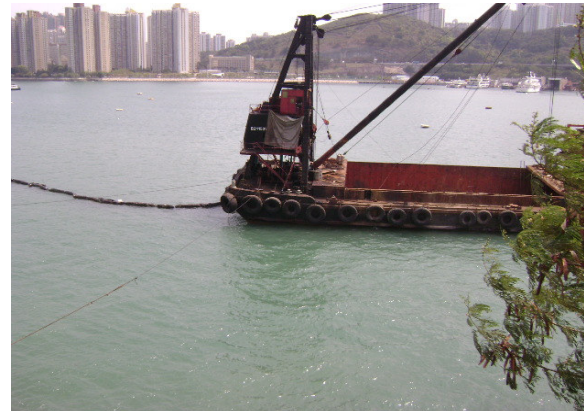
Photographic record for exceedance of Dissolved Oxygen (marine surface) recorded at O-1(ET) on 26-Mar-12

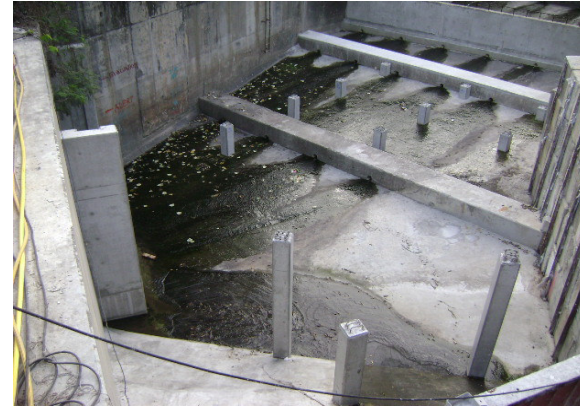
Photo taken at I-1

Photographic record for exceedance of Suspended Solids (SS) recorded at Sik Sik Yuen Ho Fung College (I-1) on 19-Mar-12

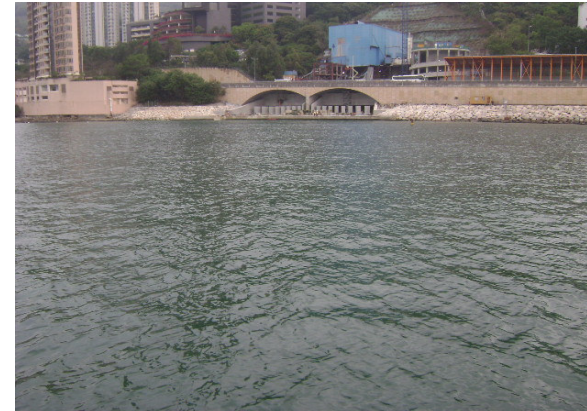
Photographic record for exceedance of Dissolved Oxygen (marine bottom) recorded at O-1(FT) on 30-Mar-12

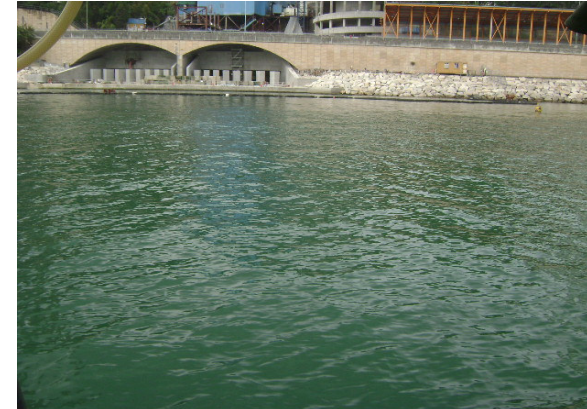
Photographic record for exceedance of Dissolved Oxygen (marine mid-depth) recorded at O-1(ET) on 30-Mar-12
