Interim Notification of Environmental Quality Limit Exceedance

Project	Tsuen Wan Drainage Tunnel
Date	06-Apr-11
Time	10:25 AM
Monitoring Location	Sik Sik Yuen Ho Fung College (I-1)
Parameter	Suspended Solids
Action & Limit Levels (mg/L)	8.85 / 10.17
Measured Level (mg/L)	10.95
Possible reason for Action or Limit Level Non-compliance	A high SS level of 10.60 mg/L was recorded at Control Station (I-1-C)
Actions taken / to be taken	The measured SS level was above the baseline limit level, but lower than 120% of SS level of the control station (I-1-C). General site cleaning, rebar fixing at cascade bay 1, dismantling of formwork at vehicle access, removal of hoarding and masonry wall and geotechnical instrumentation monitoring were undertaken during the measurement. No direct disturbance was observed from the site. Thus, the exceedance was considered to be contributed by high SS level at upstream location and natural variation. Therefore, no action was required.

Photographic record for exceedance of Suspended Solids recorded at Sik Sik Yuen Ho Fung College (I-1) on 06-Apr-11

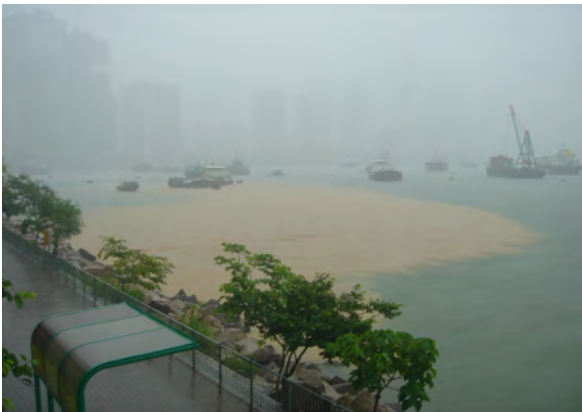
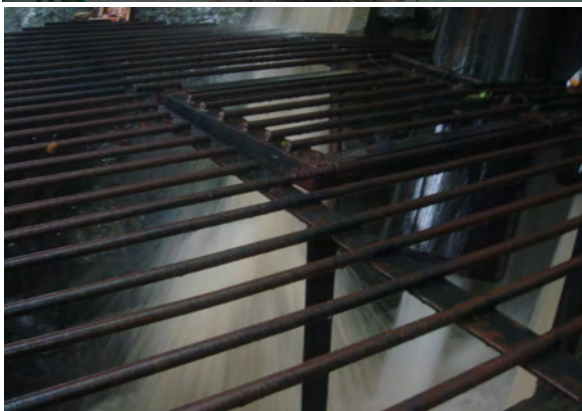
Photos of drainage outfall near the Belvedere Garden

On 29 June 2011, 76.5 mm heavy rainfall was recorded. Huge amount of muddy water discharged from streams and drainage outfalls among the coast into marine water body was observed during afternoon on the monitoring day and caused turbid sea surface.

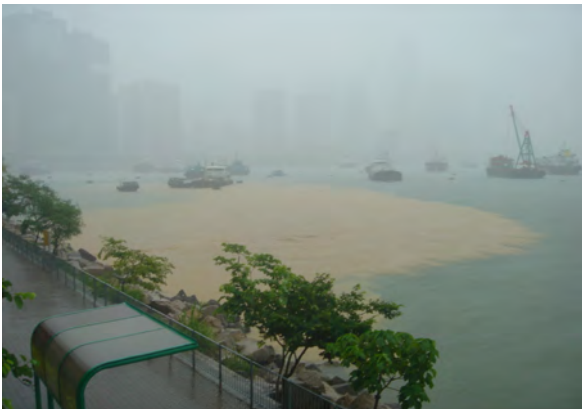
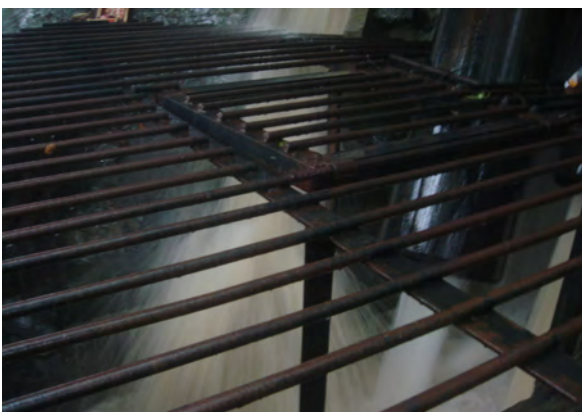
Photos of drainage outfall near the
Belvedere Garden

On 29 June 2011, 76.5 mm heavy rainfall was recorded. Huge amount of muddy water discharged from streams and drainage outfalls among the coast into marine water body was observed during afternoon on the monitoring day and caused turbid sea surface.

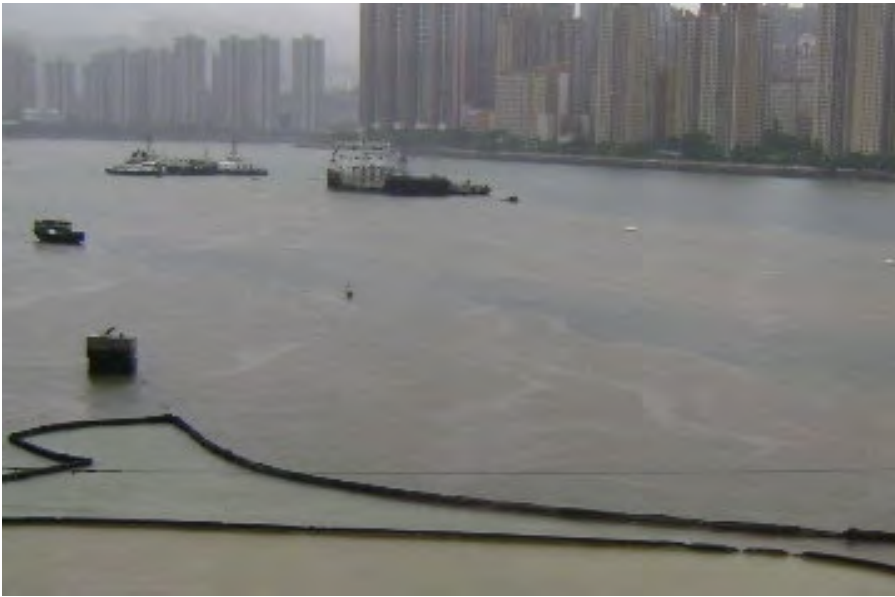
Photographic record for exceedance of Dissolved Oxygen (marine mid-depth) recorded at O-1(ET) on 29-Jun-11

Site photo
(The marine water between the inner and outer silt curtain was clearer than the marine water outside the construction site. No leakage of silt curtain was observed.)

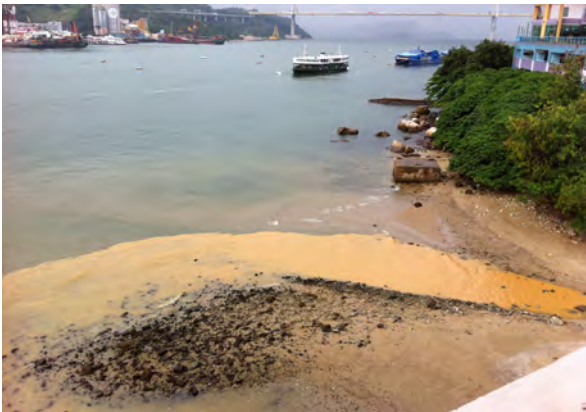
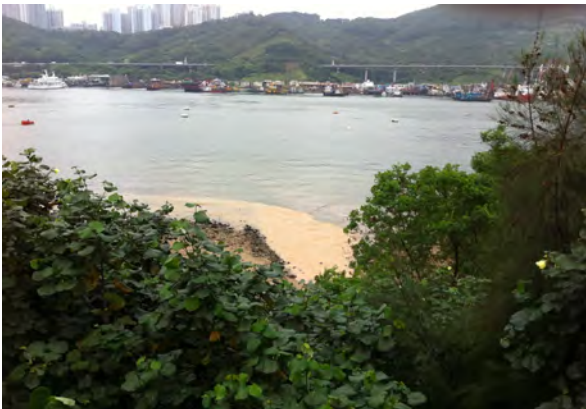
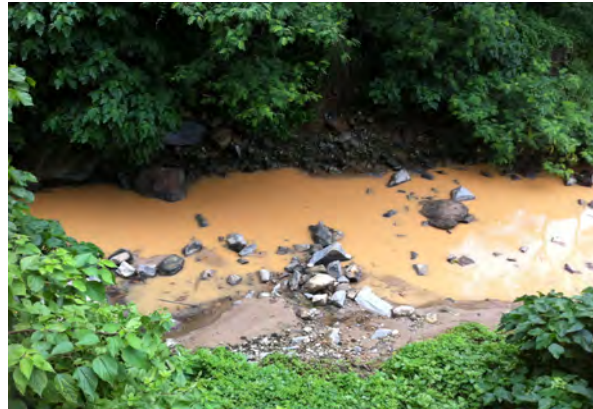
Photos of a stream between The Bay Bridge and Long Beach Garden

On 29 June 2011, 76.5 mm heavy rainfall was recorded. Huge amount of muddy water discharged from streams and drainage outfalls among the coast into marine water body was observed during monitoring and caused turbid sea surface.
