Interim Notifications of Environmental Quality Limits Exceedances

Incident Report on Action Level or Limit Level Non-compliance

Project	Tsuen Wan Drainage Tunnel
Date	02-Jul-10
Time	10:00 AM
Monitoring Location	Hong Hoi Chee Hong Temple (I-2)
Parameter	Suspended Solid
Action & Limit Levels	7.68 / 8.34
Measured Level	3.20 (higher than 120% of control station's SS)
Possible reason for Action or Limit Level Non-compliance	A low SS level of 2.50 is recorded at Control Station (I-2-C)
Actions taken / to be taken	The measured SS level was below baseline Action / Limit Level and was within the range of baseline SS concentration (1-8.5mg/L). General Site Cleaning and House Keeping; Erection of Noise Enclosure at Man Access Shaft; Excavation at Vortex Drop Shaft and Man Access Shaft; Pipe Jacking and Erection of working platform for mini-pile construction were undertaken during the measurement. No direct disturbance was observed from the site. Thus, the exceedance is considered to be contributed by natural variation and no action should be required.

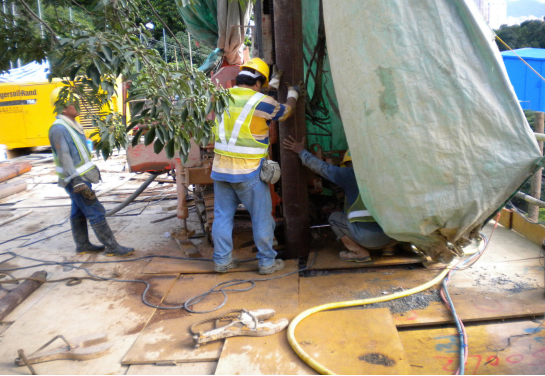
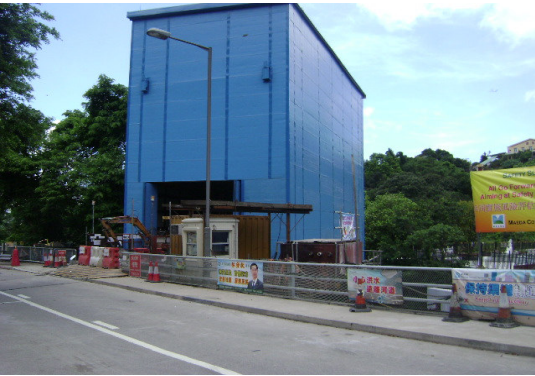
Site photo

Project	Tsuen Wan Drainage Tunnel
Date	12-Jul-10
Time	10:08 AM
Monitoring Location	Hong Hoi Chee Hong Temple (I-2)
Parameter	Suspended Solid
Action & Limit Levels	7.68 / 8.34
Measured Level	3.10 (higher than 130% of control station's SS)
Possible reason for Action or Limit Level Non-compliance	A low SS level of 2.00 is recorded at Control Station (I-2-C)
Actions taken / to be taken	The measured SS level was below baseline Action / Limit Level and was within the range of baseline SS concentration (1-8.5mg/L). General Site Cleaning and House Keeping; Excavation at Man Access Shaft; Drilling and Rock Splitting at Vortex Drop Shaft; Pipe Jacking and Drilling for mini-pile construction were undertaken during the measurement. No direct disturbance was observed from the site. Thus, the exceedance is considered to be contributed by natural variation and no action should be required.
Remarks	Following mitigation measures were provided: (1) Sedimentation tanks and wastewater treatment plant were in place for excavation works at the location of I-2. (2) A surface channel was used to collect wastewater generated from mini-pile construction to sedimentation tank and wastewater treatment plant at I-2.

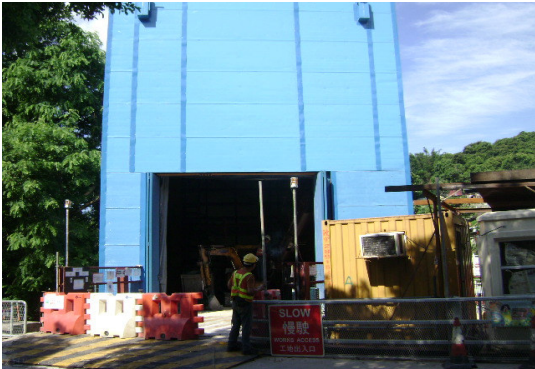
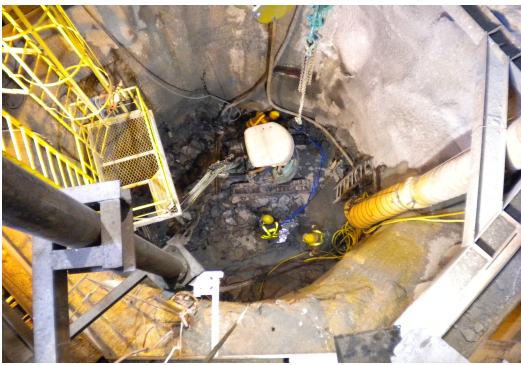
Site photo

Project	Tsuen Wan Drainage Tunnel
Date	19-Jul-10
Time	9:40 AM
Monitoring Location	Hong Hoi Chee Hong Temple (I-2)
Parameter	Suspended Solid
Action & Limit Levels	7.68 / 8.34
Measured Level	4.00 (higher than 130% of control station's SS)
Possible reason for Action or Limit Level Non-compliance	A low SS level of 2.50 is recorded at Control Station (I-2-C)
Actions taken / to be taken	The measured SS level was below baseline Action / Limit Level and was within the range of baseline SS concentration (1-8.5mg/L). General site cleaning and house keeping; excavation at man access shaft; rock splitting at vortex drop shaft; extension of steel platform; pipe jacking and mini piling were undertaken during the measurement. No direct disturbance was observed from the site. Thus, the exceedance is considered to be contributed by natural variation and no action should be required.
Remarks	Following mitigation measures were provided: (1) Sedimentation tanks and wastewater treatment plant were in place for excavation works at the location of I-2. (2) A surface channel was used to collect wastewater generated from mini-pile construction to sedimentation tank and wastewater treatment plant at I-2.

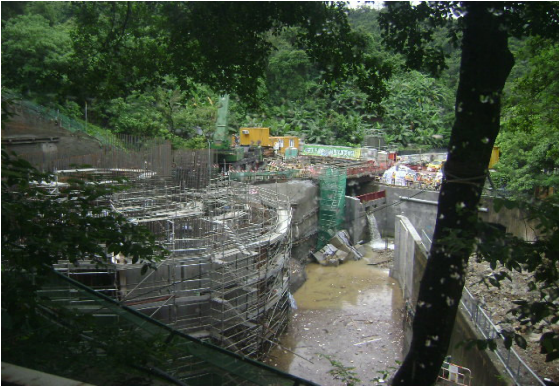
Site photo

Project	Tsuen Wan Drainage Tunnel
Date	23-Jul-10
Time	9:00 AM
Monitoring Location	Sik Sik Yuen Ho Fung College (I-1)
Parameter	Turbidity
Action & Limit Levels	9.75 / 12.47
Measured Level	16.27
Possible reason for Action or Limit Level Non-compliance	A high turbidity level of 17.19 is recorded at Control Station (I-1-C).
Actions taken / to be taken	The measured turbidity level was above baseline Limit Level. It was also beyond the range of baseline turbidity concentration (3.13 - 13.15 NTU). Black storm signal was held on 22 July 2010. No construction activity was carried out on the following day. The exceedance is considered by natural variation. No action should be taken as the turbidity result at monitoring station was below the action and limit level of control station.
Remarks	Sand/silts removal facilities were installed for the treatment of wastewater at the location of I-1. However, other mitigation measures provided (e.g. sandbags) were found damaged by the heavy rainstorm.

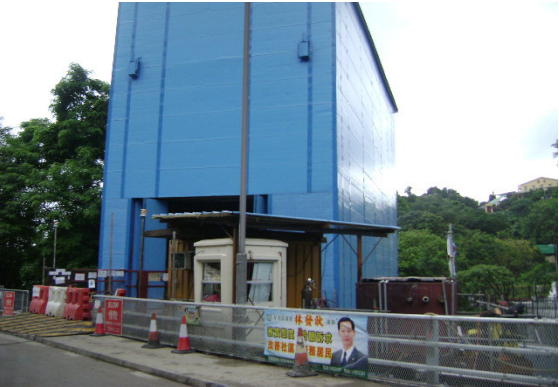
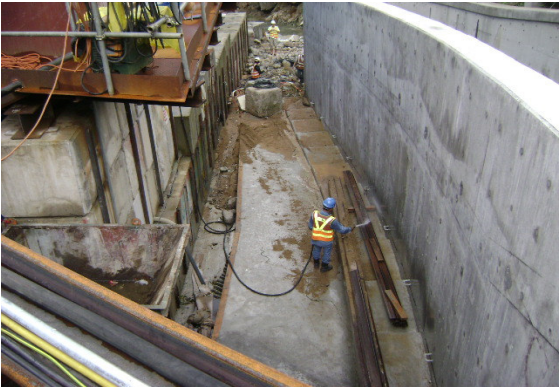
Site photo

Project	Tsuen Wan Drainage Tunnel
Date	23-Jul-10
Time	10:35 AM
Monitoring Location	Hong Hoi Chee Hong Temple (I-2)
Parameter	Turbidity
Action & Limit Levels	6.63 / 6.99
Measured Level	10.13
Possible reason for Action or Limit Level Non-compliance	A high turbidity level of 10.76 is recorded at Control Station (I-2-C).
Actions taken / to be taken	The measured turbidity level was above baseline Limit Level. It was also beyond the range of baseline turbidity concentration (2.17 - 7.08 NTU). Black storm signal was held on 22 July 2010. No construction activity was carried out on the following day. The exceedance is considered by natural variation. No action should be taken as the turbidity result at monitoring station was below the action and limit level of control station.
Remarks	Sand/silts removal facilities were installed for the treatment of wastewater at the location of I-2. However, other mitigation measures provided (e.g. sandbags) were found damaged by the heavy rainstorm.

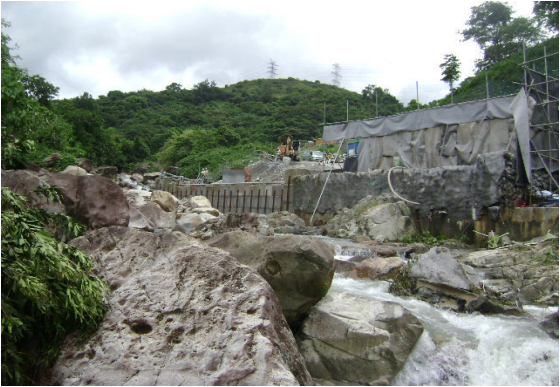
Site photo

Project	Tsuen Wan Drainage Tunnel
Date	23-Jul-10
Time	11:10 AM
Monitoring Location	Squatters (I-3)
Parameter	Turbidity
Action & Limit Levels	3.99 / 4.18
Measured Level	8.79
Possible reason for Action or Limit Level Non-compliance	A high turbidity level of 8.72 is recorded at Control Station (I-3-C).
Actions taken / to be taken	The measured turbidity level was above baseline Limit Level. It was also beyond the range of baseline turbidity concentration (1.41 - 4.23 NTU). Black storm signal was held on 22 July 2010. No construction activity was carried out on the following day. The exceedance is considered by natural variation. No action should be taken as the turbidity result at monitoring station was below the action and limit level of control station.
Remarks	Sand/silts removal facilities were installed for the treatment of wastewater at the location of I-3. However, other mitigation measures provided (e.g. sandbags) were found damaged by the heavy rainstorm.

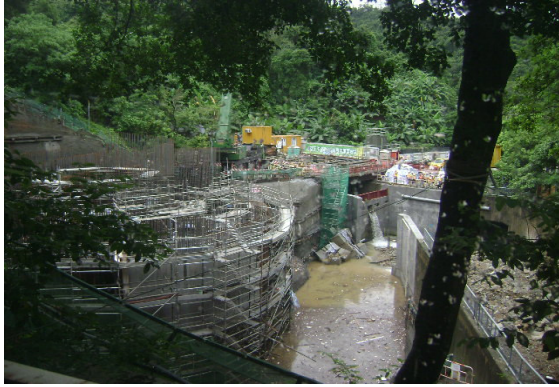
Site photo

Project	Tsuen Wan Drainage Tunnel
Date	23-Jul-10
Time	9:00 AM
Monitoring Location	Sik Sik Yuen Ho Fung College (I-1)
Parameter	Suspended Solid
Action & Limit Levels	8.85 / 10.17
Measured Level	12.25
Possible reason for Action or Limit Level Non-compliance	SS level of 11.90 is recorded at Control Station (I-1-C).
Actions taken / to be taken	The measured SS level was above baseline Limit Level. It was also beyond the range of baseline SS concentration (1 - 10.5 mg/L). Black storm signal was held on 22 July 2010. No construction activity was carried out on the following day. The exceedance is considered by natural variation and no action should be required.
Remarks	Sand/silts removal facilities were installed for the treatment of wastewater at the location of I-1. However, other mitigation measures provided (e.g. sandbags) were found damaged by the heavy rainstorm.

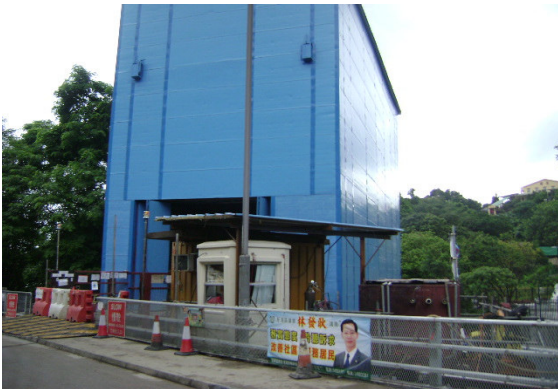
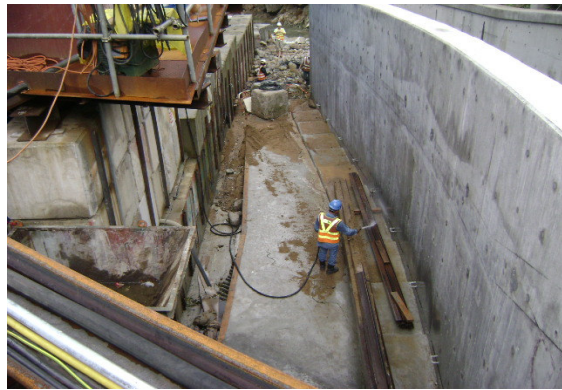
Site photo

Project	Tsuen Wan Drainage Tunnel
Date	23-Jul-10
Time	10:35 AM
Monitoring Location	Hong Hoi Chee Hong Temple (I-2)
Parameter	Suspended Solid
Action & Limit Levels	7.68 / 8.34
Measured Level	6.35 (higher than 130% of control station's SS)
Possible reason for Action or Limit Level Non-compliance	A low SS level of 4.05 is recorded at Control Station (I-2-C).
Actions taken / to be taken	The measured SS level was below baseline Action / Limit Level and was within the range of baseline SS concentration (1-8.5mg/L). Black storm signal was held on 22 July 2010. No construction activity was carried out on the following day. The exceedance is considered by natural variation and no action should be required.
Remarks	Sand/silts removal facilities were installed for the treatment of wastewater at the location of I-2. However, other mitigation measures provided (e.g. sandbags) were found damaged by the heavy rainstorm.

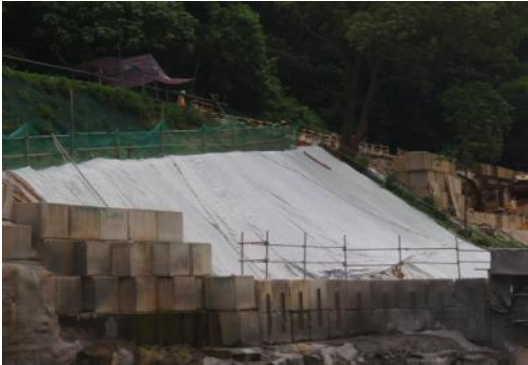
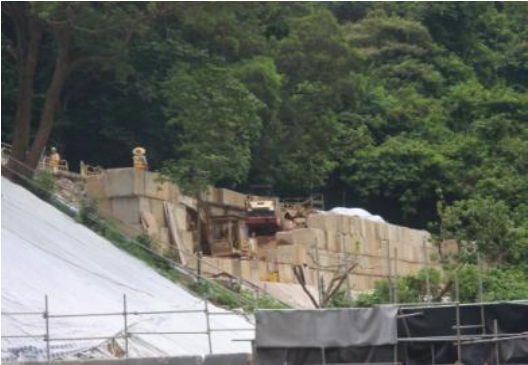
Site photo

Project	Tsuen Wan Drainage Tunnel
Date	11-Aug-10
Time	9:27 AM
Monitoring Location	Squatters (I-3)
Parameter	Suspended Solid
Action & Limit Levels	6.13 / 7.23
Measured Level	3.15 (higher than 130% of control station's SS)
Possible reason for Action or Limit Level Non-compliance	A low SS level of 2.00 is recorded at Control Station (I-3-C)
Actions taken / to be taken	The measured SS level was within the range of baseline SS concentration (1-7.5mg/L). Drilling holes and breaking for spiral ramp excavation; Excavation for PB Wall working platform were undertaken during the measurement. No direct disturbance was observed from the site. Thus, the exceedance is considered not due to works and no action should be required.
Remarks	Following mitigation measures were provided: (1) Waste Water Treatment Plant was in-place to treat the waste water before discharge. (2) Bare slope surface was cover by tarpaulin sheet.

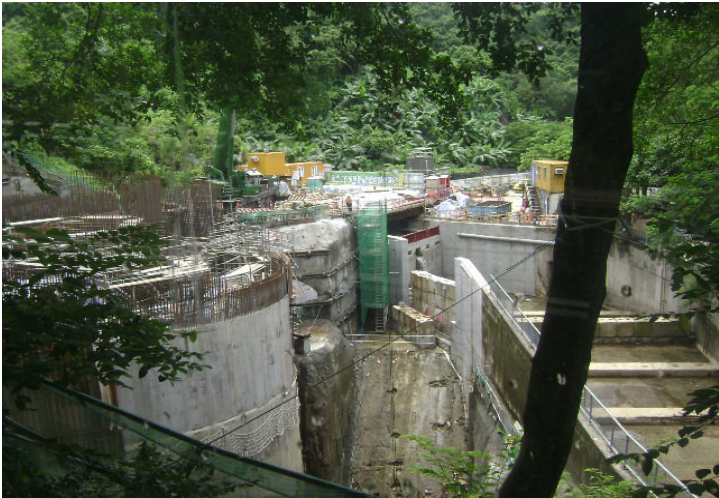
Site photo

Project	Tsuen Wan Drainage Tunnel
Date	16-Aug-10
Time	10:45 AM
Monitoring Location	Sik Sik Yuen Ho Fung College (I-1)
Parameter	Suspended Solid
Action & Limit Levels	8.85 / 10.17
Measured Level	3.35 (higher than 130% of control station's SS)
Possible reason for Action or Limit Level Non-compliance	A low SS level of 2.55 is recorded at Control Station (I-1-C)
Actions taken / to be taken	The measured SS level was below baseline Action/Limit Level and was within the range of baseline SS concentration (1 - 10.5 mg/L). General site cleaning; dismantle HDD area working platform and remove debris and rubbish from spiral ramp shaft; and dismantle and remove drilling rig from HDD working platform were undertaken during the measurement. No direct disturbance was observed from the site. Thus, the exceedance is considered to be contributed by natural variation and no action should be required.
Remarks	Following mitigation measures were provided: (1) Waste Water Treatment Plant was in-place to treat the waste water before discharge; (2) Existing stream has been diverted and banded by sealed concrete block wall.

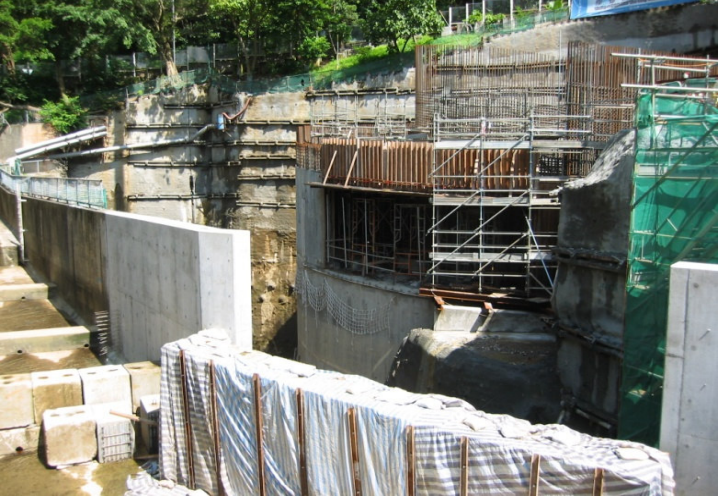
Site photo

Project	Tsuen Wan Drainage Tunnel
Date	20-Aug-10
Time	10:20 AM
Monitoring Location	Sik Sik Yuen Ho Fung College (I-1)
Parameter	Suspended Solid
Action & Limit Levels	8.85 / 10.17
Measured Level	34.00
Possible reason for Action or Limit Level Non-compliance	SS level of 5.25 is recorded at Control Station (I-1-C)
Actions taken / to be taken	<p>Measured SS level at I-1 on 20 August 2010 was 34.0mg/L and above the limit level. But in-situ turbidity monitoring at I-1 (7.85 NTU) was below the Action/Limit level (9.75/12.47). Site activities included general site cleaning; remove debris and rubbish from Sprial Ramp, Shaft; and dismantle HDD area working platform during the monitoring. The Contractor has provided the wastewater treatment plant for the site effluent before discharge and erected the sealed concrete block wall to separate the existing stream and site works area. No wastewater directly discharge from the site was observed. Exceedance of SS at I-1 on 20 August 2010 was considered not project related. As shallow water at I-1 on 20 August 2010 during collect the water sample. Exceedance of SS on 20 August 2010 was suspected sand grabbed into the container by the site staff during sample collected. We have reminded our site staff to take extra care for collect water sample under shallow water condition and prevent the recurrence of similar incident. No SS exceedance at I-1 (3.55 mg/L) was occurred and below the action/limit level on 23 August 2010.</p>

Remarks	<p>Following mitigation measures were provided: (1) Waste Water Treatment Plant was in-place to treat the waste water before discharge; (2) Existing stream has been diverted and bunded by sealed concrete block wall.</p>

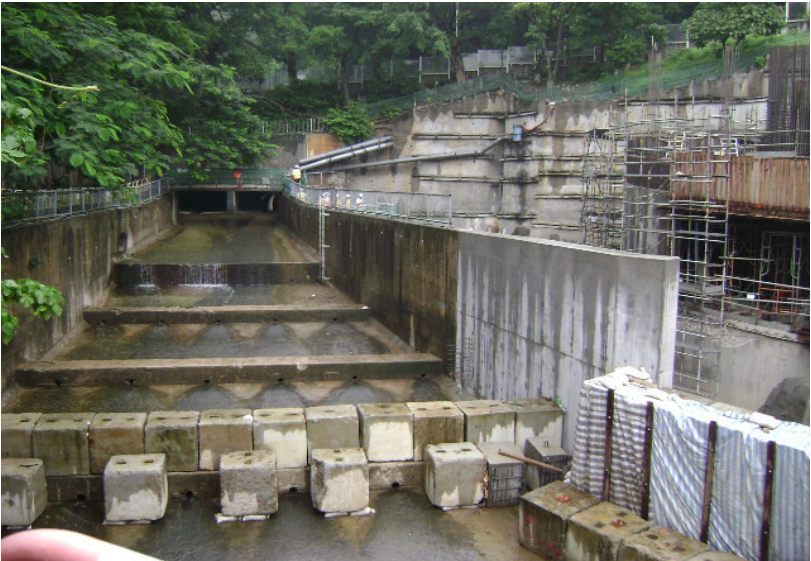
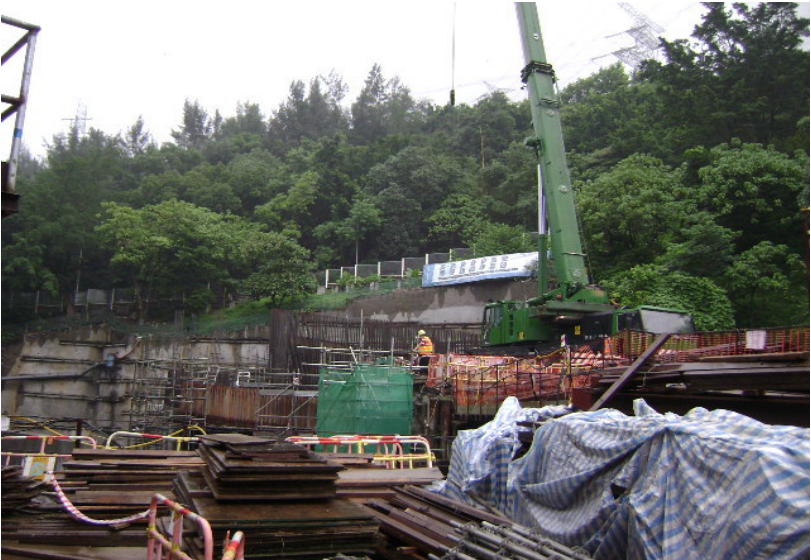
Site photo

Project	Tsuen Wan Drainage Tunnel
Date	03-Sep-10
Time	8:35 AM
Monitoring Location	Sik Sik Yuen Ho Fung College (ASR1)
Parameter	Total Suspended Particle
Action & Limit Levels	306.6/500
Measured Level	351.1 ug/m3 was recorded in the 1st TSP monitoring.
Possible reason for Action or Limit Level Non-compliance	General Site Cleaning; re-erecting façade scaffolding platform at Spiral Ramp Shaft; and erecting formwork for Bay 14 of Spiral Ramp Shaft were observed during the measurement of 1st 1hr TSP monitoring.
Actions taken / to be taken	Contractor was requested to provide water spraying for dust suppression. Water spraying was immediately provided by Contractor. The consequent monitoring results (2nd, 270.6ug/m3 and 3rd, 256.0 ug/m3) were below Action and Limit Level. The recommended dust suppression measures were effective.
Remarks	Following mitigation measures were provided: (1) Water spraying frequency was increased to prevent fugitive dust emission ; (2) Dusty material was properly covered.

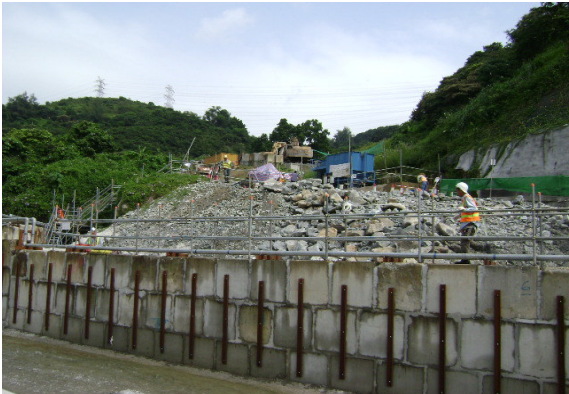
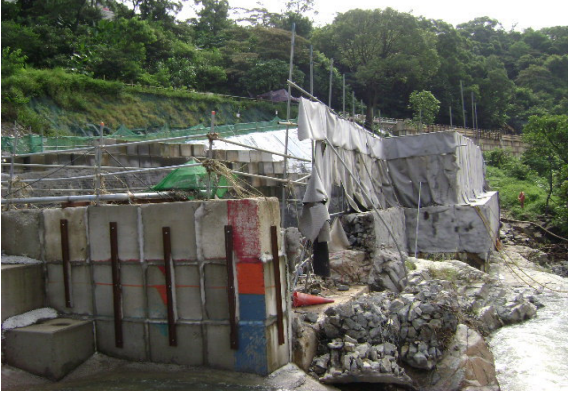
Site photo

Project	Tsuen Wan Drainage Tunnel
Date	10-Sep-10
Time	9:20 AM
Monitoring Location	Squatters (I-3)
Parameter	Turbidity
Action & Limit Levels	3.99 / 4.18
Measured Level	9.52
Possible reason for Action or Limit Level Non-compliance	A high turbidity level of 9.64 is recorded at Control Station (I-3-C). And heavy rainfall was recorded on the same day.
Actions taken / to be taken	The measured turbidity level was above baseline Limit Level. It was also beyond the range of baseline turbidity concentration (1.41 - 4.23 NTU). General Site Cleaning; PB Wall Concreting of Bay 2, 4 & 6; and Rock Breaking for spiral ramp excavation were undertaken during measurement. No direct disturbance was observed from the site and the turbidity result at monitoring station was below the level of control station. Thus, the exceedance is considered to be contributed by natural variation with heavy rainfall (early morning) and no action should be required.

Remarks	Following mitigation measures were provided: 1) Waste Water Treatment Plant was in-place to treat the waste water before discharge; 2) Existing Stream has been diverted and banded by sealed concrete block wall.

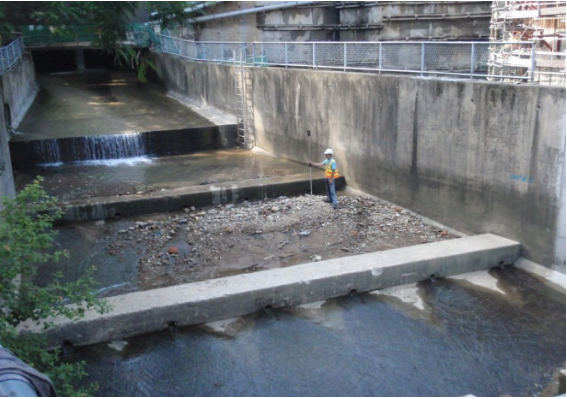
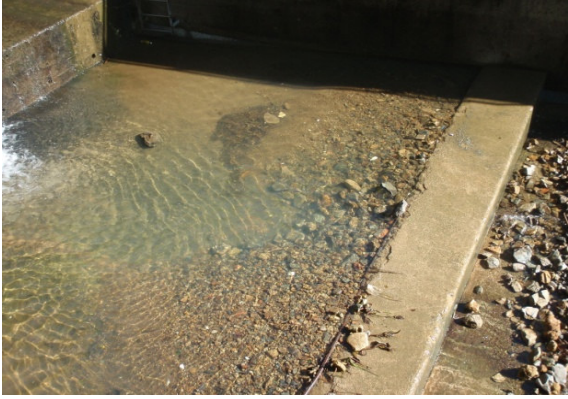
Project	Tsuen Wan Drainage Tunnel
Date	13-Sep-10
Time	10:10 AM
Monitoring Location	Sik Sik Yuen Ho Fung College (I-1)
Parameter	Turbidity
Action & Limit Levels	9.75 / 12.47
Measured Level	10.20
Possible reason for Action or Limit Level Non-compliance	A high turbidity level of 10.60 is recorded at Control Station (I-1-C). Heavy rainfall was recorded on 12 Sep 2010.
Actions taken / to be taken	The measured turbidity level was above baseline Action Level. It was within the range of baseline turbidity concentration (3.13 - 13.15 NTU). General Site Cleaning; steel bracket fixing for planter wall; erecting formwork for Bay 15 & 16 of Spiral Ramp Shaft were undertaken during measurement. No direct disturbance was observed from the site and the turbidity result at monitoring station was below the level of control station. Besides, as advise by the Contractor, rocks and soil were found washed down to the stream from the upstream. Thus, the exceedance is considered to be contributed by natural variation and no action should be required.

Site photo. As advised by Contractor, rocks and soil were found washed down to the stream from the upstream

Remarks	Following mitigation measures were provided: 1) Waste Water Treatment Plant was in-place to treat the waste water before discharge; 2) Existing Stream has been diverted and bunded by sealed concrete block wall.

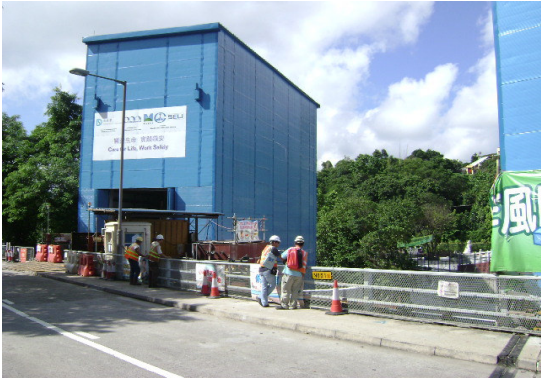
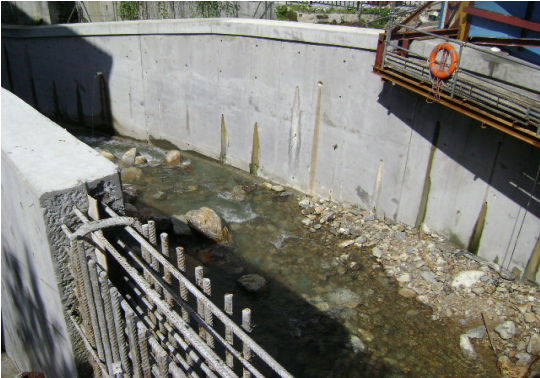
Site photo.

Project	Tsuen Wan Drainage Tunnel
Date	13-Sep-10
Time	9:35 AM
Monitoring Location	Hong Hoi Chee Hong Temple (I-2)
Parameter	Suspended Solid
Action & Limit Levels	7.68 / 8.34
Measured Level	3.15 (higher than 130% of control station's SS)
Possible reason for Action or Limit Level Non-compliance	A low SS level of 2.00 is recorded at Control Station (I-2-C)
Actions taken / to be taken	The measured SS level was below baseline Action / Limit Level and was within the range of baseline SS concentration (1-8.5mg/L). General site cleaning; Excavation (rock splitting and drilling holes) at Vortex Drop Shaft & Installation of dowel bar; and Excavation (rock splitting and drilling holes) at Man Access Shaft were undertaken during the measurement. No direct disturbance was observed from the site. Thus, the exceedance is considered to be contributed by natural variation and no action should be required.
Remarks	Following mitigation measures were provided: 1) Waste water will be collected to Waste Water Treatment Plant and treat before discharge.
