**Interim Notifications of Environmental Quality Limits Exceedances**

Incident Report on Action Level or Limit Level Non-compliance

Project	Tsuen Wan Drainage Tunnel
Date	06-Jul-09
Time	9:28 AM
Monitoring Location	Hong Hoi Chee Hong Temple (I-2)
Parameter	Suspended Solid
Action & Limit Levels	7.68 / 8.34
Measured Level	4.1 (higher than 130% of control station's SS)
Possible reason for Action or Limit Level Non-compliance	A low SS level of 2.2 is recorded at Control Station (I-2-C)
Actions taken / to be taken	The measured SS level was below baseline Action / Limit Level and was within the range of baseline SS concentration (1-8.5mg/L). Site tidiness & cleanliness, installation of safety net and noise barrier, demolition of piling platform and excavated and disposed C&D materials were undertaken during the measurement and no direct disturbance was observed from the site. Thus, the exceedance is considered to be contributed by natural variation and no action should be required.
Remarks	Following mitigation measures were provided: (1) exposed surfaces were covered by tarpaulin. (2) sandbags were used to avoid wastewater from site activities directly running down to the river of I-2.

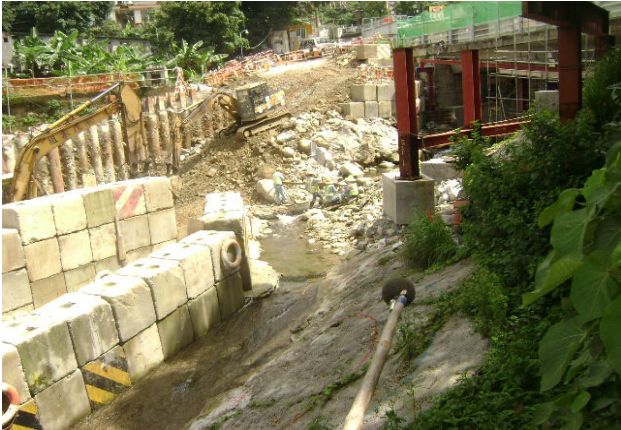
Site photo

Photographic record for exceedance of Suspended Solid recorded at Hong Hoi Chee Hong Temple (I-2) on 06-Jul-09

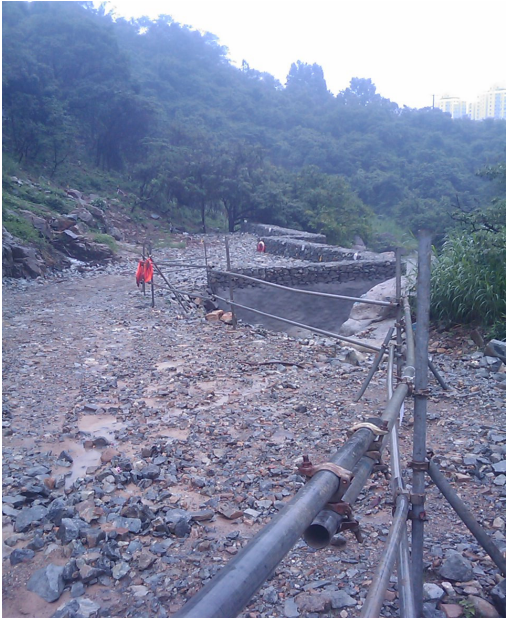
Site photo

Photographic record for exceedance of Suspended Solid recorded at Squatters (I-3) on 06-Jul-09

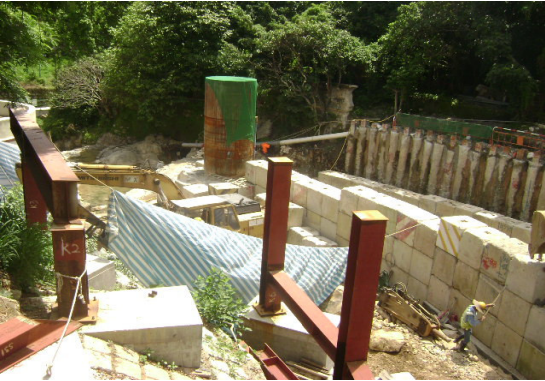
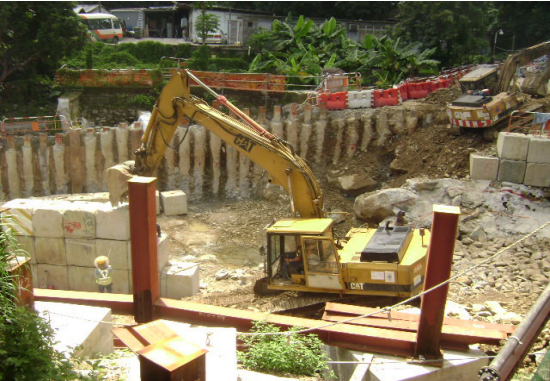
Site photo

Photographic record for exceedance of Suspended Solid recorded at Hong Hoi Chee Hong Temple (I-2) on 08-Jul-09

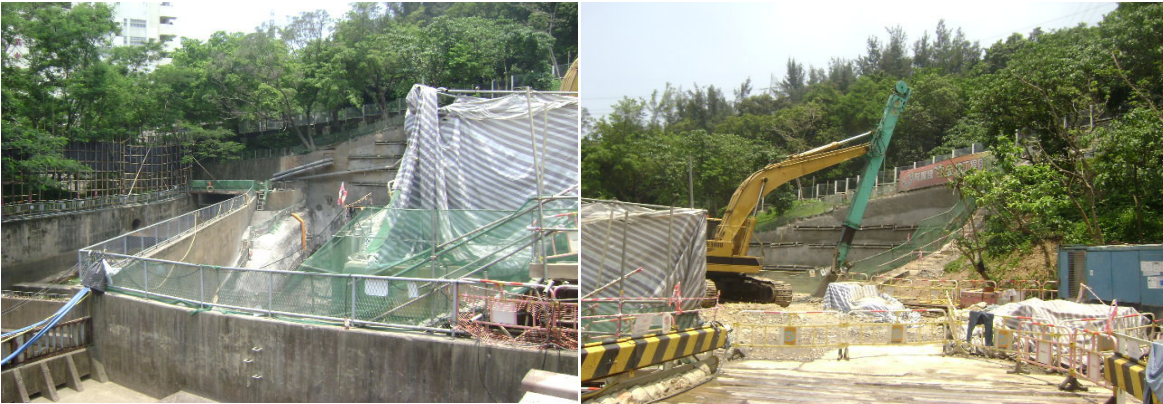
Site photo

**Photographic record for exceedance of Suspended Solid recorded at Sik Sik Yuen Ho Fung College (I-1) on 10-Jul-09**

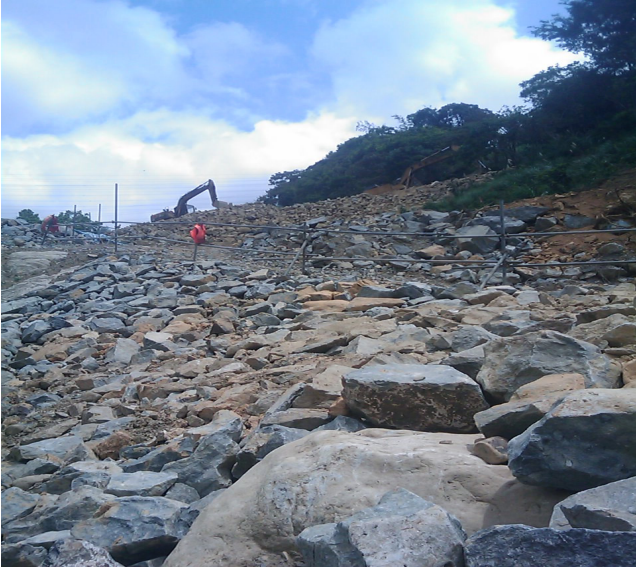
Site photo

**Photographic record for exceedance of Suspended Solid recorded at Squatters (I-3) on 10-Jul-09**

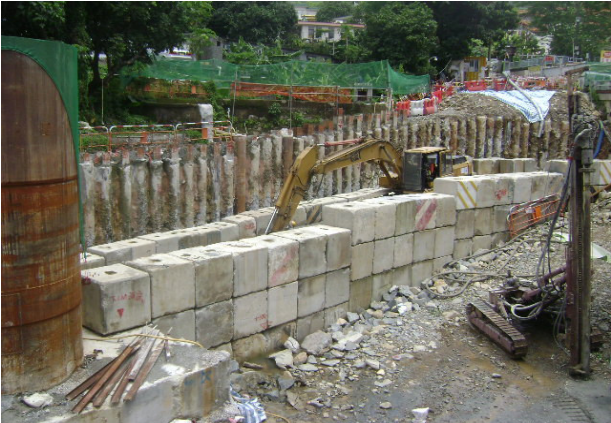
Site photo

**Photographic record for exceedance of Suspended Solid recorded at Hong Hoi Chee Hong Temple (I-2) on 13-Jul-09**

Remarks	Following mitigation measures were provided: (1) exposed surfaces were covered by tarpaulin. (2) sandbags were used to avoid wastewater from site activities directly running down to the river of I-2. (3) sand/silts removal facilities was installed at the location of I-2.

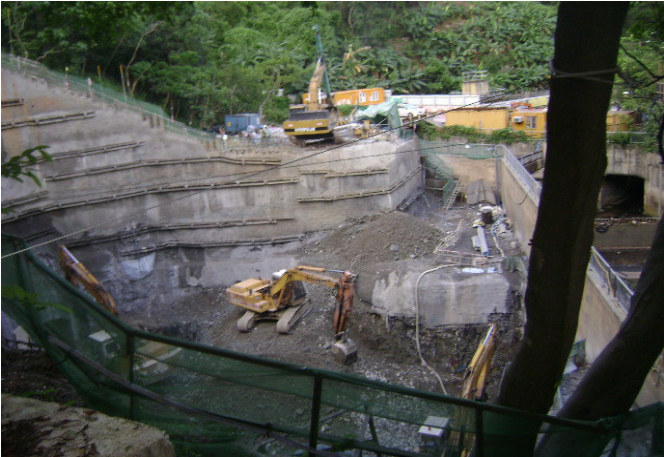
Site photo

**Photographic record for exceedance of Suspended Solid recorded at Sik Sik Yuen Ho Fung College (I-1) on 20-Jul-09**

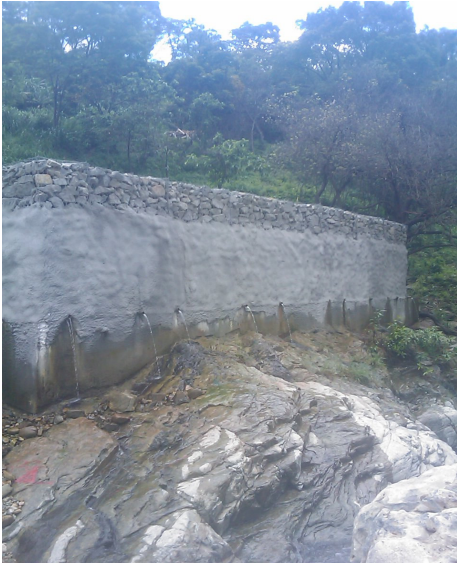
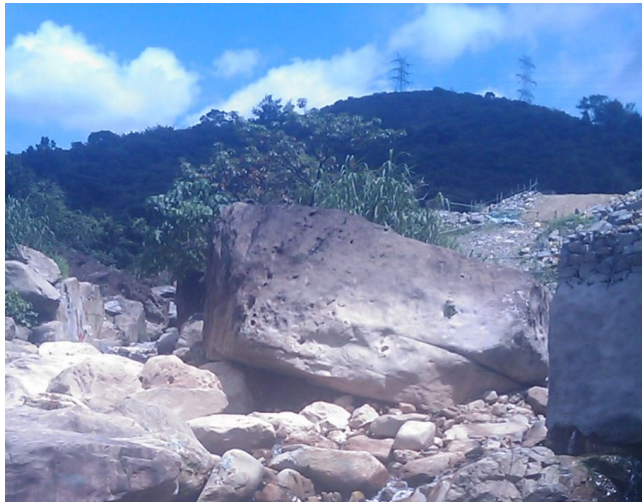
Site photo

**Photographic record for exceedance of turbidity recorded at Squatters (I-3) on 20-Jul-09**

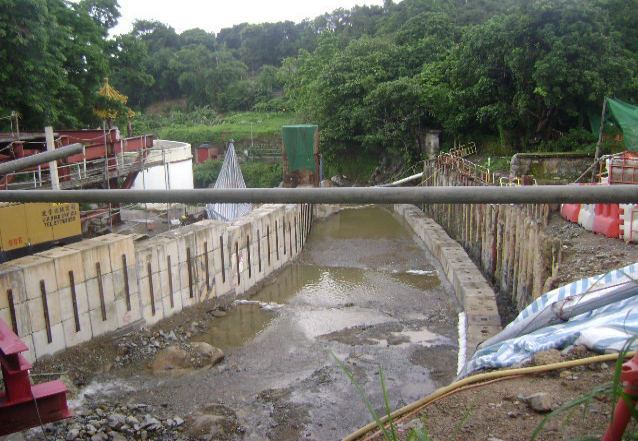
Site photo

**Photographic record for exceedance of turbidity recorded at Hong Hoi Chee Hong Temple (I-2) on 24-Jul-09**

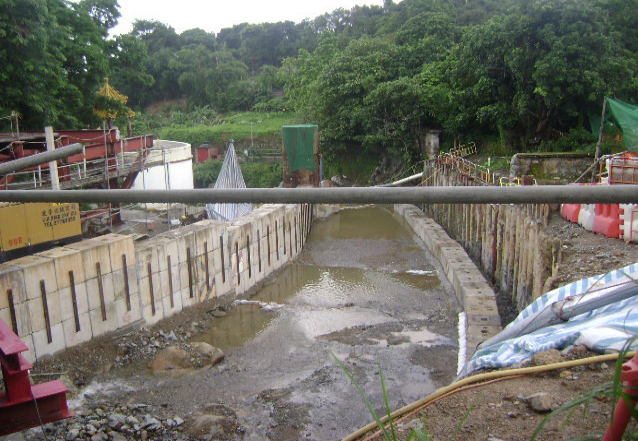
Site photo

**Photographic record for exceedance of Suspended Solid recorded at Hong Hoi Chee Hong Temple (I-2) on 24-Jul-09**

Remarks	Following mitigation measures were provided: (1) exposed surfaces were covered by tarpaulin. (2) sandbags & concrete block were used to avoid wastewater from site activities directly running down to the river of I-2. (3) sand/silts removal facilities was installed at the location of I-2.

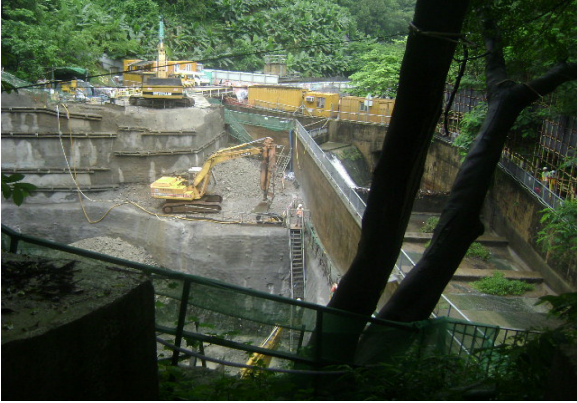
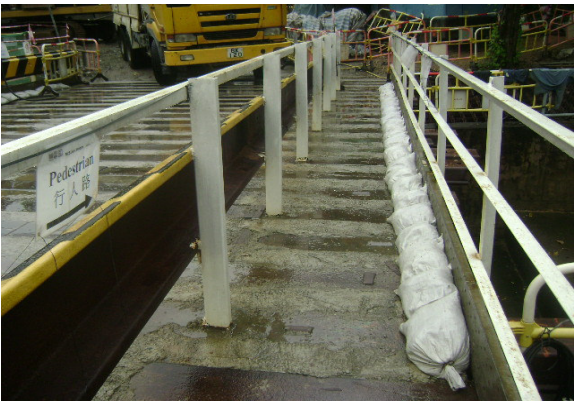
Site photo

Photographic record for exceedance of Suspended Solid recorded at Sik Sik Yuen Ho Fung College (I-1) on 14-Aug-09

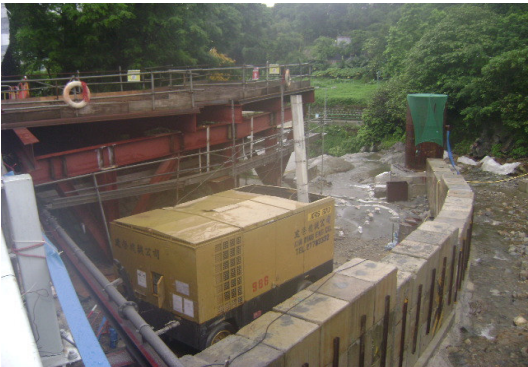
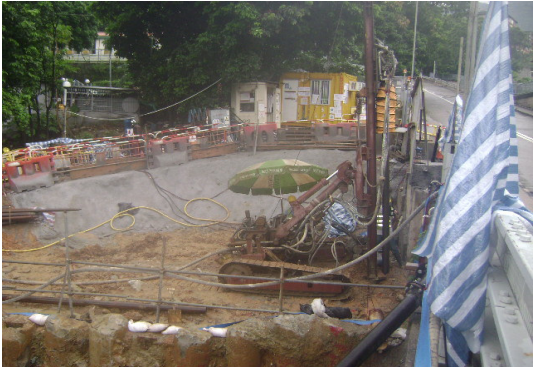
Site photo

**Photographic record for exceedance of Suspended Solid recorded at Hong Hoi Chee Hong Temple (I-2) on 14-Aug-09**

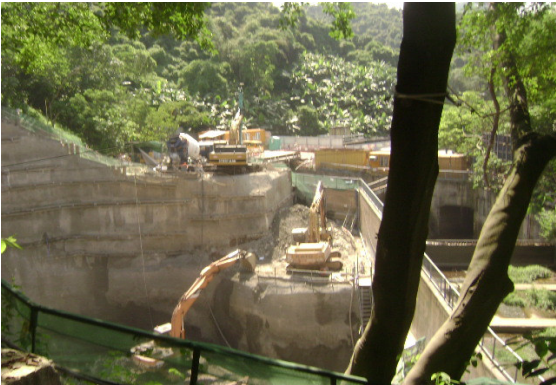
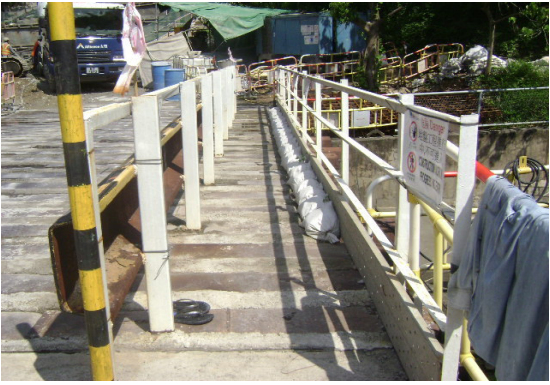
Site photo

**Photographic record for exceedance of Suspended Solid recorded at Sik Sik Yuen Ho Fung College (I-1) on 28-Aug-09**

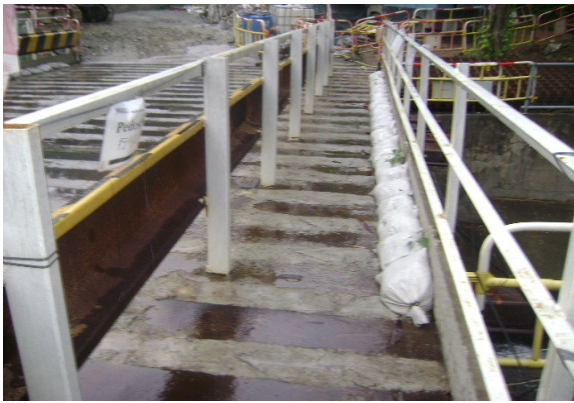
Site photo

**Photographic record for exceedance of Suspended Solid recorded at Sik Sik Yuen Ho Fung College (I-1) on 11-Sep-09**

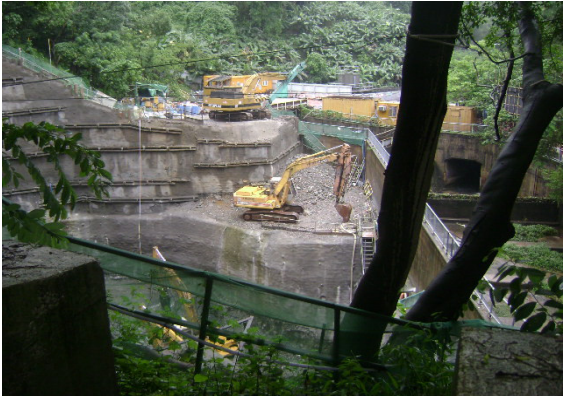
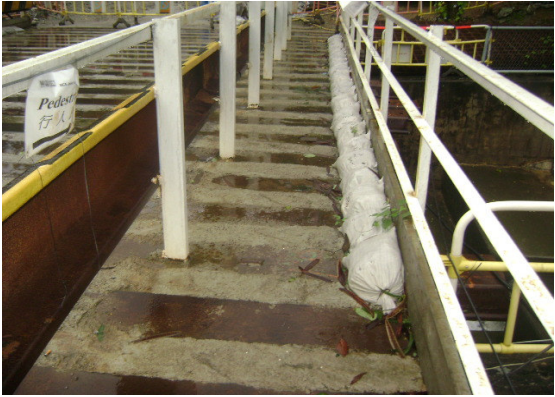
Site photo

**Photographic record for exceedance of Suspended Solid recorded at Sik Sik Yuen Ho Fung College (I-1) on 16-Sep-09**
