**Interim Notifications of Environmental Quality Limits Exceedances**

Incident Report on Action Level or Limit Level Non-compliance

**Complaint Investigation Report**

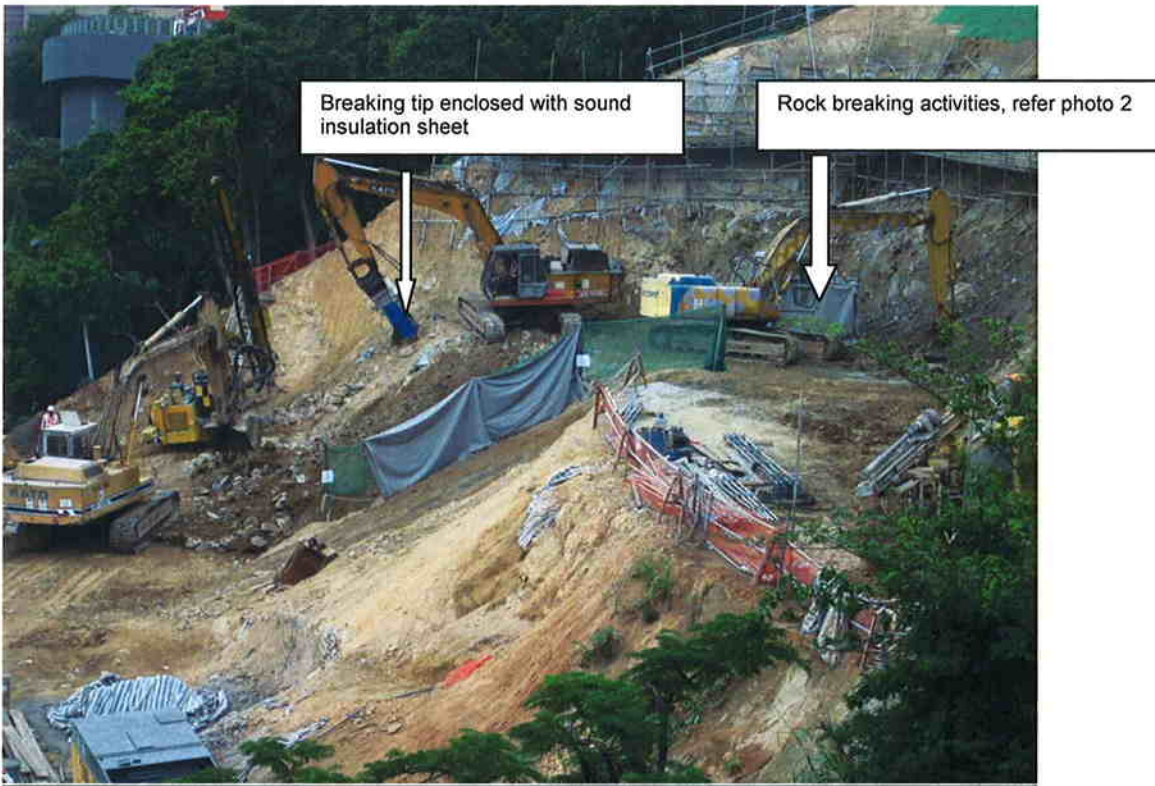
- Quiet equipment e.g. generator and air compressor was used on-site.
- The equipments are generally maintaining in good operation condition.
- Few sound insulation sheets were used during rock breaking but not well in place.

1. Sound insulation sheet erected with the green net.

- For the idling plant, it should be switched off to reduce noise level generated.
- The sound insulation sheets and noise insulation materials should be placed to enclose the breaking tip tightly and also aside or surrounding the breaking activities as recommended in the following photos 1-3 in noise mitigation measures.
- Noise monitoring frequency was increased in order to check the effectiveness of the mitigation measures. The 2<sup>nd</sup> measurement on 27 May 2009 was also taken after all the measures implemented. The noise level ( $L_{eq, 30 \text{ min}}$ ) was 70.9 dB (A), which comply with the limit level in accordance with the EIAO-TM.

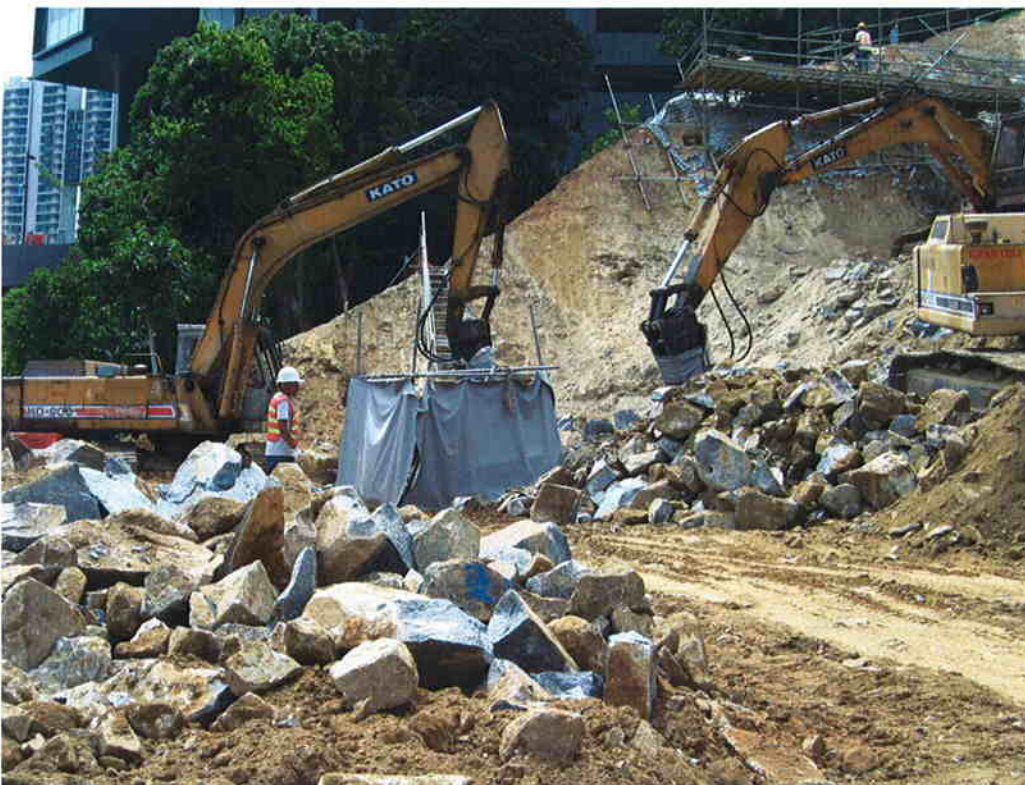
2. Sound insulation sheet surrounding the rock breaking activities as far as possible.

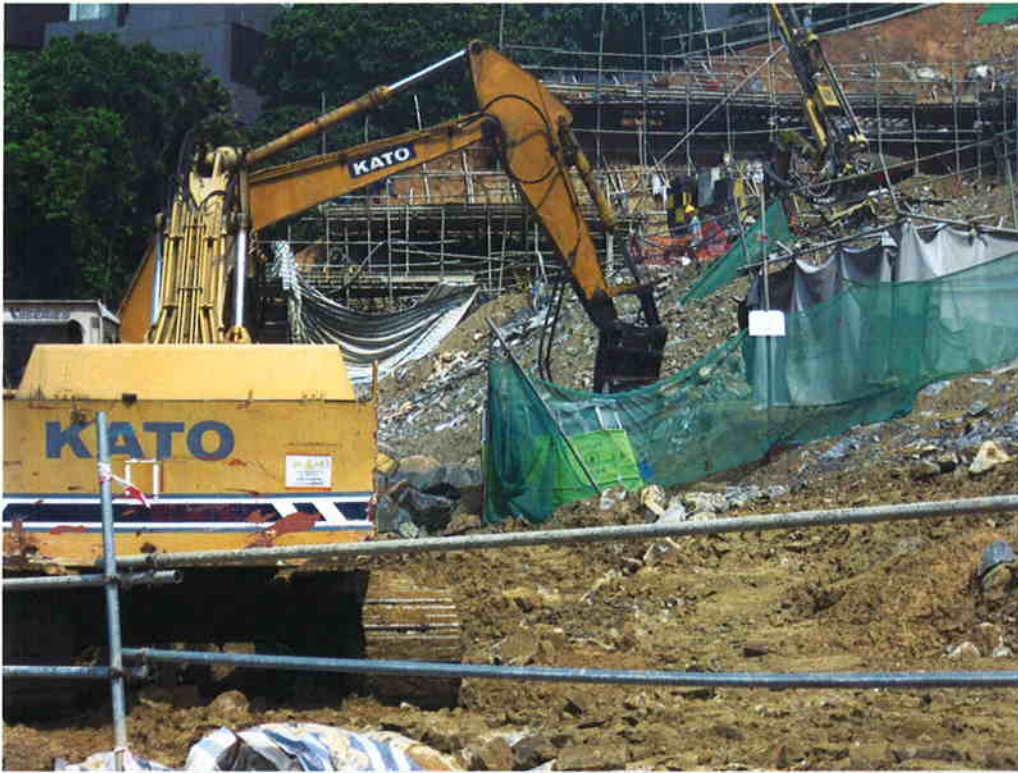
3. Noise insulation material for rock breaking.

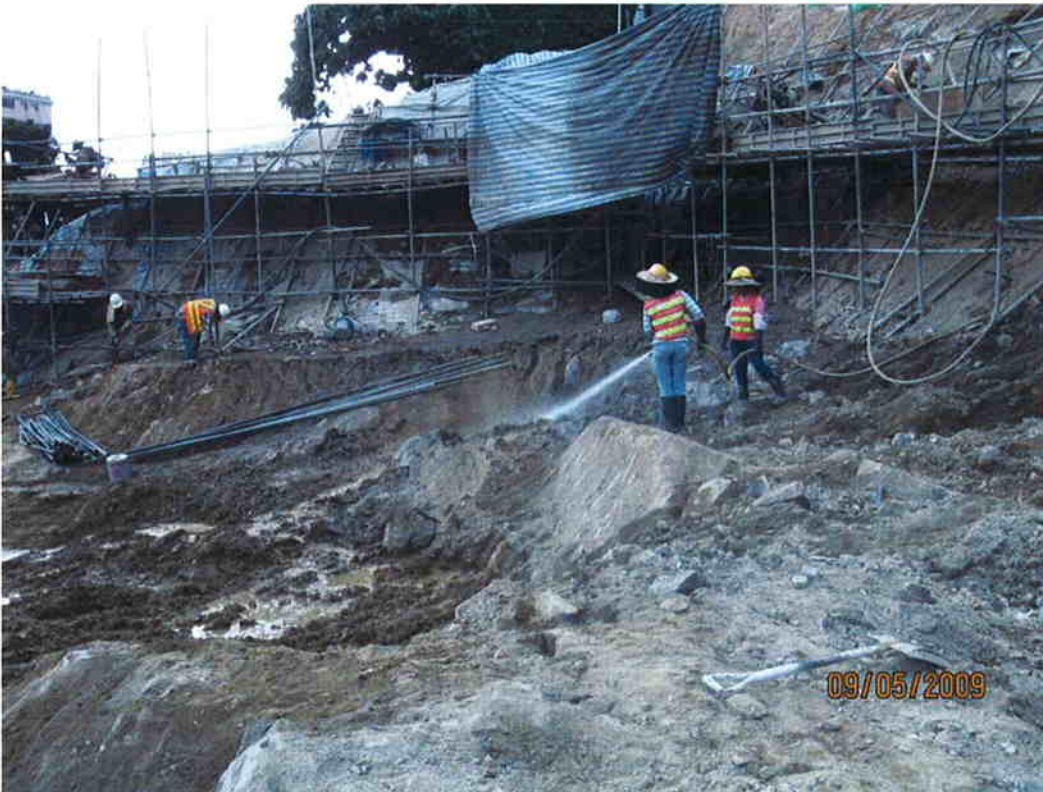
1. Water spraying for the exposed area.

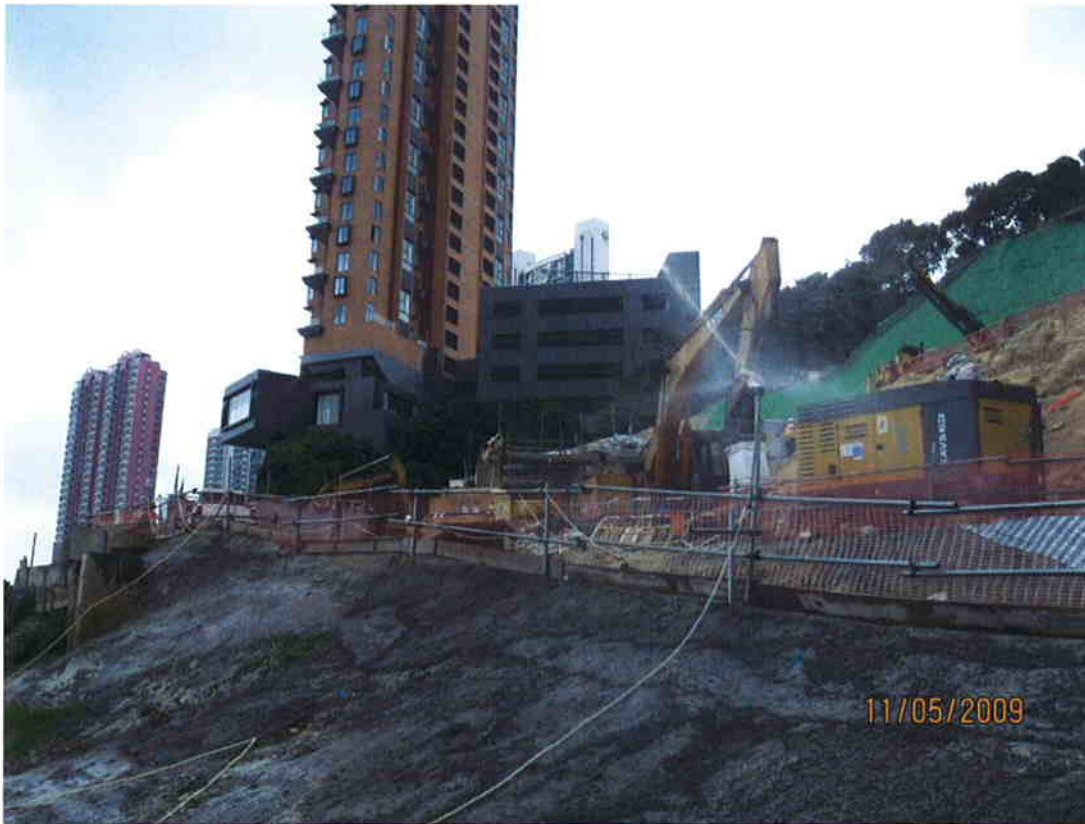
2. Automatic sprinkler spraying the haul road.

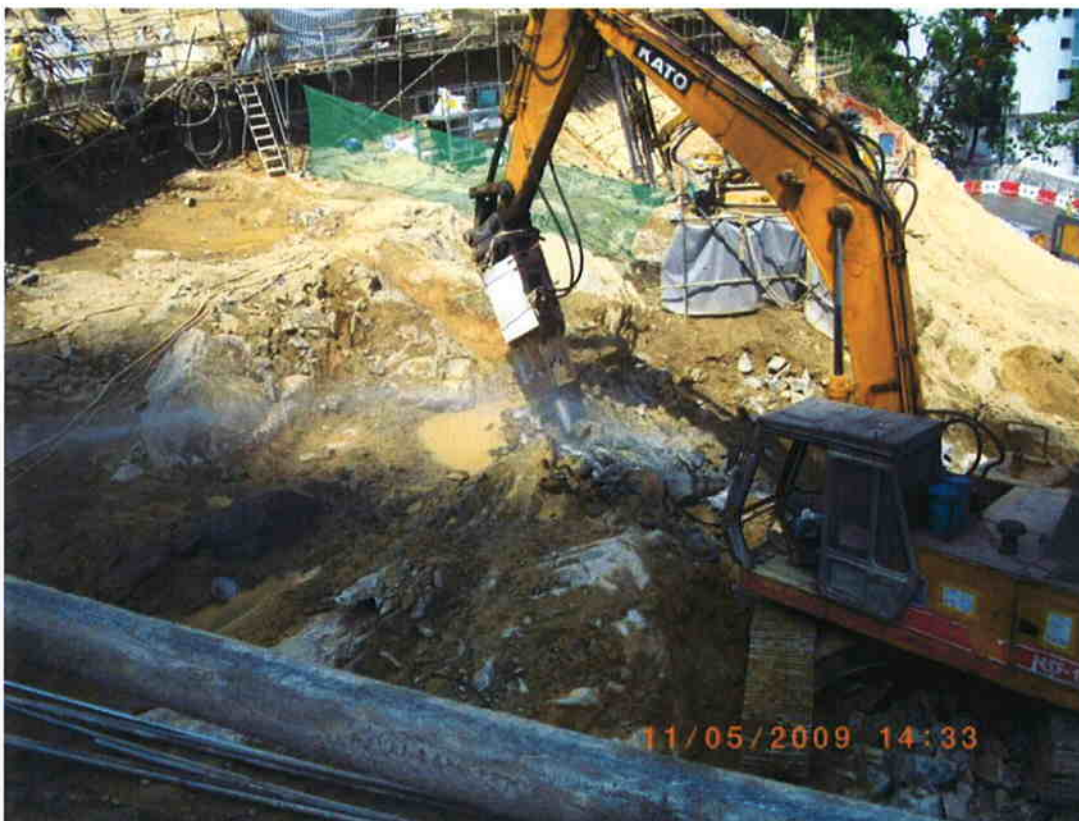
3. Water spraying during rock breaking.

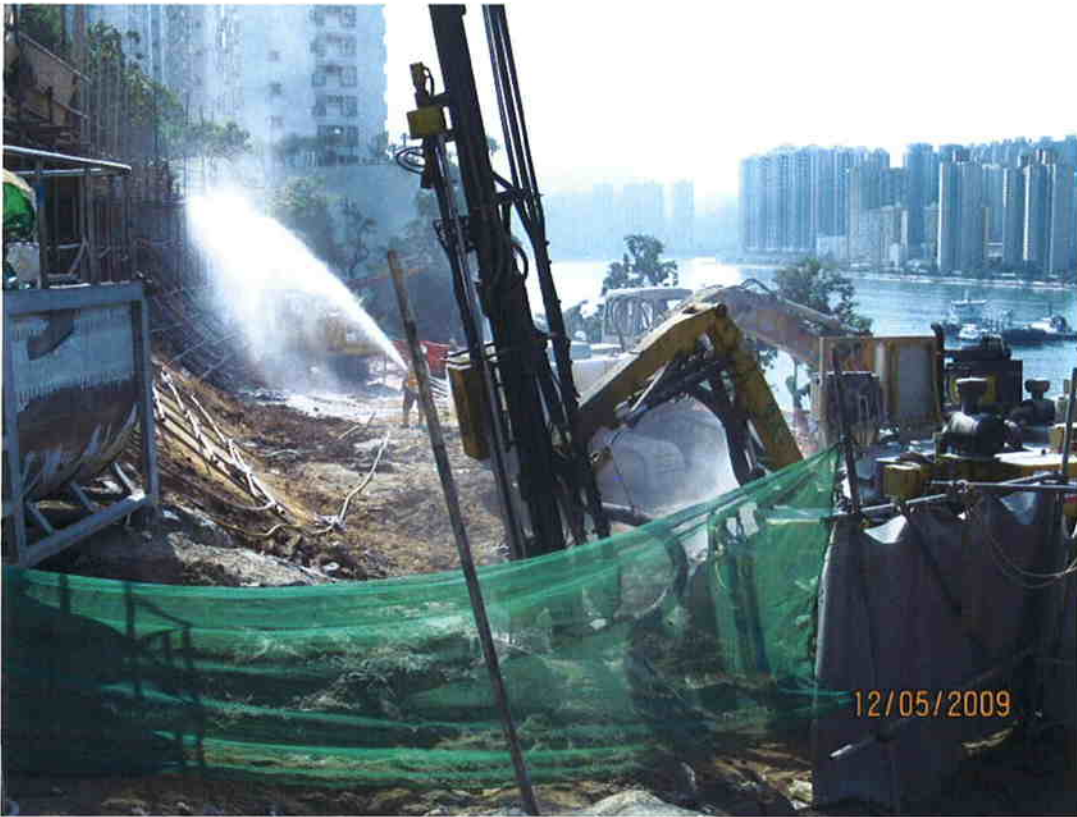
4. Water Spraying for soil nail work.
