COMPLAINT LOG

Noise Mitigation Measures

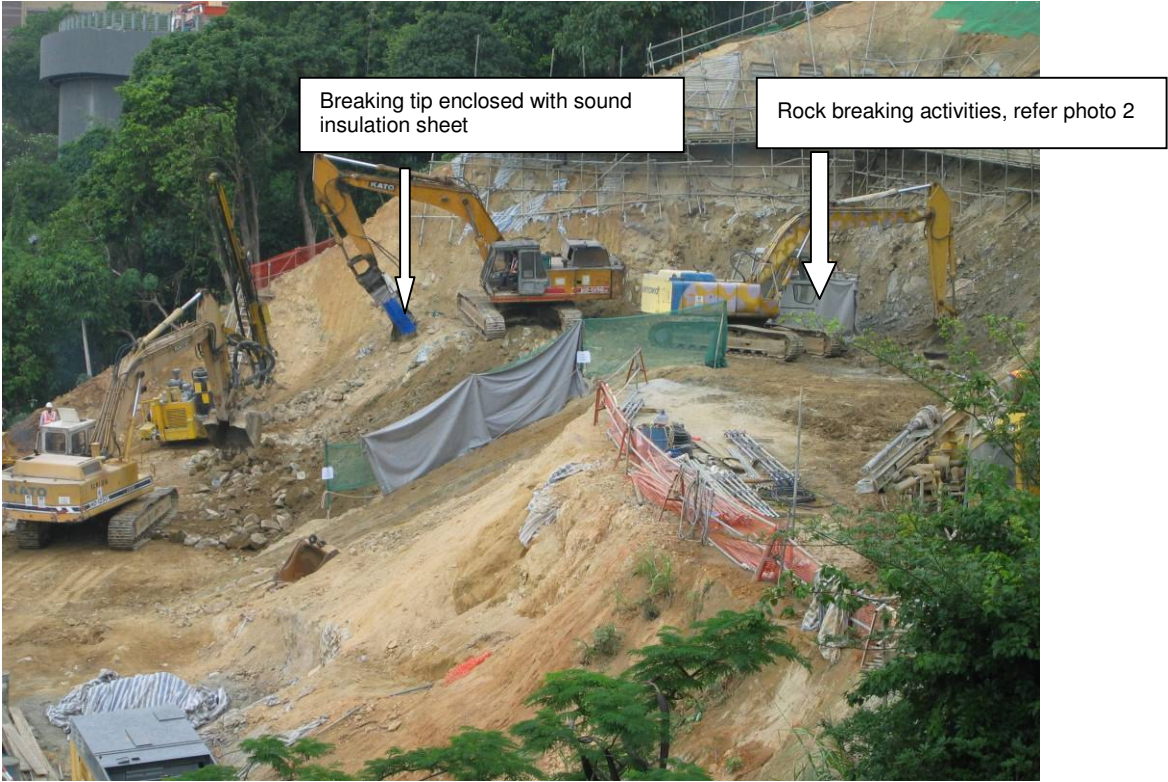
1. Sound insulation sheet erected with the green net.

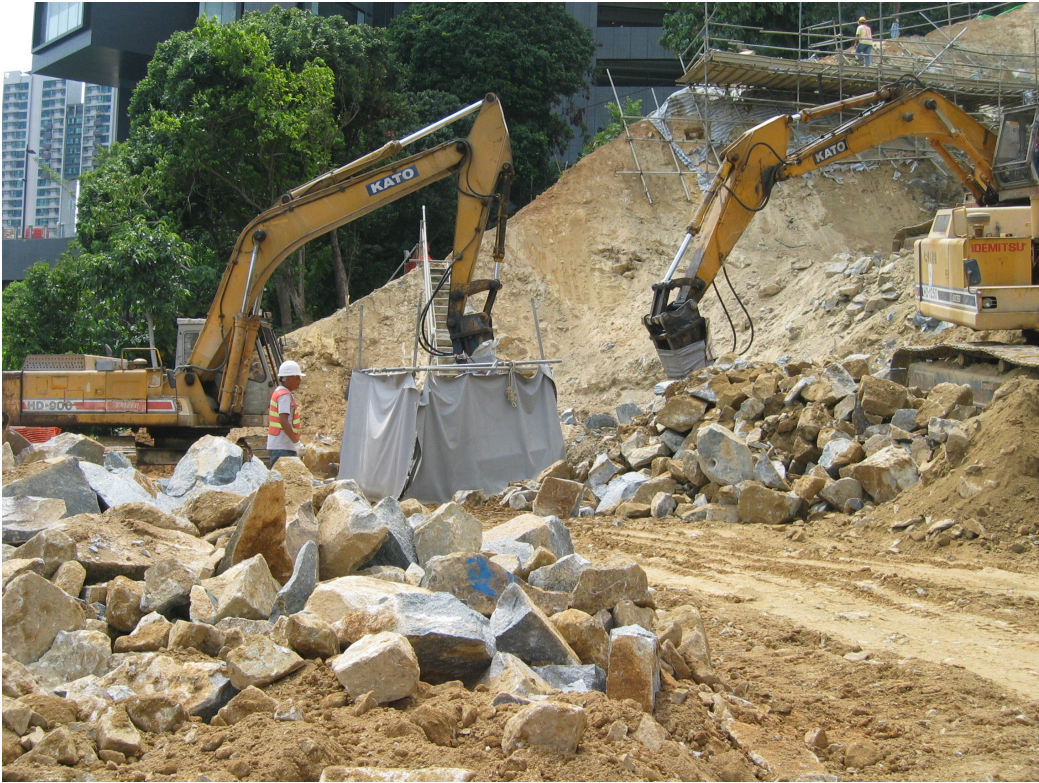
2. Sound insulation sheet surrounding the rock breaking activities as far as possible.

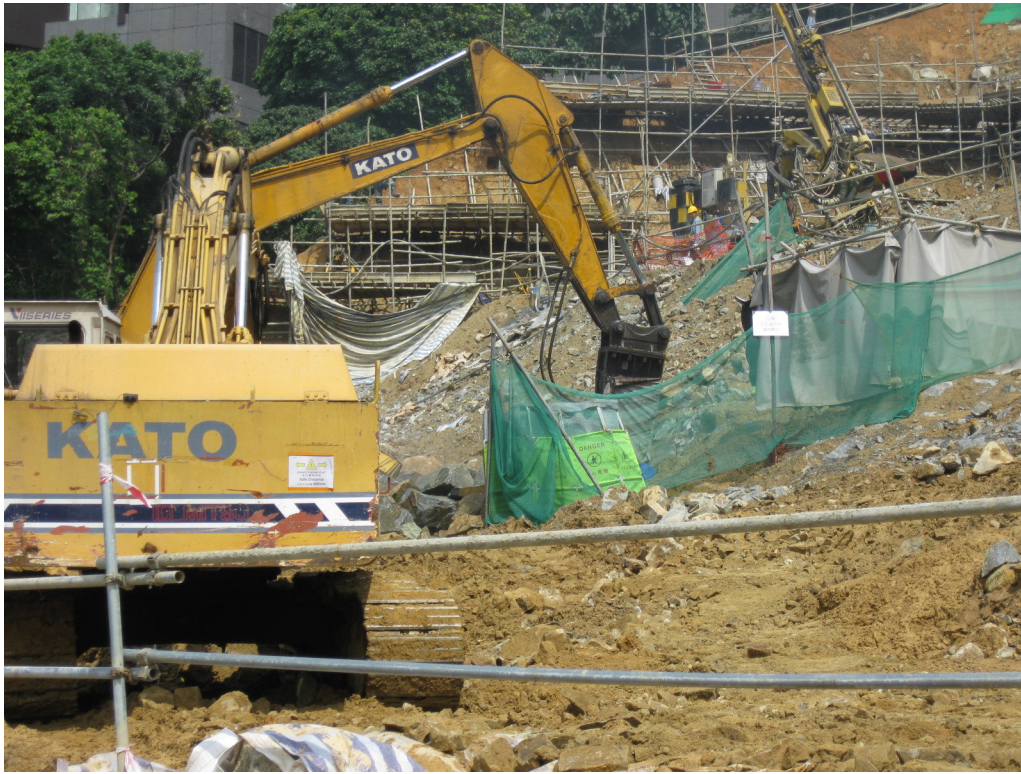
3. Noise insulation material for rock breaking.

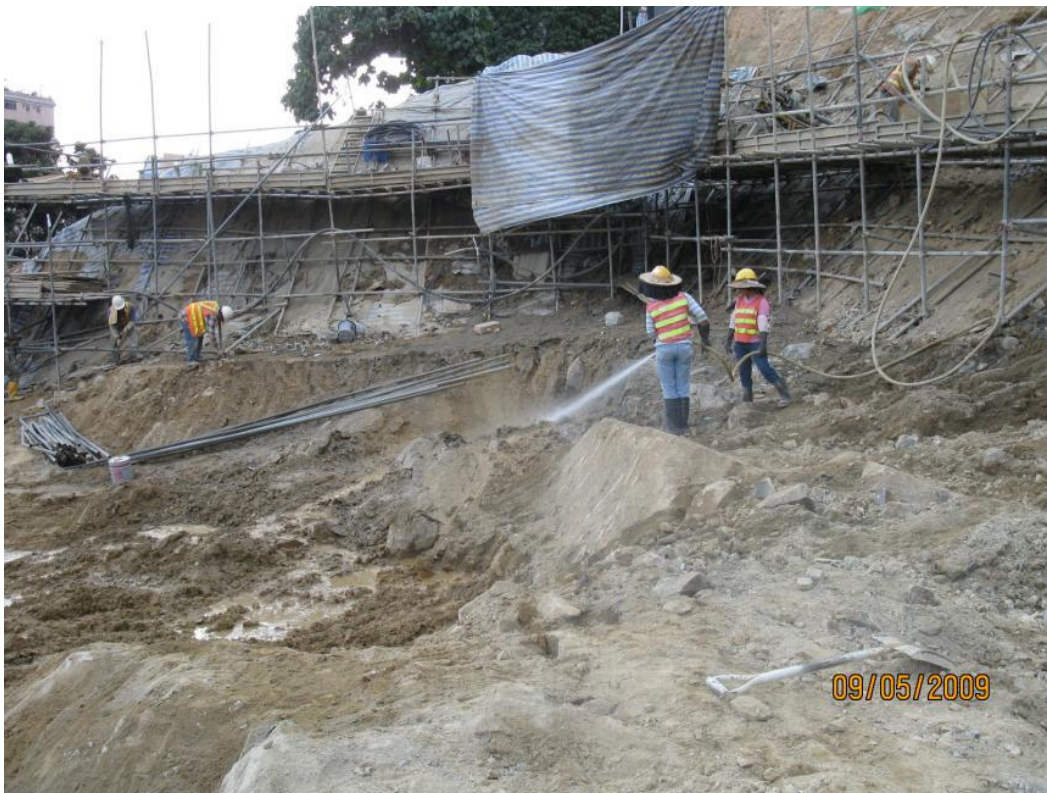
1. Water spraying for the exposed area.

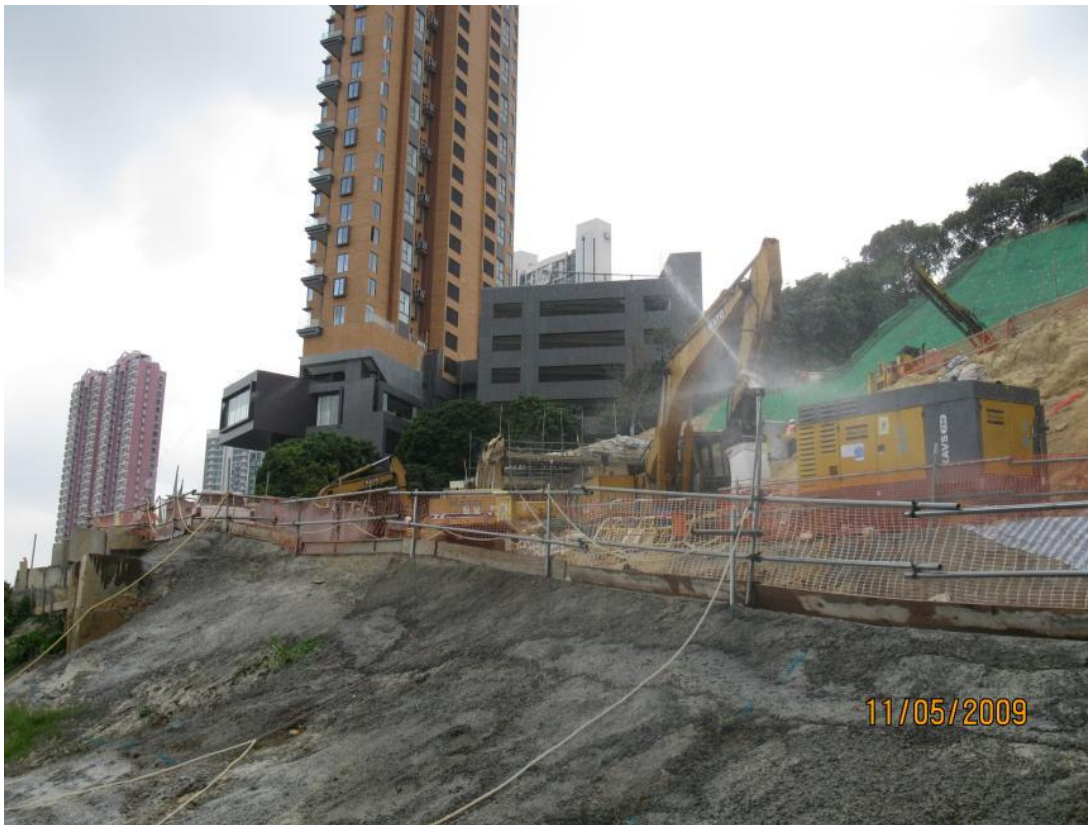
2. Automatic sprinkler spraying the haul road.

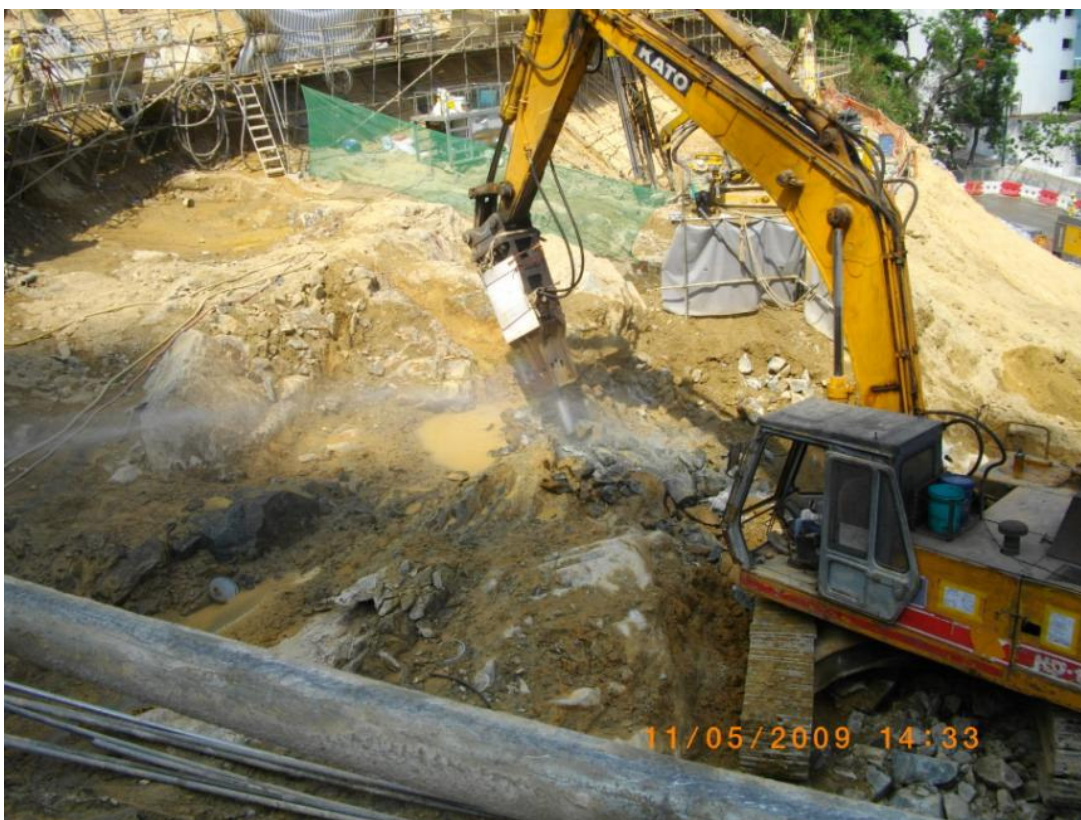
3. Water spraying during rock breaking.

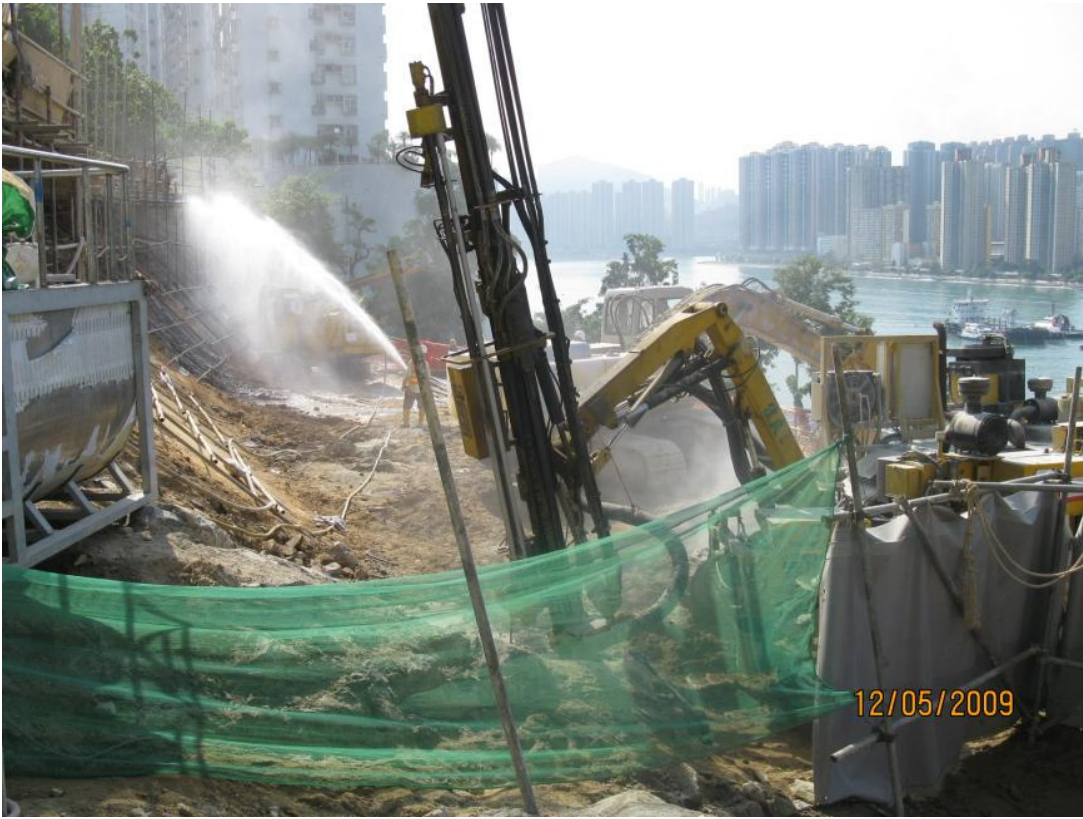
4. Water Spraying for soil nail work.
