**Interim Notifications of Environmental Quality Limits Exceedances**

Incident Report on Action Level or Limit Level Non-compliance

Project	Tsuen Wan Drainage Tunnel
Date	15-Oct-10
Time	9:38 AM
Monitoring Location	Hong Hoi Chee Hong Temple (I-2)
Parameter	Turbidity
Action & Limit Levels	6.63/6.99
Measured Level	7.72
Possible reason for Action or Limit Level Non-compliance	A high turbidity level of 7.73 is recorded at Control Station (I-2-C)
Actions taken / to be taken	The measured turbidity level was above the Baseline Limit level and beyond the range of baseline turbidity concentration (2.17-7.08 NTU). Construction activities including General Site Cleaning & Housekeeping; Excavation and rock splitting at Vortex Drop Shaft; Excavation and rock splitting at Man Access Shaft; Pipe Jacking at Portion G; and Erect formwork and rebar fixing of pile caps at Portion G. No direct disturbance was observed from the site. Thus, the exceedance is considered to be natural variation and no action should be taken.
Remarks	Following mitigation measures were provided: (1) Waste water will be collected to Waste Water Treatment Plant and treat before discharge; (2) Existing Stream has been diverte

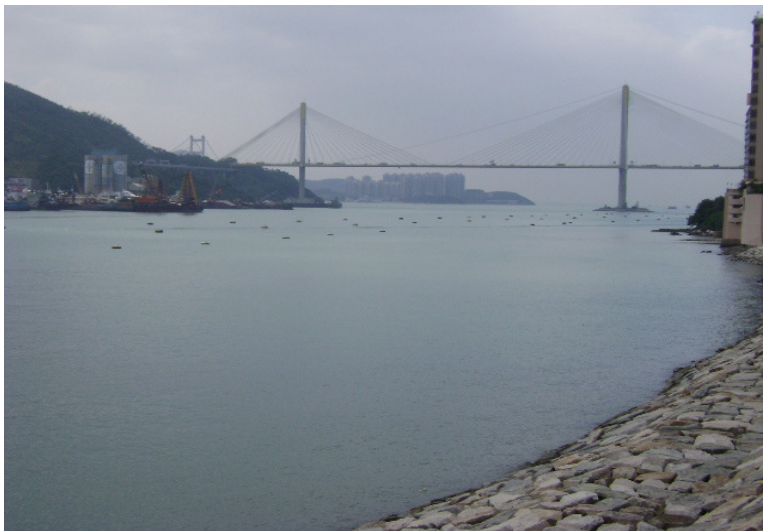
Site photo

Project	Tsuen Wan Drainage Tunnel
Date	25-Oct-10
Time	9:35 AM
Monitoring Location	O-1(FT)
Parameter	Dissolved Oxygen (marine bottom)
Action & Limit Levels (mg/L)	6.99 / 6.96
Measured Level (mg/L)	6.79
Possible reason for Action or Limit Level Non-compliance	The measured DO level (marine bottom) was below baseline Action / Limit Level but was within the ranges of 3-year (2007 - 2009) marine bottom DO variation between 2.2 and 8.8 mg/L at EPD WM4 marine water quality monitoring station near Ma Wan and between 3.4 and 8.6 mg/L at EPD VM14 marine water quality monitoring station towards the north of Rambler Channel. Marker buoys were setting up at the dredging area during measurement. No marine dredging activity was undertaken on 25 October 2010. Thus, the exceedance is considered to be contributed by natural variation and no action is required.
Actions taken / to be taken	None
Remarks	None

Photographic record for exceedance of Dissolved Oxygen (marine bottom) recorded at O-1(FT) on 25-Oct-10

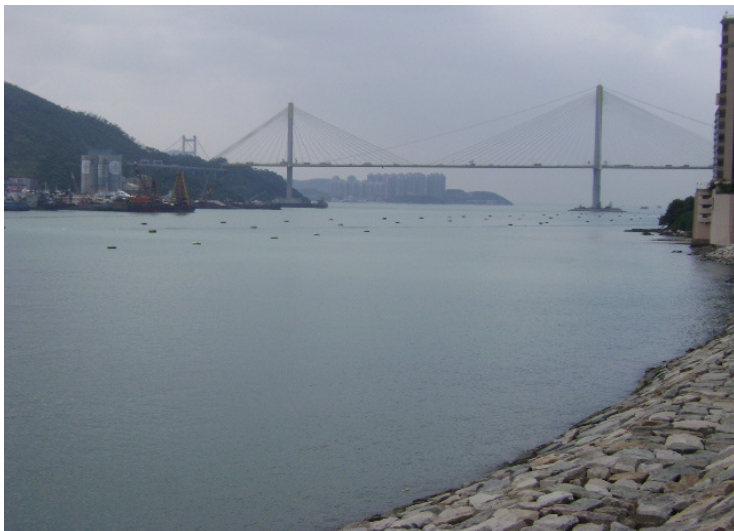
Site photo

Project	Tsuen Wan Drainage Tunnel
Date	25-Oct-10
Time	12.55:00 PM
Monitoring Location	O-1(ET)
Parameter	Dissolved Oxygen (mid-depth)
Action & Limit Levels (mg/L)	7.02 / 6.94
Measured Level (mg/L)	6.93
Possible reason for Action or Limit Level Non-compliance	The measured DO level (mid-depth) was below the baseline Action / Limit Level but was within the ranges of 3-year (2007 - 2009) mid-depth DO records between 2.6 and 9.1 mg/L at EPD WM4 marine water quality monitoring station near Ma Wan and between 3.9 and 8.5 mg/L at EPD VM14 marine water quality monitoring station towards the north of Rambler Channel. Marker buoys were setting up at the dredging area during measurement. No marine dredging activity was undertaken on 25 October 2010. Thus, the exceedance is considered to be contributed by natural variation and no action is required.
Actions taken / to be taken	None
Remarks	None

Photographic record for exceedance of Dissolved Oxygen (mid-depth) recorded at O-1(ET) on 25-Oct-10

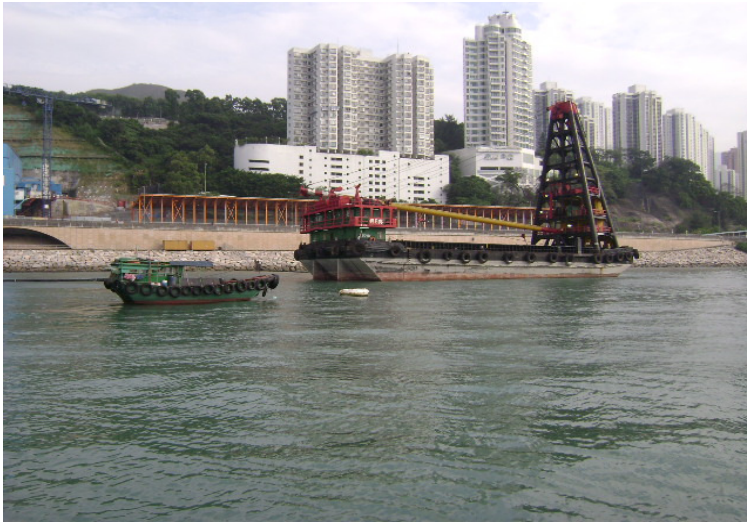
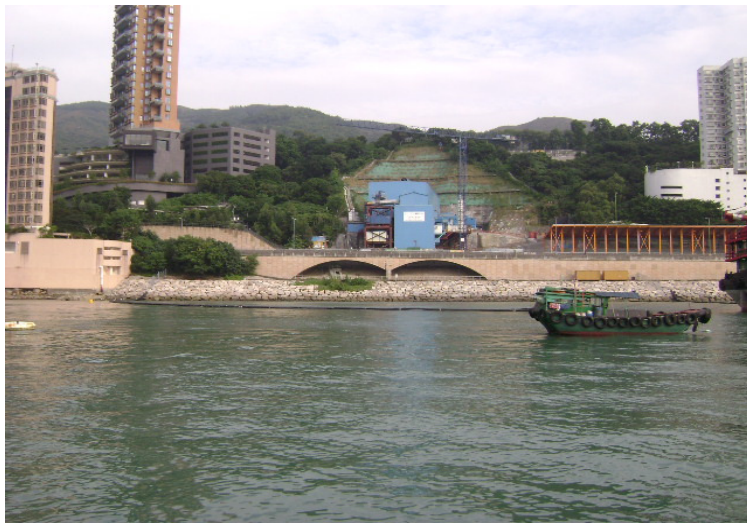
Project	Tsuen Wan Drainage Tunnel
Date	27-Oct-10
Time	9:05 AM
Monitoring Location	O-1(FT)
Parameter	Dissolved Oxygen (marine surface)
Action & Limit Levels (mg/L)	6.84 / 6.81
Measured Level (mg/L)	5.50
Possible reason for Action or Limit Level Non-compliance	The measured DO level (marine surface) was below the baseline Action / Limit Level but was within the ranges of 3-year (2007 - 2009) marine surface DO records between 4.3 and 9.4 mg/L at EPD WM4 marine water quality monitoring station near Ma Wan and between 4.2 and 8.6 mg/L at EPD VM14 marine water quality monitoring station towards the north of Rambler Channel. Silt curtains were setting up at the dredging area during measurement. No marine dredging activity was undertaken on 27 October 2010. Thus, the exceedance is considered to be contributed by natural variation and no action is required.
Actions taken / to be taken	None
Remarks	None

Photographic record for exceedance of Dissolved Oxygen (marine surface) recorded at O-1(FT) on 27-Oct-10

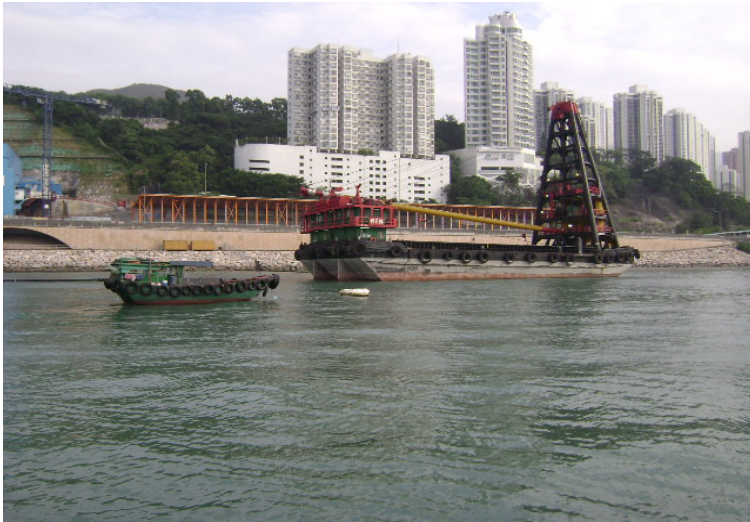
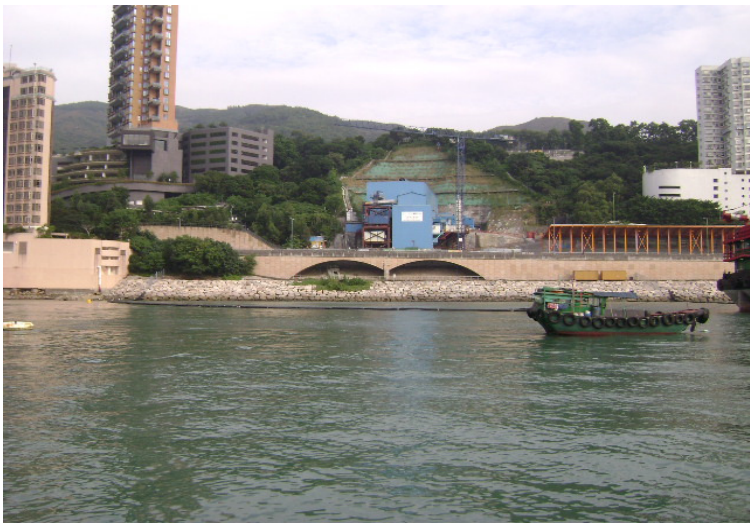
Project	Tsuen Wan Drainage Tunnel
Date	27-Oct-10
Time	9:05 AM
Monitoring Location	O-1(FT)
Parameter	Dissolved Oxygen (mid-depth)
Action & Limit Levels (mg/L)	6.84 / 6.81
Measured Level (mg/L)	5.88
Possible reason for Action or Limit Level Non-compliance	The measured DO level (mid-depth) was below the baseline Action / Limit Level but was within the ranges of 3-year (2007 - 2009) mid-depth DO records between 2.6 and 9.1 mg/L at EPD WM4 marine water quality monitoring station near Ma Wan and between 3.9 and 8.5 mg/L at EPD VM14 marine water quality monitoring station towards the north of Rambler Channel. Silt curtains were setting up at the dredging area during measurement. No marine dredging activity was undertaken on 27 October 2010. Thus, the exceedance is considered to be contributed by natural variation and no action is required.
Actions taken / to be taken	None
Remarks	None

Photographic record for exceedance of Dissolved Oxygen (mid-depth) recorded at O-1(FT) on 27-Oct-10

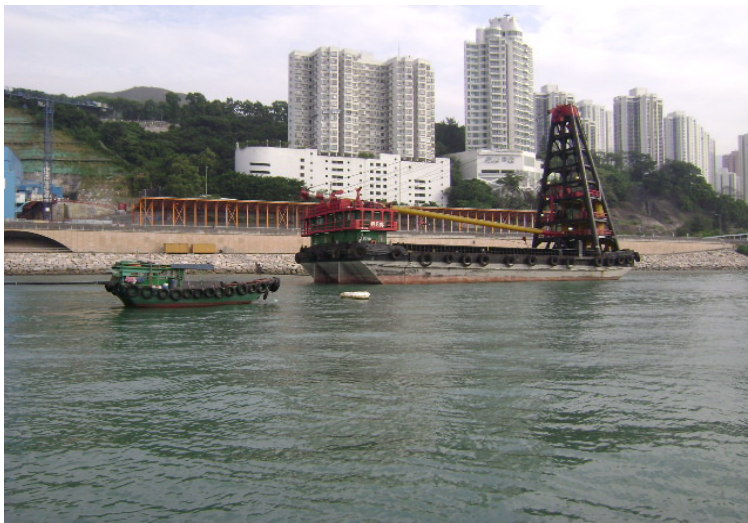
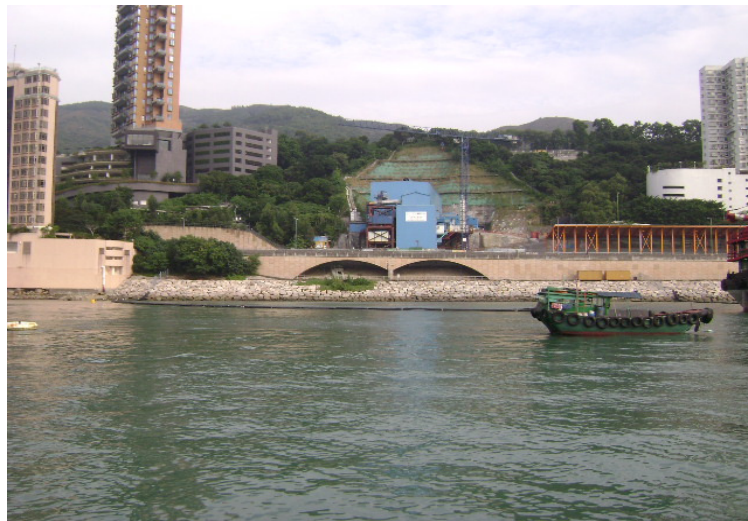
Project	Tsuen Wan Drainage Tunnel
Date	27-Oct-10
Time	9:05 AM
Monitoring Location	O-1(FT)
Parameter	Dissolved Oxygen (marine bottom)
Action & Limit Levels (mg/L)	6.99 / 6.96
Measured Level (mg/L)	5.87
Possible reason for Action or Limit Level Non-compliance	The measured DO level (marine bottom) was below the baseline Action / Limit Level but was within the ranges of 3-year (2007 - 2009) marine bottom DO records between 2.2 and 8.8 mg/L at EPD WM4 marine water quality monitoring station near Ma Wan and between 3.4 and 8.6 mg/L at EPD VM14 marine water quality monitoring station towards the north of Rambler Channel. Silt curtains were setting up at the dredging area during measurement. No marine dredging activity was undertaken on 27 October 2010. Thus, the exceedance is considered to be contributed by natural variation and no action is required.
Actions taken / to be taken	None
Remarks	None

**Photographic record for exceedance of Dissolved Oxygen (marine bottom) recorded at O-1(FT) on 27-Oct-10**

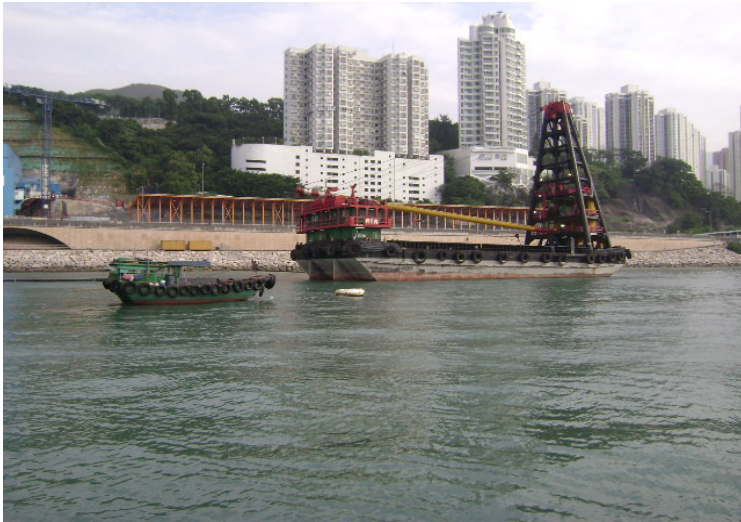
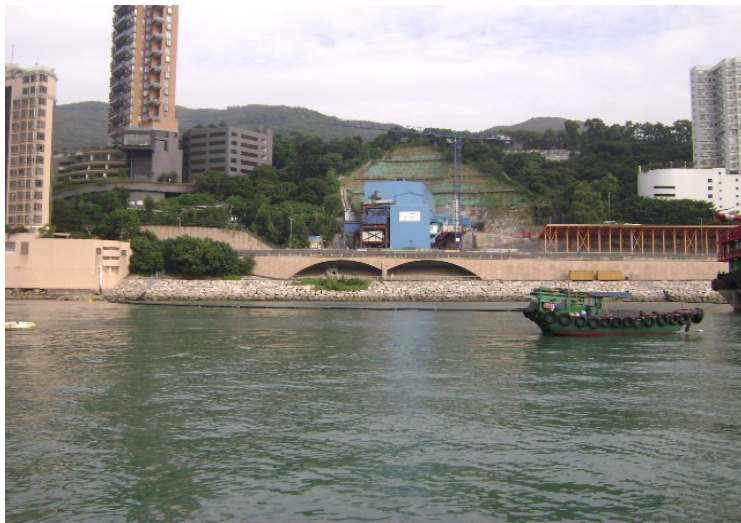
Project	Tsuen Wan Drainage Tunnel
Date	27-Oct-10
Time	3:00 PM
Monitoring Location	O-1(ET)
Parameter	Dissolved Oxygen (marine surface)
Action & Limit Levels (mg/L)	7.02 / 6.94
Measured Level (mg/L)	6.01
Possible reason for Action or Limit Level Non-compliance	The measured marine surface DO level was below the baseline Action / Limit Level but was within the ranges of 3-year (2007 - 2009) marine surface DO records between 4.3 and 9.4 mg/L at EPD WM4 marine water quality monitoring station near Ma Wan and between 4.2 and 8.6 mg/L at EPD VM14 marine water quality monitoring station towards the north of Rambler Channel. Silt curtains were setting up at the dredging area during measurement. No marine dredging activity was undertaken on 27 October 2010. Thus, the exceedance is considered to be contributed by natural variation and no action is required.
Actions taken / to be taken	None
Remarks	None

Photographic record for exceedance of Dissolved Oxygen (marine surface) recorded at O-1(ET) on 27-Oct-10

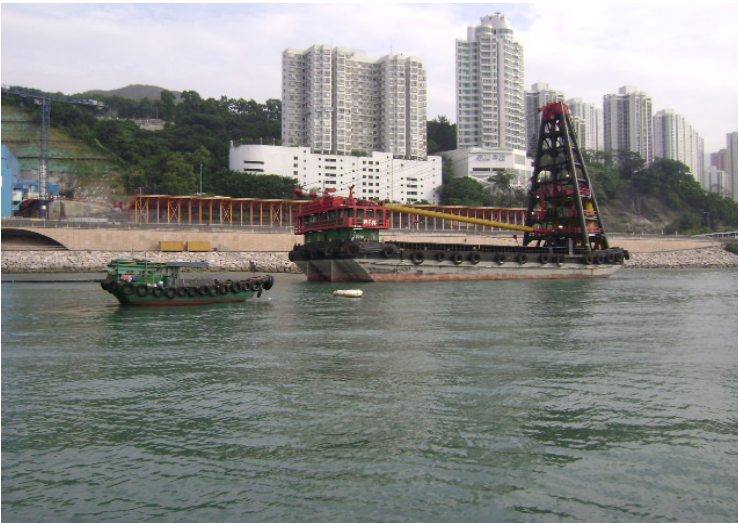
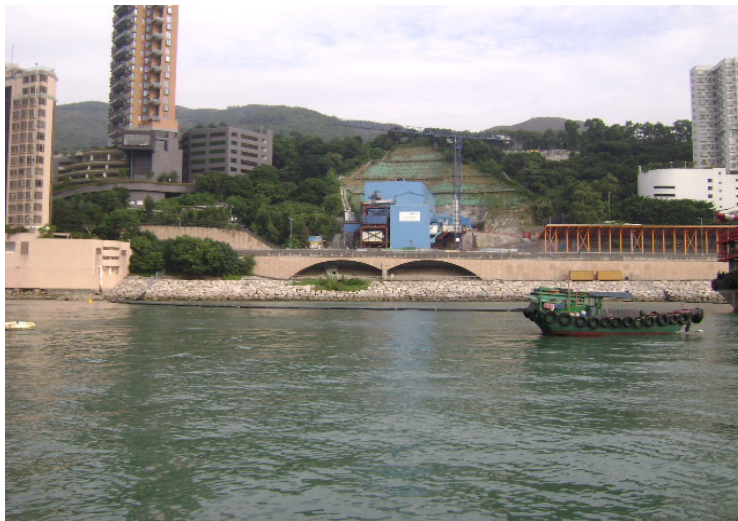
Photographic record for exceedance of Dissolved Oxygen (mid-depth) recorded at O-1(ET) on 27-Oct-10

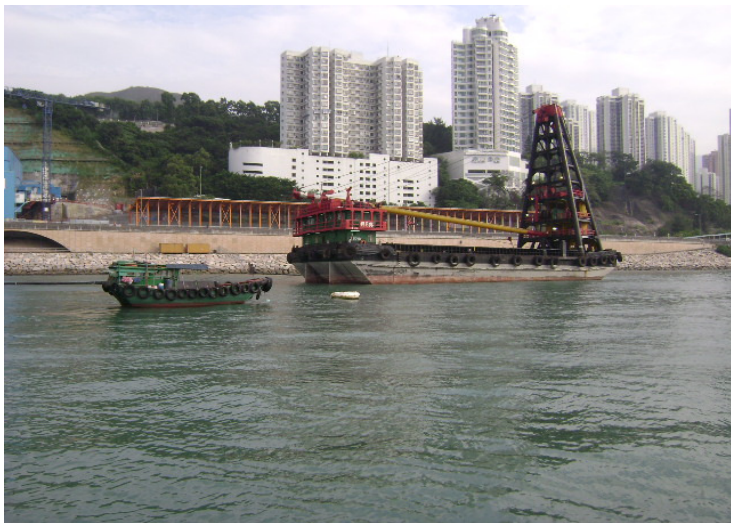
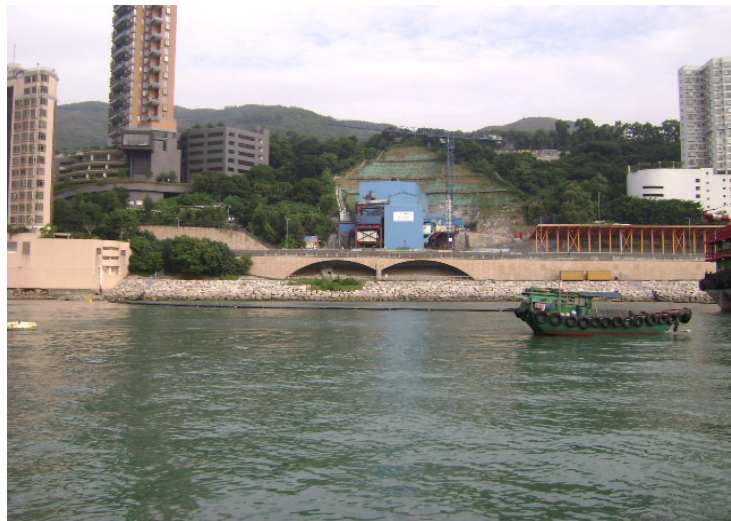
**Photographic record for exceedance of Dissolved Oxygen (marine bottom) recorded at O-1(ET) on 27-Oct-10**

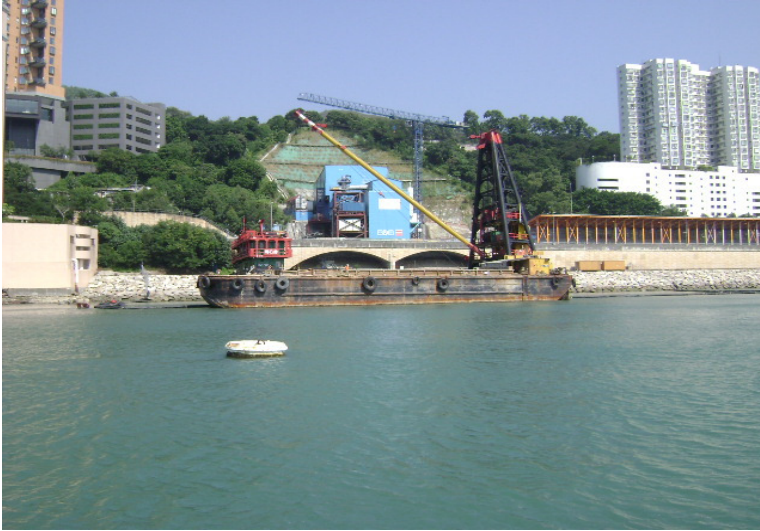
Site photo

Photographic record for exceedance of Dissolved Oxygen (marine surface) recorded at O-1(ET) on 29-Oct-10

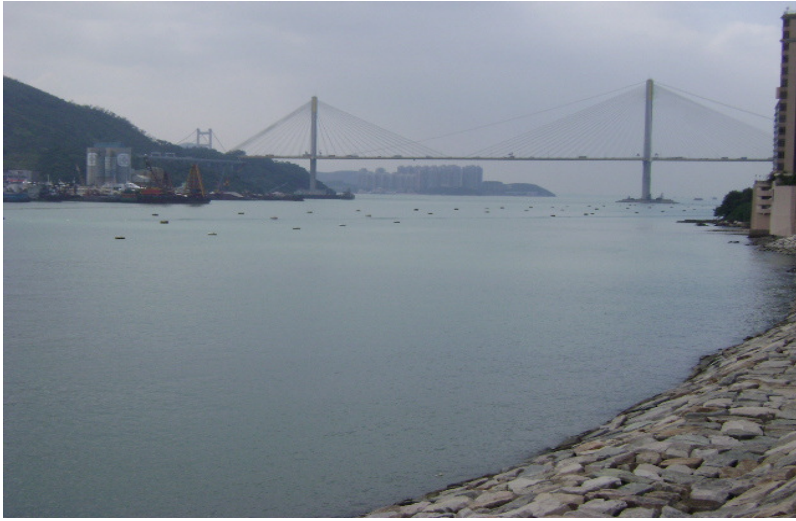
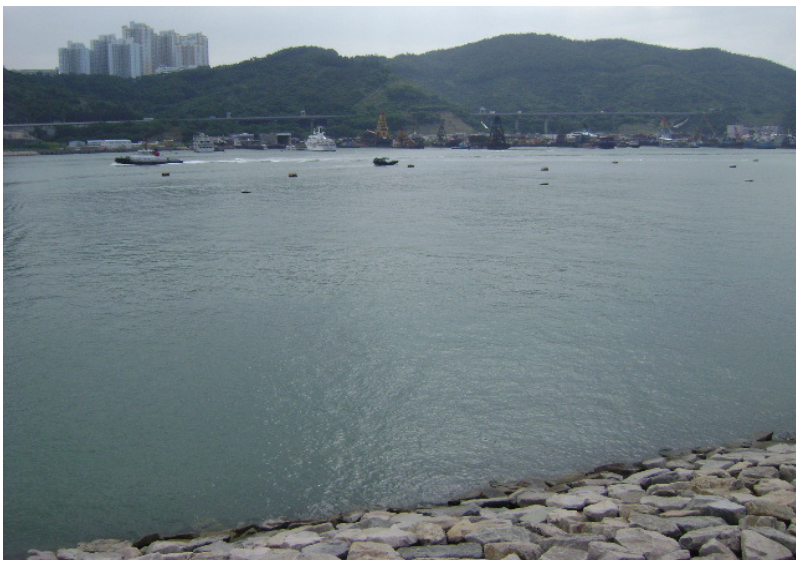
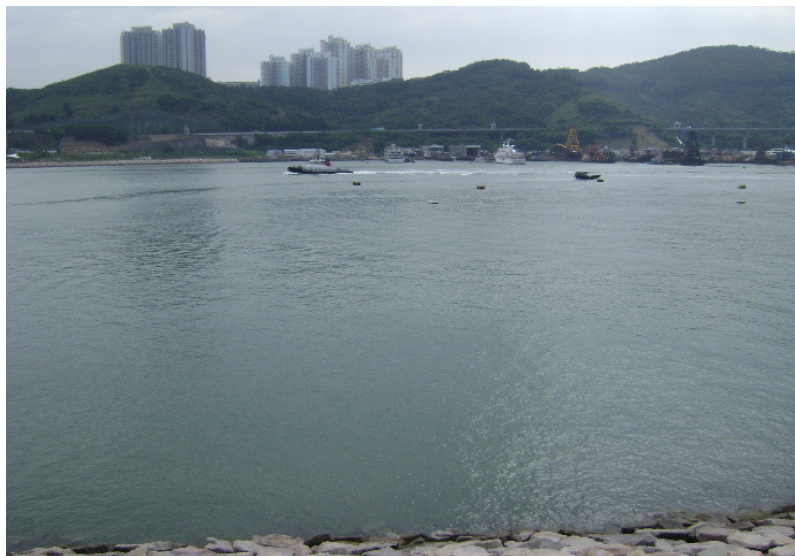
Photographic record for exceedance of Turbidity (Tby) recorded at O-1(FT) on 25-Oct-10

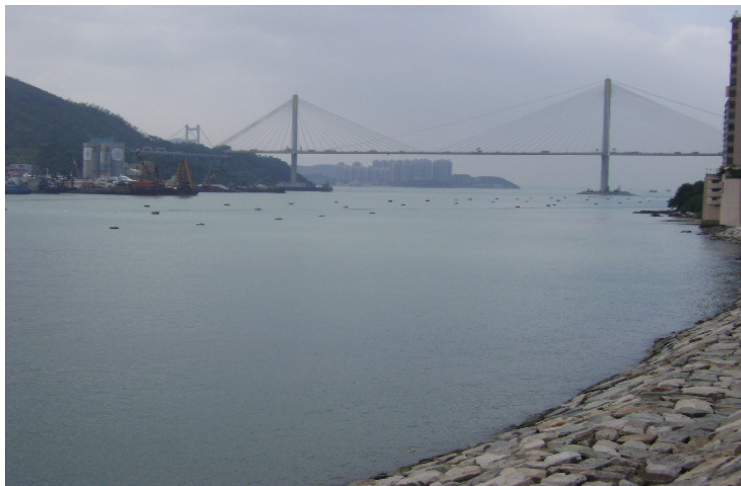
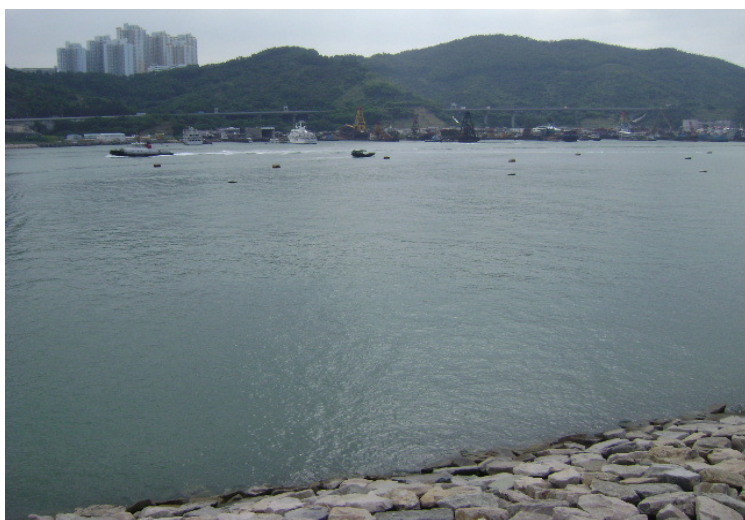
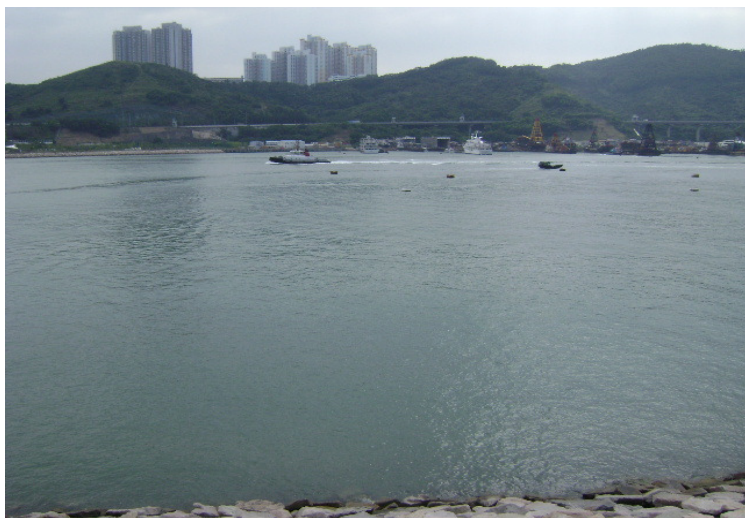
Photographic record for exceedance of Suspended Solids (SS) recorded at O-1(FT) on 25-Oct-10

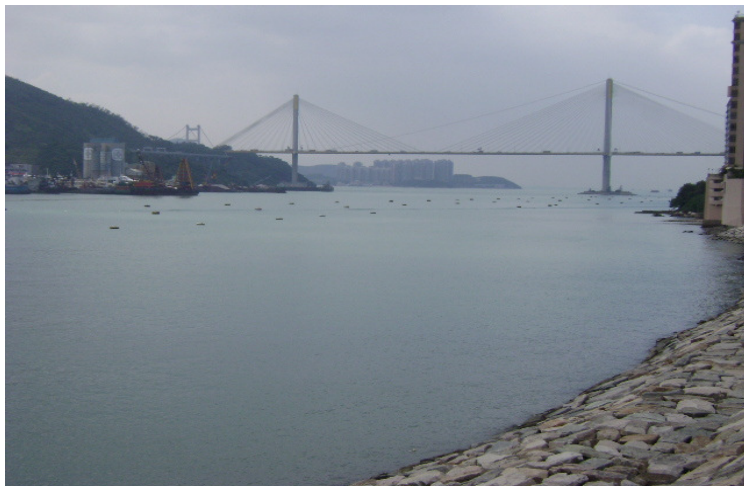
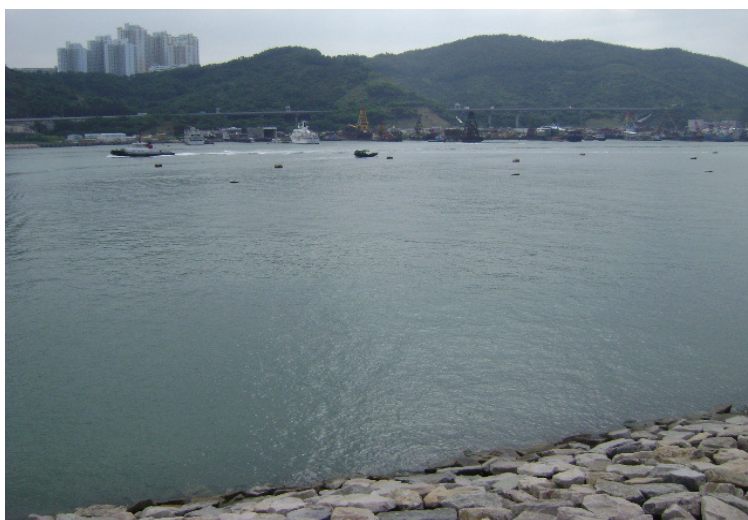
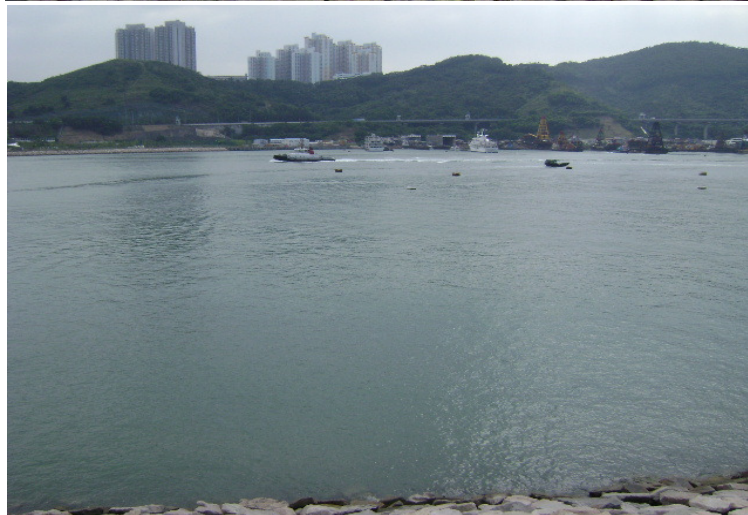
Photographic record for exceedance of Suspended Solids (SS) recorded at O-1(ET) on 25-Oct-10

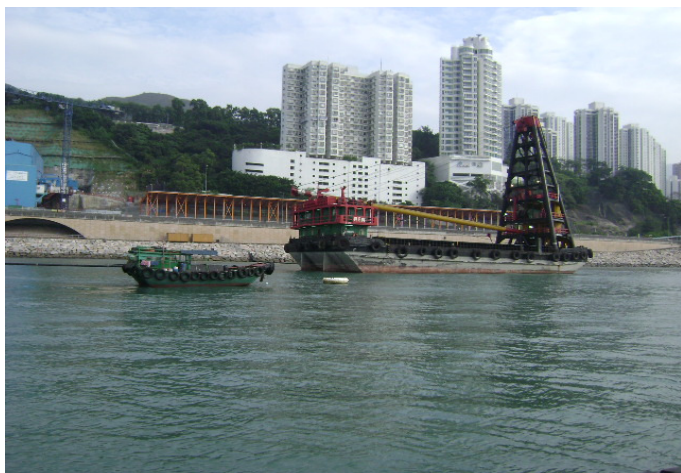
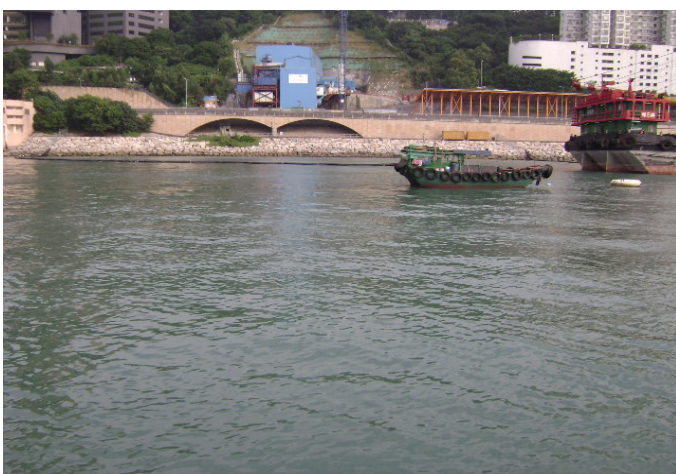
Photographic record for exceedance of Suspended Solids (SS) recorded at O-1(FT) on 27-Oct-10

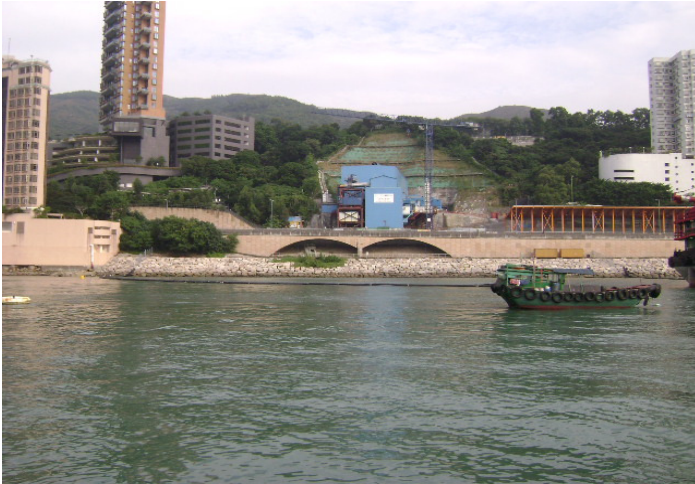
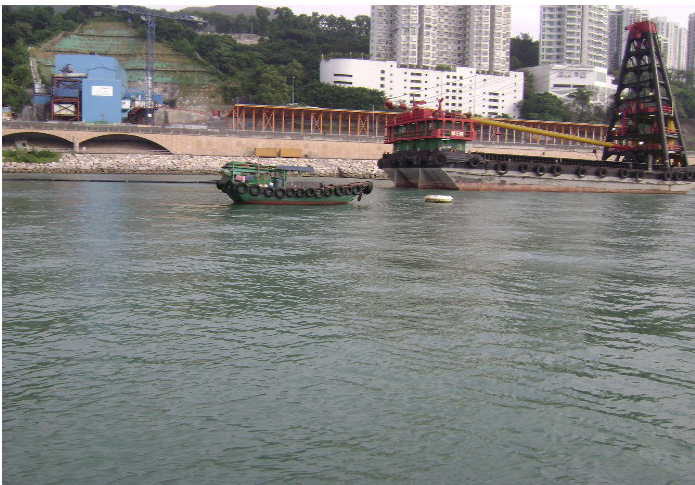
Photographic record for exceedance of Suspended Solids (SS) recorded at O-1(ET) on 27-Oct-10

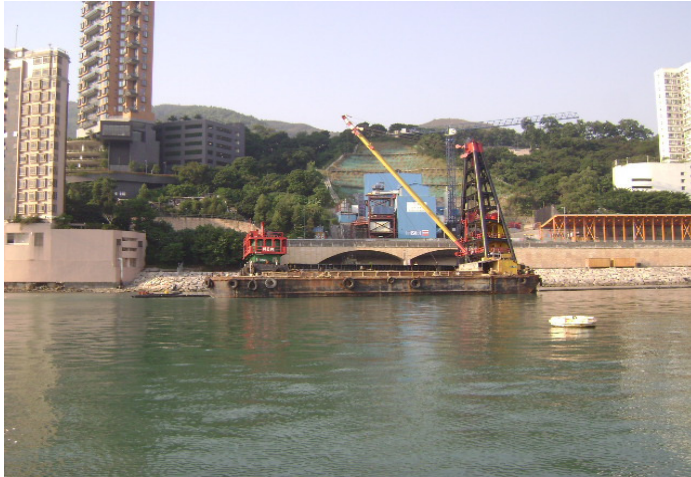
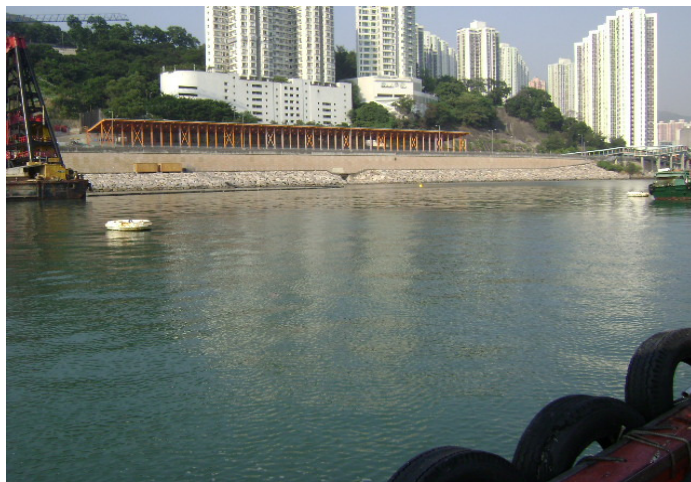
Photographic record for exceedance of Suspended Solids (SS) recorded at O-1(ET) on 29-Oct-10

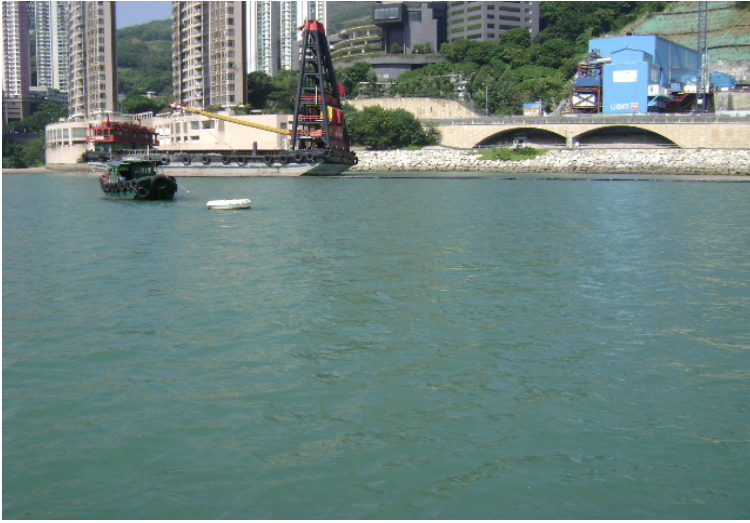
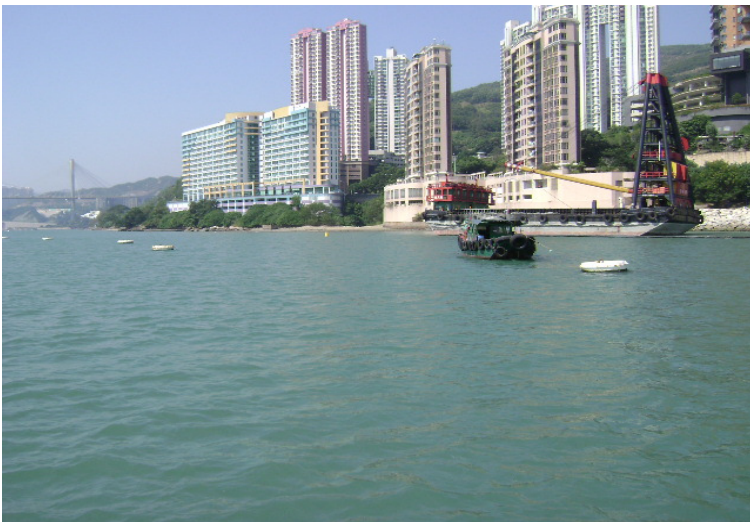
**Photographic record for exceedance of Dissolved Oxygen (marine surface) recorded at O-1(FT) on 01-Nov-10**

Actions taken / to be taken	(1) Silt curtains had been provided along the dredging boundary line and extended from the seawater level to the bottom of seabed; (2) Frame-type silt curtains had been employed for the derrick barge and all dredging operation was confined in the frame-type silt curtain; (3) Closed grab had been used and the daily dredging rate was less than 960 m <sup>3</sup> ; (4) Sufficient slacks of silt curtains were allowed to ensure the curtains rested on the seabed to cope with waves and tides; (5) Condition of silt curtains had been checked by the on-board supervisor daily before any dredging activity; (6) Operator had been instructed to manoeuvre the grab with due care to prevent fast lifting out of the grab from the frame-type silt curtains.
Remarks	None

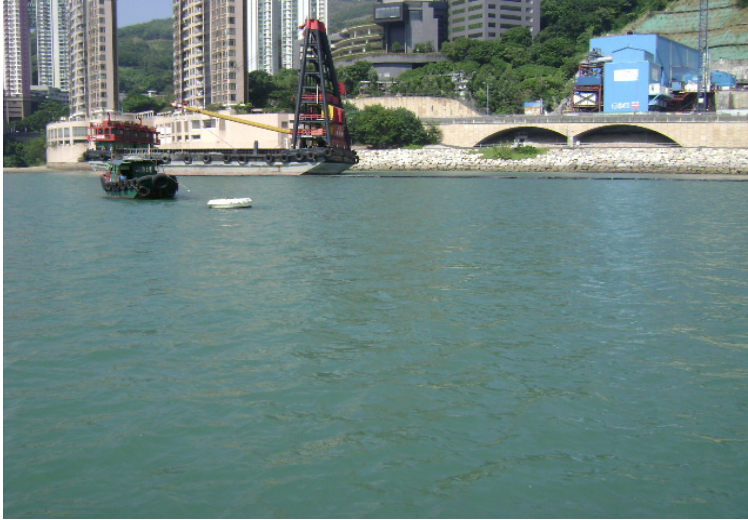
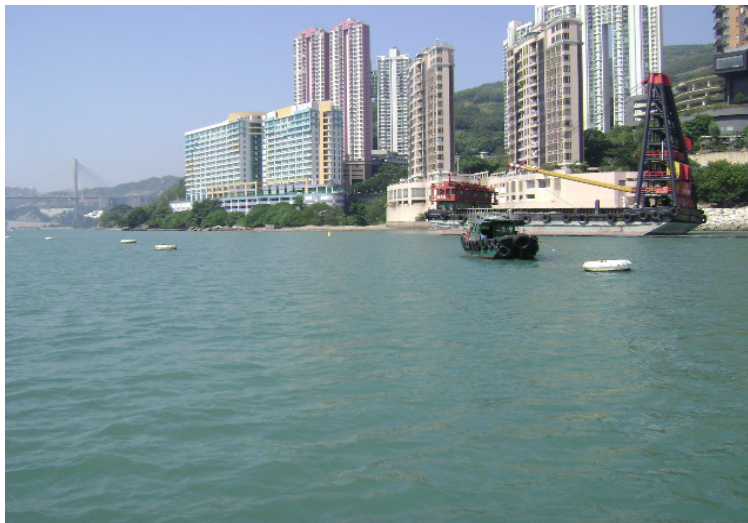
**Photographic record for exceedance of Dissolved Oxygen (mid-depth) recorded at O-1(FT) on 01-Nov-10**

Actions taken / to be taken	(1) Silt curtains had been provided along the dredging boundary line and extended from the seawater level to the bottom of seabed; (2) Frame-type silt curtains had been employed for the derrick barge and all dredging operation was confined in the frame-type silt curtain; (3) Closed grab had been used and the daily dredging rate was less than 960 m <sup>3</sup> ; (4) Sufficient slacks of silt curtains were allowed to ensure the curtains rested on the seabed to cope with waves and tides; (5) Condition of silt curtains had been checked by the on-board supervisor daily before any dredging activity; (6) Operator had been instructed to manoeuvre the grab with due care to prevent fast lifting out of the grab from the frame-type silt curtains.
Remarks	None

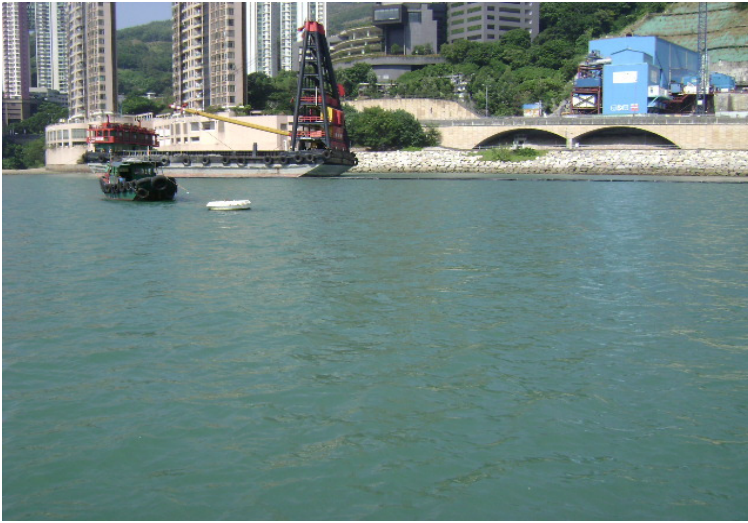
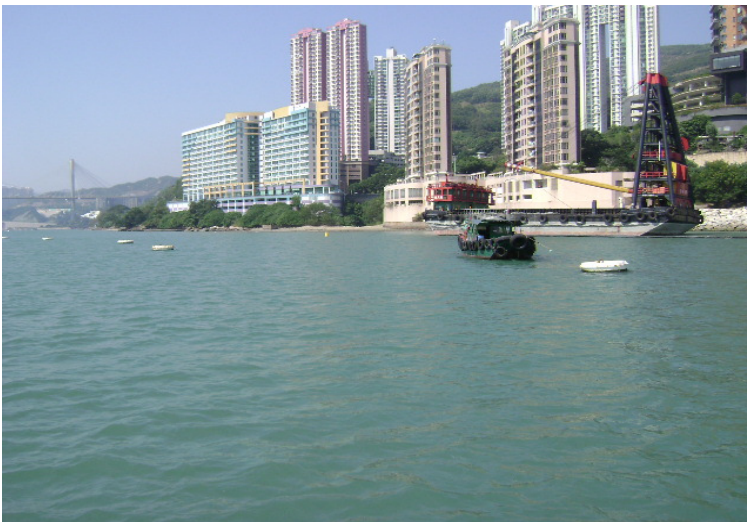
**Photographic record for exceedance of Dissolved Oxygen (marine bottom) recorded at O-1(FT) on 01-Nov-10**

Actions taken / to be taken	(1) Silt curtains had been provided along the dredging boundary line and extended from the seawater level to the bottom of seabed; (2) Frame-type silt curtains had been employed for the derrick barge and all dredging operation was confined in the frame-type silt curtain; (3) Closed grab had been used and the daily dredging rate was less than 960 m <sup>3</sup> ; (4) Sufficient slacks of silt curtains were allowed to ensure the curtains rested on the seabed to cope with waves and tides; (5) Condition of silt curtains had been checked by the on-board supervisor daily before any dredging activity; (6) Operator had been instructed to manoeuvre the grab with due care to prevent fast lifting out of the grab from the frame-type silt curtains.
Remarks	None

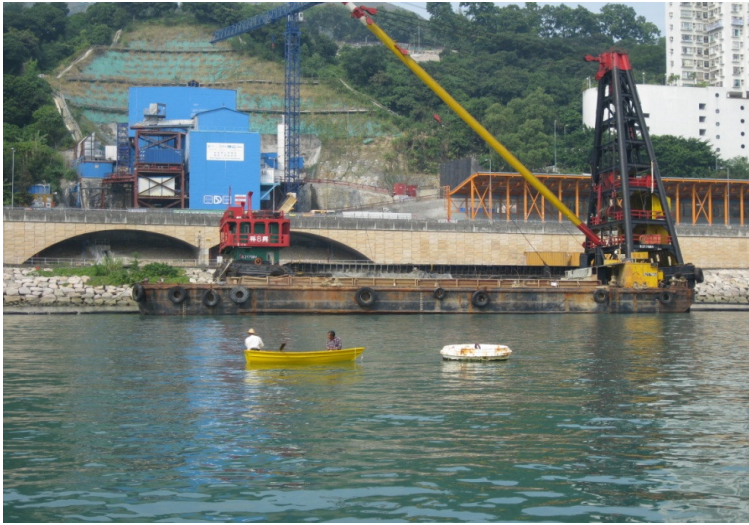
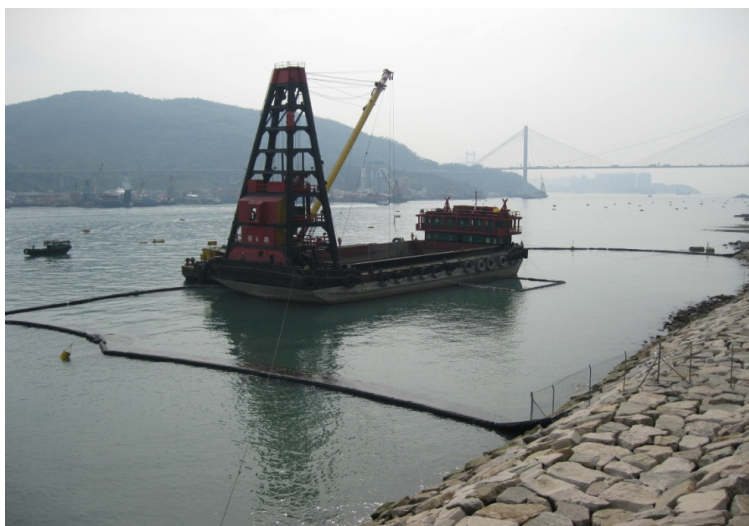
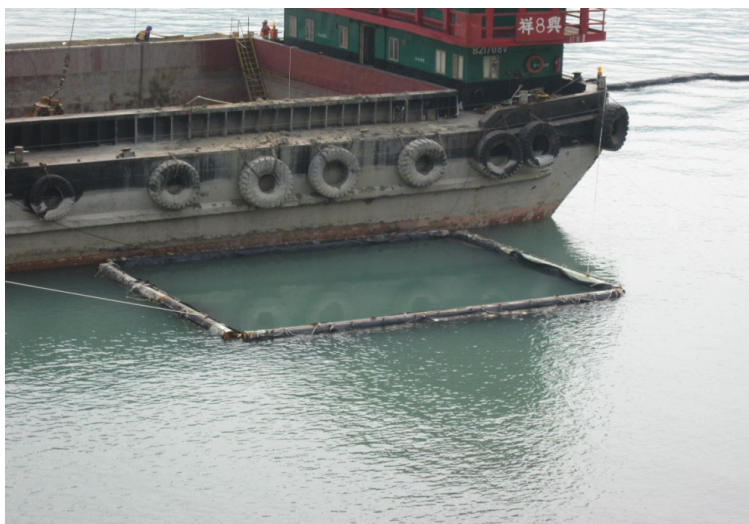
Photographic record for exceedance of Dissolved Oxygen (marine surface) recorded at O-1(FT) on 03-Nov-10

Actions taken / to be taken	(1) Silt curtains had been provided along the dredging boundary line and extended from the seawater level to the bottom of seabed; (2) Frame-type silt curtains had been employed for the derrick barge and all dredging operation was confined in the frame-type silt curtain; (3) Closed grab had been used and the daily dredging rate was less than 960 m <sup>3</sup> ; (4) Sufficient slacks of silt curtains were allowed to ensure the curtains rested on the seabed to cope with waves and tides; (5) Condition of silt curtains had been checked by the on-board supervisor daily before any dredging activity; (6) Operator had been instructed to manoeuvre the grab with due care to prevent fast lifting out of the grab from the frame-type silt curtains.
Remarks	None

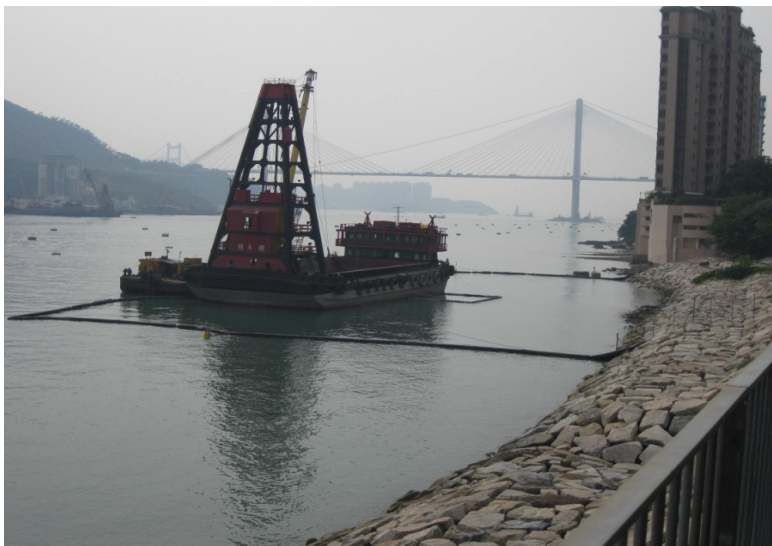
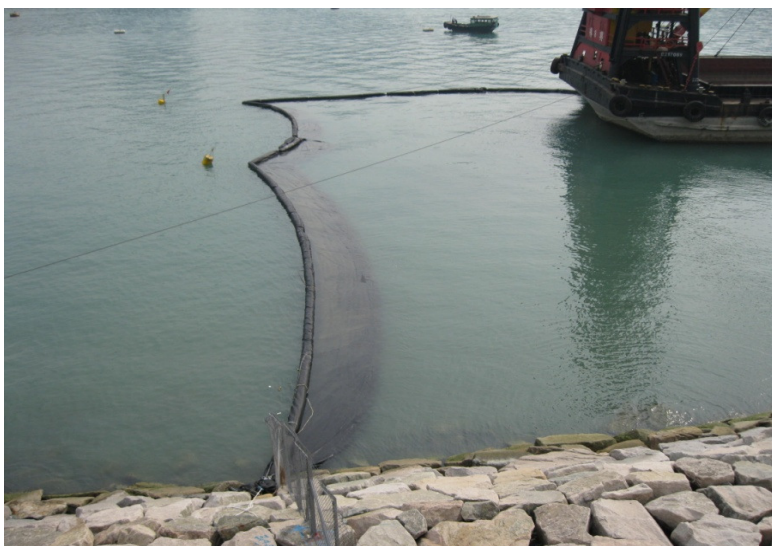
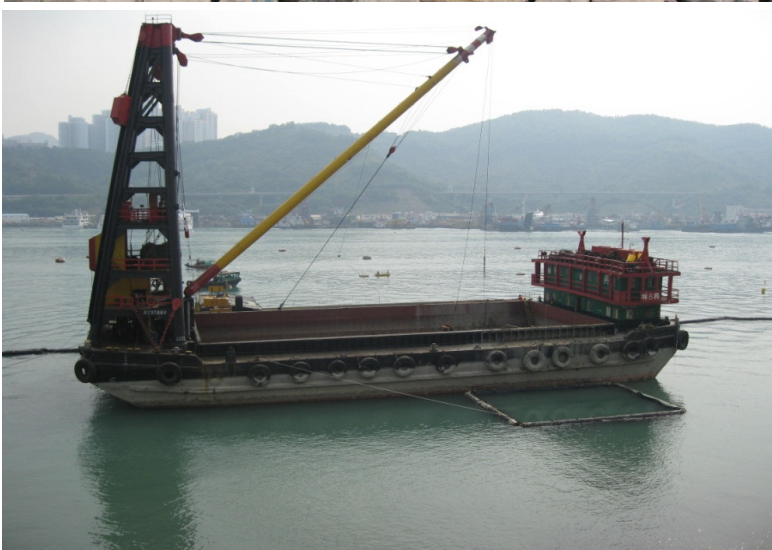
Photographic record for exceedance of Dissolved Oxygen (mid-depth) recorded at O-1(FT) on 03-Nov-10

Actions taken / to be taken	(1) Silt curtains had been provided along the dredging boundary line and extended from the seawater level to the bottom of seabed; (2) Frame-type silt curtains had been employed for the derrick barge and all dredging operation was confined in the frame-type silt curtain; (3) Closed grab had been used and the daily dredging rate was less than 960 m <sup>3</sup> ; (4) Sufficient slacks of silt curtains were allowed to ensure the curtains rested on the seabed to cope with waves and tides; (5) Condition of silt curtains had been checked by the on-board supervisor daily before any dredging activity; (6) Operator had been instructed to manoeuvre the grab with due care to prevent fast lifting out of the grab from the frame-type silt curtains.
Remarks	None

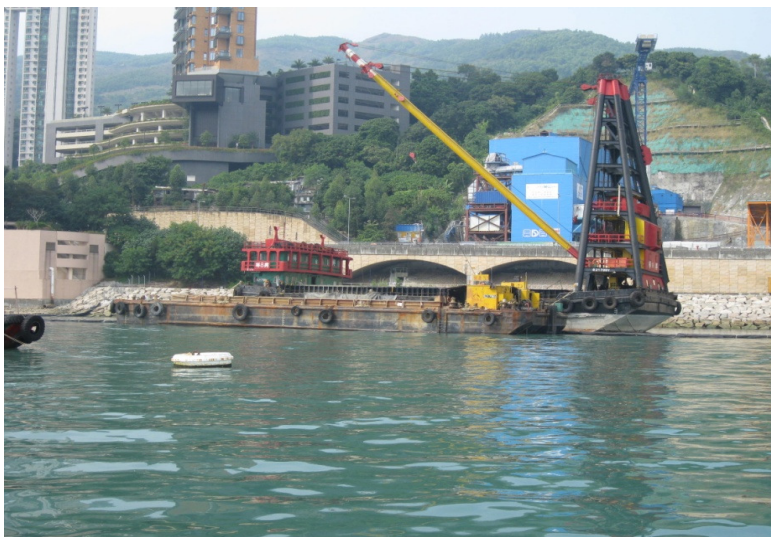
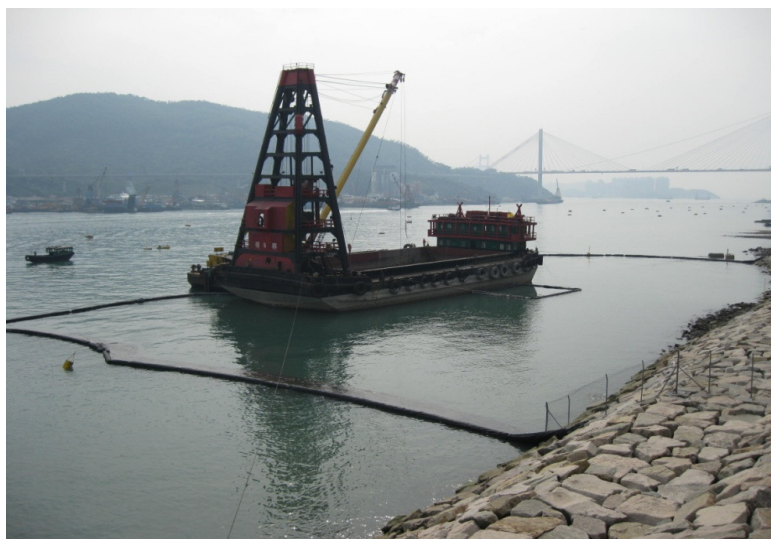
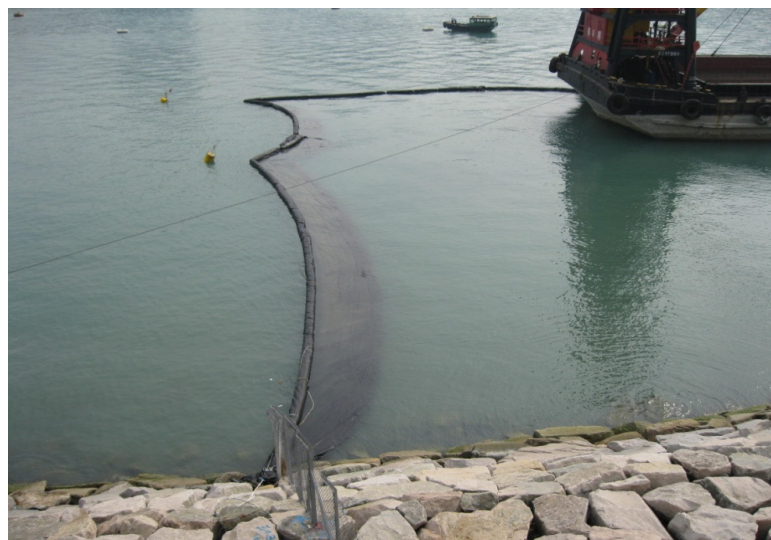
Photographic record for exceedance of Dissolved Oxygen (marine bottom) recorded at O-1(FT) on 03-Nov-10

Actions taken / to be taken	(1) Silt curtains had been provided along the dredging boundary line and extended from the seawater level to the bottom of seabed; (2) Frame-type silt curtains had been employed for the derrick barge and all dredging operation was confined in the frame-type silt curtain; (3) Closed grab had been used and the daily dredging rate was less than 960 m <sup>3</sup> ; (4) Sufficient slacks of silt curtains were allowed to ensure the curtains rested on the seabed to cope with waves and tides; (5) Condition of silt curtains had been checked by the on-board supervisor daily before any dredging activity; (6) Operator had been instructed to manoeuvre the grab with due care to prevent fast lifting out of the grab from the frame-type silt curtains.
Remarks	None

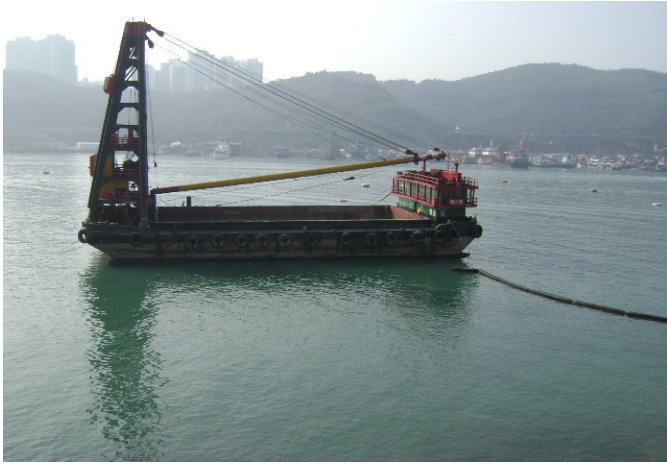
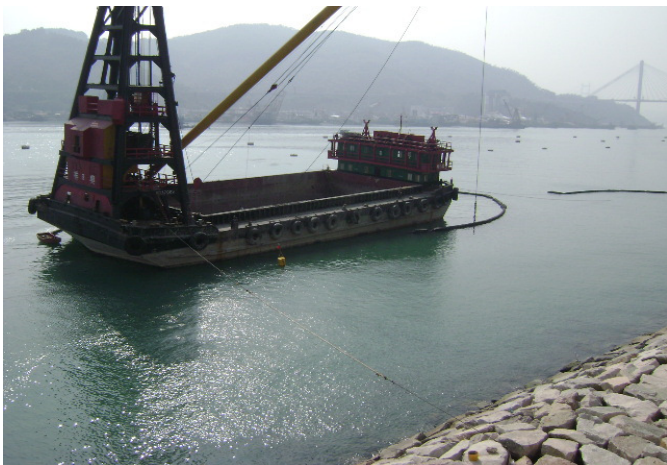
Photographic record for exceedance of Suspended Solids (SS) recorded at O-1(FT) on 19-Nov-10

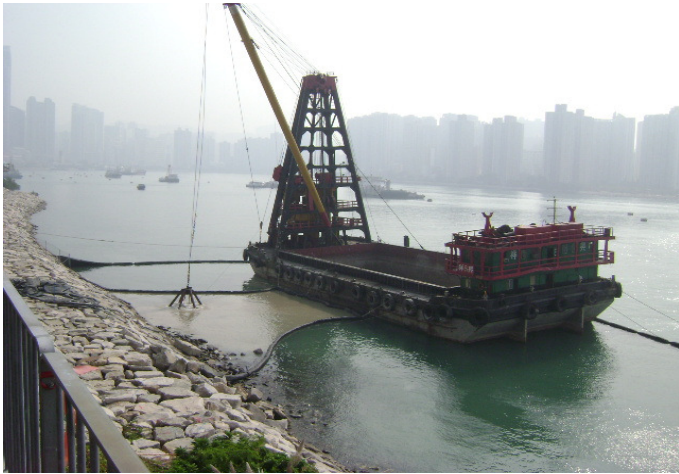
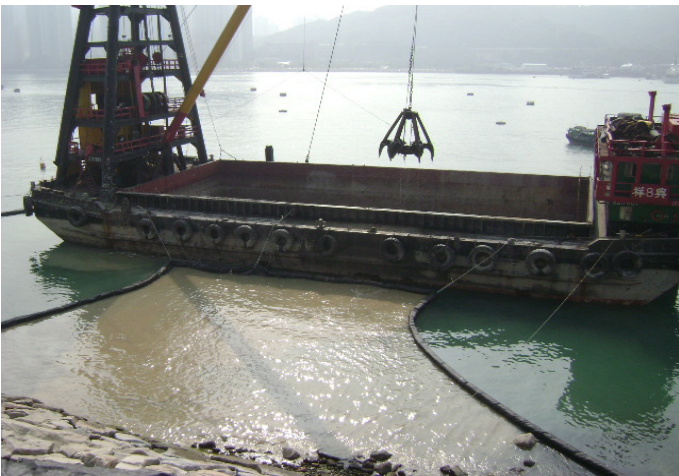
Photographic record for exceedance of Suspended Solids (SS) recorded at O-1(FT) on 22-Nov-10

Actions taken / to be taken	(1) Silt curtains had been provided along Portion E boundary line and extended from seawater level to the bottom of seabed; (2) frame / floating type silt curtains had been employed for the derrick barge; (3) rocks removal operation was confined in the inner (frame / floating type) silt curtain; (4) closed grab had been used and the daily dredging rate was less than 960 m <sup>3</sup> ; (5) Sufficient slacks of silt curtains were allowed to ensure the curtains rested on the seabed to cope with waves and tides; (6) condition of silt curtains had been checked by the on-board supervisor daily before any dredging activity; (7) operator had been instructed to manoeuvre the grab with due care to prevent fast lifting out of the grab from the frame-type silt curtains.
Remarks	None
