**Interim Notifications of Environmental Quality Limits Exceedances**

Incident Report on Action Level or Limit Level Non-compliance

Project	Tsuen Wan Drainage Tunnel
Date	15-Oct-10
Time	9:38 AM
Monitoring Location	Hong Hoi Chee Hong Temple (I-2)
Parameter	Turbidity
Action & Limit Levels	6.63/6.99
Measured Level	7.72
Possible reason for Action or Limit Level Non-compliance	A high turbidity level of 7.73 is recorded at Control Station (I-2-C)
Actions taken / to be taken	The measured turbidity level was above the Baseline Limit level and beyond the range of baseline turbidity concentration (2.17-7.08 NTU). Construction activities including General Site Cleaning & Housekeeping; Excavation and rock splitting at Vortex Drop Shaft; Excavation and rock splitting at Man Access Shaft; Pipe Jacking at Portion G; and Erect formwork and rebar fixing of pile caps at Portion G. No direct disturbance was observed from the site. Thus, the exceedance is considered to be natural variation and no action should be taken.
Remarks	Following mitigation measures were provided: (1) Waste water will be collected to Waste Water Treatment Plant and treat before discharge; (2) Existing Stream has been diverte

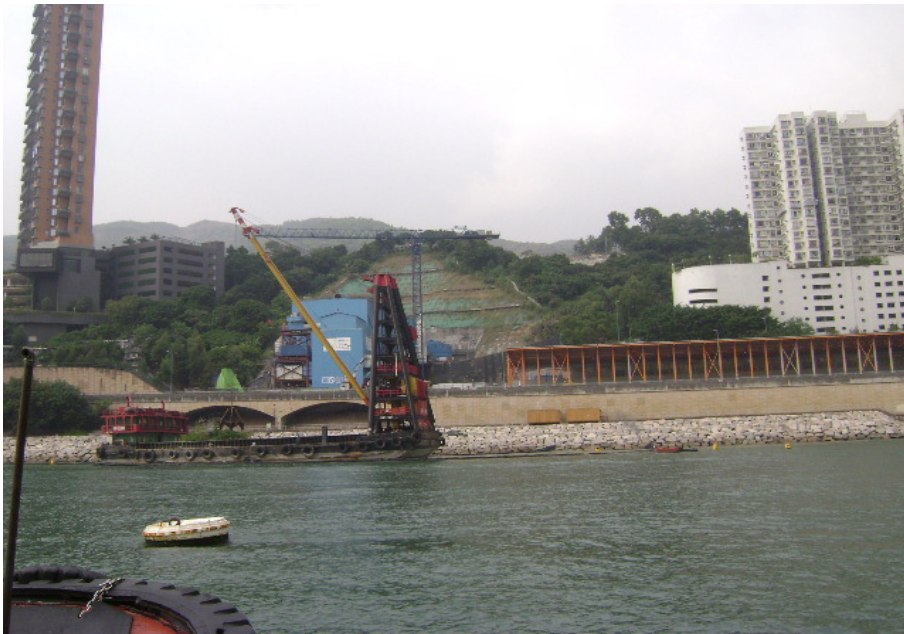
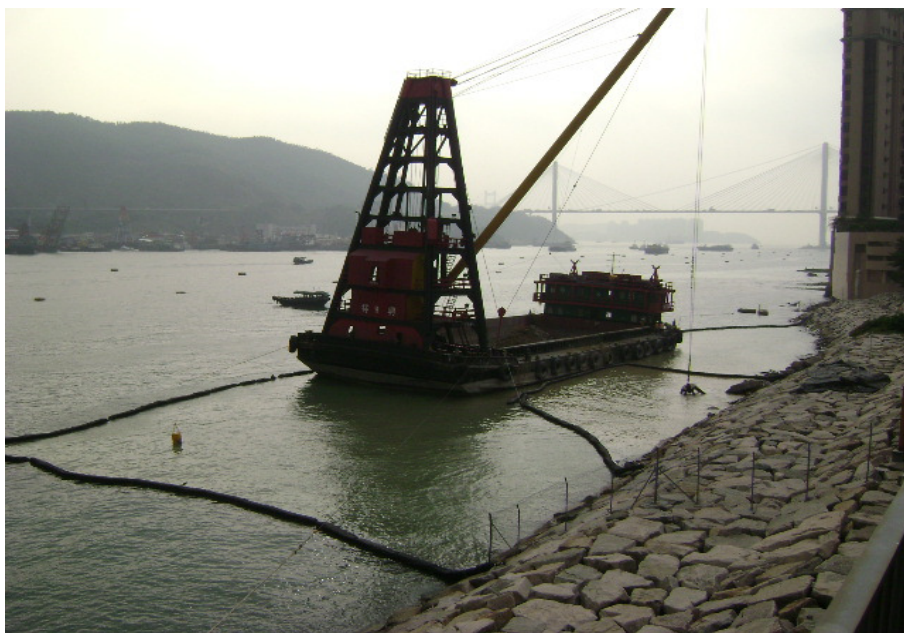
Photographic record for exceedance of Suspended Solids (SS) recorded at O-1(FT) on 24-Nov-10

Actions taken / to be taken	(1) Silt curtain had been provided along the Portion E boundary line and extended from seawater level to the bottom of seabed; (2) Frame / floating type silt curtain had been employed for the derrick barge and rocks removal operation was confined in the inner (frame / floating type) silt curtain; (3) Sufficient slacks of silt curtains were allowed to ensure the curtains rested on the seabed to cope with waves and tides; (4) condition of silt curtains had been checked by the on-board supervisor daily before any marine works activity; (5) operator had been instructed to manoeuvre the grab with due care to prevent fast lifting out of the grab from the inner (frame / floating type) silt curtains; (6) and closed grab had been used for dredging operation and the daily dredging rate was limited to less than 960 m <sup>3</sup> .
Remarks	None

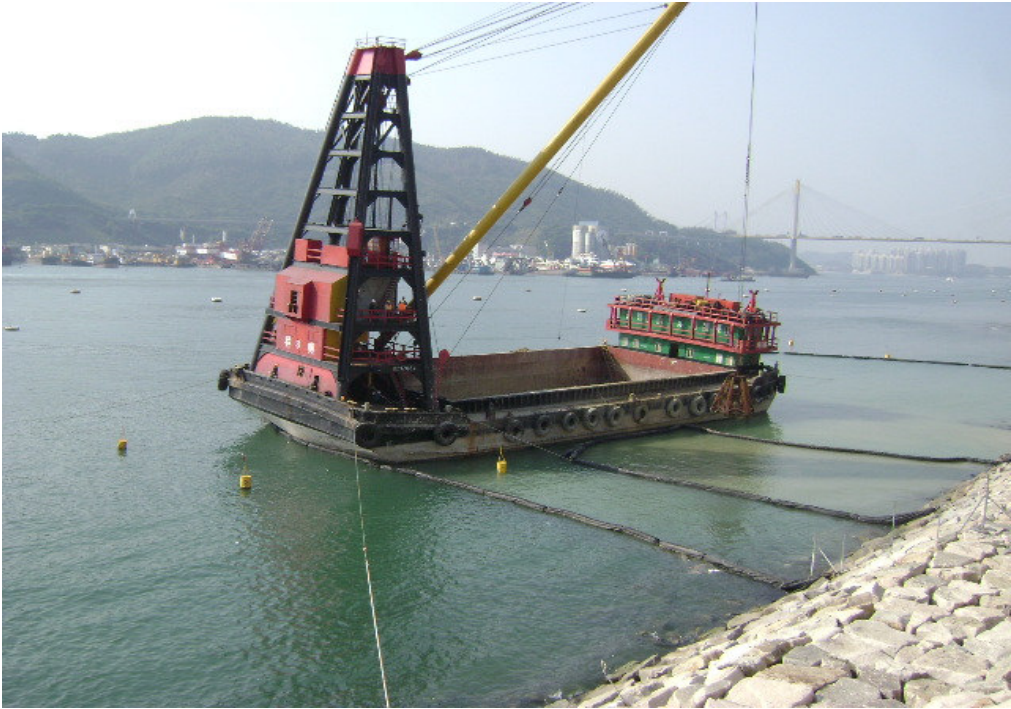
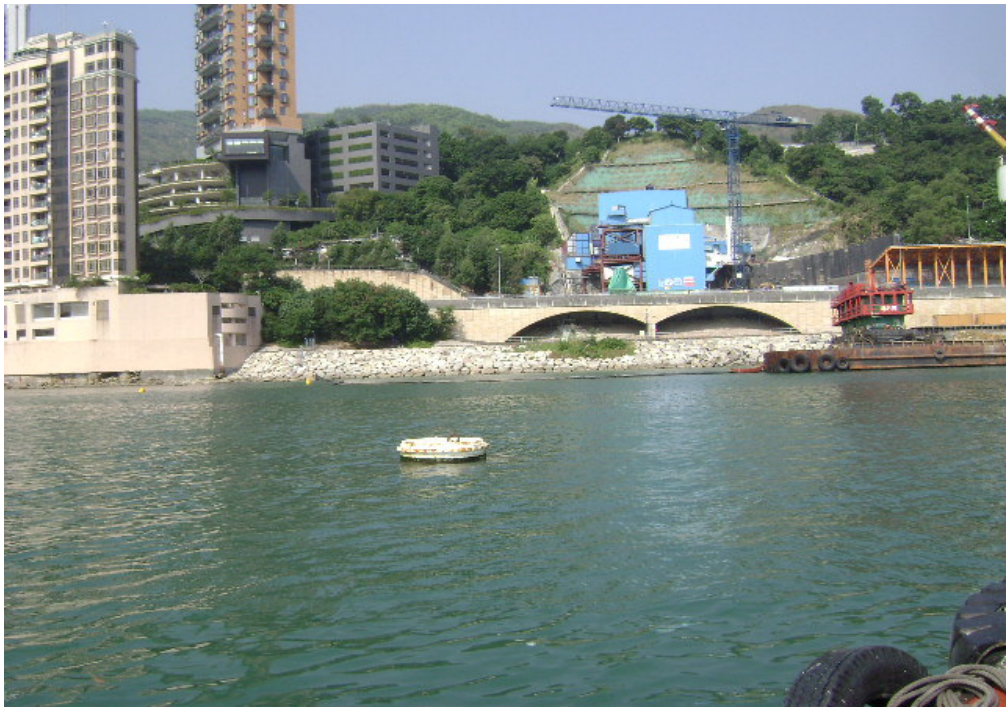
Photographic record for exceedance of Suspended Solids (SS) recorded at O-1(FT) on 26-Nov-10

Actions taken / to be taken	(1) Silt curtain had been provided along the Portion E boundary line and extended from seawater level to the bottom of seabed; (2) Frame / floating type silt curtain had been employed for the derrick barge and rocks removal operation was confined in the inner (frame / floating type) silt curtain; (3) Sufficient slacks of silt curtains were allowed to ensure the curtains rested on the seabed to cope with waves and tides; (4) condition of silt curtains had been checked by the on-broad supervisor daily before any marine works activity; (5) operator had been instructed to manoeuvre the grab with due care to prevent fast lifting out of the grab from the inner (frame / floating type) silt curtains; (6) and closed grab had been used for dredging operation and the daily dredging rate was limited to less than 960 m <sup>3</sup> .
Remarks	None

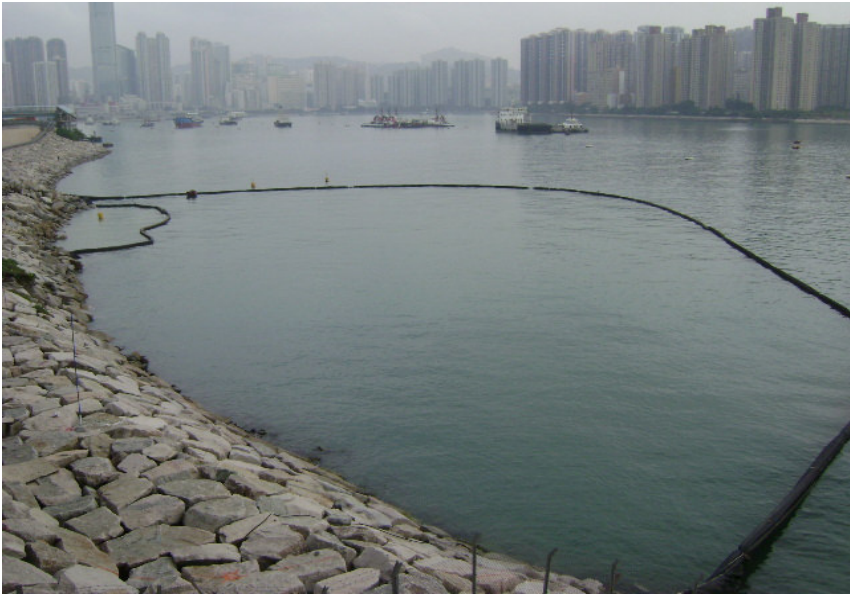
Site photo

**Photographic record for exceedance of Suspended Solids (SS) recorded at O-1(ET) on 13-Dec-10**

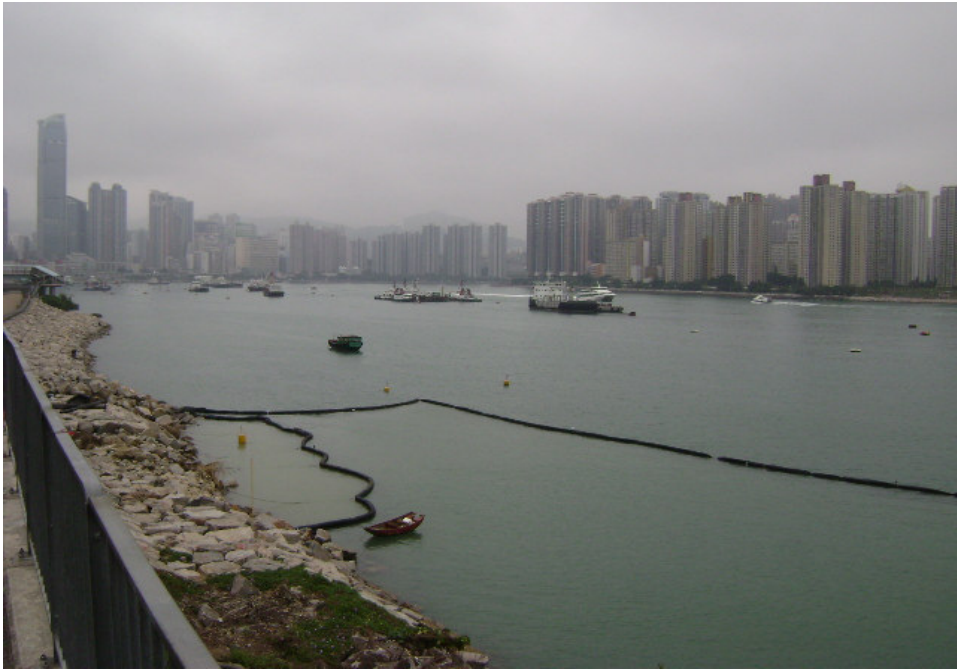
Site photo

**Photographic record for exceedance of Suspended Solids (SS) recorded at O-1(FT) on 15-Dec-10**

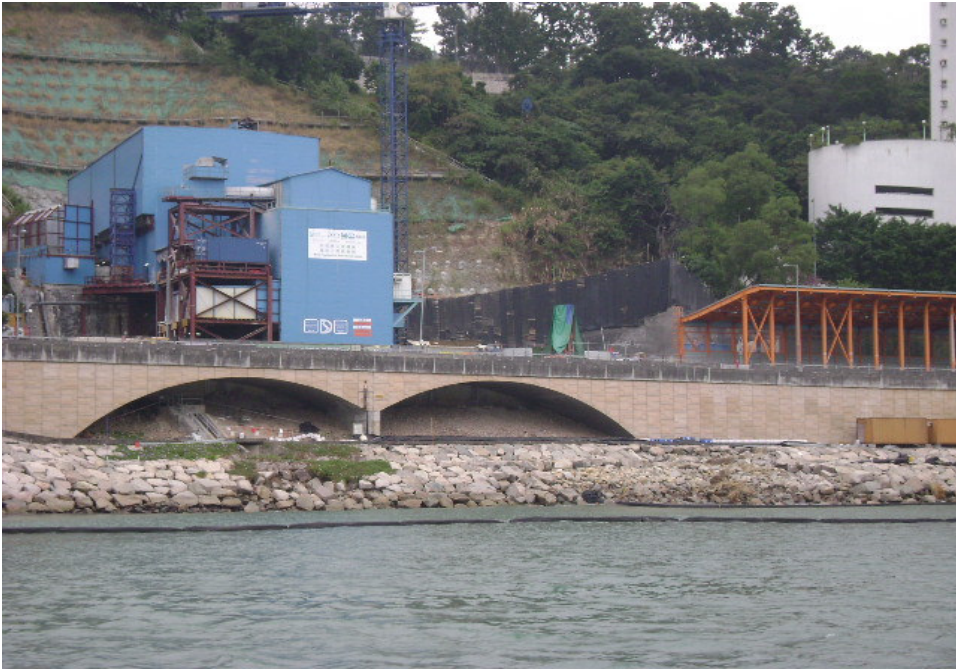
Site photo

Photographic record for exceedance of Suspended Solids (SS) recorded at O-1(ET) on 15-Dec-10

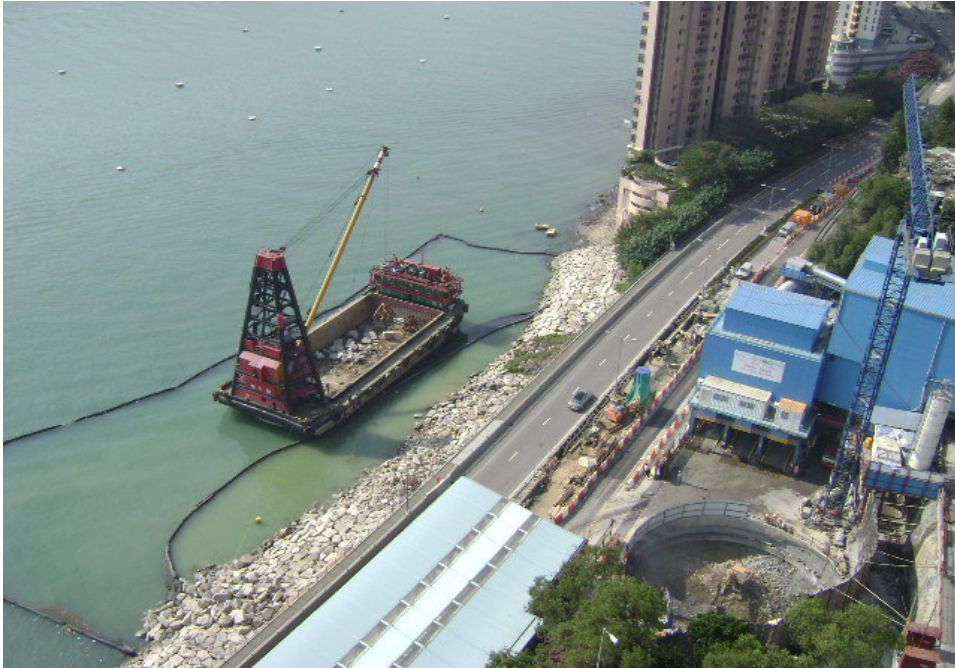
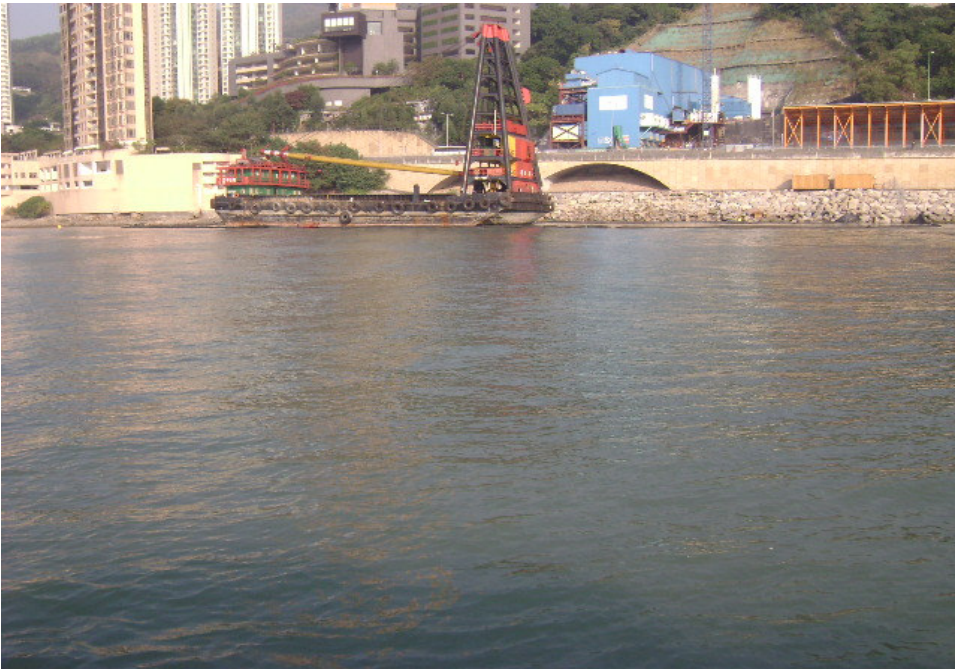
Photographic record for exceedance of Suspended Solids (SS) recorded at O-1(FT) on 22-Dec-10

Actions taken / to be taken	(1) Silt curtain was provided along the Portion E boundary line and extended from seawater level to the bottom of seabed; (2) Floating type silt curtain had also been employed at the inner side; (3) Sufficient slack of silt curtain was allowed to cope with the wave and tidal action to ensure the curtains (outer and inner) were rested on seabed; and (4) Condition of silt curtains had been checked by the supervisor daily prior to marine works operation.
Remarks	None

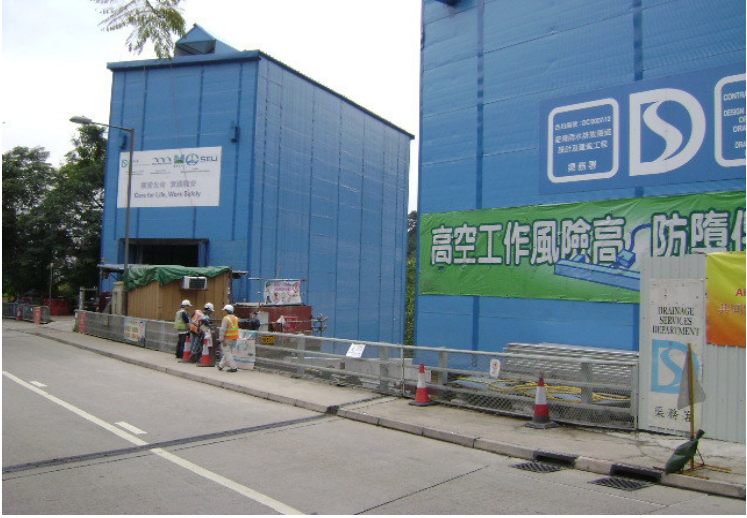
Site photo

**Photographic record for exceedance of Suspended Solid recorded at Hong Hoi Chee Hong Temple (I-2) on 24-Dec-10**

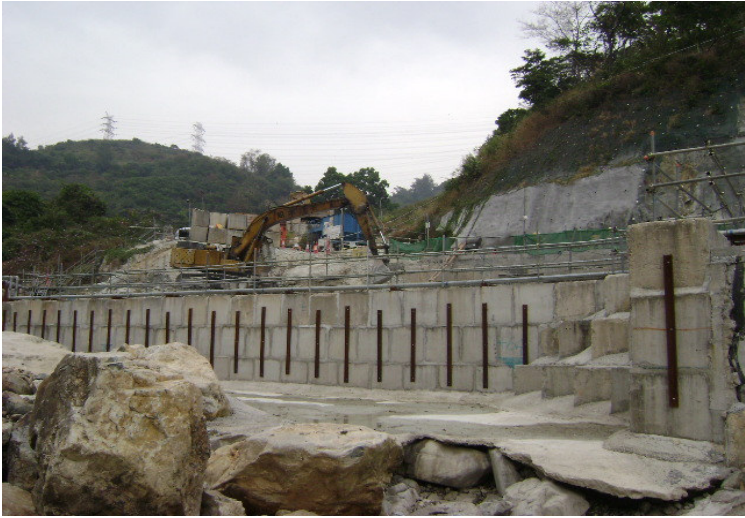
Site photo

Photographic record for exceedance of Suspended Solid recorded at Squatters (I-3) on 24-Dec-10

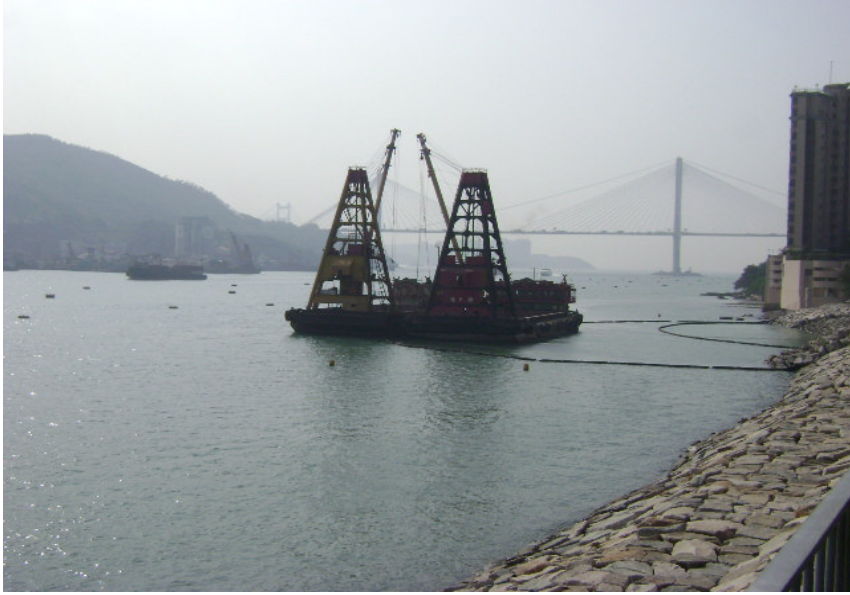
Site photo

**Photographic record for exceedance of Suspended Solids (SS) recorded at O-1(ET) on 24-Dec-10**

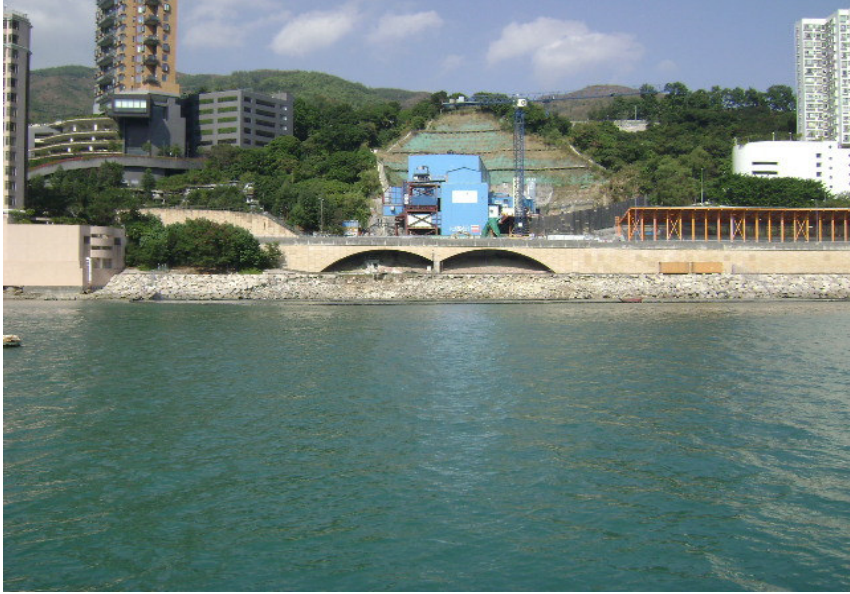
Site photo

**Photographic record for exceedance of Suspended Solids (SS) recorded at O-1(FT) on 29-Dec-10**

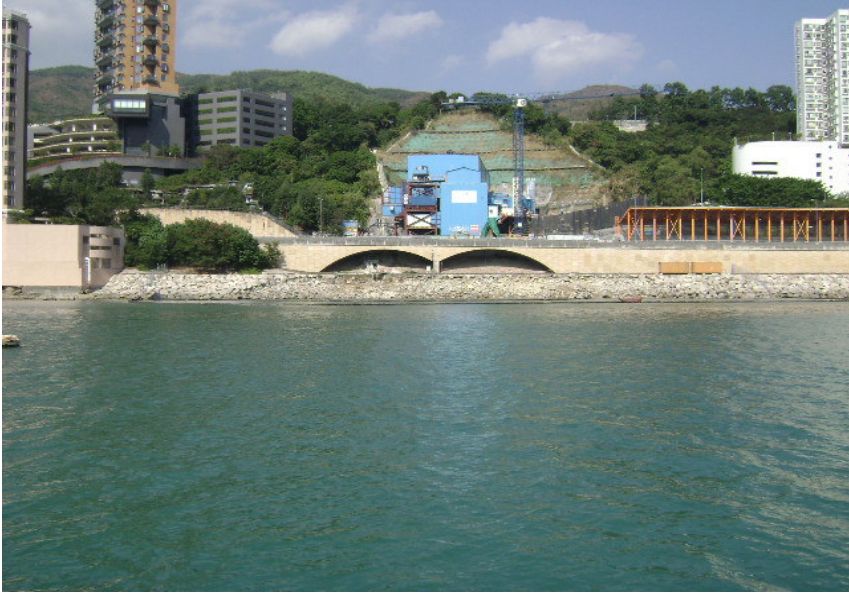
Site photo

**Photographic record for exceedance of Suspended Solids (SS) recorded at O-1(ET) on 29-Dec-10**

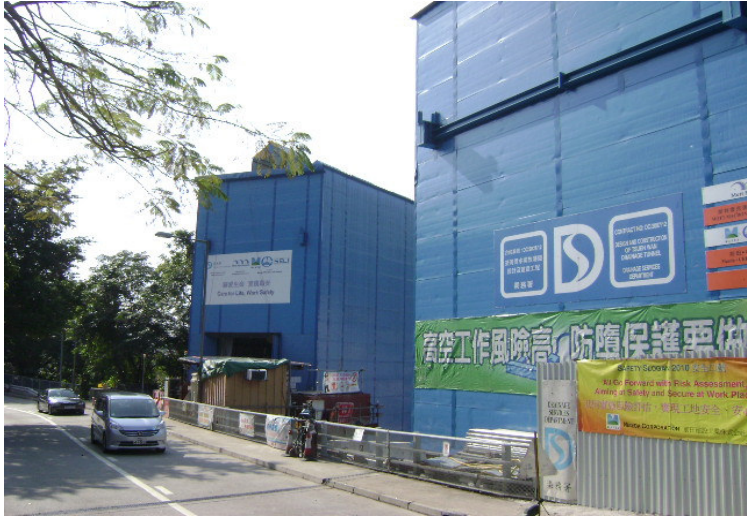
Site photo

**Photographic record for exceedance of Suspended Solid recorded at Hong Hoi Chee Hong Temple (I-2) on 31-Dec-10**
