VCAB Compliance Checklist Item 5: Landscaping Design Aesthetic (5.2)

VCAB Compliance Checklist Item 5: Landscaping Design Life cycle costing (5.3)

Sustainability (5.4) – Right plant at the right place

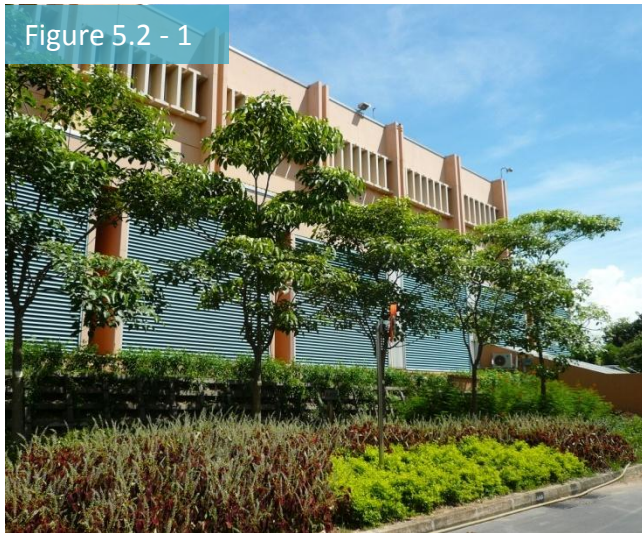
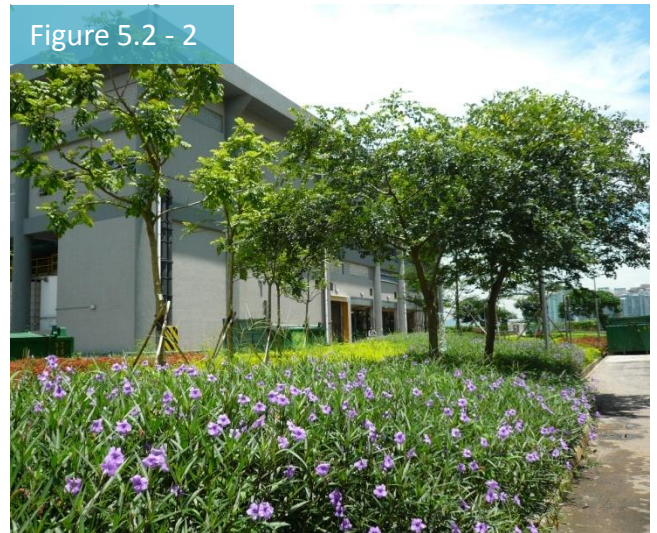
Fig. 5.2 - 1 & 2

- Sha Tin Sewage Treatment Works (STW) occupies an area of 28 hectares and is open to public during DSD Open Day and group visits by appointment.
- **Landscape theme: Four Seasons Planting** with a welcoming atmosphere for visitors and a comfortable environment for staff.

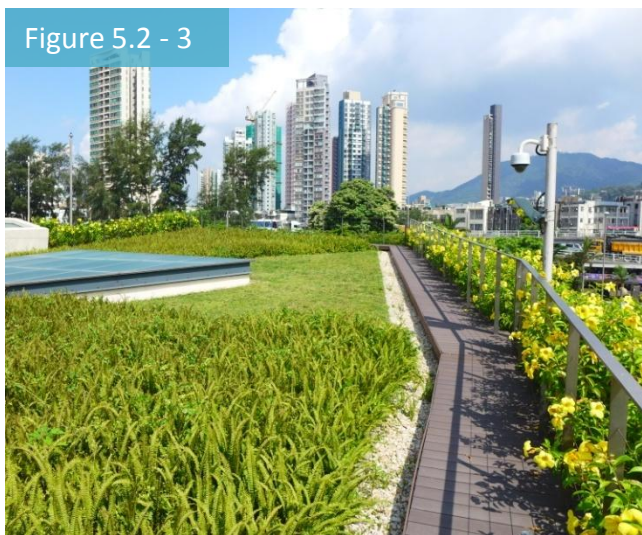
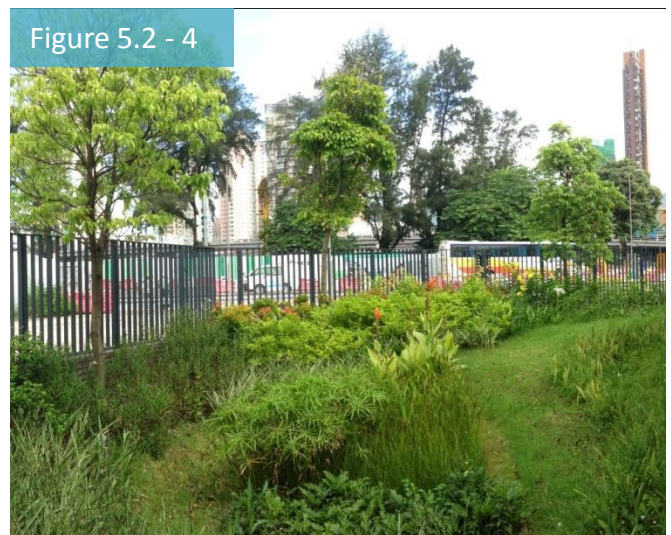
Fig. 5.2 - 3 & 4

- Kowloon City Sewage Pumping Station (SPS) No. 2 occupies an area of 2000m² with a green ratio over 50% and has achieved a BEAM Plus Platinum Rating.
- **Landscape theme: Green Oasis** with native plants to attract wildlife and enhance biodiversity and low maintenance plants to suit the unmanned site.
- For projects involving facilities with a **high green ratio**, sufficient recurrent cost should be earmarked at the funding stage. Early engagement of a maintenance team allows **reservation of appropriate resources for future maintenance**.

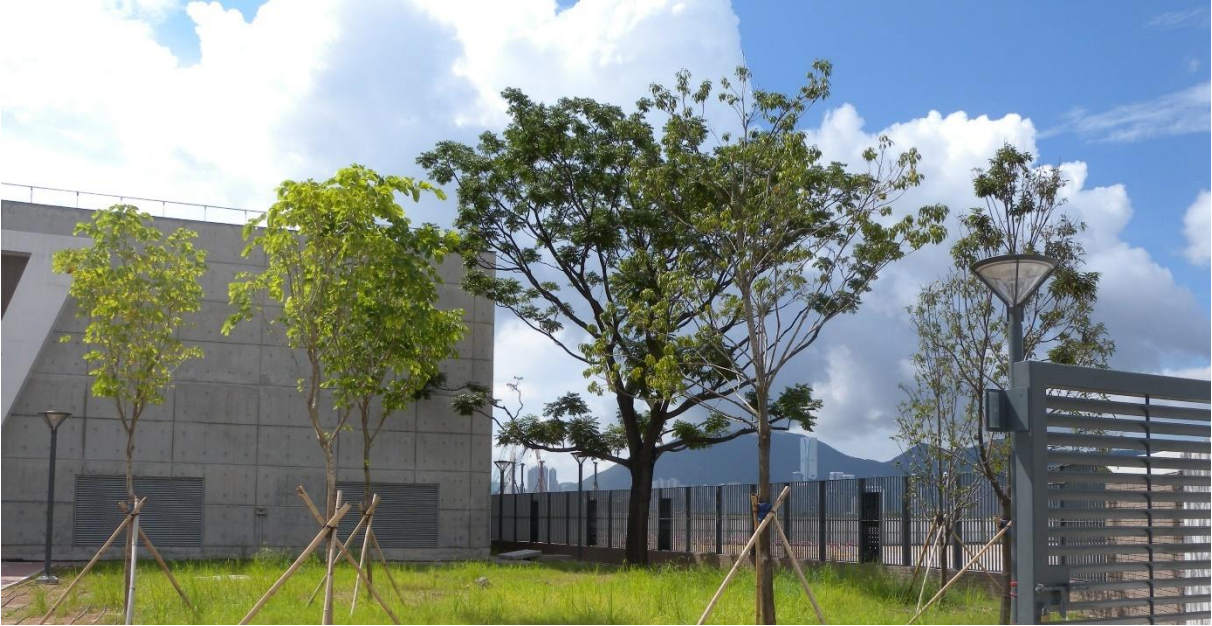
Fig. 5.2 - 5

- Consideration is given to preserve existing mature trees/tree groups on site for the sense of place and instant greening effect.

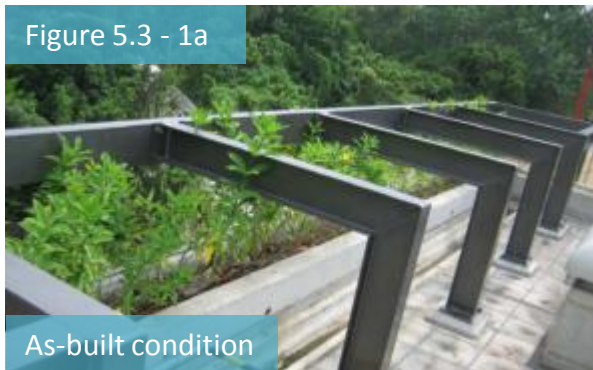
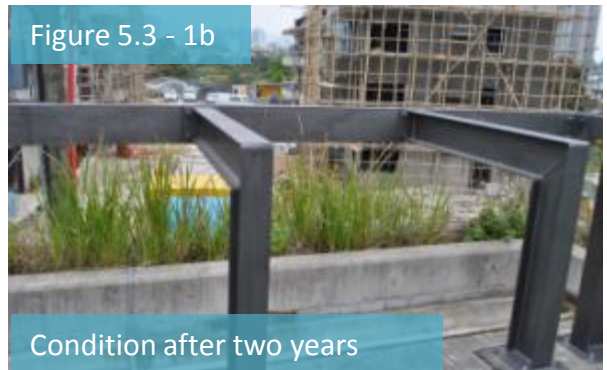
Fig. 5.3 - 1a & 1b

As-built condition

Condition after two years

- Narrow planters (less than 450mm wide and deep) along the roof edge do not provide sufficient soil mass for sustainable plant growth and should be avoided.
- Two years after installation, the plants in narrow planters perform poorly due to insufficient soil depth.

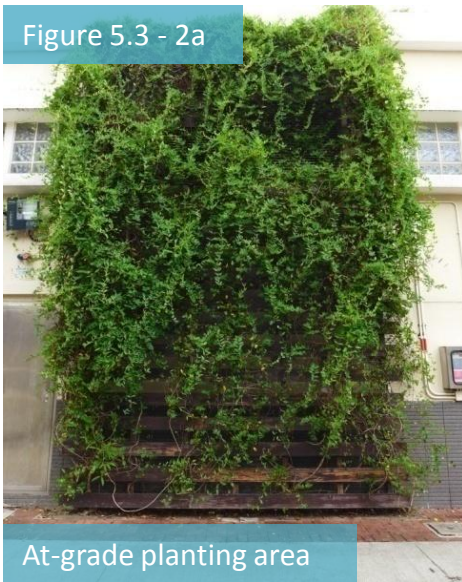
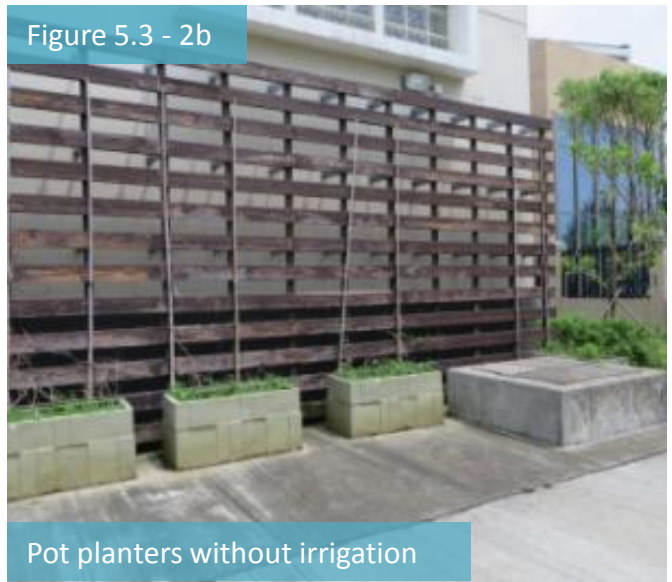
Fig. 5.3 - 2a & 2b

At-grade planting area

Pot planters without irrigation

- The figures show the performance of climbers in two different types of planters in an unmanned site without automatic irrigation after two years of handover. Climbers in the at-grade planting area (Fig. 5.3 - 2a) still perform very well, whereas those in pot planters died (Fig. 5.3 - 2b). At-grade planting areas have deeper soil to retain more moisture for sustainable plant growth. Plants in pot planters usually die due to limited soil mass and moisture.
- Plants in raised up planters/pot planters perform well only with sufficient soil depth and irrigation (Fig. 5.3 - 3 & 4).

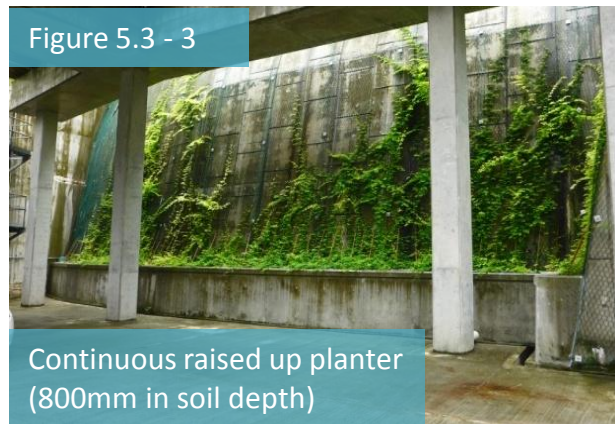
Figure 5.3 - 3

Continuous raised up planter (800mm in soil depth)

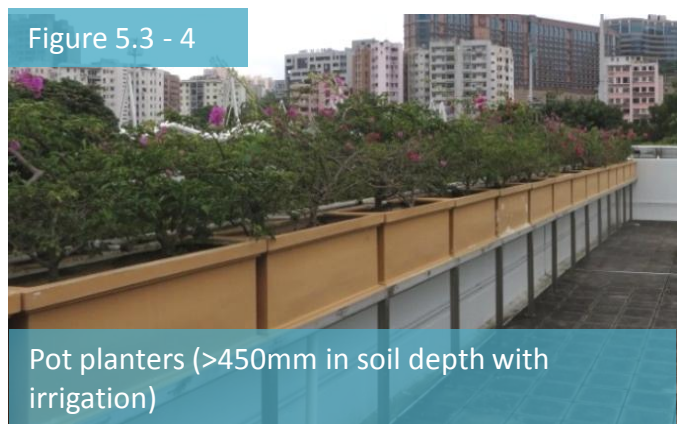
Figure 5.3 - 4

Pot planters (>450mm in soil depth with irrigation)

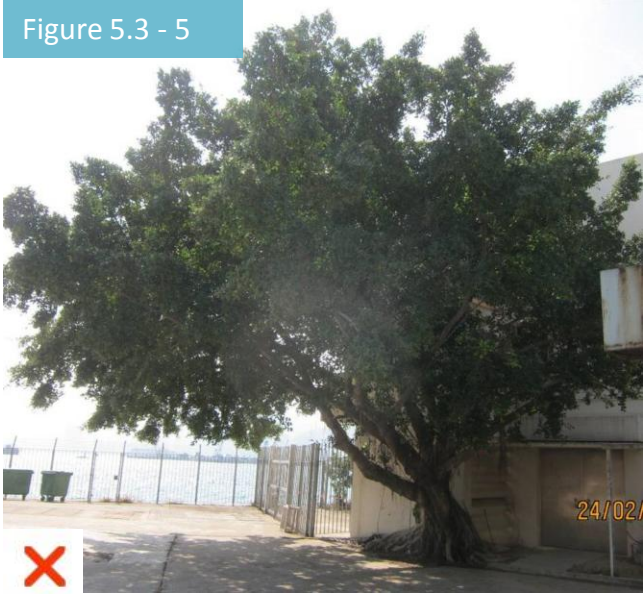
Figure 5.3 - 5

Fig. 5.3 - 5
Tree species with large mature size (e.g. *Ficus* trees) should not be planted next to the building/boundary as they tend to lean towards the light and become lopsided. Their aggressive root systems may also affect the building structure.

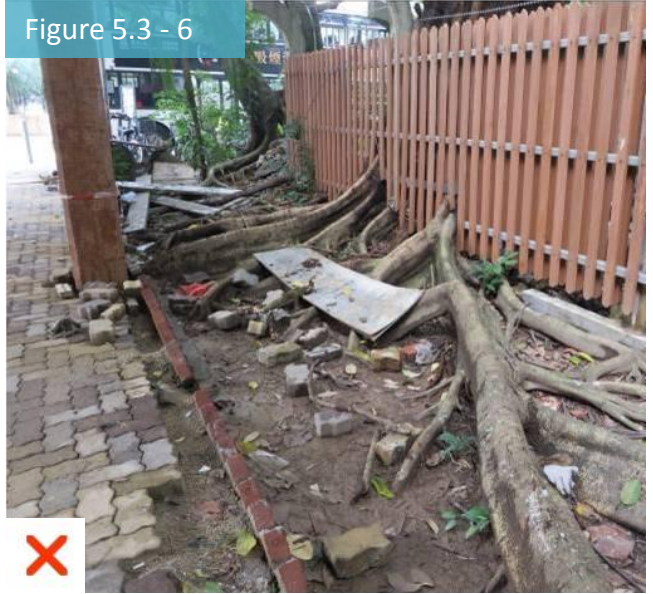
Figure 5.3 - 6

Fig. 5.3 - 6
Tree species with vigorous root systems (such as *Ficus spp.*, *Delonix regia*, etc.) should not be planted at the boundary edge/narrow planter/pit as their roots may twist and become unstable, or cause pavement uplifts or damage to the adjacent property.

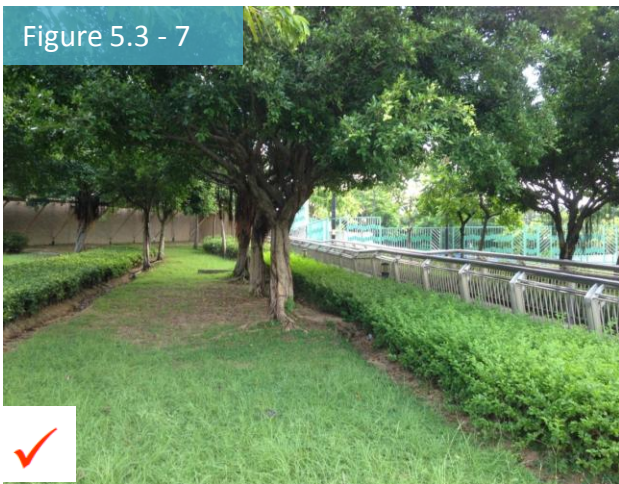
Figure 5.3 - 7

Fig. 5.3 - 7
Tree species with large mature size (e.g. *Ficus spp.*, *Delonix regia*, etc.) should be planted in locations where sufficient spacing and setback from the building are allowed for sustainable tree growth.

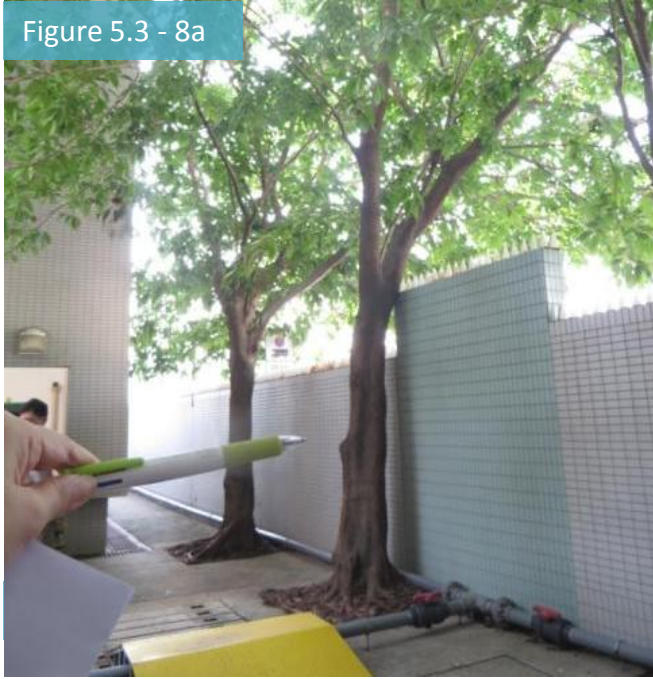
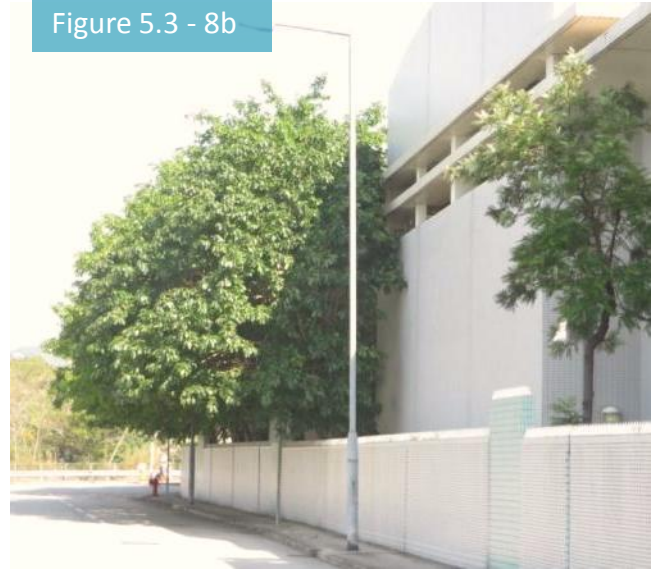
Fig. 5.3 - 8a & 8b are examples of trees planted right beside the wall and pipes. Some day either the wall and pipes or trees will be damaged/have to be removed.

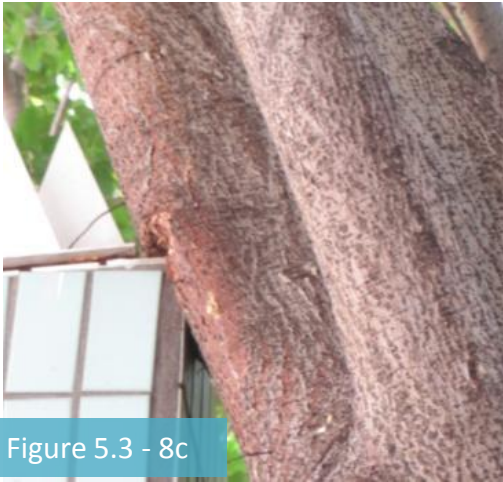
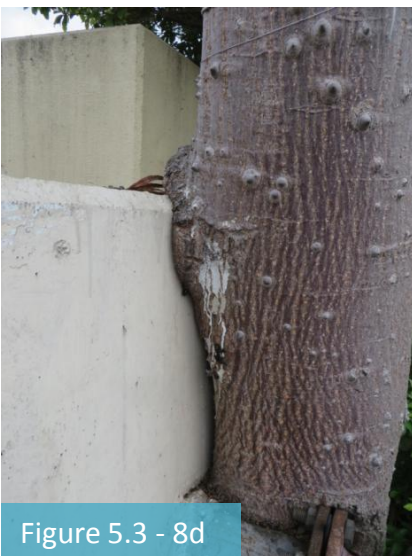
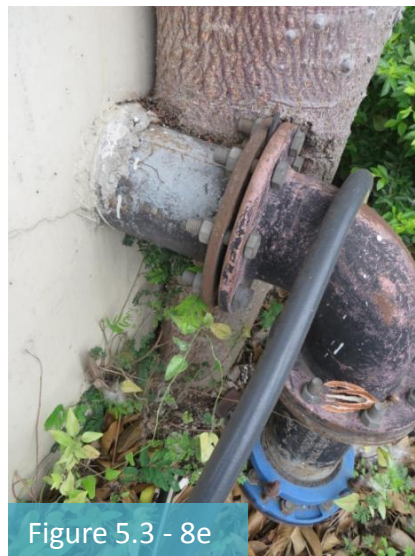
Fig. 5.3 - 8c to 8e show how the trees were damaged by the too-close building/utilities.

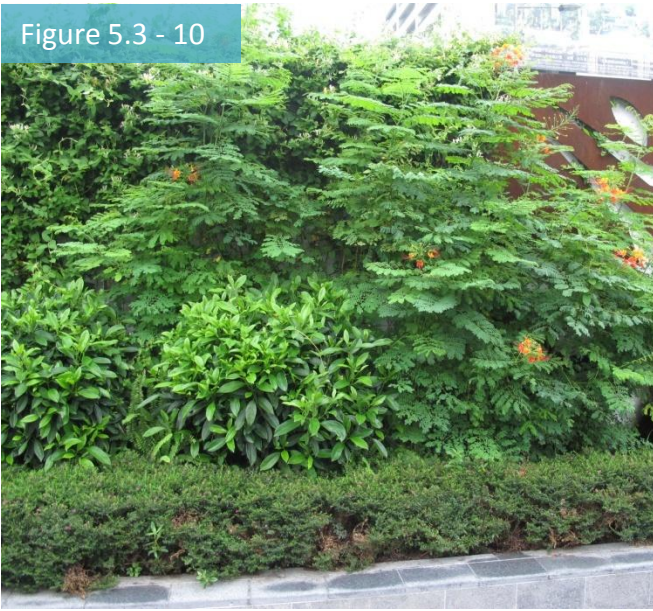
Figure 5.3 - 10

Fig. 5.3 - 10 to 12 are some appropriate planting designs for narrow planters (i.e. 800 to 1500mm wide **open bottom planters**) adjoining the building/boundary wall/fence.

- i) tall shrubs (e.g. *Caesalpinia pulcherrima* in Fig. 5.3 - 10) mixed with vertical greening;
- ii) short bamboos (e.g. *Bambusa ventricosa* in Fig. 5.3 - 11); and
- iii) small to medium size palm trees (e.g. *Chrysalidocarpus lutescens* in Fig. 5.3 - 12) may be considered.

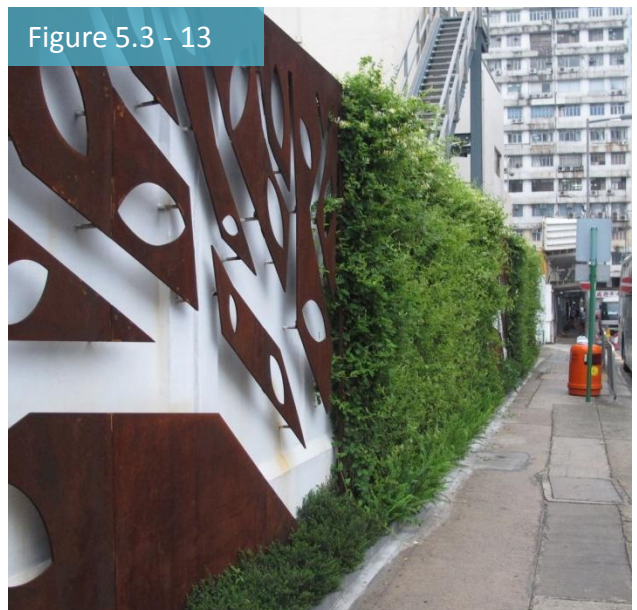
Figure 5.3 - 13

Planters along the wall/fence should be 300 to 500mm wide. Fig. 5.3 - 13 shows a good example of vertical greening with a climber species (*Lonicera japonica*) on mesh system with an **open bottom planter** of 300mm wide.

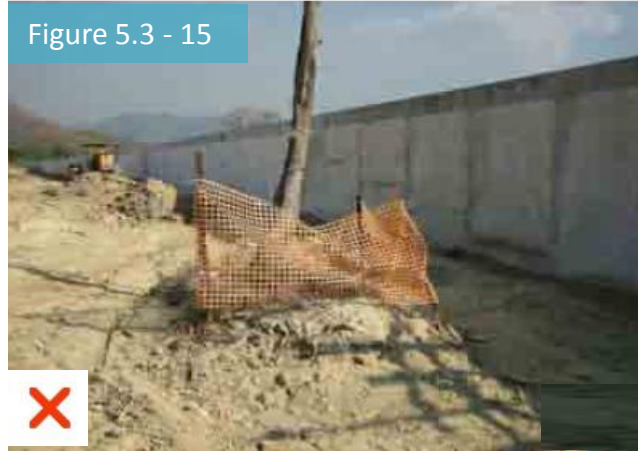
Fig. 5.3 - 15

Orange mesh is not an acceptable tree protection fence.

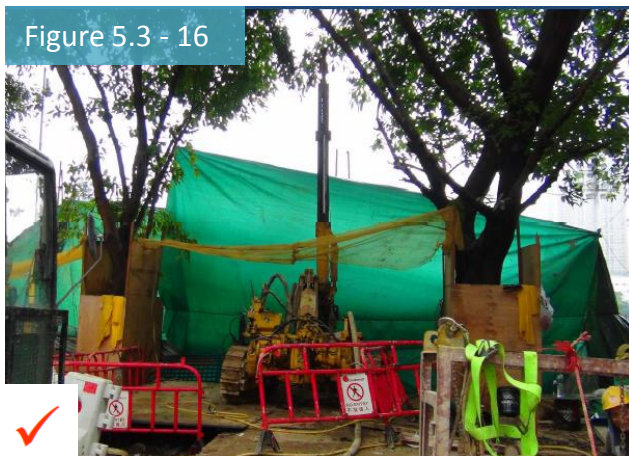
Fig. 5.3 - 16

Works within the tree dripline shall be avoided.

If inevitable, planks shall be erected around the tree trunk and sand bags and steel plates laid on roots as temporary protection for trees.

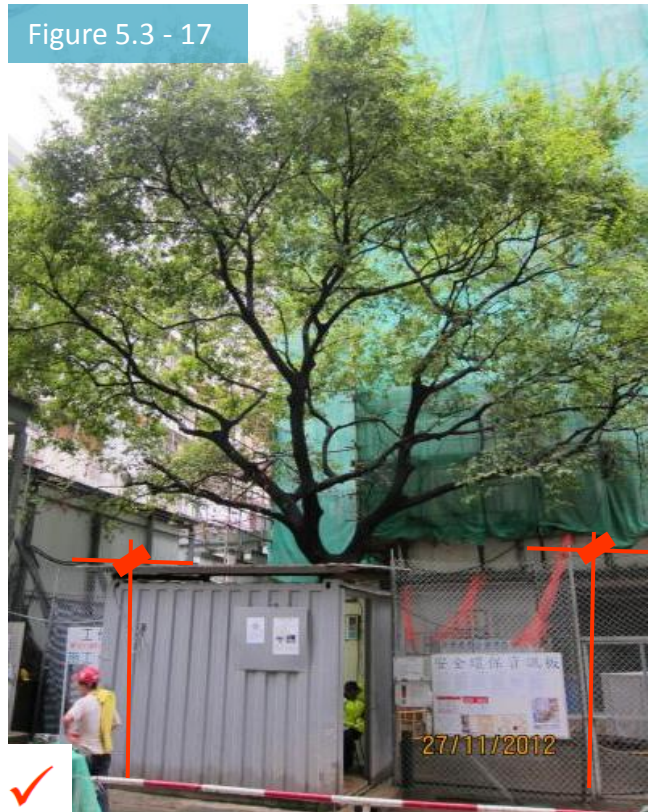
Fig. 5.3 - 17

A sturdy fence with high grade steel mesh and posts shall be put up to protect the preserved tree at the construction site entrance.

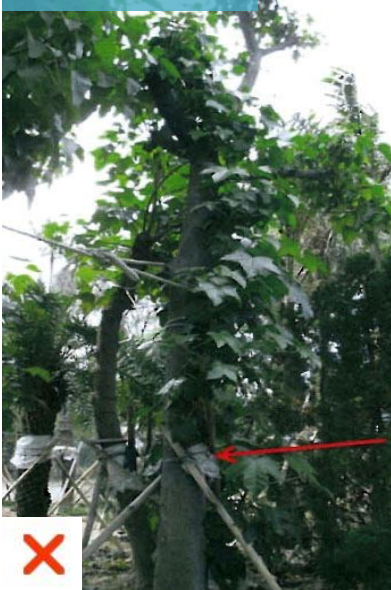
Figure 5.3 - 18a

Fig. 5.3 - 18a
Tall trees shall not be transplanted off-site, as it will require extensive pruning and greatly reduce their amenity value.

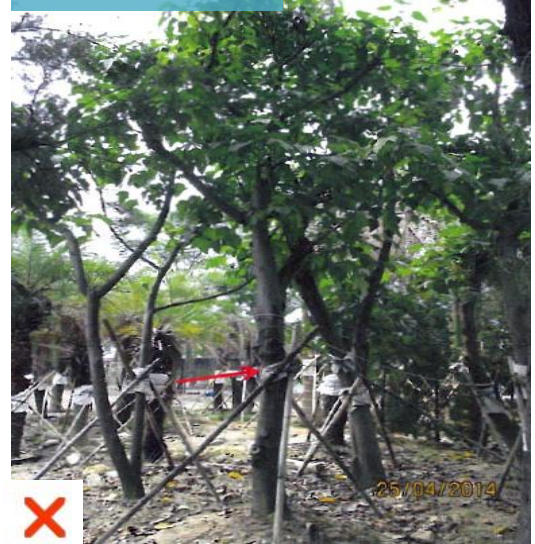
Figure 5.3 - 18b

Fig. 5.3 - 18b
Transplanted trees at the holding nursery shall not be:

- topped/deformed;
- too close without sufficient space and sunlight for growth; and
- with rootballs directly sitting on the ground.

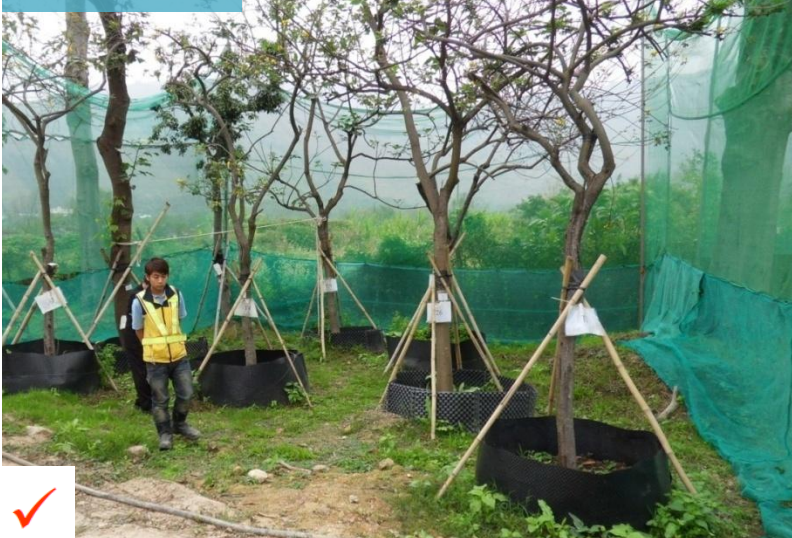
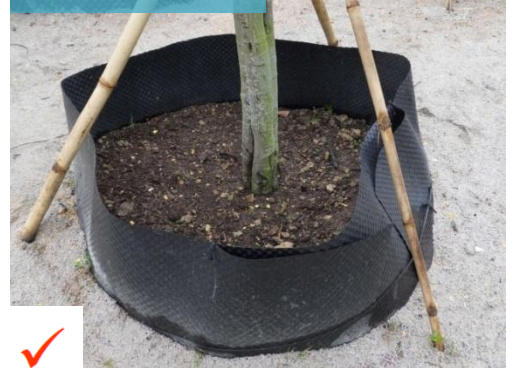
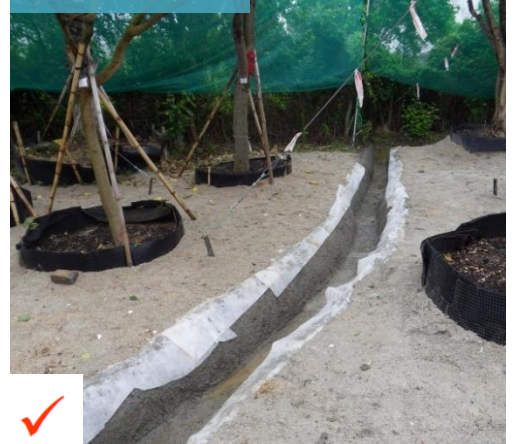
Fig. 5.3 - 19a to 19c
Proper setup of the holding nursery can help reduce impacts on tree health. Sufficient space for tree growth and proper drainage shall be provided. Rootball wrap shall allow room for root growth and free drainage. Wrapping materials shall not encourage root girdling. Mulch shall be applied to prevent weed growth.

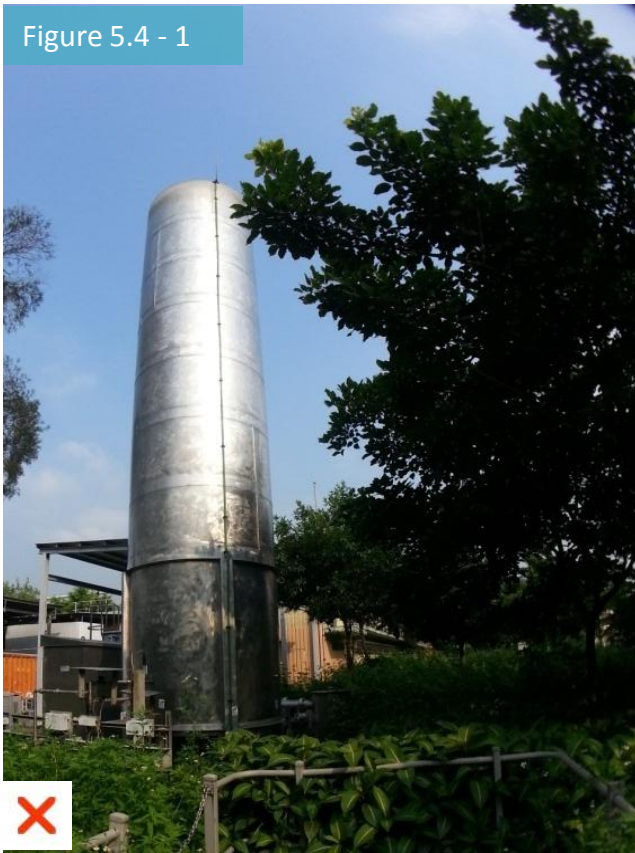
Figure 5.4 - 1

- Fast growing trees with large crown size (e.g. *Ficus elastic*) should not be planted near biogas burners and other electrical and mechanical (E&M) installations liable to produce sparks.

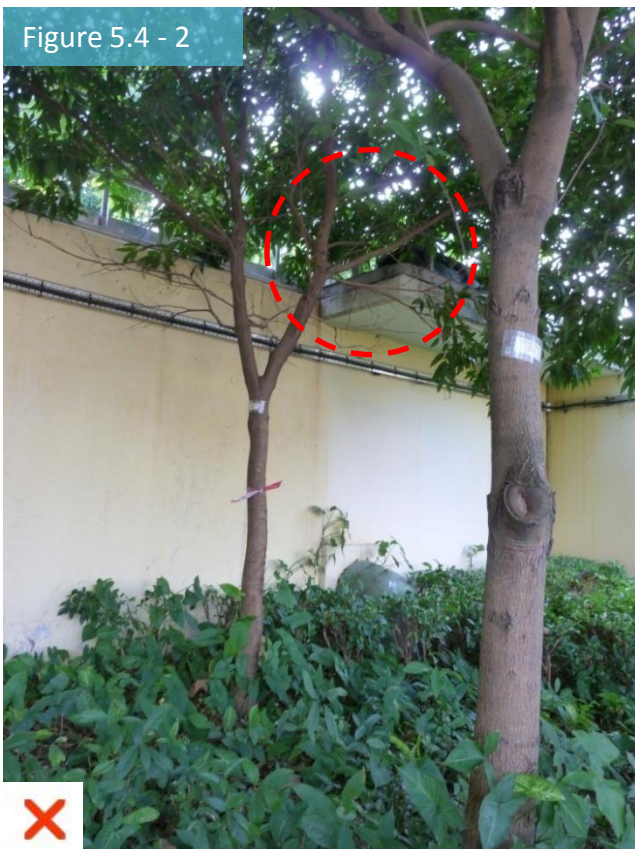
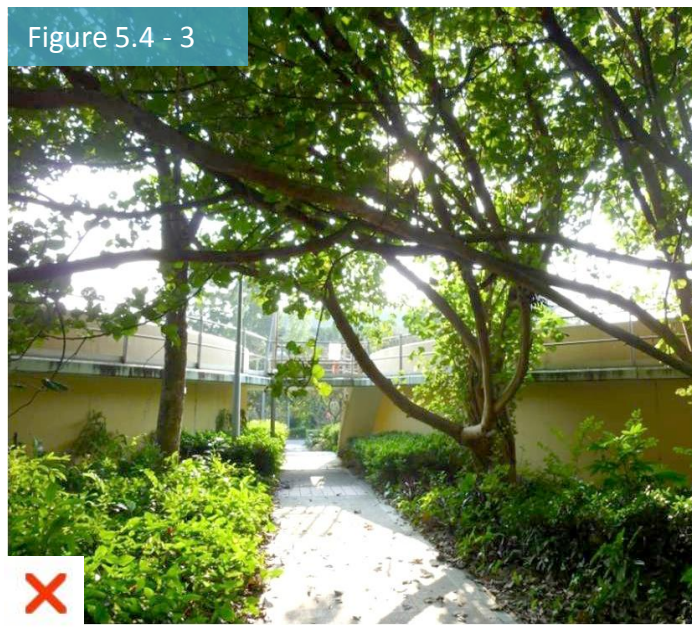
Fig. 5.4 - 2 & 3

- Trees should be provided with sufficient space/setback from the building for growth.
- Trees should not be planted adjacent to any open sedimentation tank as broken branches may fall into the tank and disrupt its operation.
- Low branching trees (e.g. *Hibiscus tiliaceus*/*Macaranga tanarius*) should not be planted alongside any maintenance access as they require frequent pruning to keep the path unobstructed.

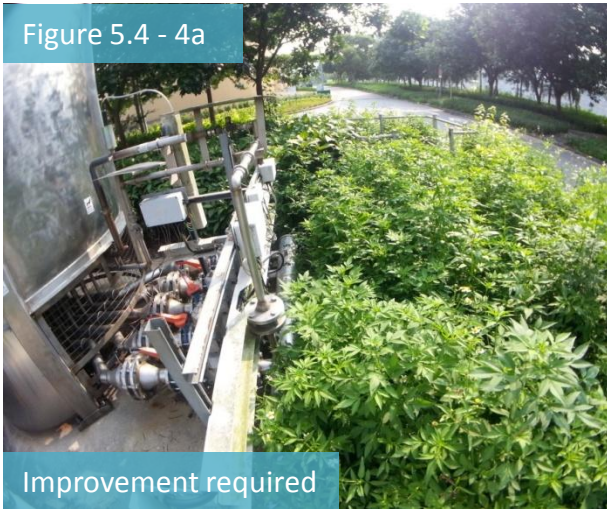
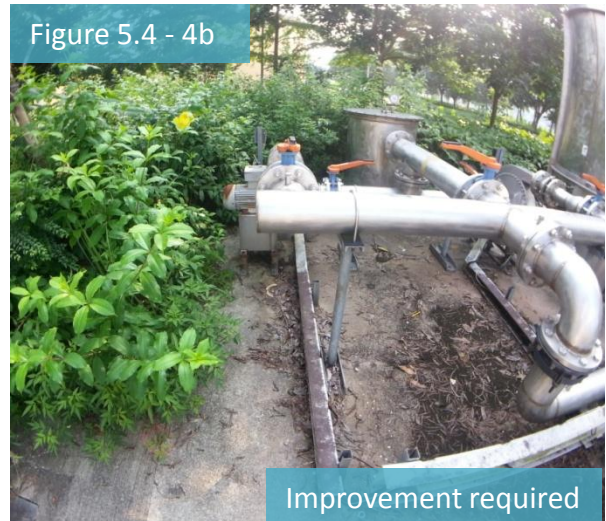
Fig. 5.4 - 4a & 4b

Plants should not be planted right next to E&M installations given the high fire risk and that maintenance access should be provided for E&M equipment inspection and repair works.

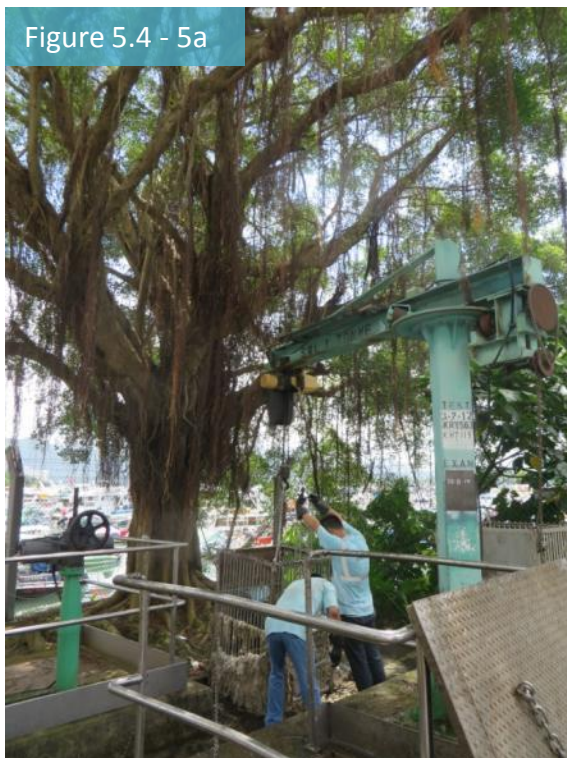
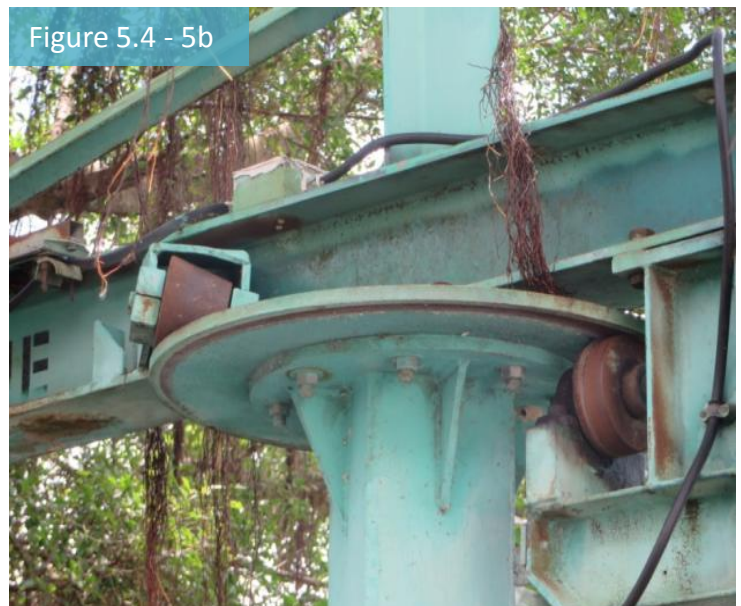
Fig. 5.4 - 5a & 5b

In siting the plant equipment, preserved trees should be taken into account. Lifting equipment should not be located under a Ficus tree as it requires frequent pruning, otherwise the aerial roots may twist around the lifting arm and affect its operation.

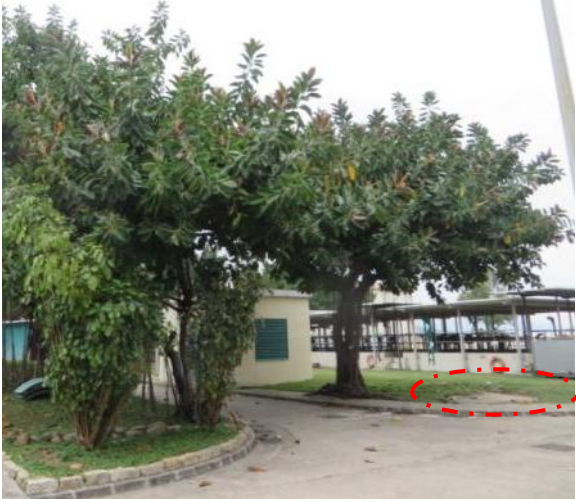
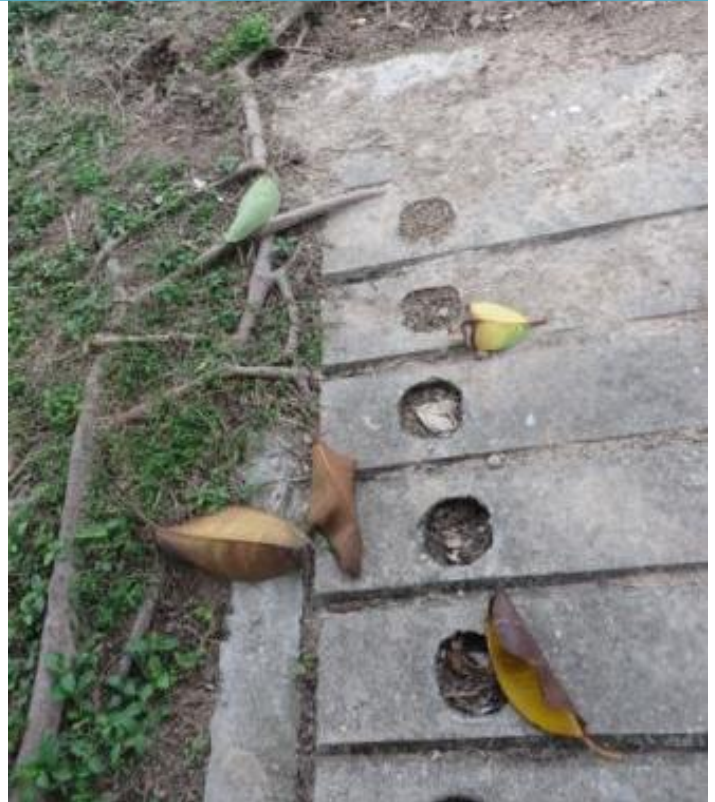
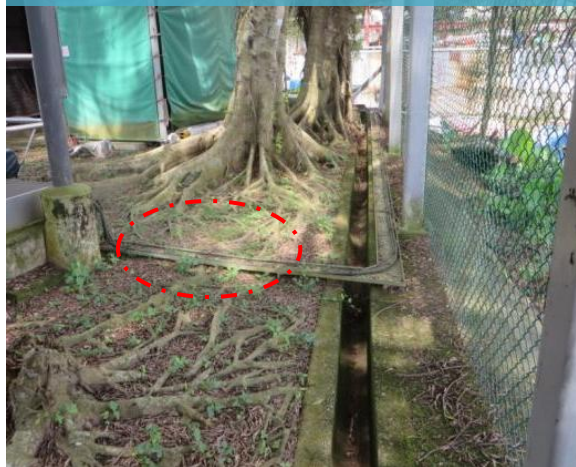
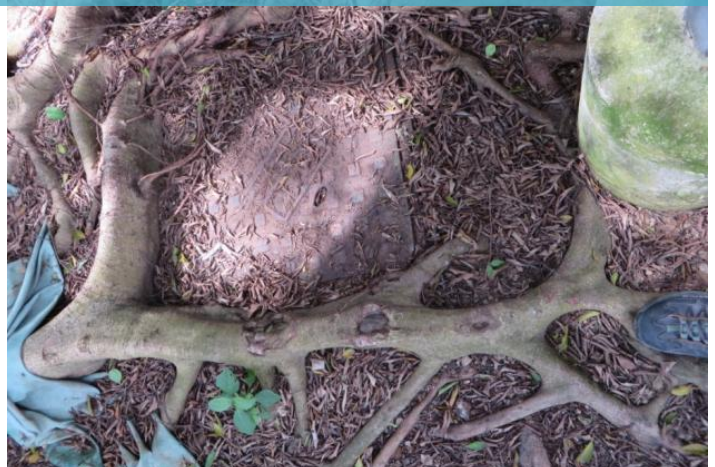
Fig. 5.4 - 6a & 6b

Planting Ficus species and other tree species with aggressive root systems next to utilities is not recommended. Also, siting new utilities adjoining preserved/newly planted trees with aggressive root systems should be avoided.

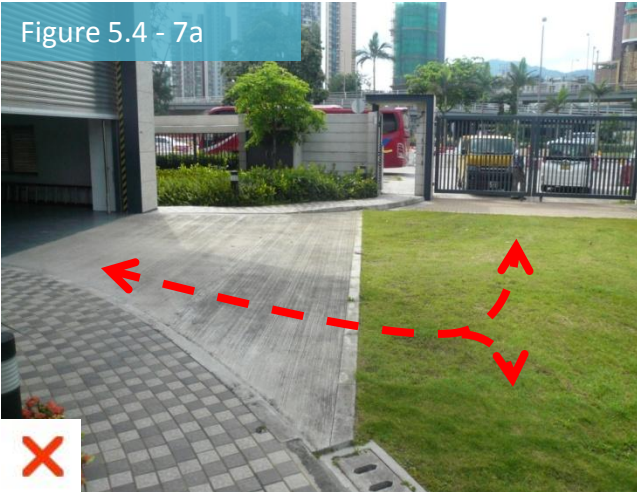
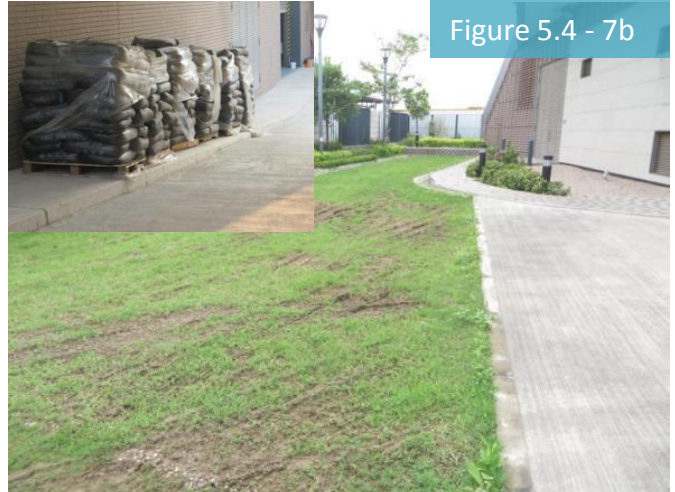
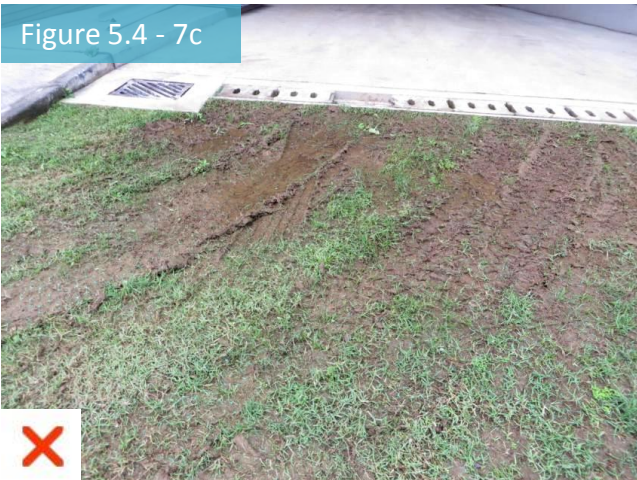
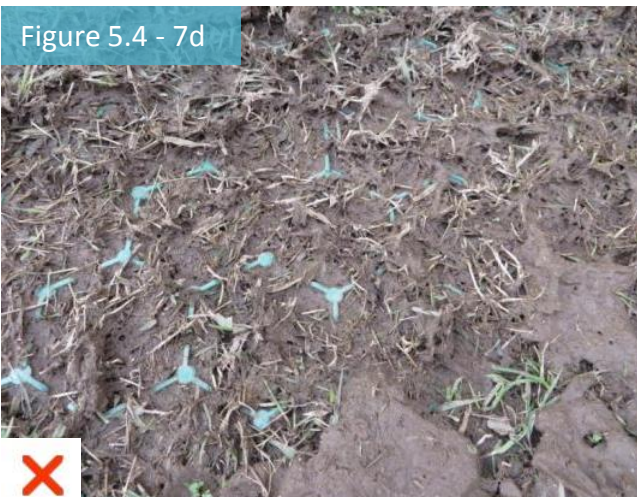
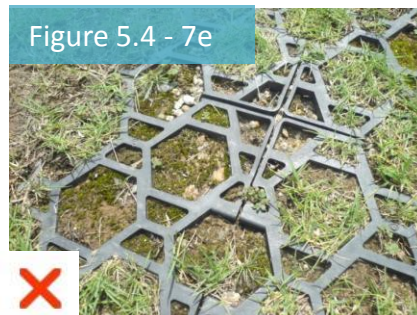
Fig. 5.4 - 7a to 7e show two examples of proprietary grass pavement at frequently used vehicular access. For frequently used vehicular access to, e.g. inlet screen, proprietary grass pavement system is not recommended and hard paved surface is preferred.

Grass surface is slippery and may cause hazard, especially at a sloping location and when carrying out emergency maintenance under adverse weather conditions.

Vehicles carrying sludge from inlet screen in SPS remove patches of grass in every ride after heavy rain. The grass does not have sufficient time for recovery or re-establishment after replacement and thus the green coverage cannot be maintained.

For any incorporation of green infrastructure elements, consider sustainability including but not limited to its functionality, maintenance cost and safety concern. Before finalizing the design, consult the maintenance team.

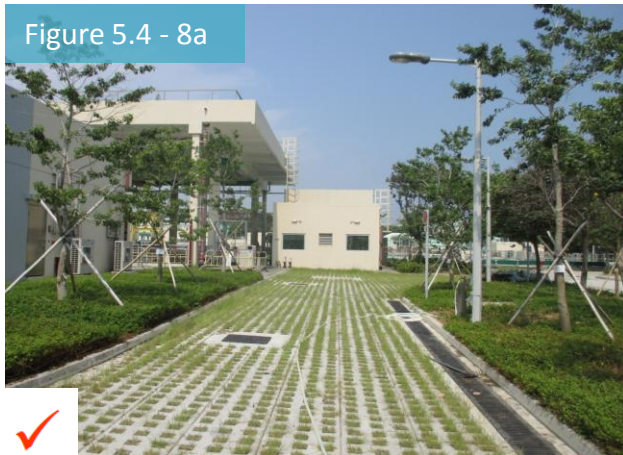
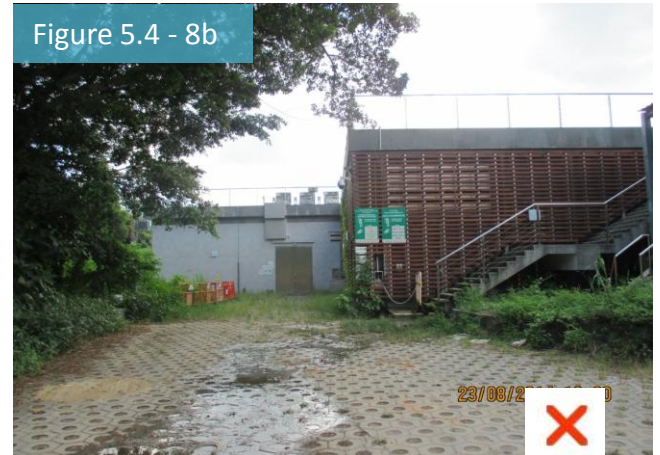
The performance of grasscrete at low-use and sunny maintenance access (Fig. 5.4 - 8a) is much better than that in main entrance and shady areas (Fig. 5.4 - 8b).

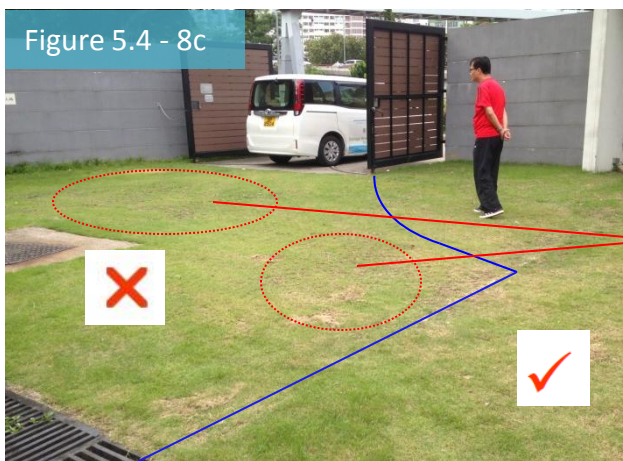
Fig. 5.4 - 8c
Grass pavement for entrances and exits is not recommended, as daily access by contract cars will compact the soil and impede grass growth. The concerned area will be hard paved.

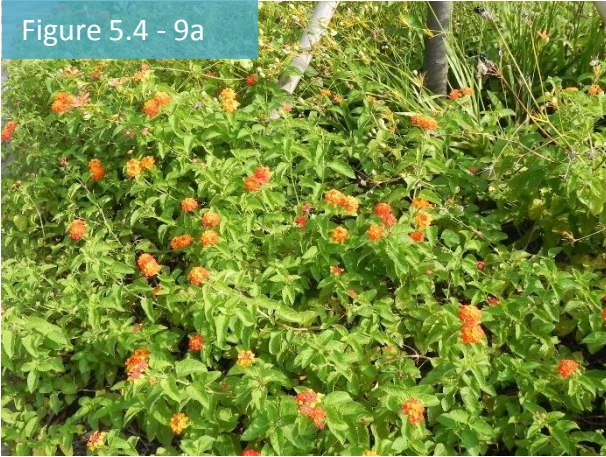
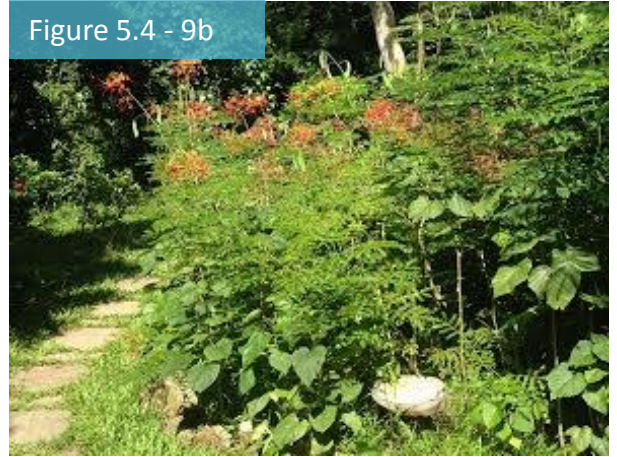
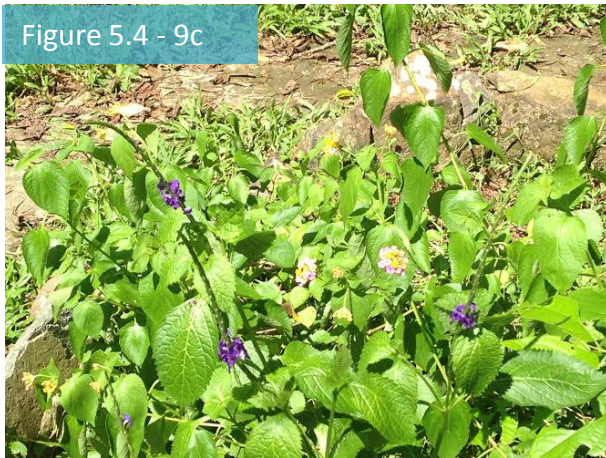
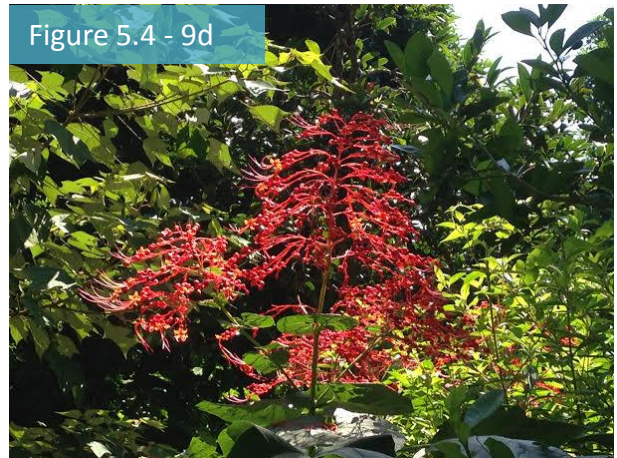
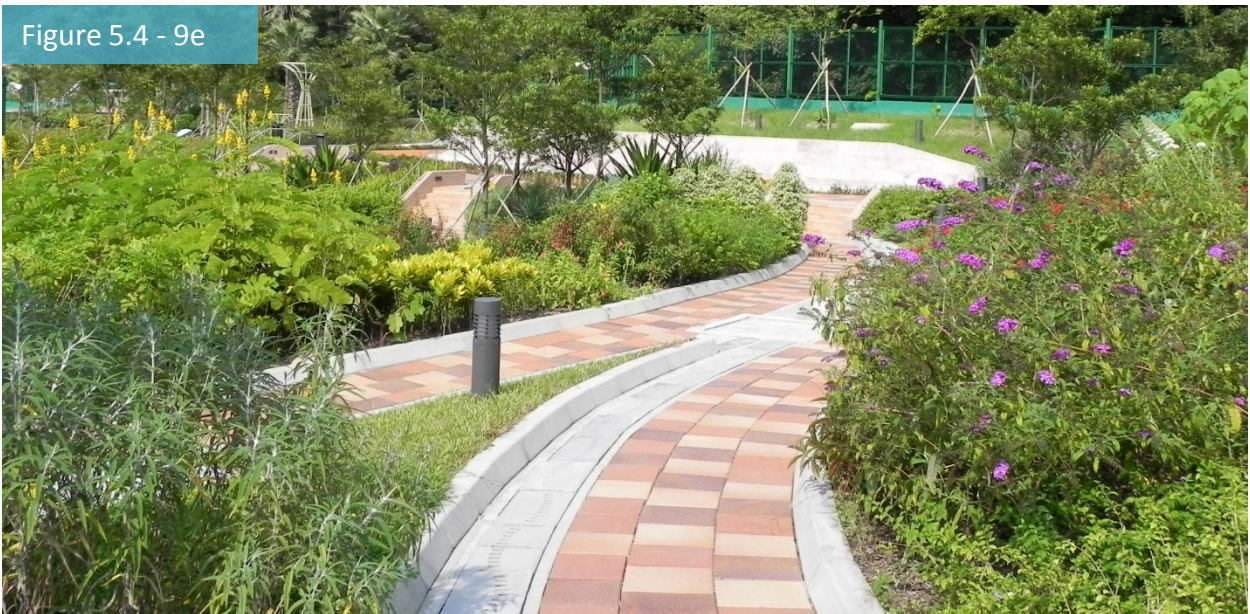
Fig. 5.4 - 9a to 9e

Native species and wildlife attracting plants shall account for more than 60% of the vegetation in total. Nectar plants for butterflies include but not limited to *Lantana camara* (9a), *Caesalpinia pulcherrima* (9b), *Stachytarpheta jamaicensis* (9c), *Clerodendrum japonicum* (9d), *Cassia alata* and *Buddleja spp* (9e), etc. could be considered for large Sewage Treatment Plants.
