# Sewer Installation by Pipejacking in the Urban Areas of Hong Kong

## Part I – Planning, Design, Construction and Challenges

#### – Wan Chai East and North Point Sewerage – Trunk Sewers

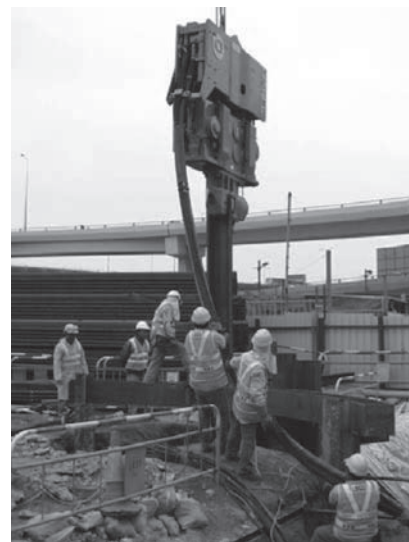
Figure 3 – Sheetpiling Works in Progress

The sheetpiling method (Fig 3) was commonly used for homogeneous, sandy ground, due to its fast operation and cheaper cost, whereas at locations where boulder obstructions were present or rockhead was high, the pipepiling method (Fig 4), with the aid of a down-the-hole hammer, which has the ability to penetrate with high efficiency to the required depth, was adopted. Vibration monitoring was carried out at sensitive utilities and structures throughout the course of pile driving.

toe grouting to avoid excessive vibration and noise nuisance as a result of hard driving, and to maintain piping stability. Difficult driving was experienced in bouldery ground although preboring was carried out in advance, affecting the vertical alignment and in the worst case, resulting in the broken toe and the necessity of extracting sheetpiles and using pipepiles instead.

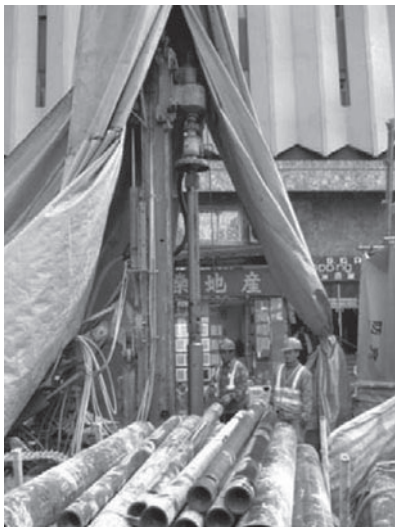
Figure 4 – Pipejacking Works in Progress

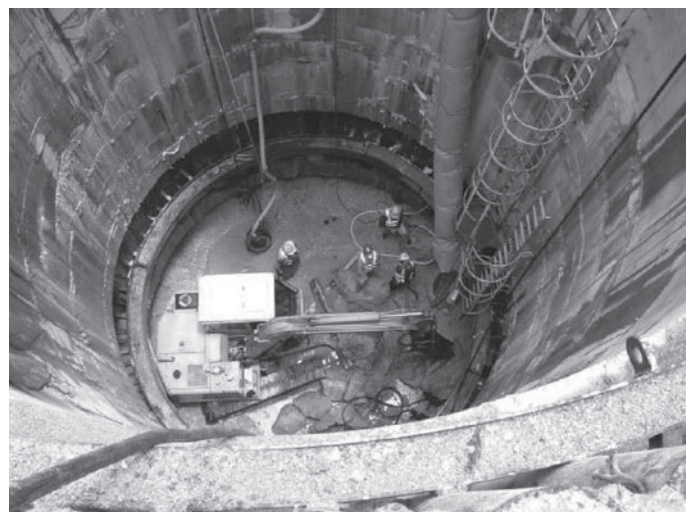
Figure 5 – Construction of 5.5 m Diameter Concrete Ring Wall

might not have fully and effectively penetrated into the soil. Similar situations also existed in clayey ground. Therefore, concrete ring walls had to be constructed as a waling system to prevent ingress of water (Fig 5). This arrangement was also adopted for the temporary shafts formed by pipepiles where existing watermain were in close proximity. This was because their bursting could cause migration of the surrounding soils into the shaft through the gap in the piles, causing road collapse, despite the fact that a grout curtain had been formed outside the shaft in advance, by injection of grout from the slots of the piles.

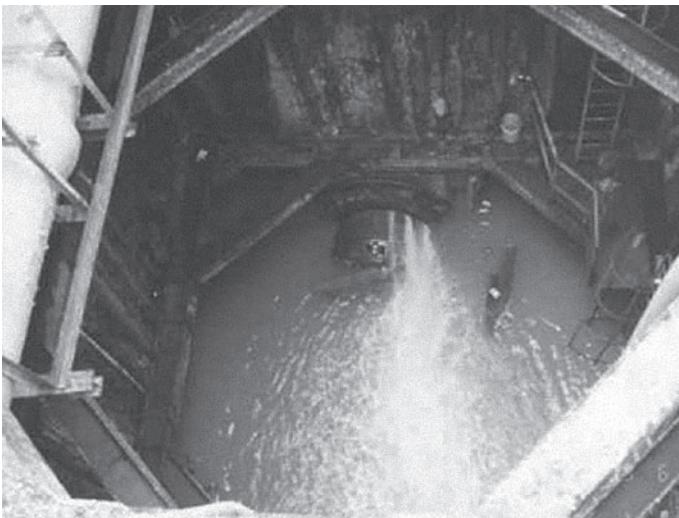
Figure 19 – Grout Plug Failure during TBM Breakthrough

Failure of the grout block was experienced at two receiving shafts, causing significant ingress of water and migration of soil, through the receiving eye (Fig 19). After this incident, the jacking and receiving eyes for the remaining drives were modified to be formed from a single concrete structure to a complete ring wall cast against the sheet/pipe piles, with double layers of rubber seal provided.

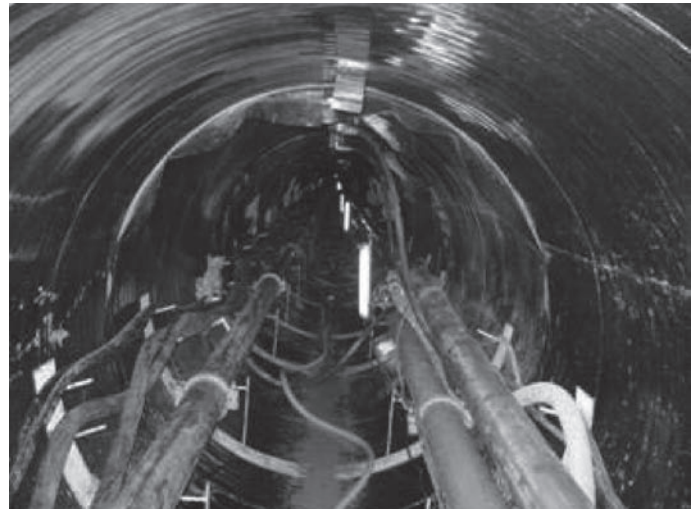
Typical operations in a jacking shaft and the condition of a jacked pipeline are shown in Figs 20 and 21 respectively.

Figure 20 – Launching of TBM in Jacking Shaft

Figure 21 – Typical Condition of a Jacked Pipeline

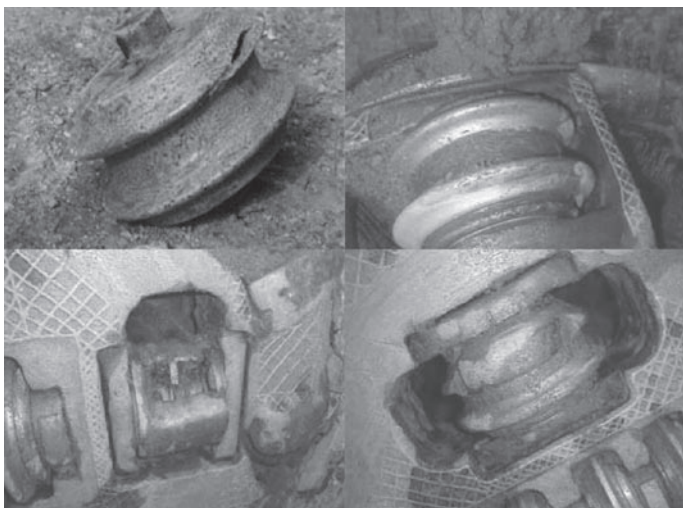
Figure 23 – Conditions of Damaged Disc Cutters

The conditions of some of the worn-out and damaged disc cutters are shown in Fig 23.

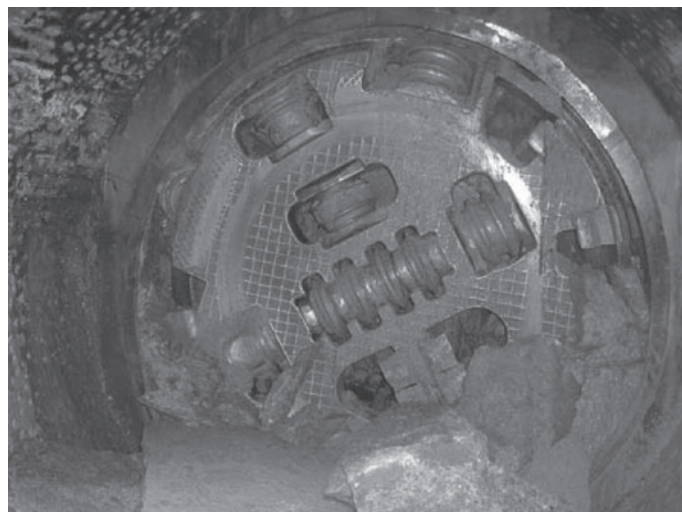
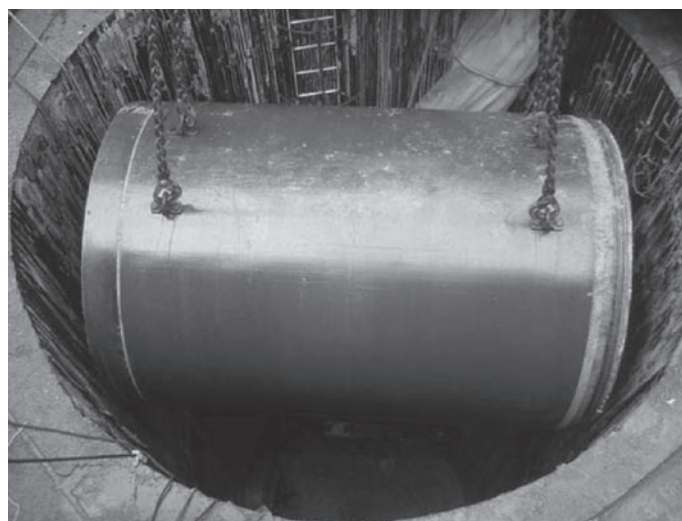
Figure 32 – TBM Breakthrough in Receiving Permanent Shaft

Figure 33 – Lifting-up of the Longest Machine Can of TBM from Receiving Shaft

The clearance between the shaft wall of NP3 and the longest section of the TBM, at the narrowest point, was only 100 mm. This had to be checked carefully and repeatedly, so as to ensure that the TBM could be lifted up upon completion of the drive.

The TBM breakthrough at NP3 and the condition of the TBM when lifting up are shown in Figs 32 and 33 respectively.
