Interim Notification of Environmental Quality Limit Exceedance

Incident Report on Limit Level Non-compliance

Project	Tsuen Wan Drainage Tunnel
Date	06-Apr-11
Time	10:25 AM
Monitoring Location	Sik Sik Yuen Ho Fung College (I-1)
Parameter	Suspended Solids
Action & Limit Levels (mg/L)	8.85 / 10.17
Measured Level (mg/L)	10.95
Possible reason for Action or Limit Level Non-compliance	A high SS level of 10.60 mg/L was recorded at Control Station (I-1-C)
Actions taken / to be taken	The measured SS level was above the baseline limit level, but lower than 120% of SS level of the control station (I-1-C). General site cleaning, rebar fixing at cascade bay 1, dismantling of formwork at vehicle access, removal of hoarding and masonry wall and geotechnical instrumentation monitoring were undertaken during the measurement. No direct disturbance was observed from the site. Thus, the exceedance was considered to be contributed by high SS level at upstream location and natural variation. Therefore, no action was required.

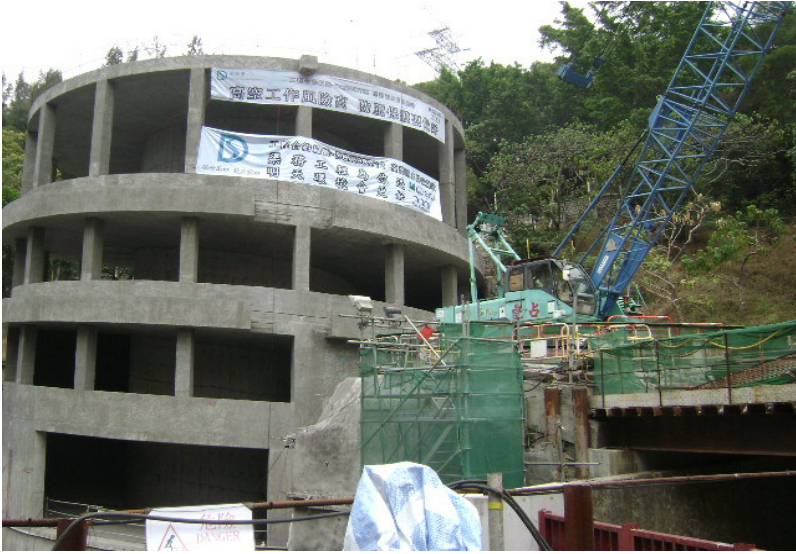
Site photo

Project	Tsuen Wan Drainage Tunnel
Date	08-Apr-11
Time	2:37 PM
Monitoring Location	Sik Sik Yuen Ho Fung College (I-1)
Parameter	Suspended Solids
Action & Limit Levels (mg/L)	8.85 / 10.17
Measured Level (mg/L)	9.45
Possible reason for Action or Limit Level Non-compliance	A high SS level of 10.00 mg/L was recorded at Control Station (I-1-C)
Actions taken / to be taken	The measured SS level was above the baseline action level, but lower than the SS level of the control station (I-1-C). General site cleaning, rebar fixing at cascade bay 3, formwork prepaing, removal of masonry wall, pipe roof corning drilling and geotechnical instrumentation monitoring were undertaken during the measurement. No direct disturbance was observed from the site. Thus, the exceedance was considered to be contributed by high SS level of the upstream location and natural variation. Therefore, no action was required.
Remarks	The following mitigation measures were provided: (1) Waste water was collected and diverted to waste water treatment plant for treatment before discharge; (2) Nullah and site area were separated by sealed concrete block.

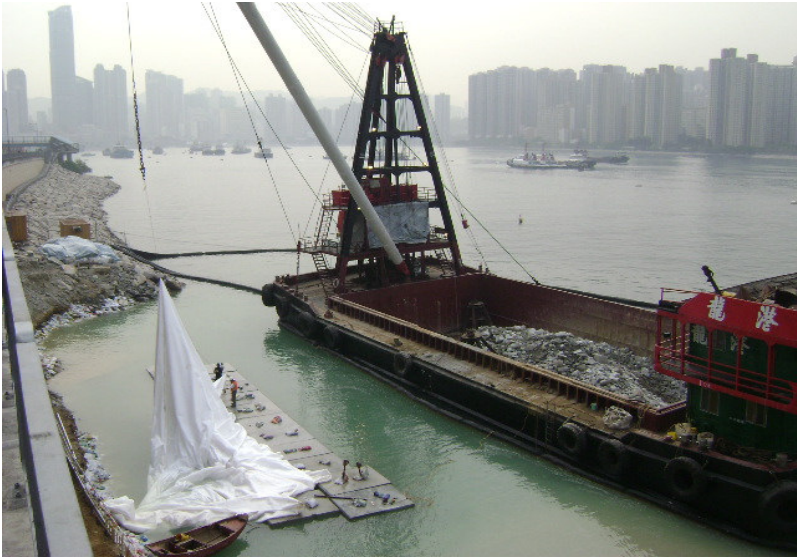
Site photo

Project	Tsuen Wan Drainage Tunnel
Date	08-Apr-11
Time	9:12 AM
Monitoring Location	O-1(FT)
Parameter	Suspended Solids (SS)
Action & Limit Levels (mg/L)	14.10 / 18.08 (derived from the baseline monitoring data)
Measured Level (depth-averaged) at Monitoring Location (mg/L)	5.35
Control Station	O-1-C(FT)
Measured Level (depth averaged) at Control Station (mg/L)	4.20
Possible reason for Action or Limit Level Non-compliance	The measured SS level (depth-averaged) at O-1(FT) was below the baseline action/limit level but was higher than 120% of the control station's SS level (O-1-C(FT)) at the same tide of the same day. Only laying non-woven geo-textile and backfilling grade 200 rockfill behind installed seawall blocks were undertaken and there was no other marine works during monitoring. Silt curtain was deployed along the Portion E boundary line and extended from seawater level to seabed. Floating type silt curtain was also employed at the inner side. As such, the exceedance was considered to be contributed by natural variation and no further action was required.

Actions taken / to be taken	(1) Silt curtain had been provided along the Portion E boundary line and extended from seawater level to the bottom of seabed; (2) Floating type silt curtain had been employed at the inner side; (3) Sufficient slack of silt curtain was allowed to cope with the wave and tidal action to ensure the curtains (outer and inner) were rested on seabed; (4) condition of silt curtain was checked by the supervisor daily; (5) and seawall blocks installation was undertaken within the inner silt curtain area only.
Remarks	None

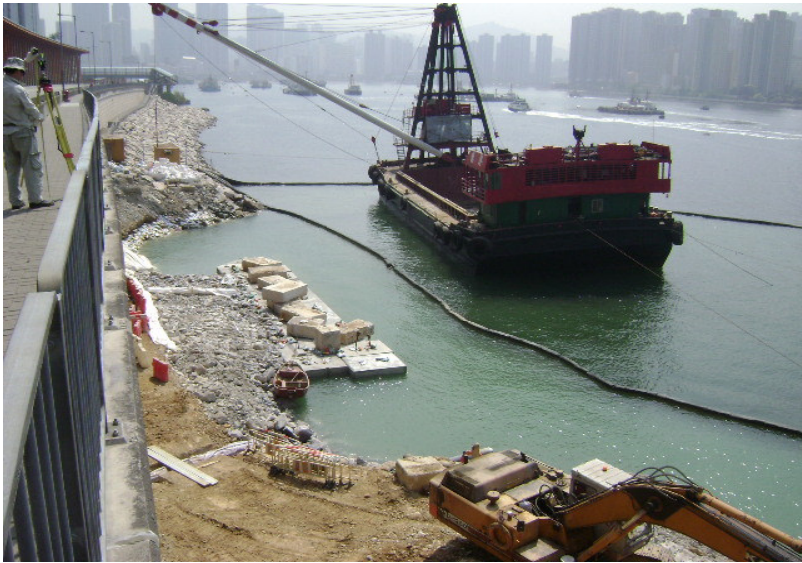
Site photo

Project	Tsuen Wan Drainage Tunnel
Date	11-Apr-11
Time	10:20 AM
Monitoring Location	O-1(FT)
Parameter	Suspended Solids (SS)
Action & Limit Levels (mg/L)	14.10 / 18.08 (derived from the baseline monitoring data)
Measured Level (depth-averaged) at Monitoring Location (mg/L)	5.27
Control Station	O-1-C(FT)
Measured Level (depth averaged) at Control Station (mg/L)	4.27
Possible reason for Action or Limit Level Non-compliance	The measured SS level (depth-averaged) at O-1(FT) was below the baseline action/limit level but was higher than 120% of the control station's SS level (O-1-C(FT)) at the same tide of the same day. Only installation of temporary concrete blocks and placing leveling stone were undertaken and there was no other marine works during monitoring. Silt curtain was deployed along the Portion E boundary line and extended from seawater level to seabed. Floating type silt curtain was also employed at the inner side. As such, the exceedance was considered to be contributed by natural variation and no further action was required.

Actions taken / to be taken	(1) Silt curtain had been provided along the Portion E boundary line and extended from seawater level to the bottom of seabed; (2) Floating type silt curtain had been employed at the inner side; (3) Sufficient slack of silt curtain was allowed to cope with the wave and tidal action to ensure the curtains (outer and inner) were rested on seabed; (4) condition of silt curtain was checked by the supervisor daily; (5) and seawall blocks installation was undertaken within the inner silt curtain area only.
Remarks	None

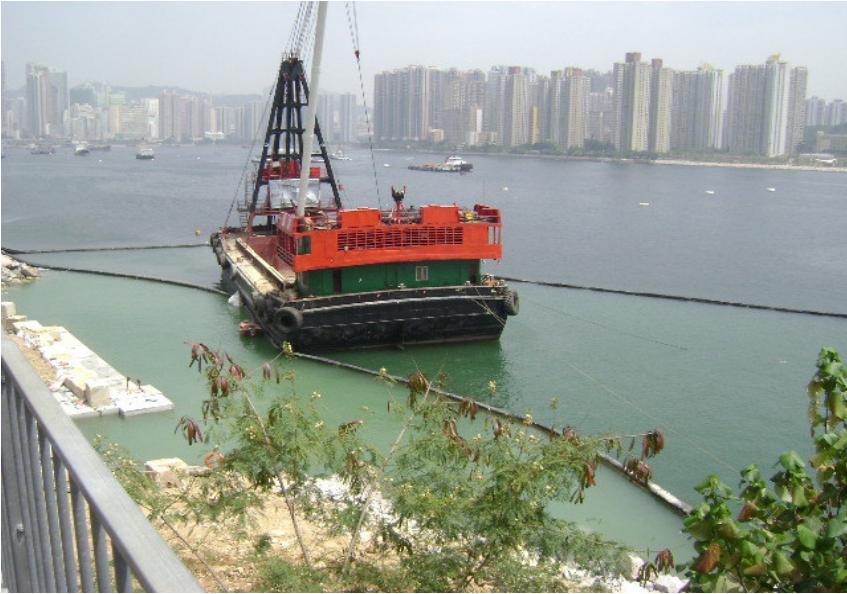
Site photo

Project	Tsuen Wan Drainage Tunnel
Date	13-Apr-11
Time	2:33 PM
Monitoring Location	O-1(FT)
Parameter	Suspended Solids (SS)
Action & Limit Levels (mg/L)	14.10 / 18.08 (derived from the baseline monitoring data)
Measured Level (depth-averaged) at Monitoring Location (mg/L)	3.90
Control Station	O-1-C(FT)
Measured Level (depth averaged) at Control Station (mg/L)	3.03
Possible reason for Action or Limit Level Non-compliance	The measured SS level (depth-averaged) at O-1(FT) was below the baseline action/limit level but was higher than 120% of the control station's SS level (O-1-C(FT)) at the same tide of the same day. Only installation of bagged concrete for seawall formation was undertaken and there was no other marine works during monitoring. Silt curtain was deployed along the Portion E boundary line and extended from seawater level to seabed. Floating type silt curtain was also employed at the inner side. As such, the exceedance was considered to be contributed by natural variation and no further action was required.

Actions taken / to be taken	(1) Silt curtain had been provided along the Portion E boundary line and extended from seawater level to the bottom of seabed; (2) floating type silt curtain had been employed at the inner side; (3) sufficient slack of silt curtain was allowed to cope with the wave and tidal action to ensure the curtains (outer and inner) were rested on seabed; (4) condition of silt curtain was checked by the supervisor daily; (5) and seawall blocks installation was undertaken within the inner silt curtain area only.
Remarks	None

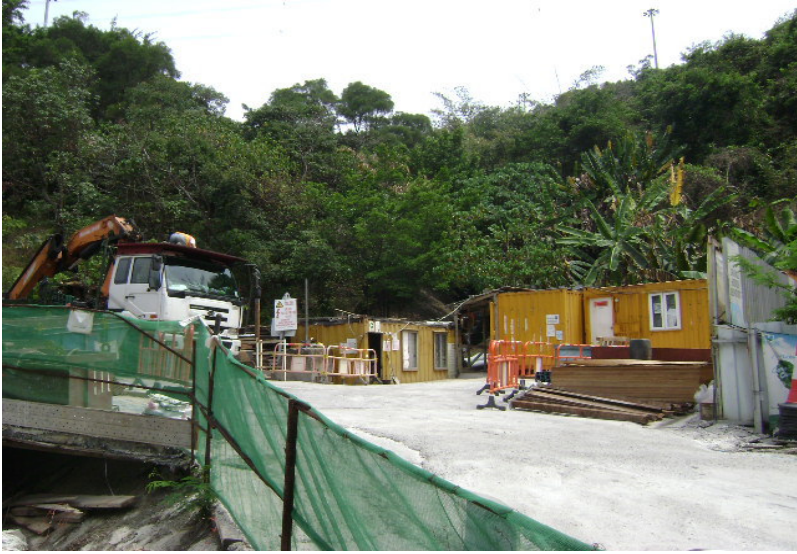
Site photo

Project	Tsuen Wan Drainage Tunnel
Date	18-Apr-11
Time	9:20 AM
Monitoring Location	Sik Sik Yuen Ho Fung College (I-1)
Parameter	Suspended Solids
Action & Limit Levels (mg/L)	8.85 / 10.17
Measured Level (mg/L)	2.70
Possible reason for Action or Limit Level Non-compliance	A low SS level of 2.10 mg/L was recorded at Control Station (I-1-C)
Actions taken / to be taken	The measured SS level was below the baseline action level, but higher than 120% of SS level of the control station (I-1-C). General site cleaning, formwork at Cascade Bay 3 and 4, construction of H-pile platform, pipe roof drilling and geotechnical instrumentation monitoring were undertaken during the measurement. No direct disturbance was observed from the site. Thus, the exceedance was considered to be contributed by natural variation and no action was required.
Remarks	The following mitigation measures were provided: (1) Waste water was collected and diverted to waste water treatment plant for treatment before discharge; (2) Nullah and site area were separated by sealed concrete block.
