**Brave  
the  
Challenges**

**Part II :**  
**Transition** to a New Era 1971–1988

## Chapter 4: Transition to New Frontier of Environmental Protection 1971–1988

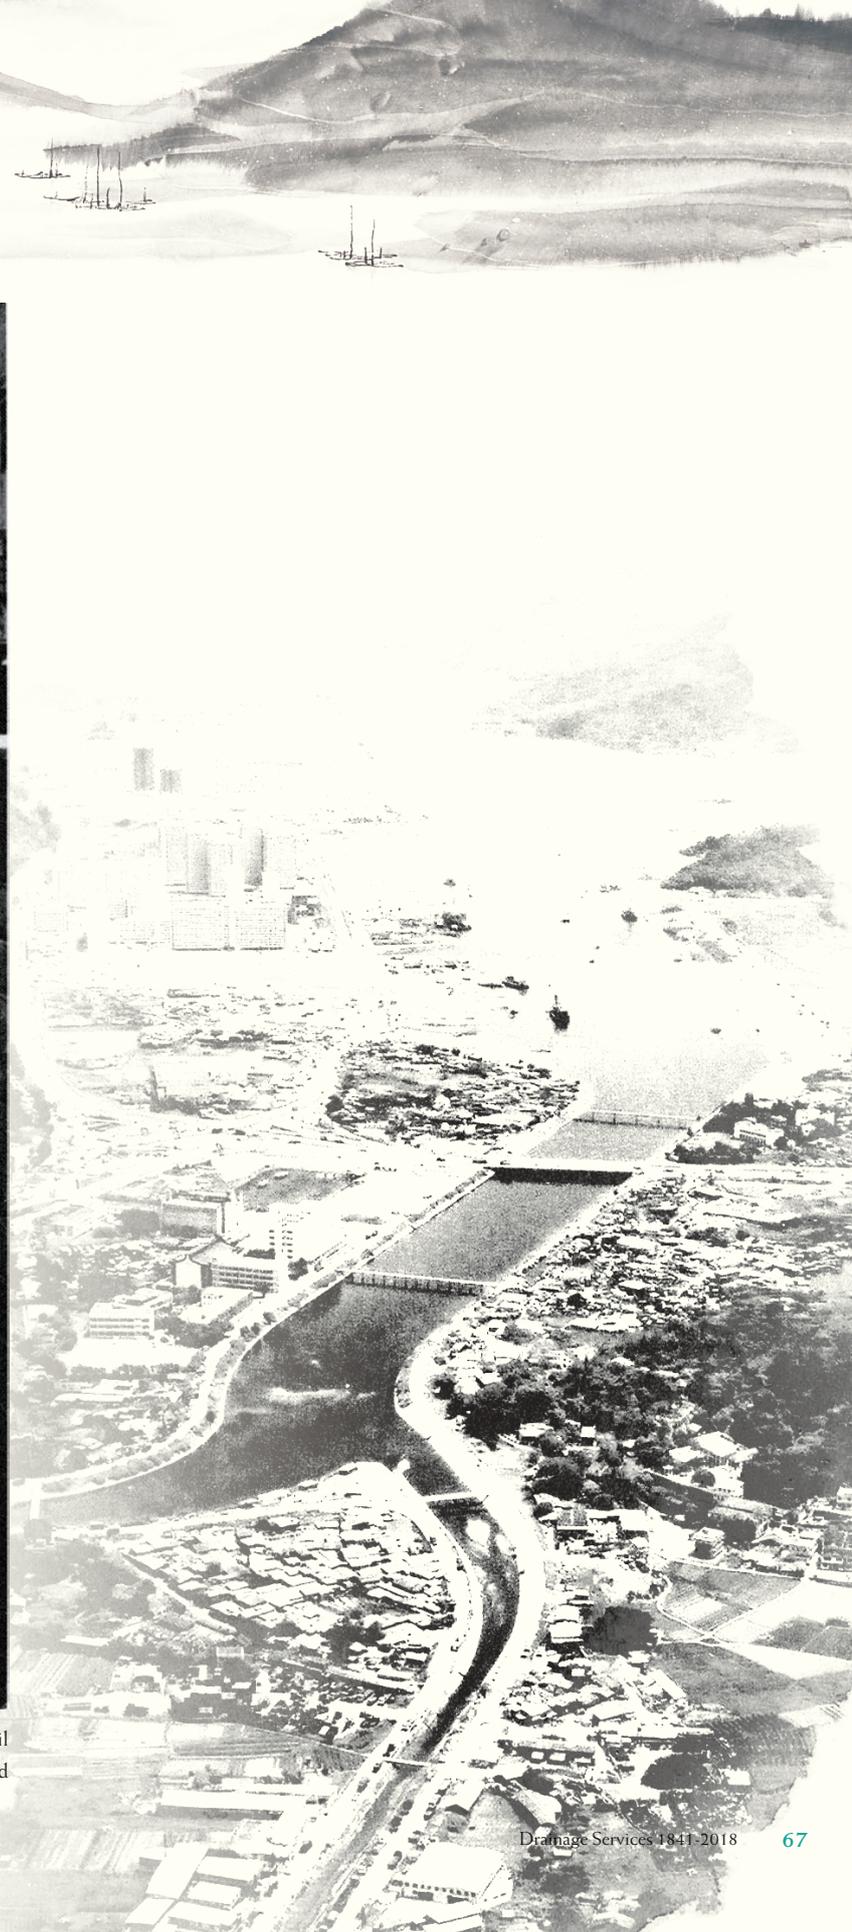
Bowrington Road Nullah in Wanchai (Canal Road of to-date). Stormwater drains carried away untreated wastewater, rubbish, oil spill and other pollutants, together with sand and silt into the nullah. Man-entry into open nullahs for manual removal of sand and silt has become uncommon nowadays.

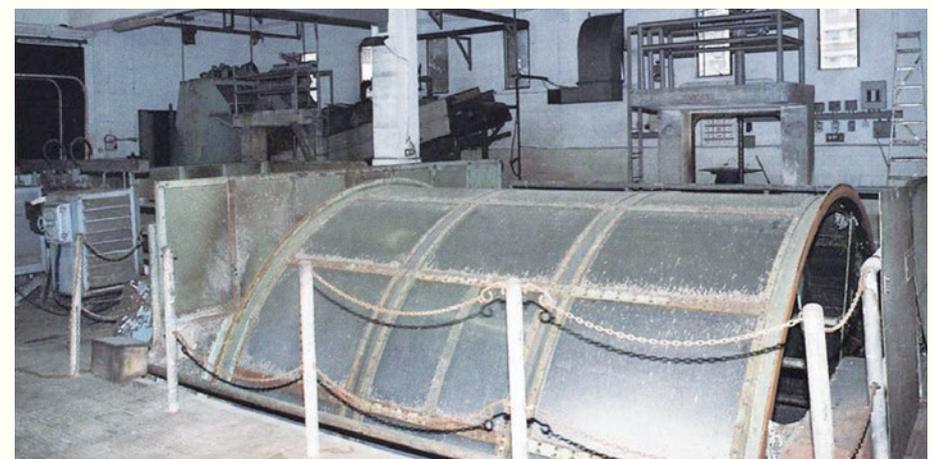
The Anchor Street Sewage Screening Plant. It was decommissioned in 1992 after commissioning of the North West Kowloon Sewage Treatment System.

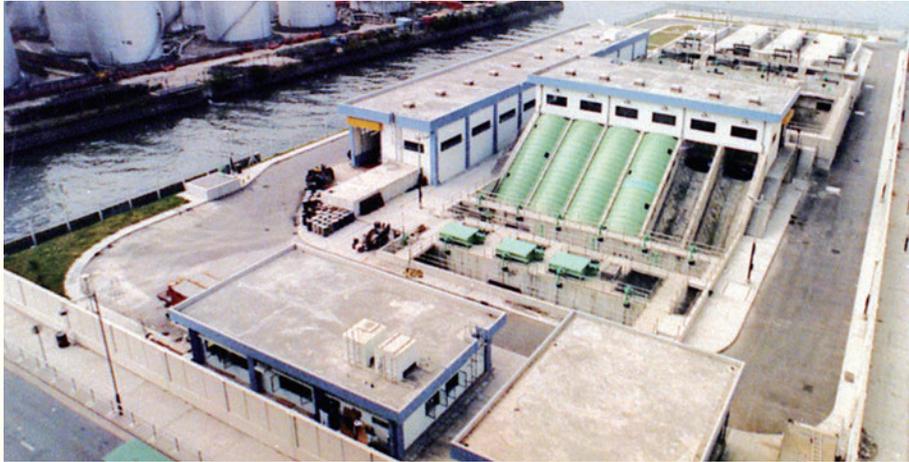
Kwun Tong Preliminary Treatment Works

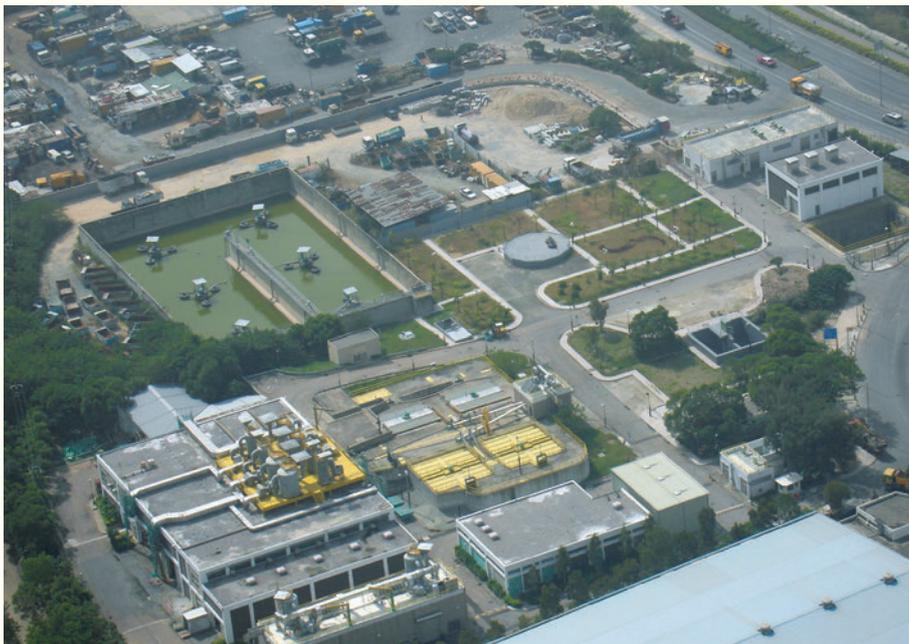
Tseung Kwan O Preliminary Treatment Works

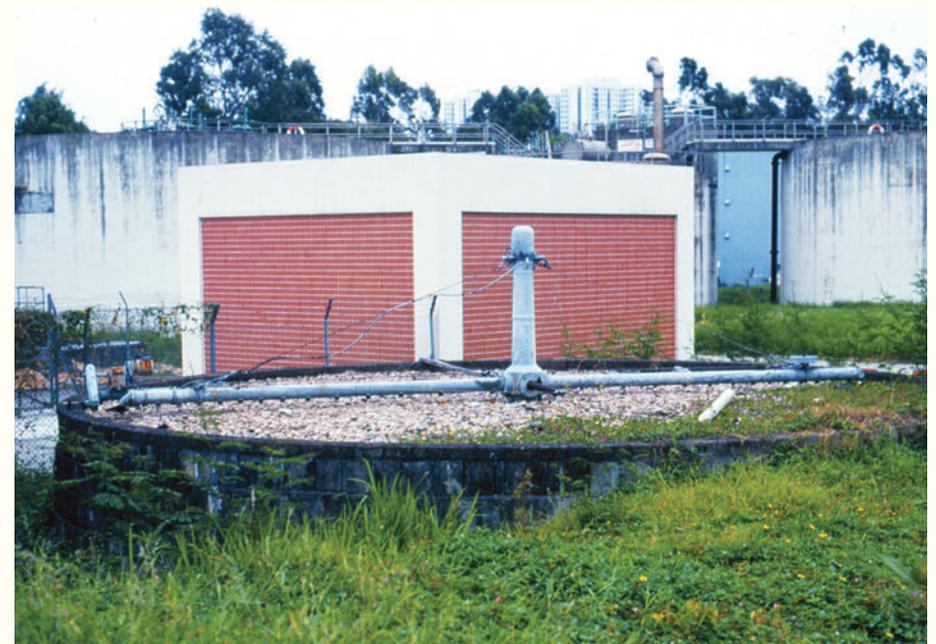
Trickling Filter of the Shek Wu Hui Pilot Sewage Treatment Plant

The trickling filter consists of a bed of highly permeable media on whose surface a mixed population of microorganisms is developed as a slime layer. The passage of wastewater through the filter causes the bacteria, protozoa and other organisms in the slime layer to consume the organic matters in the wastewater.

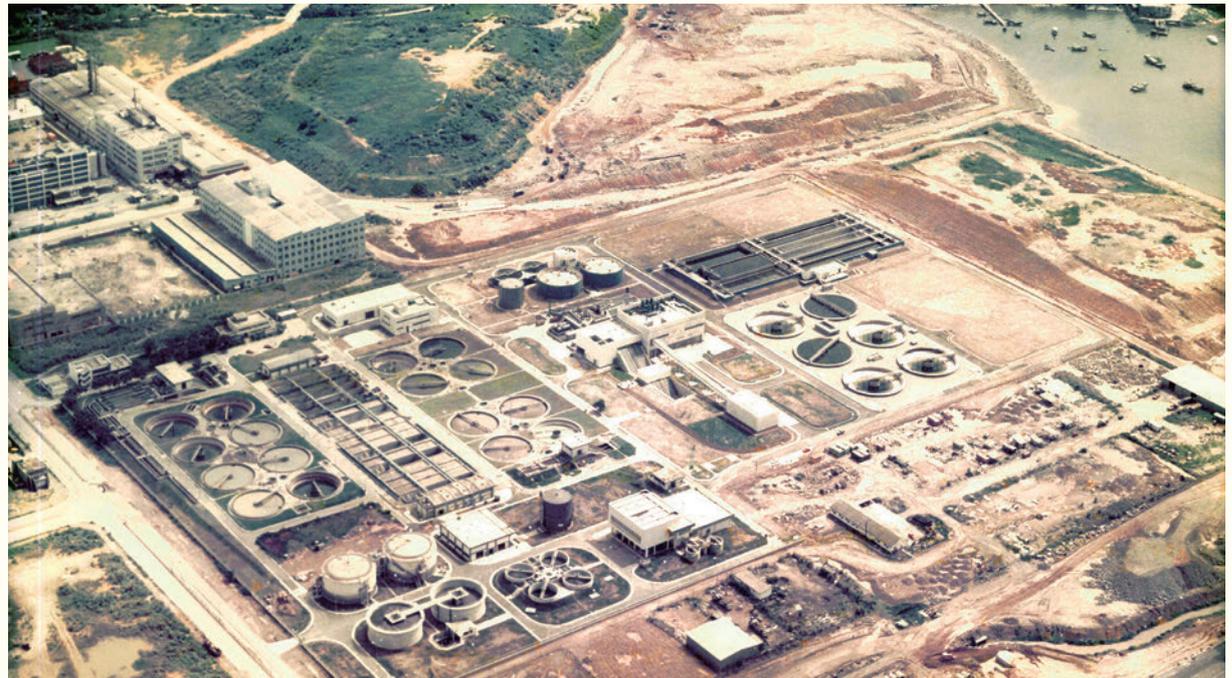
The Tai Po Sewage Treatment Works (TPSTW) within the Tai Po Industrial Estate, occupying 12 hectares of land

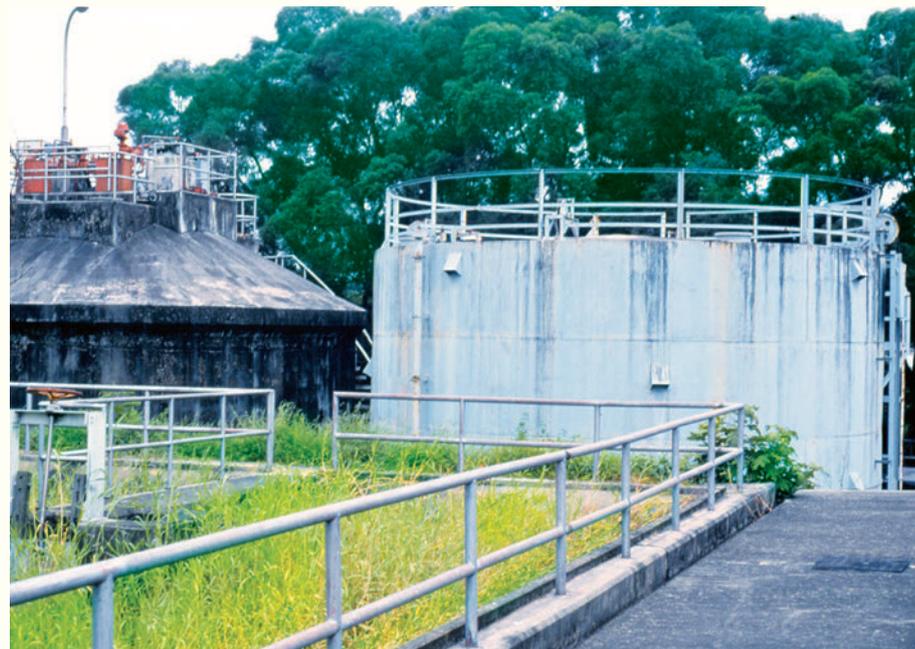
Anaerobic Sludge Digester of the Shek Wu Hui Pilot Secondary Sewage Treatment Plant

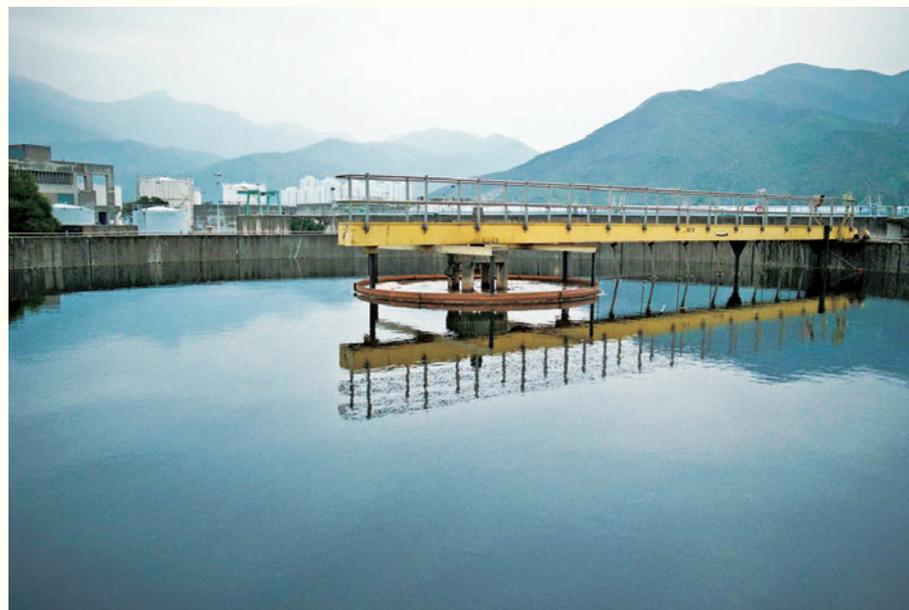
Settling Tank of the Shatin Sewage Treatment Plant

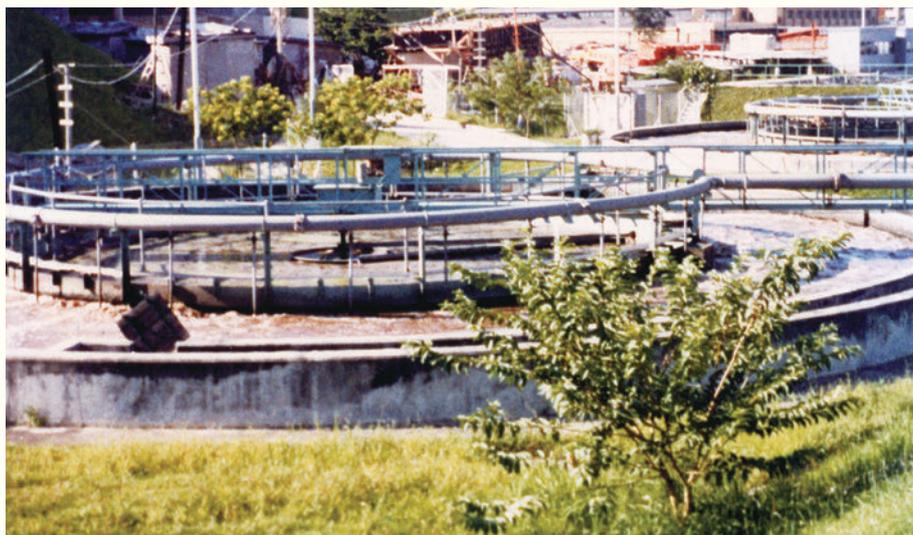
Shatin temporary secondary sewage treatment plant started operation since October 1978 and testing completed by then as well

As a stop-gap measure to control water pollution in the Sha Tin area, a temporary and interim sewage treatment plant was commissioned in phase since 1975 in a site near the downstream section of the Fo Tan Nullah (at present Jockey Club Ti-I College), adopting respectively extended aeration process and contact stabilisation process.

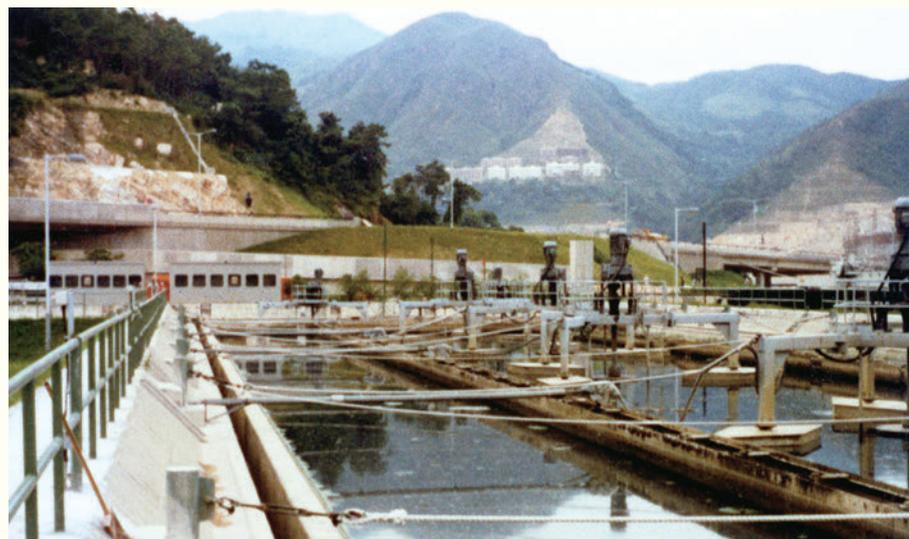
Shatin temporary secondary sewage treatment plant. In the background is the Fo Tan Road under construction.

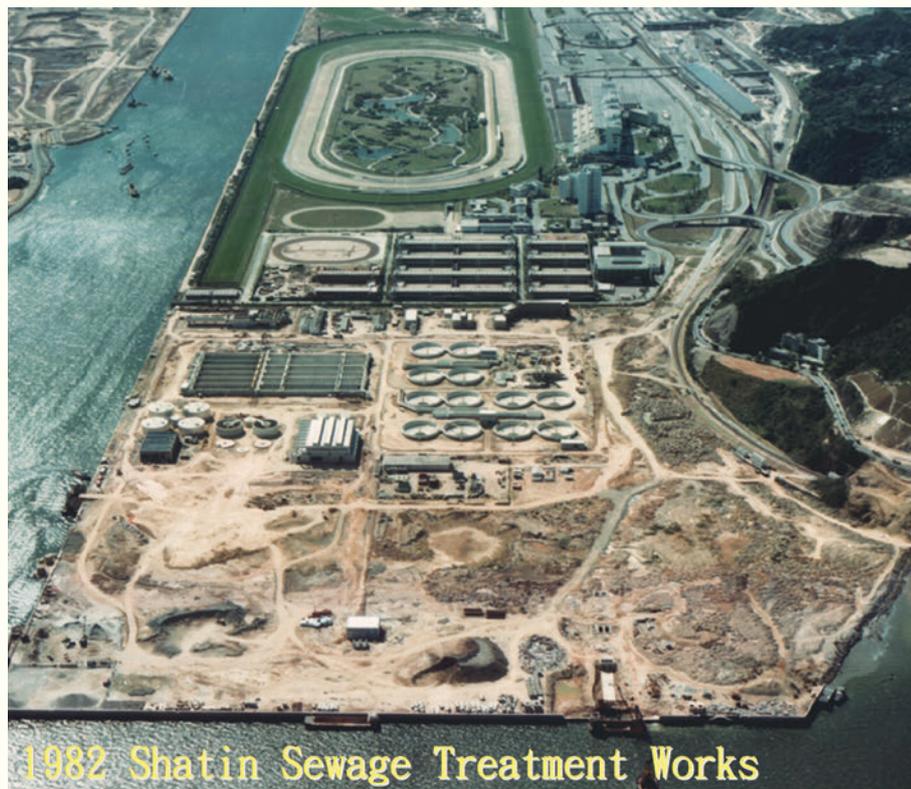
Shatin Sewage Treatment Works in 1982

In 1982, Stage I of the Sha Tin Sewage Treatment Works, capable of treating 102 870 cubic metres of sewage per day, was commissioned to take over the duty of the interim secondary sewage treatment plant. Stage II of the sewage treatment works was commissioned in 1986, increasing the treatment capacity to 205 000 cubic metres/day.

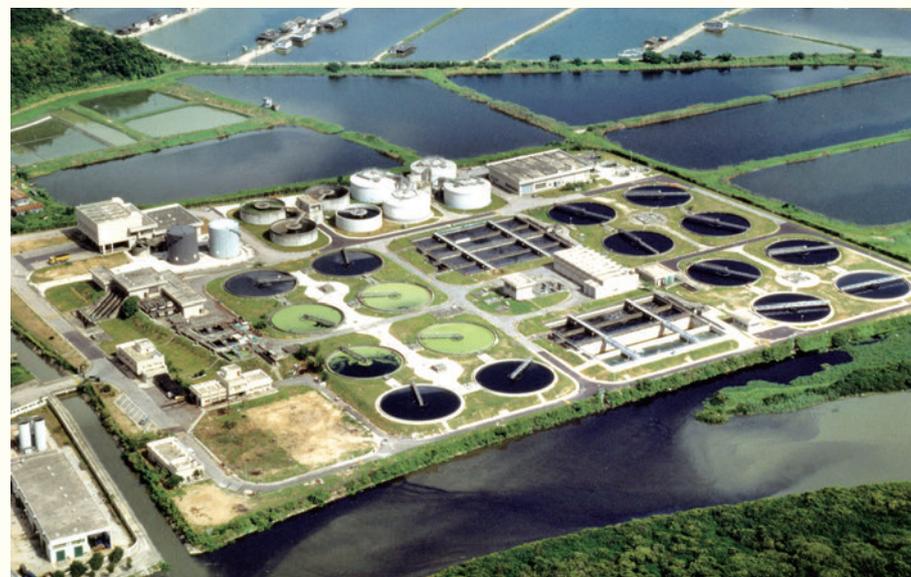
The Yuen Long Sewage Treatment Works located adjacent to the Industry Estate similar to the Tai Po Sewage Treatment Works

The Yuen Long STW was designed to treat both domestic wastewater from Yuen Long town and industrial wastewater from Yuen Long Industrial Estate. Stage I was commissioned in 1984 to provide a treatment capacity of 53 000 cubic metres/day.

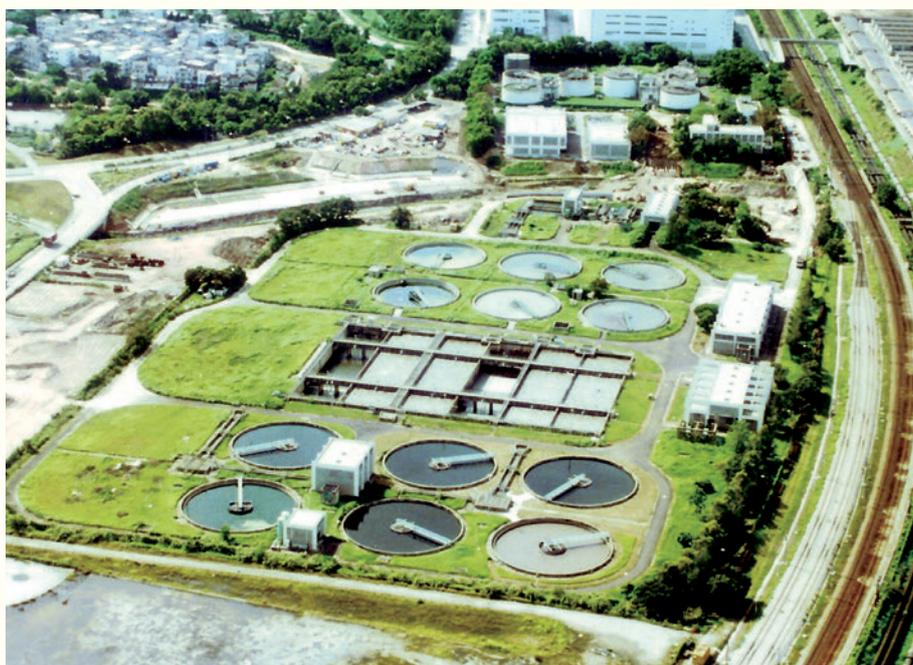
The Shek Wu Hui Sewage Treatment Works

In 1984, Stage I of Shek Wu Hui STW was constructed and commissioned to handle a dry weather flow of 60 000 cubic metres/day, serving an equivalent population of 220 000 from the new town developments in the Sheung Shui and Fanling areas.

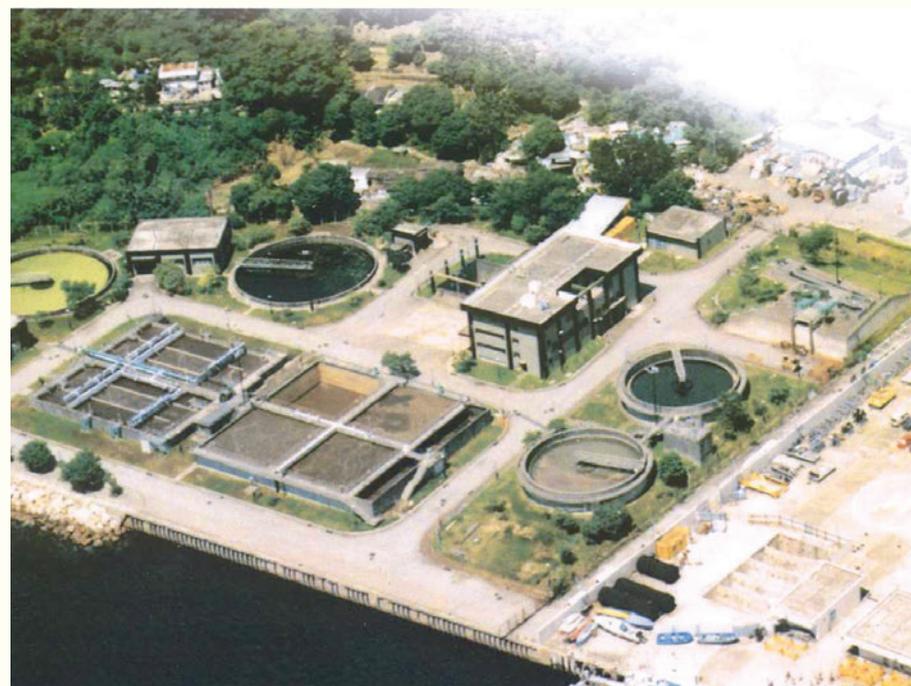
The Sai Kung Sewage Treatment Works in 1988

The Sai Kung Sewage Treatment Works, occupying an area of about two hectares on reclaimed land at Tui Min Hoi, Sai Kung, was commissioned in November 1988. It was designed to treat sewage generated from a population of 42 000 in Sai Kung District with a dry weather flow of 15 200 cubic metres/day.

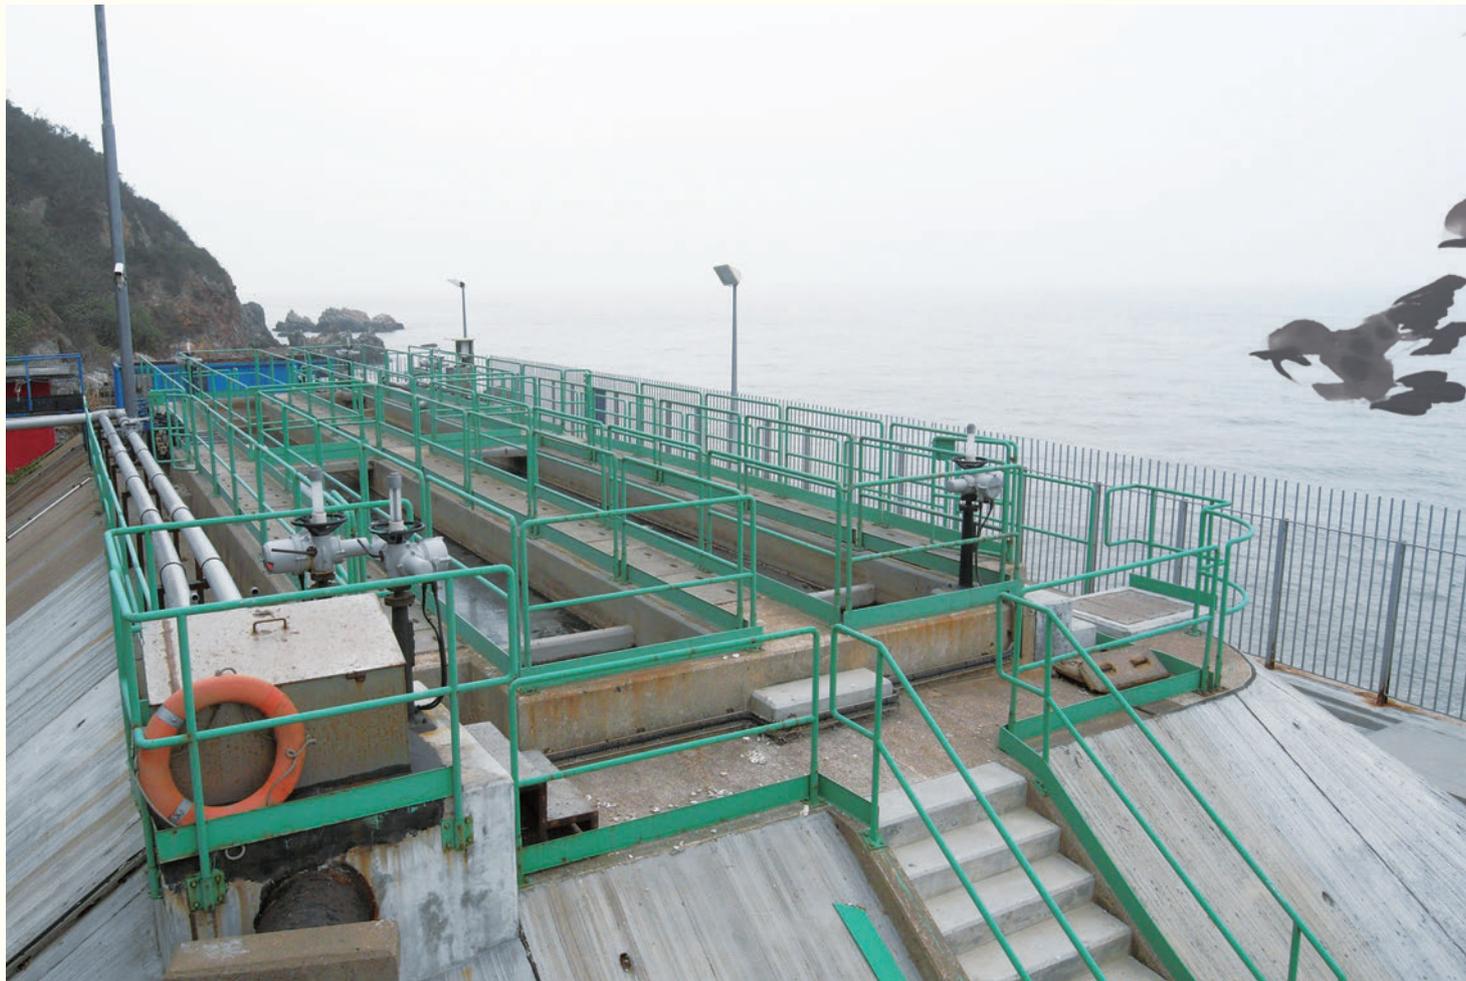
The Tai O Imhoff Tank, built in 1983, is the first primary treatment plant in Hong Kong.

built in 1983 at Tai O where an Imhoff Tank was built for processing of the sewage. The Imhoff Tank consists of a top compartment which serves as a sedimentation tank and a lower compartment in which the settled solids are collected and anaerobically stabilised. Another primary treatment plant was built in 1985 in Cheung Chau to serve the community on the island.

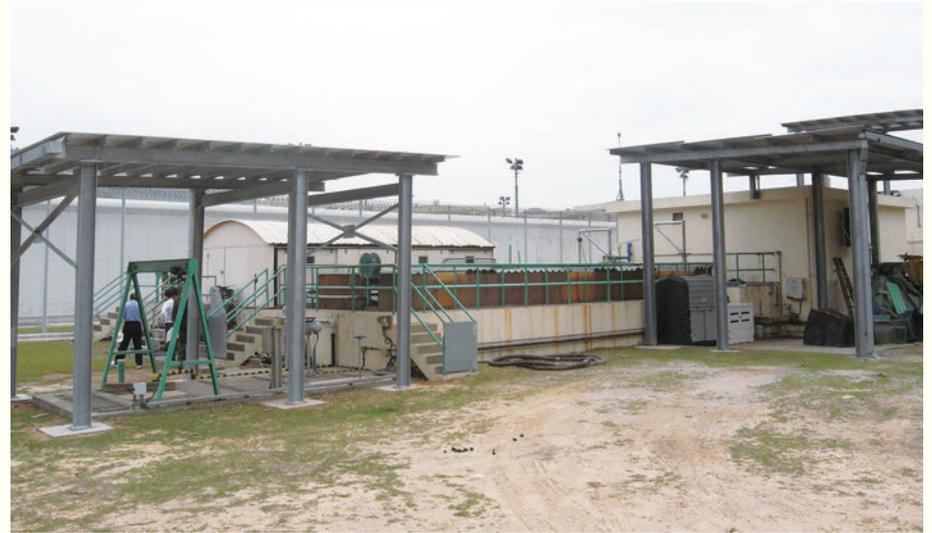
Shek Pik Rotating Biological Contactor Plant

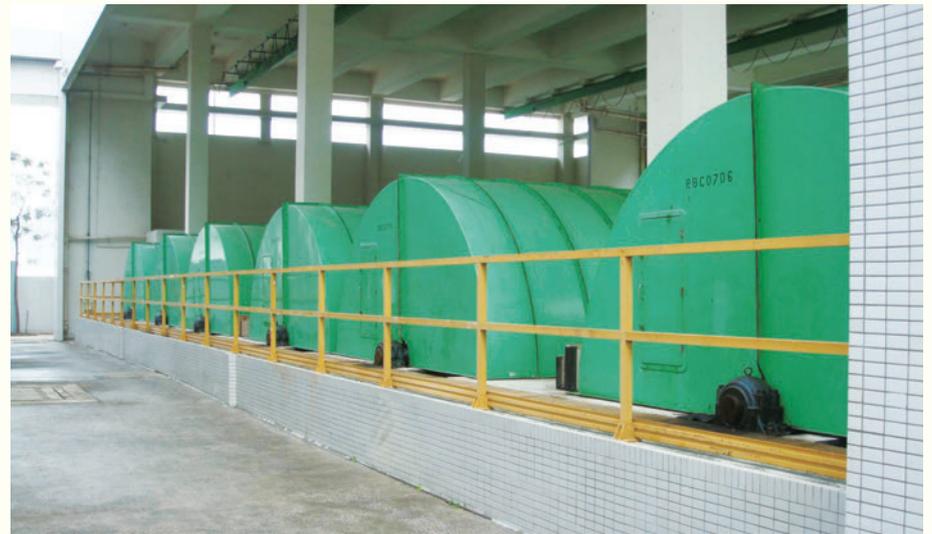
Rotating Biological Contactor

The advantage of RBCs over trickling filters is that RBCs are more reliable and can withstand sudden change in hydraulic and organic load.

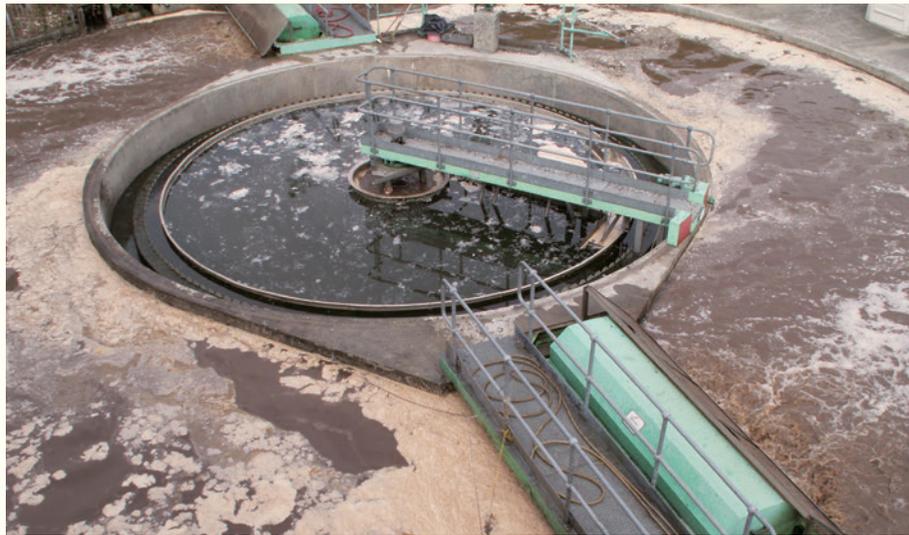
Hei Ling Chau Oxidation Ditch Plant

The first oxidation ditch plant at Hei Ling Chau Correctional Institute, with a treatment capacity of 900 cubic metres/day, was put into service in 1984. It is a small wastewater treatment device operated on extended aeration. It consists of a long channel of an elliptical or circular shape, and a rotor for generating water flow and aerating the water in the channel by stirring. With its simple structure, it is easy to operate and can remove nitrogen efficiently.

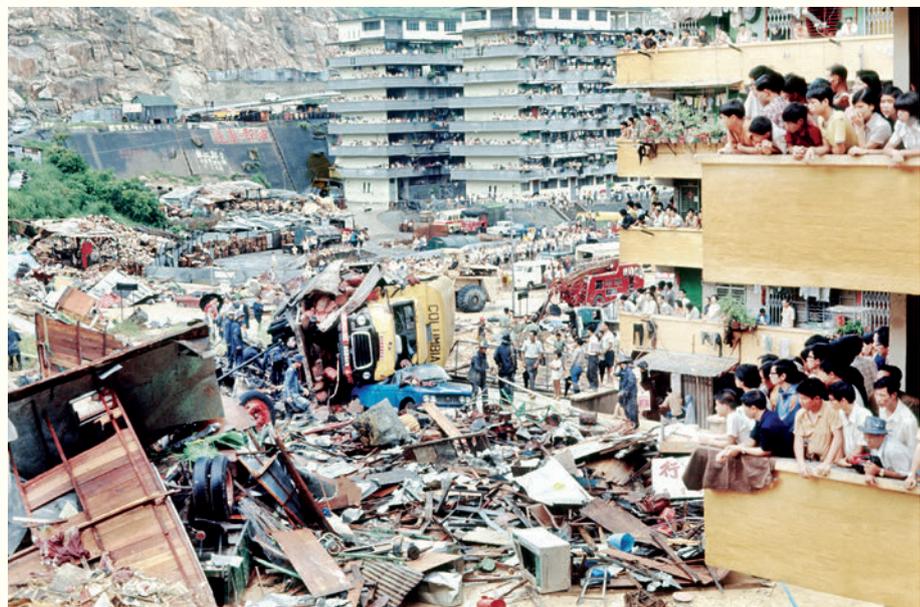
On 18th June 1972, Tsui Ping Road in Kowloon East was buried under mudslide.

The total casualty of these two incidents killed 138 people. In other parts of the territory, there were also 56 injured, flooding at 53 locations and 7 800 people rendered homeless. On 18 June 1972 alone, 232.6 millimetres of rainfall with a peak hourly rate of 98.7 millimetres from 11 am to noon was recorded.

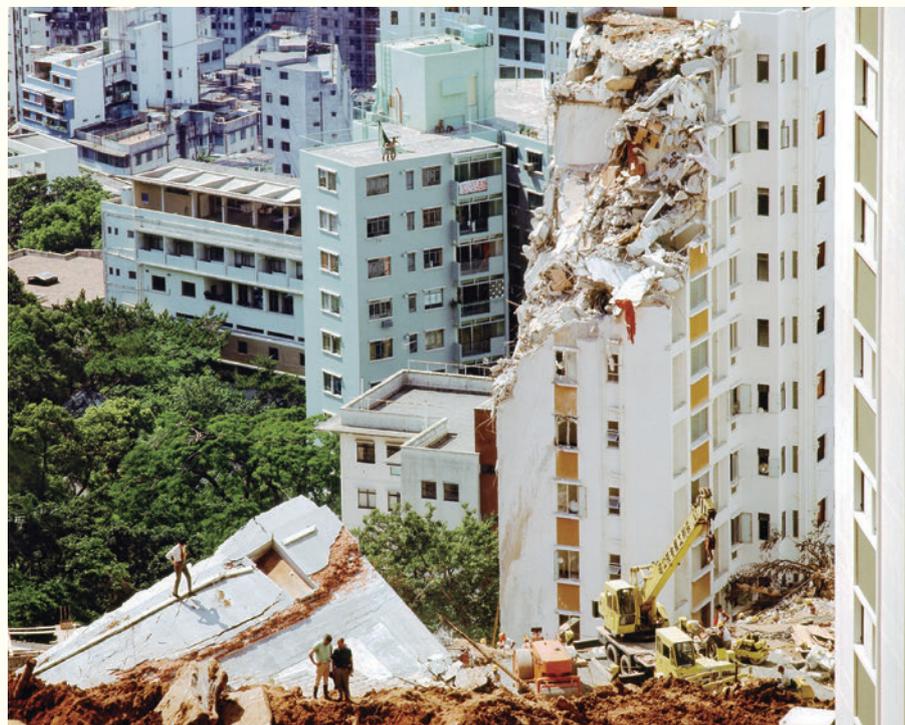
Remains of two buildings at Kotewall Road, following the devastating landslide that occurred on 18th June 1972. 40 000 cubic meters of rocky debris unearthed in this slip.

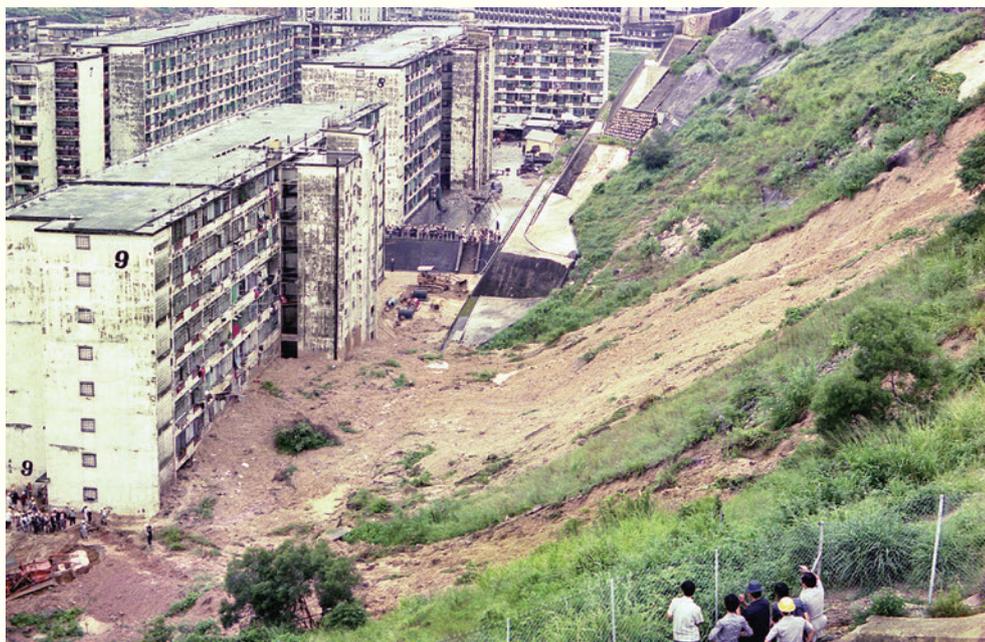
The tropical cyclone that occurred between 24th and 25th August 1976 had brought about unusually heavy rains, leading to landslip in Sau Mau Ping.

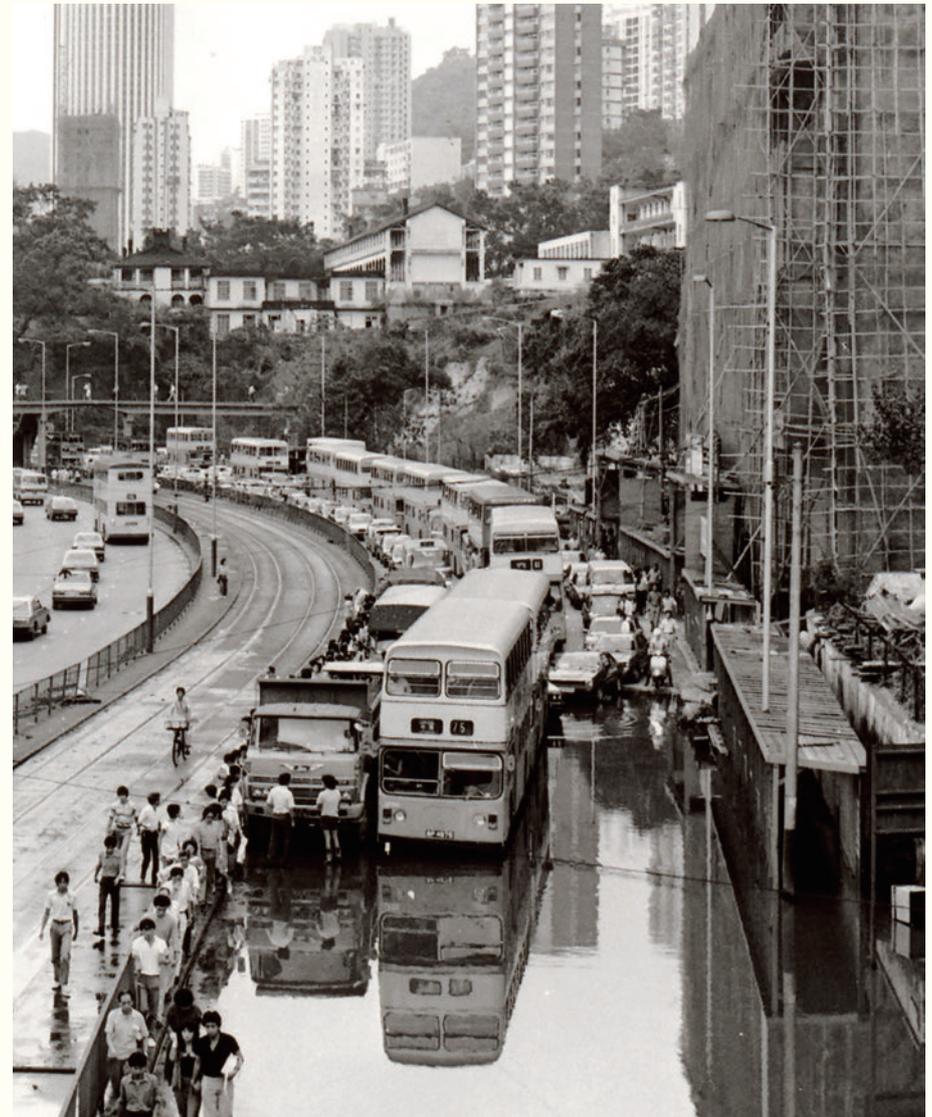
Floods near Admiralty brought by Typhoon Ellen in 1983

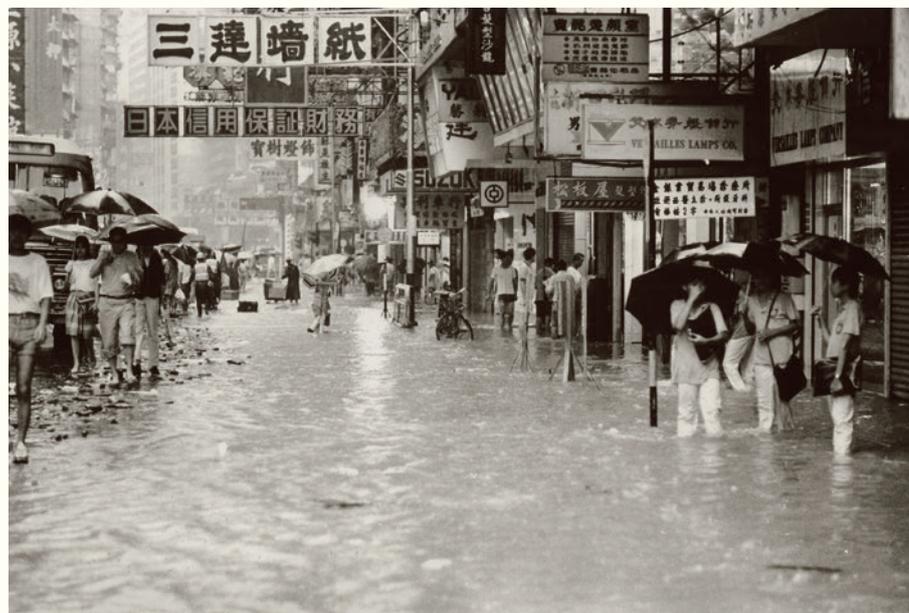
Rainstorm occurred between 1960 to 1980 has caused floods near Hennessy Road, Wanchai.

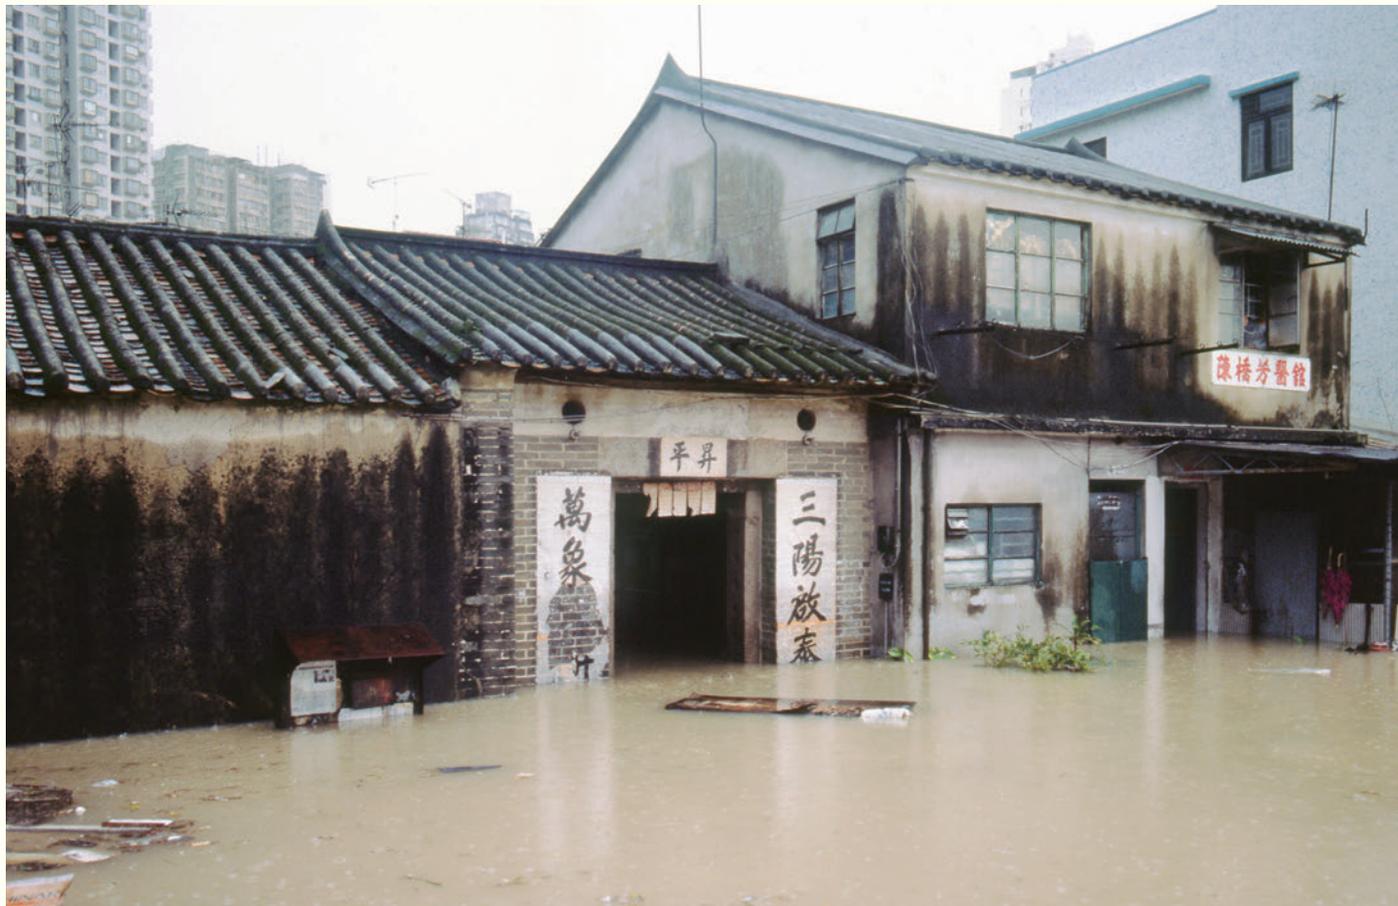
Nam Pin Wai, Yuen Long was turned into a swamp due to rainstorm.

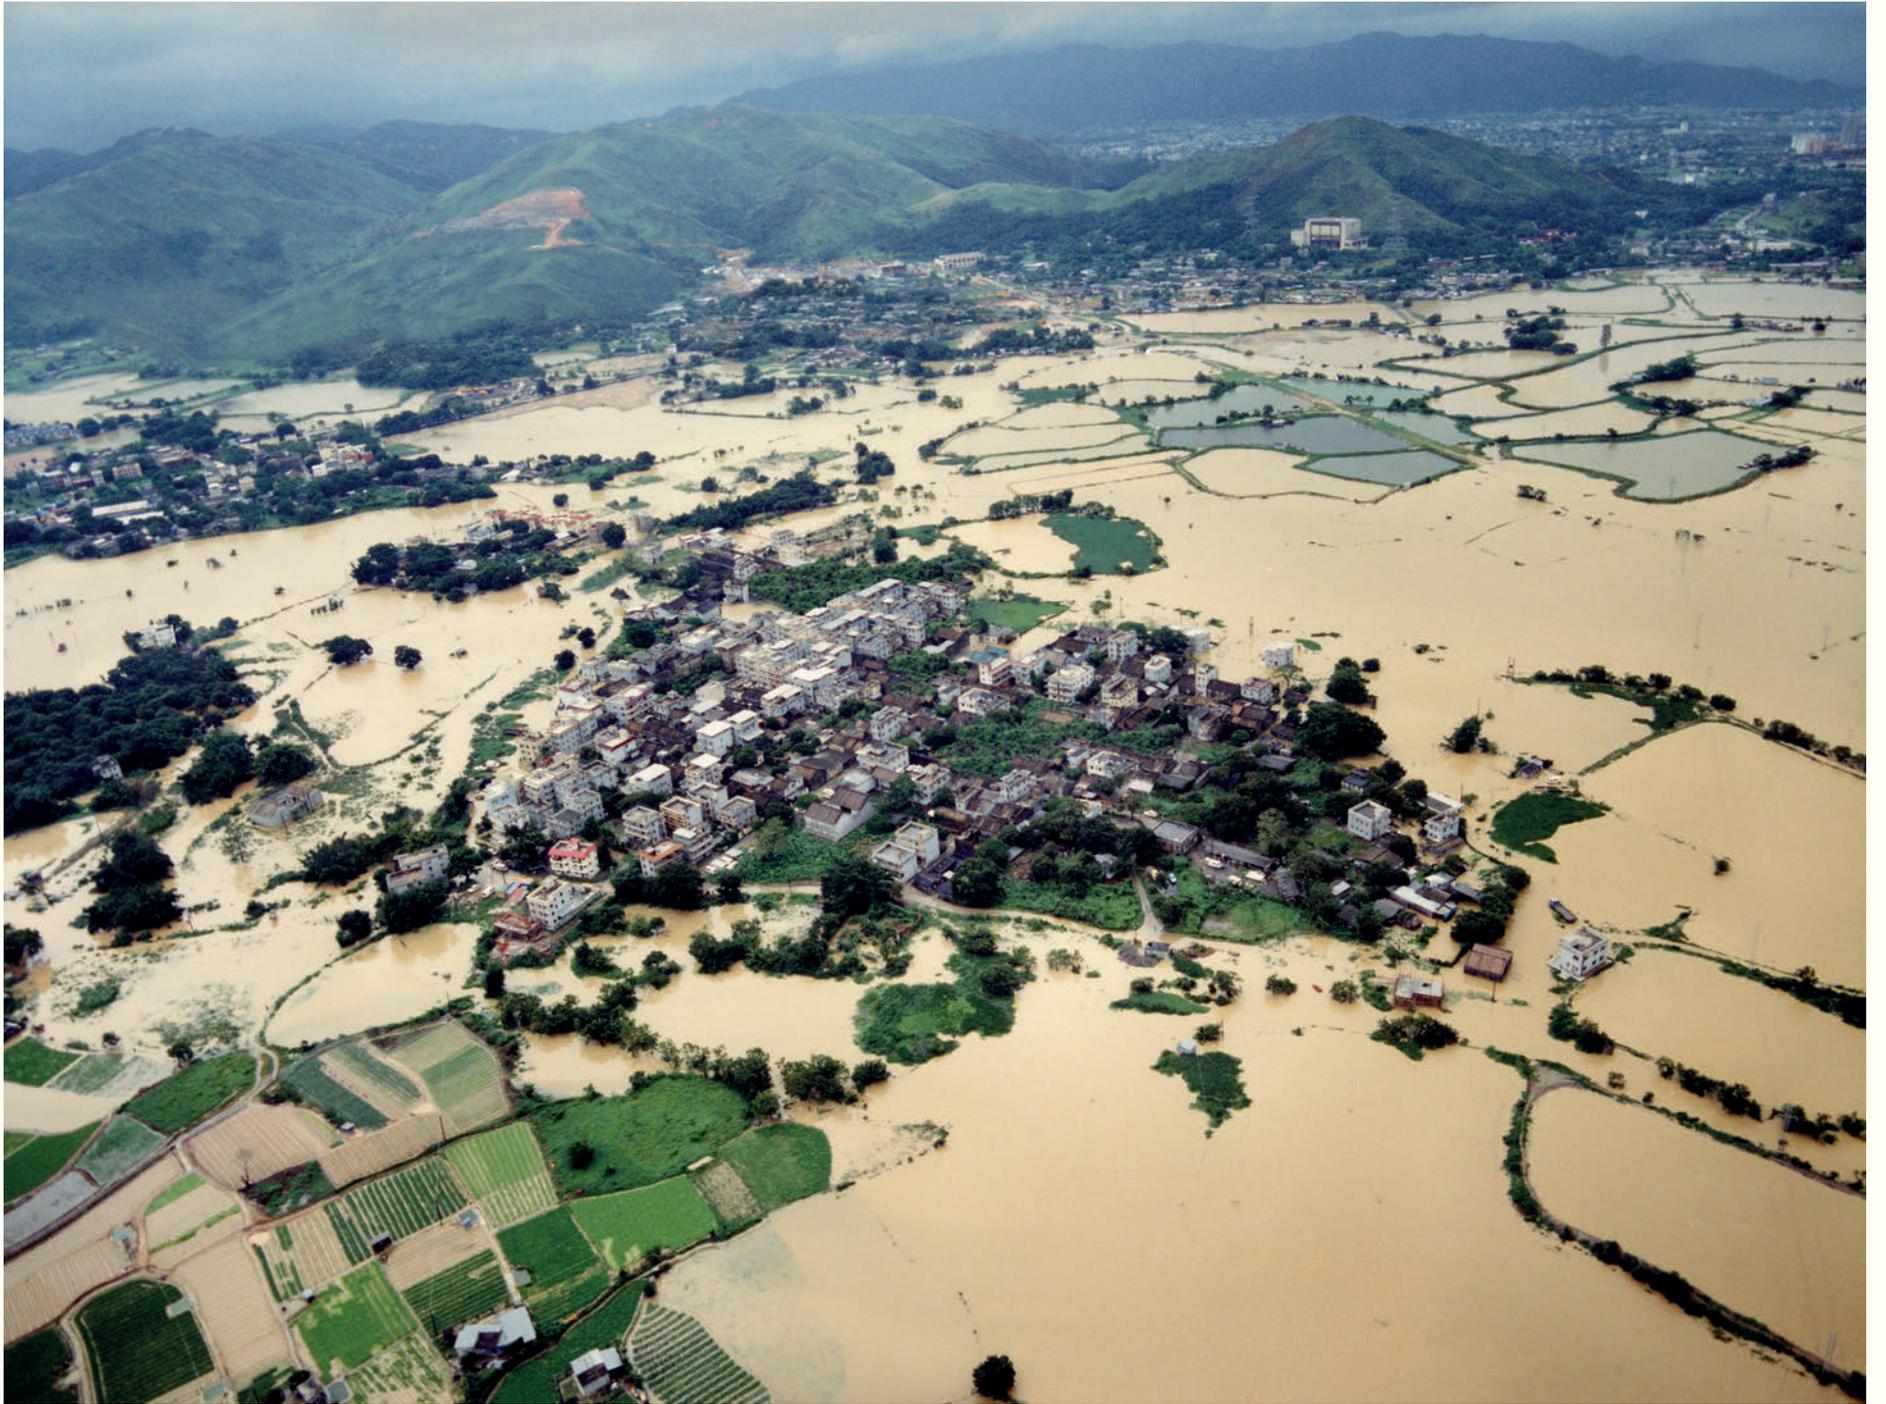
Typhoon Brenda had brought about serious floods in Kam Tin in 1989
