Interim Notifications of Environmental Quality Limits Exceedances

Incident Report on Action Level or Limit Level Non-compliance

Project	Tsuen Wan Drainage Tunnel
Date	04-Nov-09
Time	10:00 AM
Monitoring Location	Sik Sik Yuen Ho Fung College (I-1)
Parameter	Turbidity
Action & Limit Levels	9.75 / 12.47
Measured Level	13.68
Possible reason for Action or Limit Level Non-compliance	A high turbidity level of 14.11 is recorded at Control Station (I-1-C)
Actions taken / to be taken	The measured turbidity level was above baseline Action and Limit Levels as well as the range of baseline turbidity concentration (3.13 - 13.15 NTU). Construction activities, such as rock breaking, rock dowel and mucking out, were undertaken during the measurement and no direct disturbance was observed from the site. Thus, the exceedance is considered to be contributed by the high turbidity level of control station (I-1-C) and no action should be required.
Remarks	Following mitigation measures were provided: (1) sandbags were used at the gap of the bridge to avoid wastewater from site activities directly running down to the channel of I-1. (2) The working site was segregated with a wall and no wastewater was obs

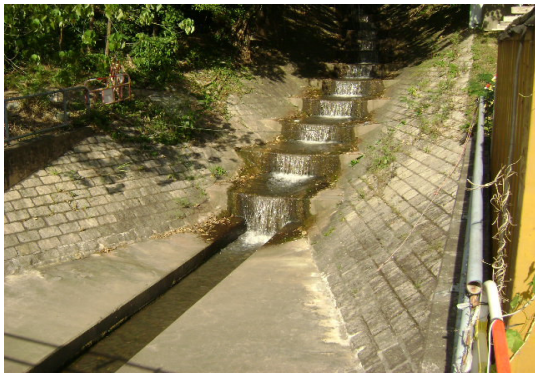
Photo taken at I-1

Project	Tsuen Wan Drainage Tunnel
Date	02-Nov-09
Time	10:00 AM
Monitoring Location	Sik Sik Yuen Ho Fung College (I-1)
Parameter	Suspended Solid
Action & Limit Levels	8.85 / 10.17
Measured Level	17.8
Possible reason for Action or Limit Level Non-compliance	A high SS level of 16.7 is recorded at Control Station (I-1-C) and muddy stain was observed at the exit of closed channel at Shing Mun Lane referred to attached photo for details.
Actions taken / to be taken	The measured SS level was above baseline Action and Limit Levels as well as the range of baseline SS level (1 - 10.5 mg/L). Construction activities, such as rock breaking, rock dowel and mucking out, were undertaken during the measurement and no direct disturbance was contributed by project construction activities. The exceedance is considered to be contributed by the high SS level at control station (I-1-C) from the muddy stain and no action should be taken as the SS result at monitoring station was below the action and limit level of control station.

Remarks	Following mitigation measures were provided on site: (1) sandbags were used at the gap of the bridge to avoid wastewater from site activities directly running down to the channel of I-1. (2) The working site was segregated with a wall and no wastewater was observed down to the channel-I1. (3) Sand/silts removal facilities was installed at the location of I-1.

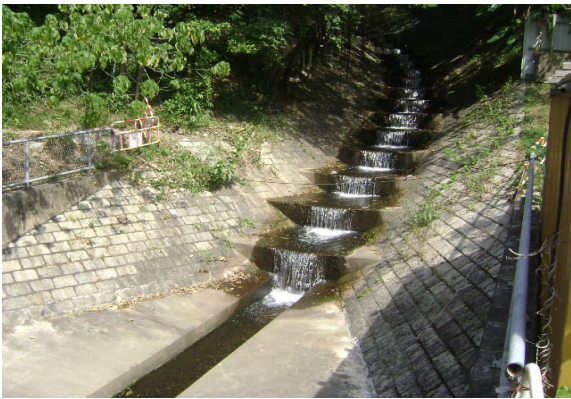
Photo taken at I-1

Project	Tsuen Wan Drainage Tunnel
Date	04-Nov-09
Time	10:00 AM
Monitoring Location	Sik Sik Yuen Ho Fung College (I-1)
Parameter	Suspended Solid
Action & Limit Levels	8.85 / 10.17
Measured Level	13.7
Possible reason for Action or Limit Level Non-compliance	A high SS level of 13.7 is recorded at Control Station (I-1-C) and muddy stain was observed at the exit of closed channel at Shing Mun Lane referred to attached photo for details.
Actions taken / to be taken	The measured SS level was above baseline Action and Limit Levels as well as the range of baseline SS level (1 - 10.5 mg/L). Construction activities, such as rock breaking, rock dowl and mucking out, were undertaken during the measurement and no direct disturbance was contributed by project construction activities. The exceedance is considered to be contributed by the high SS level at control station (I-1-C) from the muddy stain and no action should be taken as the SS result at monitoring station was below the action and limit level of control station.

Remarks	Following mitigation measures were provided on site: (1) sandbags were used at the gap of the bridge to avoid wastewater from site activities directly running down to the channel of I-1. (2) The working site was segregated with a wall and no wastewater was observed down to the channel-I1. (3) Sand/silts removal facilites was installed at the location of I-1.

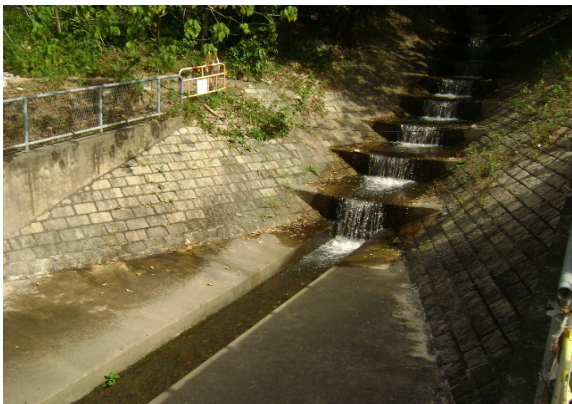
Photo taken at I-1

Project	Tsuen Wan Drainage Tunnel
Date	06-Nov-09
Time	10:07 AM
Monitoring Location	Sik Sik Yuen Ho Fung College (I-1)
Parameter	Turbidity
Action & Limit Levels	9.75 / 12.47
Measured Level	20.40
Possible reason for Action or Limit Level Non-compliance	A high turbidity level of 21.55 is recorded at Control Station (I-1-C) muddy stain was observed at the exit of closed channel at Shing Mun Lane referred to attached photo for details.
Actions taken / to be taken	The measured turbidity level was above baseline Action and Limit Levels as well as the range of baseline turbidity concentration (3.13 - 13.15 NTU). Construction activities, such as rock breaking, rock dowel and mucking out, were undertaken during the measurement and no direct disturbance was observed from the site. Thus, the exceedance is considered to be contributed by the high turbidity level of control station (I-1-C) and no action should be taken as the turbidity result at monitoring station was below the action and limit level of control station.

Remarks	Following mitigation measures were provided: (1) sandbags were used at the gap of the bridge to avoid wastewater from site activities directly running down to the channel of I-1. (2) The working site was segregated with a wall and no wastewater was observed down to the channel-I1. (3) Sand/silts removal facilites was installed at the location of I-1. The turbidity level at I-1 was below the baseline and upstream Action & Limit level for monitoring on 09-Nov-09.

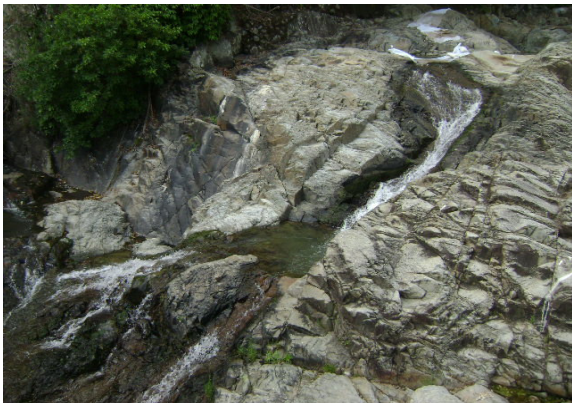
Photo taken at I-2

Project	Tsuen Wan Drainage Tunnel
Date	11-Nov-09
Time	10:27 AM
Monitoring Location	Hong Hoi Chee Hong Temple (I-2)
Parameter	Turbidity
Action & Limit Levels	6.63 / 6.99
Measured Level	9.89
Possible reason for Action or Limit Level Non-compliance	A high turbidity level of 10.29 is recorded at Control Station (I-2-C). There were construction activities of Landslip preventative works for slopes and retaining walls by CEDD at control station. (Refer to the photos below)
Actions taken / to be taken	The measured turbidity level was above baseline Action and Limit Levels as well as the range of baseline turbidity concentration (2.17 - 7.08 NTU). Construction activities, such as Steel Frame Erection and Formwork Erection for skin wall, were undertaken during the measurement and no direct disturbance was observed from the site. Thus, the exceedance is considered to be contributed by the high turbidity level of control station (I-2-C) and no action should be taken as the turbidity result at monitoring station was below the action and limit level of control station. .

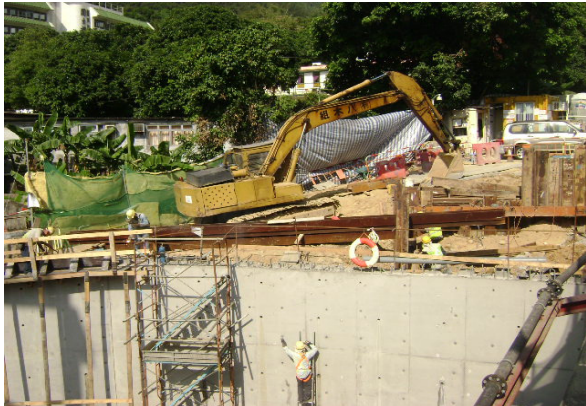
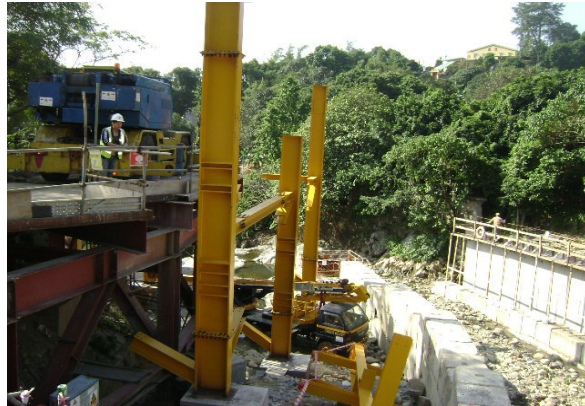
Site photo

Photographic record for exceedance of Suspended Solid recorded at Hong Hoi Chee Hong Temple (I-2) on 23-Nov-09

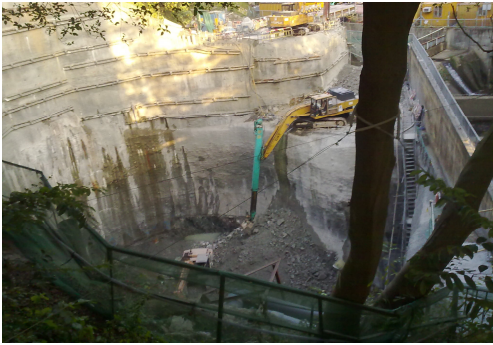
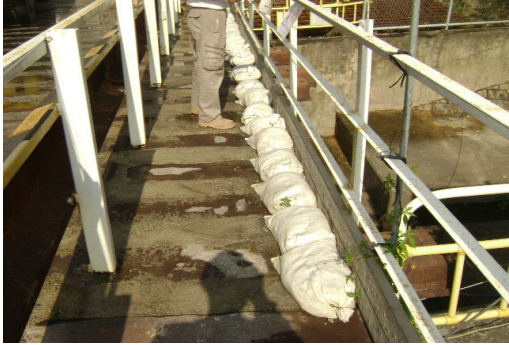
Site photo

Photographic record for exceedance of Suspended Solid recorded at Sik Sik Yuen Ho Fung College (I-1) on 25-Nov-09

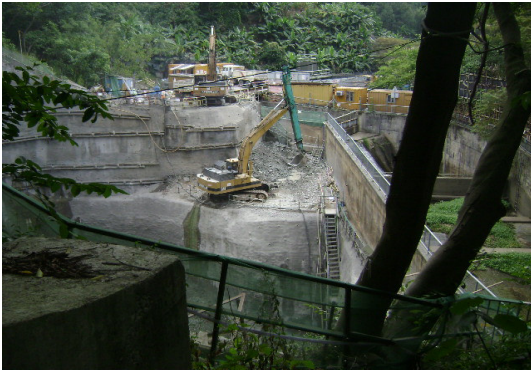
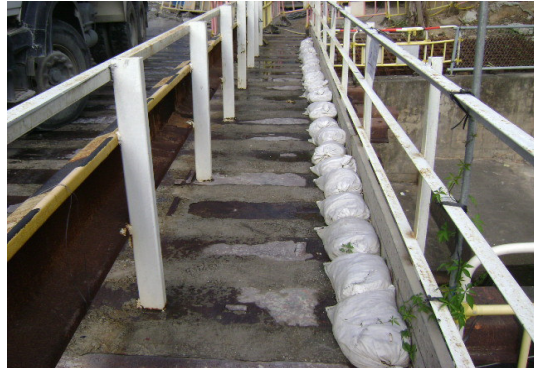
Site photo

Photographic record for exceedance of Suspended Solid recorded at Sik Sik Yuen Ho Fung College (I-1) on 27-Nov-09

Remarks	Following mitigation measures were provided: (1) sandbags were used at the gap of the bridge to avoid wastewater from site activities directly running down to the channel of I-1. (2) The working site was segregated with a wall and no wastewater was observed down to the channel-I1. (3) Sand/silts removal facilities was installed at the location of I-1.

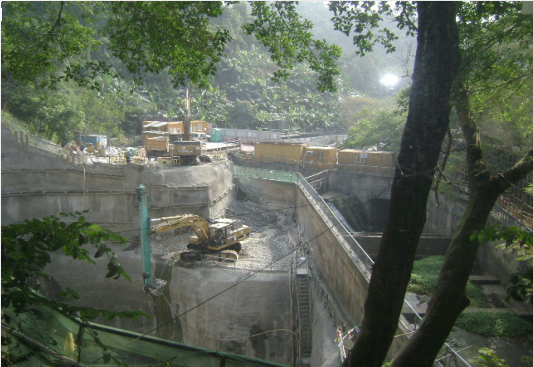
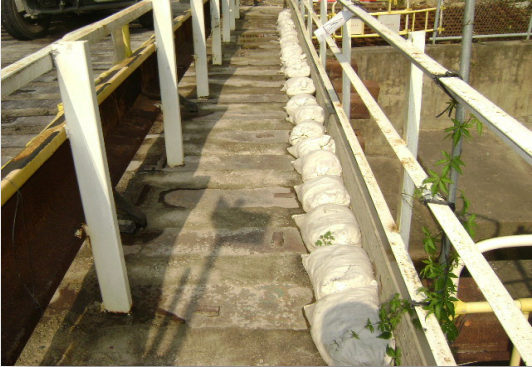
Site photo

Photographic record for exceedance of Suspended Solid recorded at Sik Sik Yuen Ho Fung College (I-1) on 30-Nov-09

Remarks	Following mitigation measures were provided: (1) sandbags were used at the gap of the bridge to avoid wastewater from site activities directly running down to the channel of I-1. (2) The working site was segregated with a wall and no wastewater was observed down to the channel-I1. (3) Sand/silts removal facilities was installed at the location of I-1.

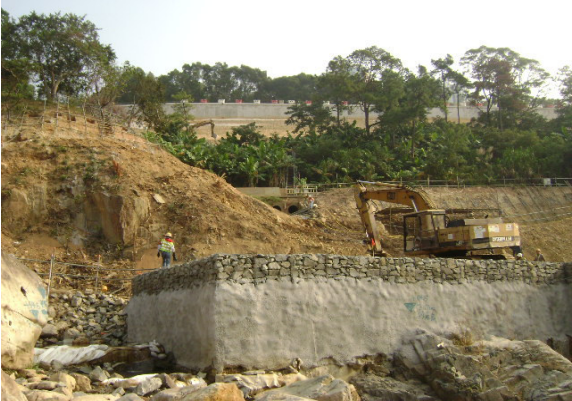
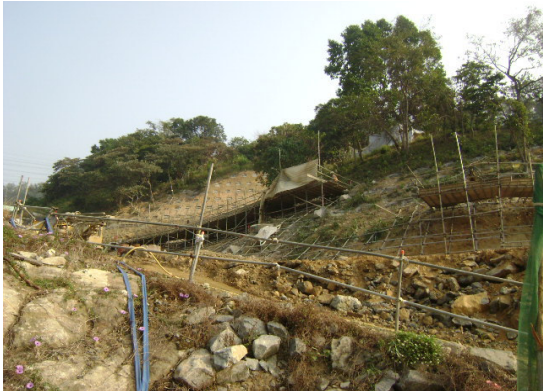
Site photo

Photographic record for exceedance of Suspended Solid recorded at Squatters (I-3) on 30-Nov-09
