Interim Notifications of Environmental Quality Limits Exceedances

Incident Report on Action Level or Limit Level Non-compliance

Project	Tsuen Wan Drainage Tunnel
Date	06-Jan-10
Time	10:30 AM
Monitoring Location	Sik Sik Yuen Ho Fung College (I-1)
Parameter	Turbidity
Action & Limit Levels	9.75 / 12.47
Measured Level	19.47
Possible reason for Action or Limit Level Non-compliance	A high turbidity level of 19.67 is recorded at Control Station (I-1-C). Other construction activities were carried out at control station during the measurement. (Refer to the photos below).
Actions taken / to be taken	The measured turbidity level was above baseline Action/Limit Levels as well as higher the range of baseline turbidity concentration (3.13-13.5 NTU). Construction activities, such as disposal of C&D materials, site cleaning and tidying as well as shotcrete to shaft wall, were undertaken during the measurement and no direct disturbance was observed from the site. Thus, the exceedance is considered to be contributed by the high turbidity level of control station (I-1-C) and no action should be taken as the turbidity result at monitoring station was below the action and limit level of control stat

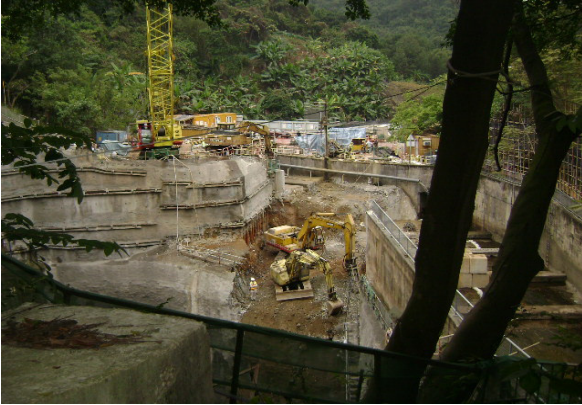
Site photo

Project	Tsuen Wan Drainage Tunnel
Date	06-Jan-10
Time	10:30 AM
Monitoring Location	Sik Sik Yuen Ho Fung College (I-1)
Parameter	Suspended Solid
Action & Limit Levels	8.85 / 10.17
Measured Level	13.6
Possible reason for Action or Limit Level Non-compliance	A high SS level of 16.3 is recorded at Control Station (I-1-C). Other construction activities were carried out at control station during the measurement. (Refer to the photos below).
Actions taken / to be taken	The measured SS level was above baseline Action/Limit Levels as well as higher than the range of baseline SS concentration (1-10.5mg/L). Construction activities, such as disposal of C&D materials, site cleaning and tidying as well as shotcrete to shaft wall, were undertaken during the measurement and no direct disturbance was observed from the site. Thus, the exceedance is considered to be contributed by the high SS level of control station (I-1-C) and no action should be taken as the SS result at monitoring station was below the action and limit level of control station.

Remarks	Following mitigation measures were provided: (1) sandbags were used at the gap of the bridge to avoid wastewater from site activities directly running down to the channel of I-1. (2) Water quality mitigation measures were implemented at working area and no wastewater was observed down to the channel-I1. (3) Sand/silts removal facilities was installed at the location of I-1.

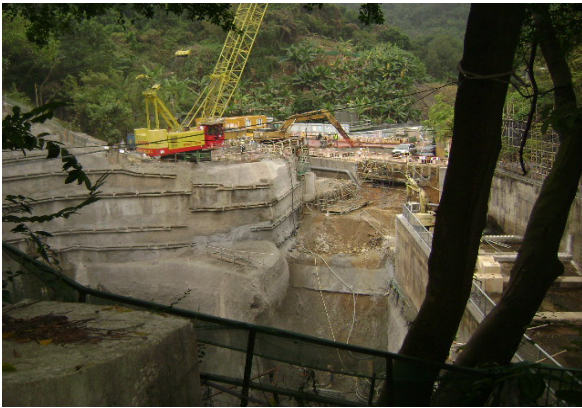
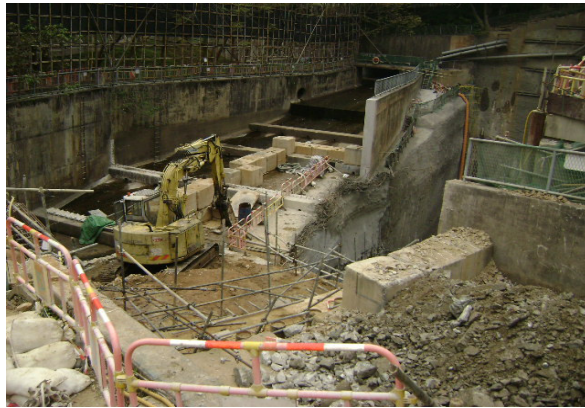
Site photo

Project	Tsuen Wan Drainage Tunnel
Date	22-Jan-10
Time	10:29 AM
Monitoring Location	Sik Sik Yuen Ho Fung College (I-1)
Parameter	Suspended Solid
Action & Limit Levels	8.85 / 10.17
Measured Level	5.9 (higher than 120% of control station's SS)
Possible reason for Action or Limit Level Non-compliance	A lower SS level of 4.8 is recorded at Control Station (I-1-C)
Actions taken / to be taken	The measured SS level was below baseline Action / Limit Level and was within the range of baseline SS concentration (1-10.5mg/L). Construction activities, such as site cleaning and tidying, disposal of C&D materials, shotcrete to shaft wall, and soil nailing for the support of Shing Mun Channel, were undertaken during the measurement and no direct disturbance was observed from the site. Thus, the exceedance is considered to be contributed by natural variation and no action should be required.
Remarks	Following mitigation measures were provided: (1) sandbags were used at the gap of the bridge to avoid wastewater from site activities directly running down to the channel of I-1. (2) Water quality mitigation measures were implemented at working area and no wastewater was observed down to the channel-I1. (3) Sand/silts removal facilities was installed at the location of I-1.

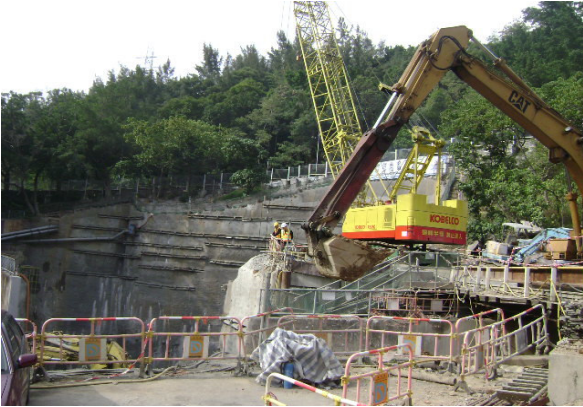
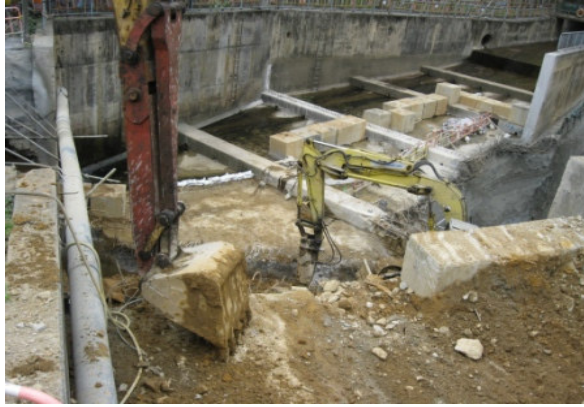
Site photo

Project	Tsuen Wan Drainage Tunnel
Date	27-Jan-10
Time	10:00 AM
Monitoring Location	Sik Sik Yuen Ho Fung College (I-1)
Parameter	Suspended Solid
Action & Limit Levels	8.85 / 10.17
Measured Level	10.15 (higher than baseline Action Level)
Possible reason for Action or Limit Level Non-compliance	SS level of 9.5 is recorded at Control Station (I-1-C)
Actions taken / to be taken	The measured SS level was above baseline Action Level but below baseline Limit Level, and it is within the range of baseline SS concentration (1-10.5mg/L). Construction activities, such as site cleaning and tidying, soil nailing as well as shotcrete to shaft wall, were undertaken during the measurement and no direct disturbance was observed from the site. Thus, the exceedance is considered to be contributed by natural variation and no action should be required.
Remarks	Following mitigation measures were provided: (1) sandbags were used at the gap of the bridge to avoid wastewater from site activities directly running down to the channel of I-1. (2) Water quality mitigation measures were implemented at working area and no wastewater was observed down to the channel-I1. (3) Sand/silts removal facilities was installed at the location of I-1.
