Interim Notification of Environmental Quality Limit Exceedance

Project	Tsuen Wan Drainage Tunnel
Date	01-Jun-11
Time	11:40 AM
Monitoring Location	O-1(ET)
Parameter	Dissolved Oxygen (marine mid-depth)
Action & Limit Levels (mg/L)	7.02 / 6.94
Measured Level (mg/L)	6.93
Control Station	O-1-C(ET)
Measured Level at the Control Station (mg/L)	7.00
Possible reason for Action or Limit Level Non-compliance	The measured DO level (marine mid-depth) of the monitoring station was slightly below the baseline limit level and the DO level at the corresponding control station. Relocation of C&D material to derrick barge was undertaken during monitoring and there was no other marine works conducted. Since the difference between the control station and impact monitoring was only 1%, the exceedance was considered contributed by natural variation and non-project related. Therefore, no further action was required.
Actions taken / to be taken	(1) Silt curtain was provided along the Portion E boundary line and extended from seawater level to the bottom of seabed; (2) floating type silt curtain was employed at the inner side; (3) sufficient slack of silt curtain was allowed to cope with the wave and tidal

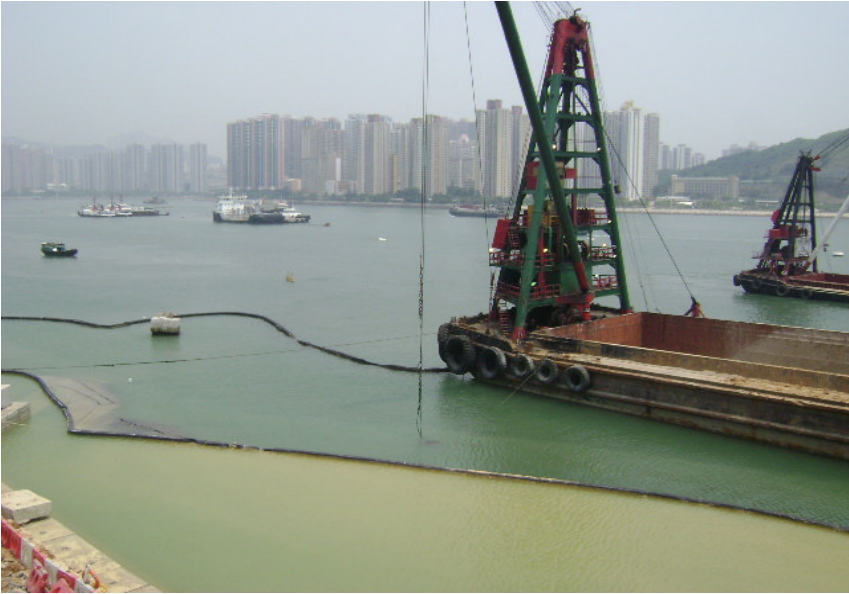
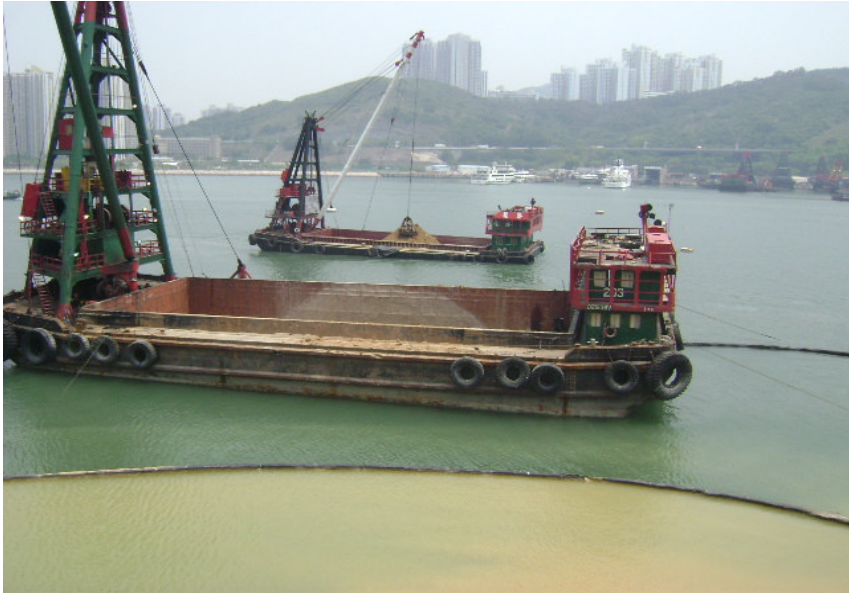
Photographic record for exceedance of Dissolved Oxygen (marine mid-depth) recorded at O-1(ET) on 01-Jun-11

Site photo

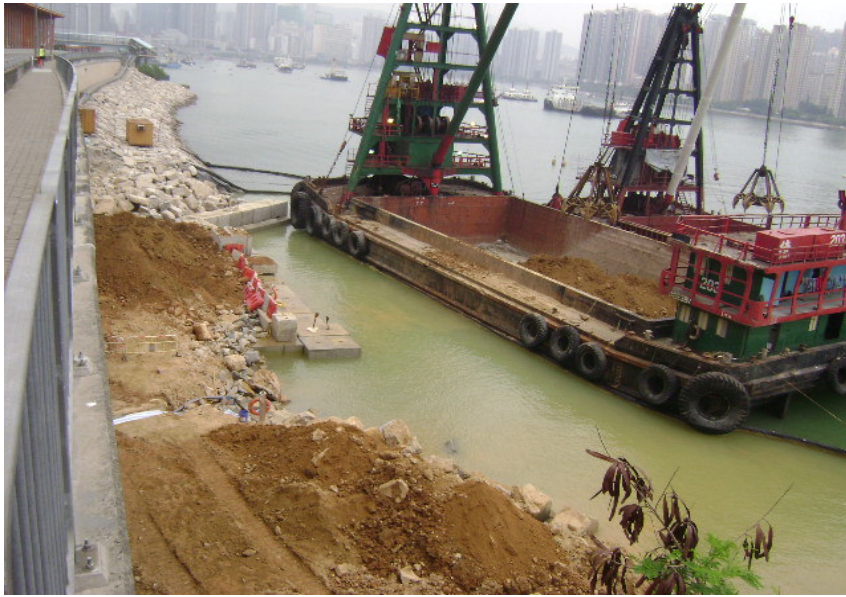
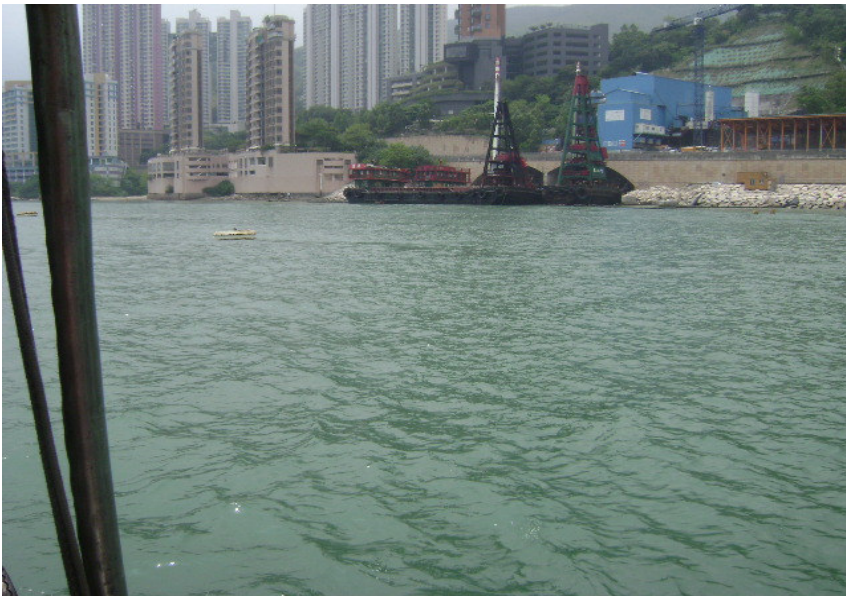
Photographic record for exceedance of Dissolved Oxygen (marine surface) recorded at O-1(ET) on 03-Jun-11

Project	Tsuen Wan Drainage Tunnel
Date	03-Jun-11
Time	1:33 PM
Monitoring Location	O-1(ET)
Parameter	Dissolved Oxygen (marine surface)
Action & Limit Levels (mg/L)	7.02 / 6.94
Measured Level (mg/L)	6.97
Control Station	O-1-C(ET)
Measured Level at the Control Station (mg/L)	7.20
Possible reason for Action or Limit Level Non-compliance	The measured DO level (marine surface) of the monitoring station was slightly below the baseline action level and was lower than the DO level at the corresponding control station. Making good of outer silt curtain and relocation of disposal materials from derrick barge (TB203) to another derrick barge (Kong Lung) was undertaken during monitoring. There was no other marine works conducted. No direct disturbance from the site was observed during monitoring. Therefore, the exceedance was considered to be contributed by natural variation and no further action was required.

Site photo

Site photo
(Photo taken at location near the site)

Actions taken / to be taken	(1) Silt curtain was provided along the Portion E boundary line and extended from seawater level to the bottom of seabed; (2) floating type silt curtain was employed at the inner side; (3) sufficient slack of silt curtain was allowed to cope with the wave and tidal action to ensure the curtains (outer and inner) were rested on seabed; (4) condition of silt curtains was checked by the supervisor daily; and (5) seawall blocks installation was undertaken within the inner silt curtain area only.
Remarks	None

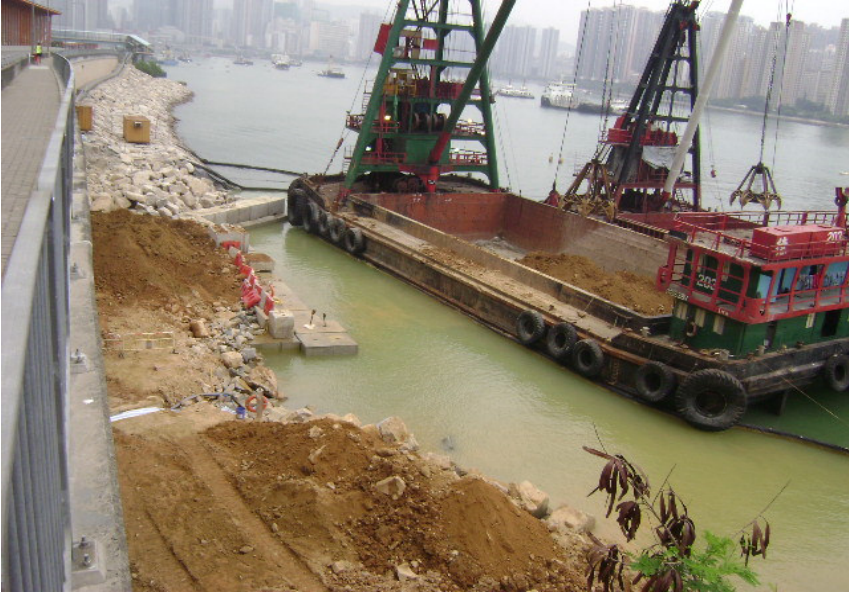
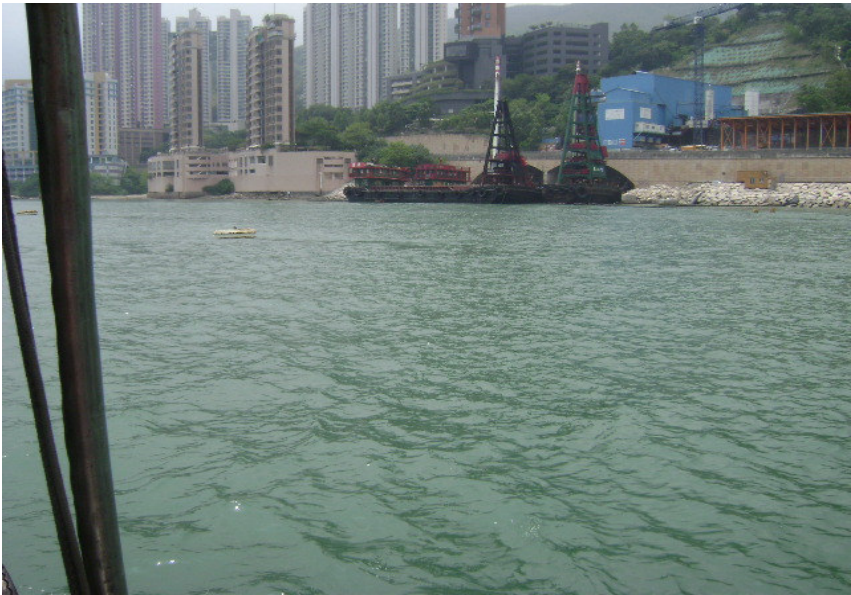
Photographic record for exceedance of Dissolved Oxygen (marine mid-depth) recorded at O-1(ET) on 03-Jun-11

Project	Tsuen Wan Drainage Tunnel
Date	03-Jun-11
Time	1:33 PM
Monitoring Location	O-1(ET)
Parameter	Dissolved Oxygen (marine mid-depth)
Action & Limit Levels (mg/L)	7.02 / 6.94
Measured Level (mg/L)	6.98
Control Station	O-1-C(ET)
Measured Level at the Control Station (mg/L)	6.92
Possible reason for Action or Limit Level Non-compliance	The measured DO level (marine mid-depth) of the monitoring station was slightly below the baseline action level but higher than the DO level at the corresponding control station. Making good of outer silt curtain and relocation of disposal materials from derrick barge (TB203) to another derrick barge (Kong Lung) was undertaken during monitoring. There was no other marine works conducted. No direct disturbance from the site was observed during monitoring. Therefore, the exceedance was considered to be contributed by natural variation and no further action was required.

Site photo

Site photo
(Photo taken at location near the site)

Actions taken / to be taken	(1) Silt curtain was provided along the Portion E boundary line and extended from seawater level to the bottom of seabed; (2) floating type silt curtain was employed at the inner side; (3) sufficient slack of silt curtain was allowed to cope with the wave and tidal action to ensure the curtains (outer and inner) were rested on seabed; (4) condition of silt curtains was checked by the supervisor daily; and (5) seawall blocks installation was undertaken within the inner silt curtain area only.
Remarks	None

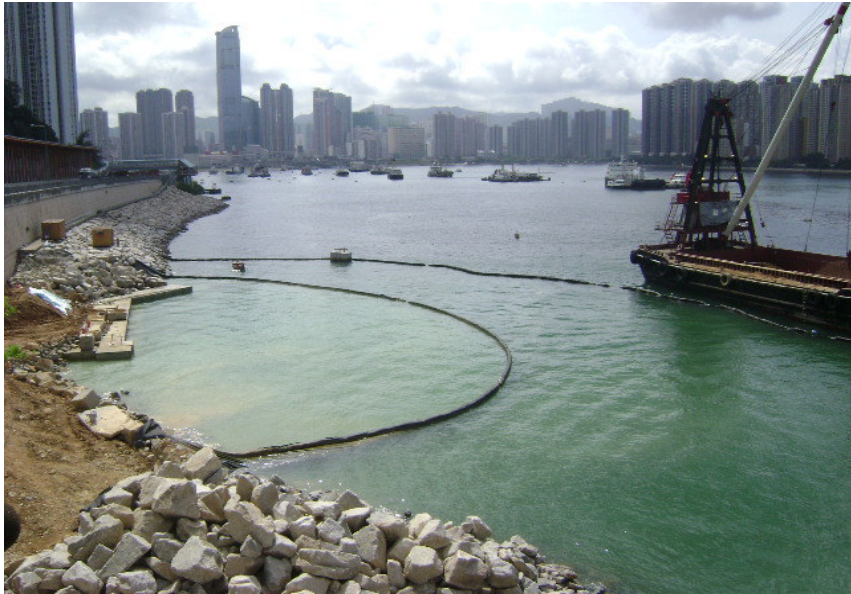
Photographic record for exceedance of Dissolved Oxygen (marine bottom) recorded at O-1(FT) on 07-Jun-11

Project	Tsuen Wan Drainage Tunnel
Date	07-Jun-11
Time	9:40 AM
Monitoring Location	O-1(FT)
Parameter	Dissolved Oxygen (marine bottom)
Action & Limit Levels (mg/L)	6.99 / 6.96
Measured Level (mg/L)	6.94
Control Station	O-1-C(FT)
Measured Level at the Control Station (mg/L)	7.08
Possible reason for Action or Limit Level Non-compliance	The measured DO level (marine bottom) at the monitoring station was slightly below the baseline limit level and was below the DO level of the corresponding control station (about 2.0%). Only loading seawall blocks onto derrick barge was undertaken at the Outfall basin (Portion E) during monitoring. No other marine works was conducted. No direct disturbance from the site was observed during monitoring. Therefore, the exceedance was considered to be contributed by natural variation and no further action was required.
Actions taken / to be taken	(1) Silt curtain was provided along the Portion E boundary line and extended from seawater level to the bottom of seabed; (2) floating type silt curtain was employed at the inner side; (3) sufficient slack of silt curtain was allowed to cope with the wave and tidal action to ensure the curtains (outer and inner) were rested on seabed; (4) condition of silt curtains was checked by the supervisor daily; and (5) seawall blocks installation was undertaken within the inner silt curtain area only.

Site photo

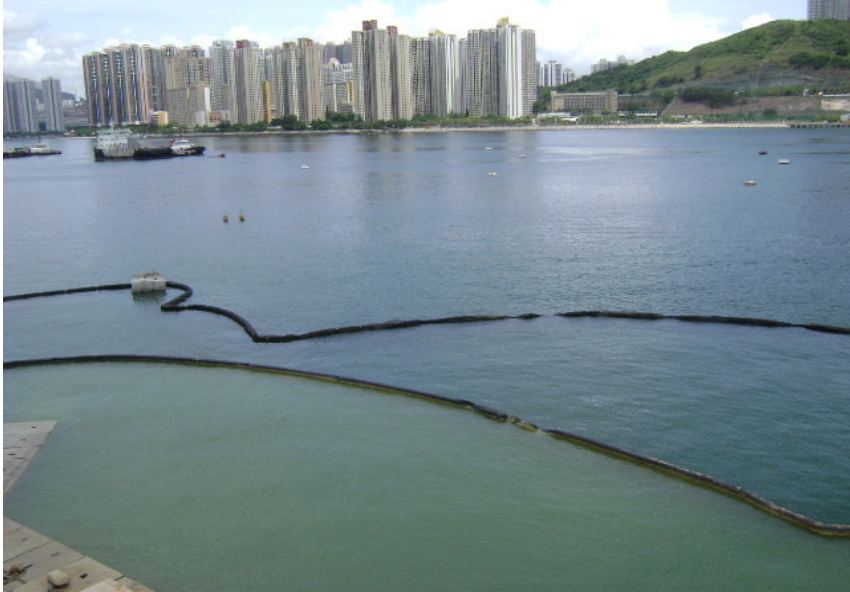
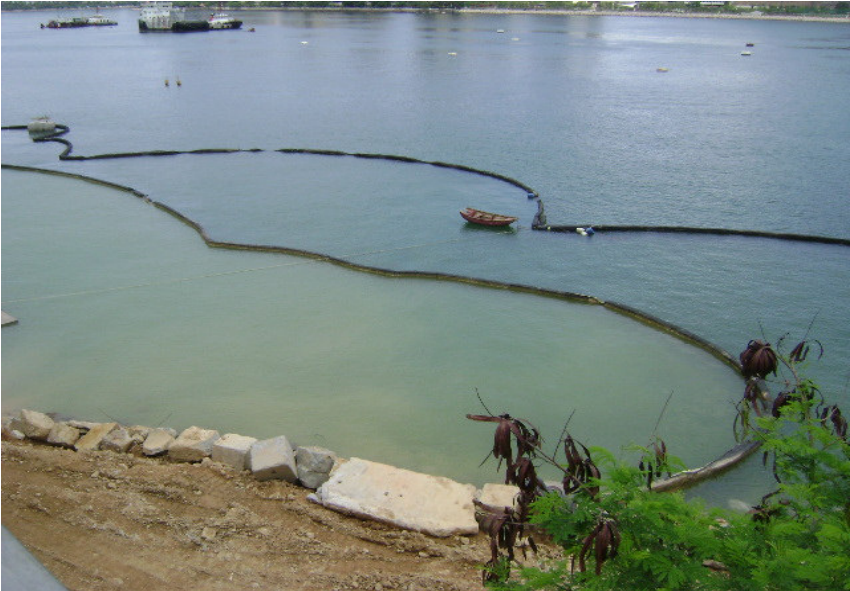
Photographic record for exceedance of Dissolved Oxygen (marine surface) recorded at O-1(ET) on 07-Jun-11

Project	Tsuen Wan Drainage Tunnel
Date	07-Jun-11
Time	2:33 PM
Monitoring Location	O-1(ET)
Parameter	Dissolved Oxygen (marine surface)
Action & Limit Levels (mg/L)	7.02 / 6.94
Measured Level (mg/L)	6.98
Control Station	O-1-C(ET)
Measured Level at the Control Station (mg/L)	7.02
Possible reason for Action or Limit Level Non-compliance	The measured DO level (marine surface) of the monitoring station was slightly below the baseline action level and DO level at the corresponding control station. Only loading seawall blocks onto derrick barge was undertaken at the Outfall basin (Portion E) on the monitoring day. No other marine works was conducted. No direct disturbance from the site was observed during monitoring. Therefore, the exceedance was considered to be contributed by natural variation and no further action was required.
Actions taken / to be taken	(1) Silt curtain was provided along the Portion E boundary line and extended from seawater level to the bottom of seabed; (2) floating type silt curtain was employed at the inner side; (3) sufficient slack of silt curtain was allowed to cope with the wave and tidal action to ensure the curtains (outer and inner) were rested on seabed; (4) condition of silt curtains was checked by the supervisor daily; and (5) seawall blocks installation was undertaken within the inner silt curtain area only.

Site photo

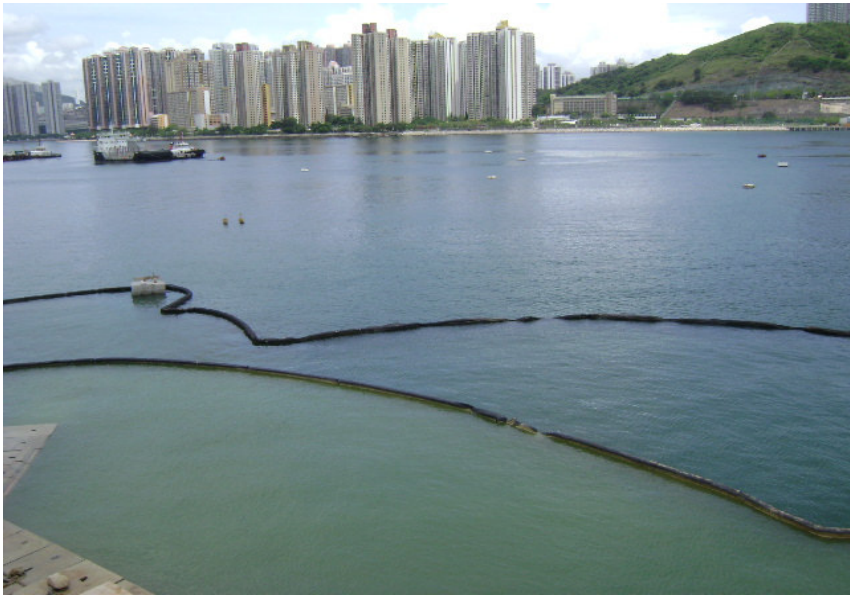
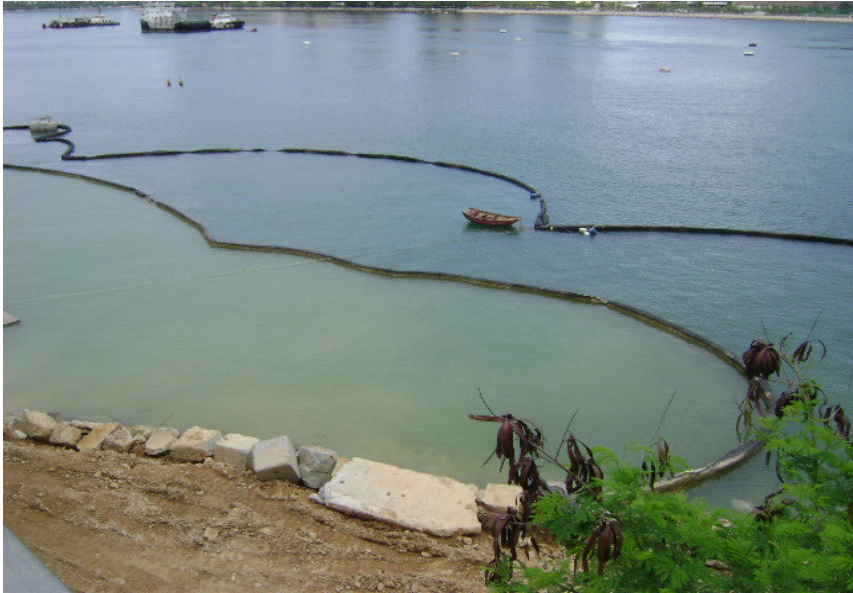
Photographic record for exceedance of Dissolved Oxygen (marine mid-depth) recorded at O-1(ET) on 07-Jun-11

Project	Tsuen Wan Drainage Tunnel
Date	07-Jun-11
Time	2:33 PM
Monitoring Location	O-1(ET)
Parameter	Dissolved Oxygen (marine mid-depth)
Action & Limit Levels (mg/L)	7.02 / 6.94
Measured Level (mg/L)	6.94
Control Station	O-1-C(ET)
Measured Level at the Control Station (mg/L)	7.11
Possible reason for Action or Limit Level Non-compliance	The measured DO level (marine mid-depth) of the monitoring station was below the baseline action level and DO level at the corresponding control station. Only loading seawall blocks onto derrick barge was undertaken at the Outfall basin (Portion E) on the monitoring day. No other marine works was conducted. No direct disturbance from the site was observed during monitoring. Therefore, the exceedance was considered to be contributed by natural variation and no further action was required.
Actions taken / to be taken	(1) Silt curtain was provided along the Portion E boundary line and extended from seawater level to the bottom of seabed; (2) floating type silt curtain was employed at the inner side; (3) sufficient slack of silt curtain was allowed to cope with the wave and tidal action to ensure the curtains (outer and inner) were rested on seabed; (4) condition of silt curtains was checked by the supervisor daily; and (5) seawall blocks installation was undertaken within the inner silt curtain area only.

Site photo

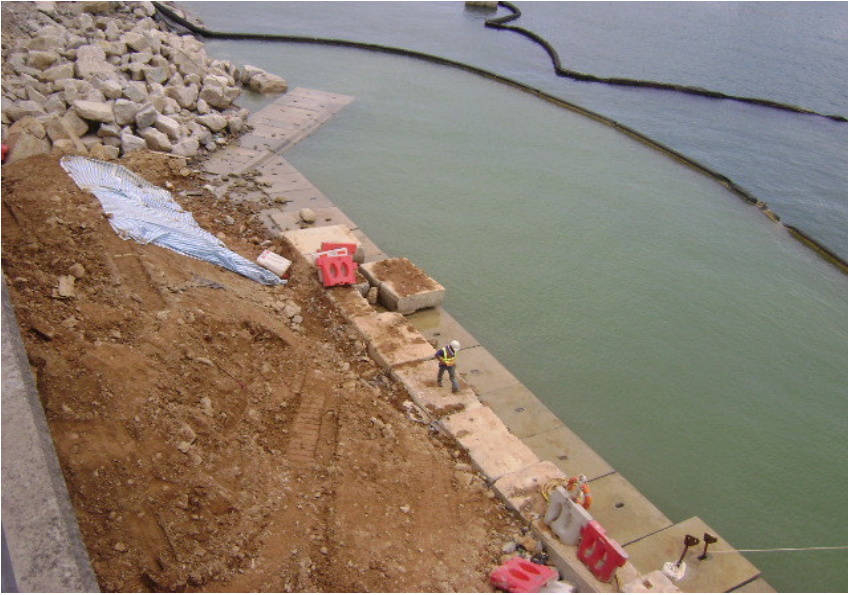
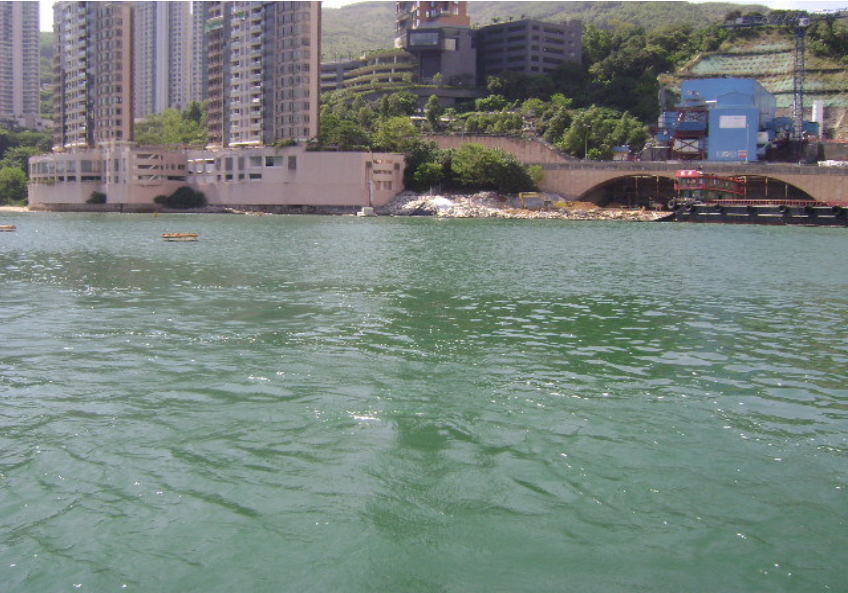
Photographic record for exceedance of Dissolved Oxygen (marine surface) recorded at O-1(ET) on 09-Jun-11

Project	Tsuen Wan Drainage Tunnel
Date	09-Jun-11
Time	4:30 PM
Monitoring Location	O-1(ET)
Parameter	Dissolved Oxygen (marine surface)
Action & Limit Levels (mg/L)	7.02 / 6.94
Measured Level (mg/L)	6.89
Control Station	O-1-C(ET)
Measured Level at the Control Station (mg/L)	7.00
Possible reason for Action or Limit Level Non-compliance	The measured DO level (marine surface) of the monitoring station was slightly below the baseline action level and was lower than DO level at the corresponding control station (about 1.5%). Only relocation of type II armour and making good of silt curtain were undertaken at the Outfall basin (Portion E) during monitoring. No other marine works was conducted. No direct disturbance from the site was observed during monitoring. Therefore, the exceedance was considered to be contributed by natural variation and no further action was required.
Actions taken / to be taken	(1) Silt curtain was provided along the Portion E boundary line and extended from seawater level to the bottom of seabed; (2) floating type silt curtain was employed at the inner side; (3) sufficient slack of silt curtain was allowed to cope with the wave and tidal action to ensure the curtains (outer and inner) were rested on seabed; (4) condition of silt curtains was checked by the supervisor daily; and (5) seawall blocks installation was undertaken within the inner silt curtain area only.

Site photo

Site photo
(Photo taken at location near the site)

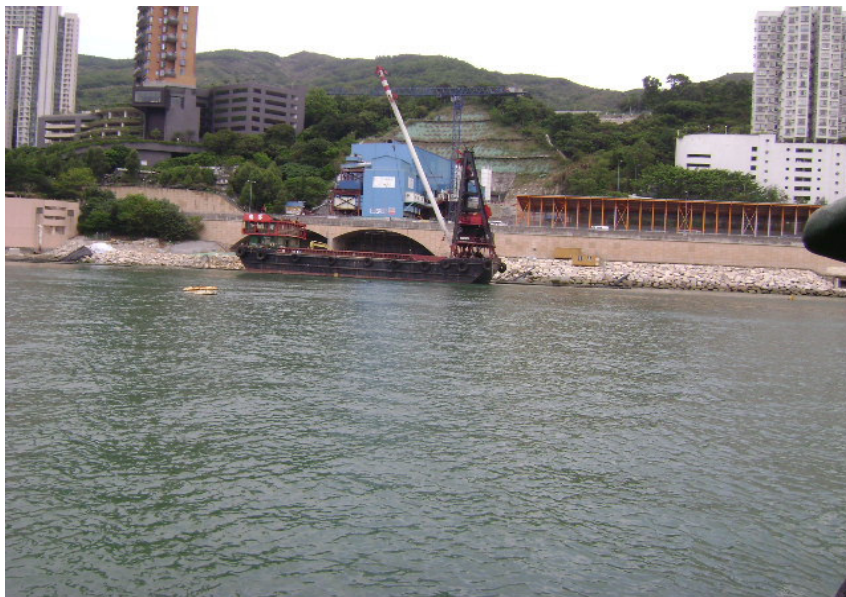
Photographic record for exceedance of Dissolved Oxygen (marine bottom) recorded at O-1(FT) on 11-Jun-11

Project	Tsuen Wan Drainage Tunnel
Date	11-Jun-11
Time	1:22 PM
Monitoring Location	O-1(FT)
Parameter	Dissolved Oxygen (marine bottom)
Action & Limit Levels (mg/L)	6.99 / 6.96
Measured Level (mg/L)	6.83
Control Station	O-1-C(FT)
Measured Level at the Control Station (mg/L)	6.90
Possible reason for Action or Limit Level Non-compliance	The measured DO level (marine bottom) at the monitoring station was below the baseline limit level and slightly lower than DO level of the corresponding control station (about 1.0%). Only outer silt curtain maintenance and repairing was undertaken at the Outfall basin (Portion E) on the monitoring day. No other marine works was conducted. No direct disturbance from the site was observed during monitoring. Therefore, the exceedance was considered to be contributed by natural variation and no further action was required.
Actions taken / to be taken	(1) Silt curtain was provided along the Portion E boundary line and extended from seawater level to the bottom of seabed; (2) floating type silt curtain was employed at the inner side; (3) sufficient slack of silt curtain was allowed to cope with the wave and tidal action to ensure the curtains (outer and inner) were rested on seabed; (4) condition of silt curtains was checked by the supervisor daily; and (5) seawall blocks installation was undertaken within the inner silt curtain area only.

Site photo
(Photo taken at location
near the site)

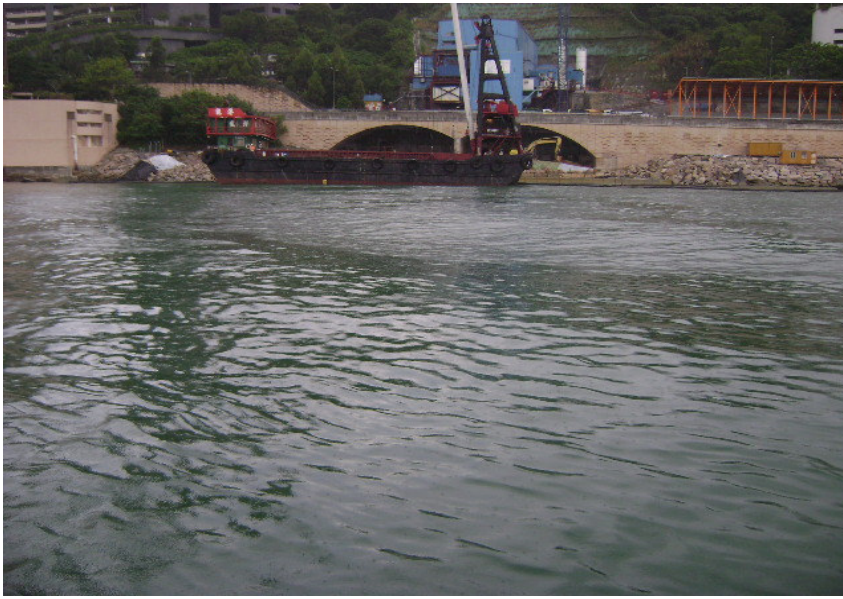
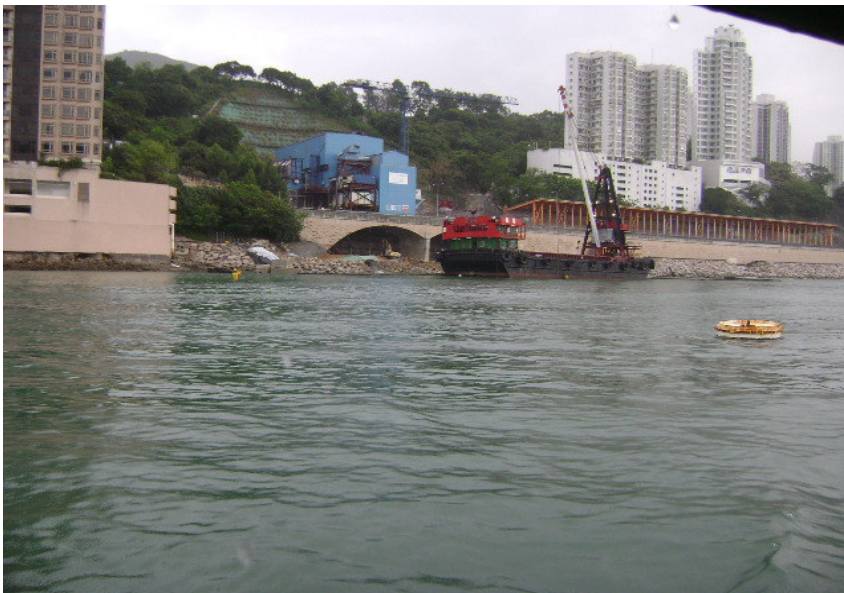
Photographic record for exceedance of Dissolved Oxygen (marine surface) recorded at O-1(ET) on 11-Jun-11

Project	Tsuen Wan Drainage Tunnel
Date	11-Jun-11
Time	9:33 AM
Monitoring Location	O-1(ET)
Parameter	Dissolved Oxygen (marine surface)
Action & Limit Levels (mg/L)	7.02 / 6.94
Measured Level (mg/L)	6.76
Control Station	O-1-C(ET)
Measured Level at the Control Station (mg/L)	6.82
Possible reason for Action or Limit Level Non-compliance	The measured DO level (marine surface) of the monitoring station was below the baseline limit level and slightly lower than DO level at the corresponding control station (less than 1%). Only outer silt curtain maintenance and repairing was undertaken at the Outfall basin (Portion E) on the monitoring day. No other marine works was conducted. No direct disturbance from the site was observed during monitoring. Therefore, the exceedance was considered to be contributed by natural variation and no further action was required.
Actions taken / to be taken	(1) Silt curtain was provided along the Portion E boundary line and extended from seawater level to the bottom of seabed; (2) floating type silt curtain was employed at the inner side; (3) sufficient slack of silt curtain was allowed to cope with the wave and tidal action to ensure the curtains (outer and inner) were rested on seabed; (4) condition of silt curtains was checked by the supervisor daily; and (5) seawall blocks installation was undertaken within the inner silt curtain area only.

Site photo
(Photo taken at location
near O-1(ET))

Site photo
(Photo taken at location
near O-1-C(ET))

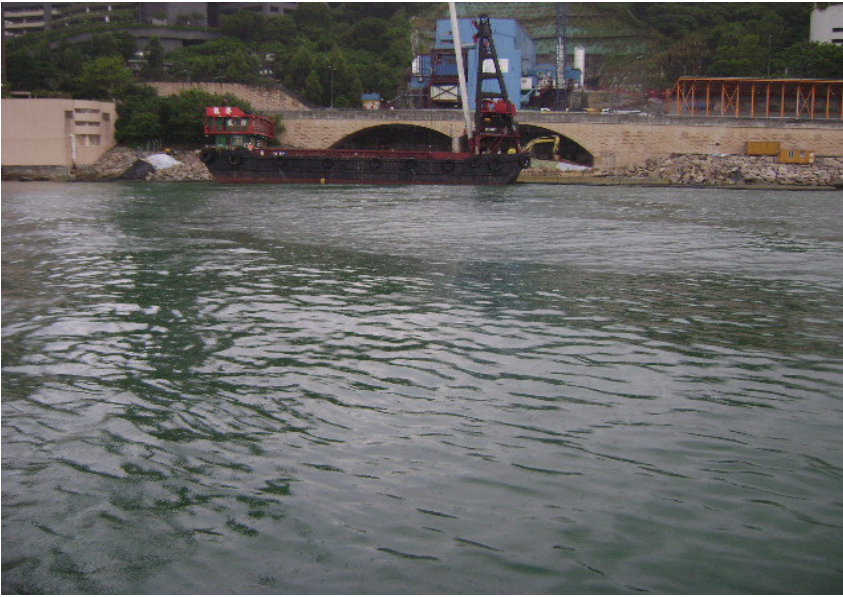
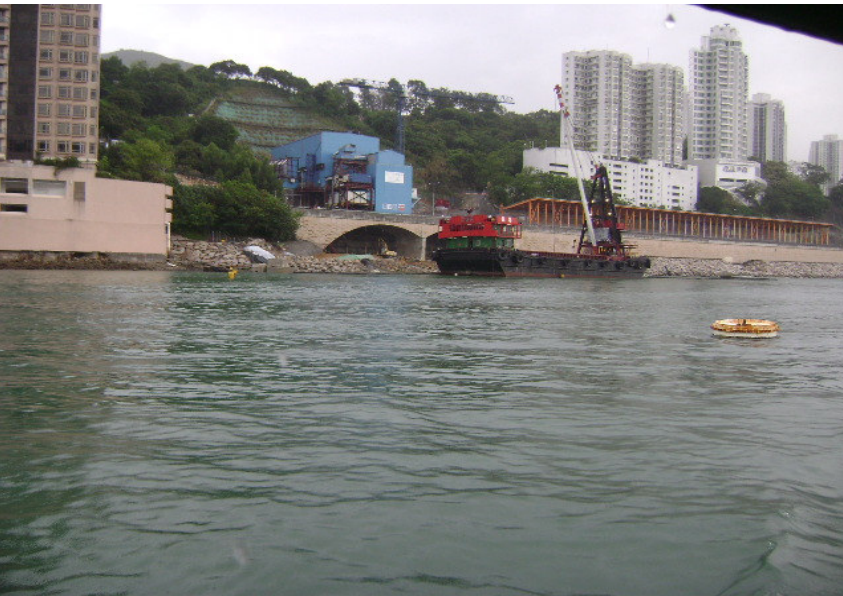
Photographic record for exceedance of Dissolved Oxygen (marine mid-depth) recorded at O-1(ET) on 11-Jun-11

Project	Tsuen Wan Drainage Tunnel
Date	11-Jun-11
Time	9:33 AM
Monitoring Location	O-1(ET)
Parameter	Dissolved Oxygen (marine mid-depth)
Action & Limit Levels (mg/L)	7.02 / 6.94
Measured Level (mg/L)	6.89
Control Station	O-1-C(ET)
Measured Level at the Control Station (mg/L)	6.92
Possible reason for Action or Limit Level Non-compliance	The measured DO level (marine mid-depth) of the monitoring station was below the baseline limit level and slightly lower than DO level at the corresponding control station (less than 0.5%). Only outer silt curtain maintenance and repairing was undertaken at the Outfall basin (Portion E) on the monitoring day. No other marine works was conducted. No direct disturbance from the site was observed during monitoring. Therefore, the exceedance was considered to be contributed by natural variation and no further action was required.
Actions taken / to be taken	(1) Silt curtain was provided along the Portion E boundary line and extended from seawater level to the bottom of seabed; (2) floating type silt curtain was employed at the inner side; (3) sufficient slack of silt curtain was allowed to cope with the wave and tidal action to ensure the curtains (outer and inner) were rested on seabed; (4) condition of silt curtains was checked by the supervisor daily; and (5) seawall blocks installation was undertaken within the inner silt curtain area only.

Site photo
(Photo taken at location
near O-1(ET))

Site photo
(Photo taken at location
near O-1-C(ET))

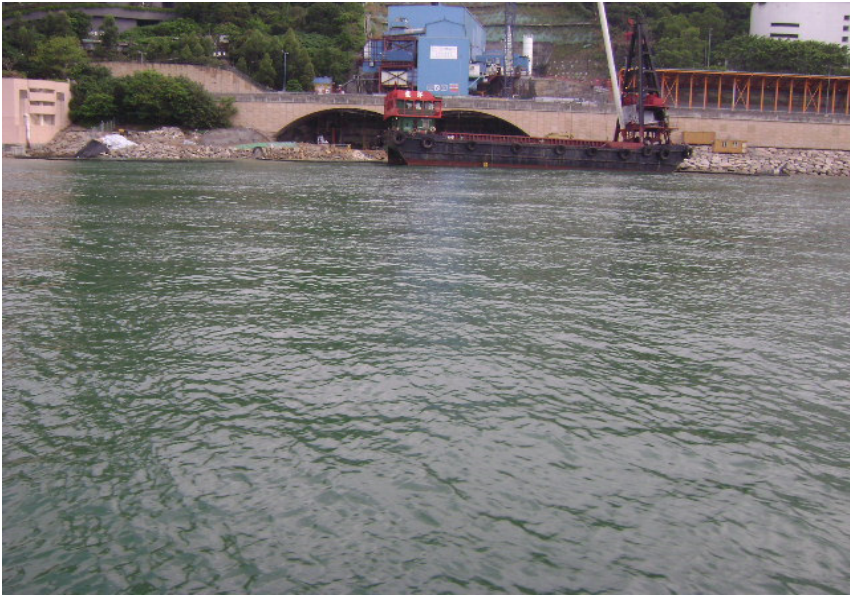
Photographic record for exceedance of Dissolved Oxygen (marine bottom) recorded at O-1(FT) on 13-Jun-11

Project	Tsuen Wan Drainage Tunnel
Date	13-Jun-11
Time	3:28 PM
Monitoring Location	O-1(FT)
Parameter	Dissolved Oxygen (marine bottom)
Action & Limit Levels (mg/L)	6.99 / 6.96
Measured Level (mg/L)	6.89
Control Station	O-1-C(FT)
Measured Level at the Control Station (mg/L)	6.89
Possible reason for Action or Limit Level Non-compliance	The measured DO level (marine bottom) at the monitoring station was below the baseline limit level but same as DO level of the corresponding control station. Only outer silt curtain maintenance and repairing was undertaken at the Outfall basin (Portion E) on the monitoring day. No other marine works was conducted. No direct disturbance from the site was observed during monitoring. Therefore, the exceedance was considered to be contributed by natural variation and no further action was required.
Actions taken / to be taken	(1) Silt curtain was provided along the Portion E boundary line and extended from seawater level to the bottom of seabed; (2) floating type silt curtain was employed at the inner side; (3) sufficient slack of silt curtain was allowed to cope with the wave and tidal action to ensure the curtains (outer and inner) were rested on seabed; (4) condition of silt curtains was checked by the supervisor daily; and (5) seawall blocks installation was undertaken within the inner silt curtain area only.

Site photo
(Photo taken at location
near the site)

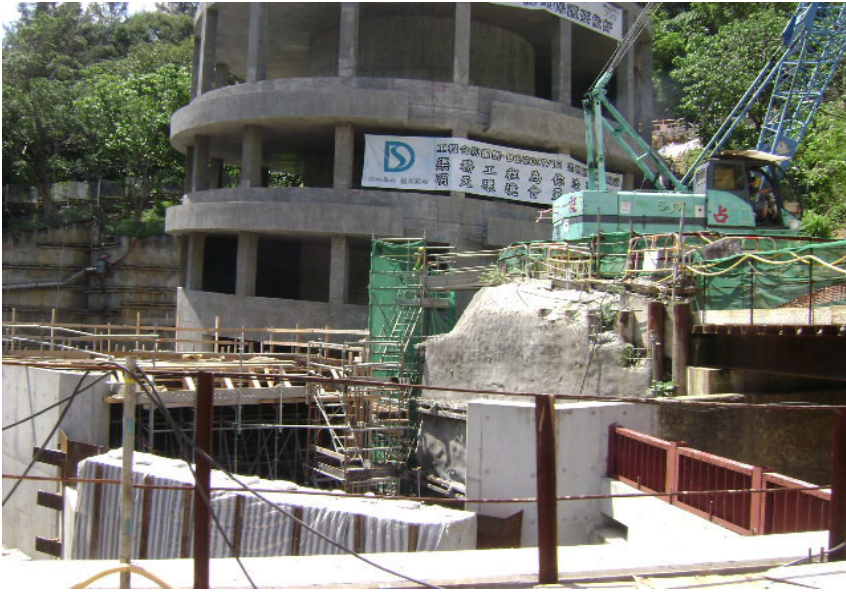
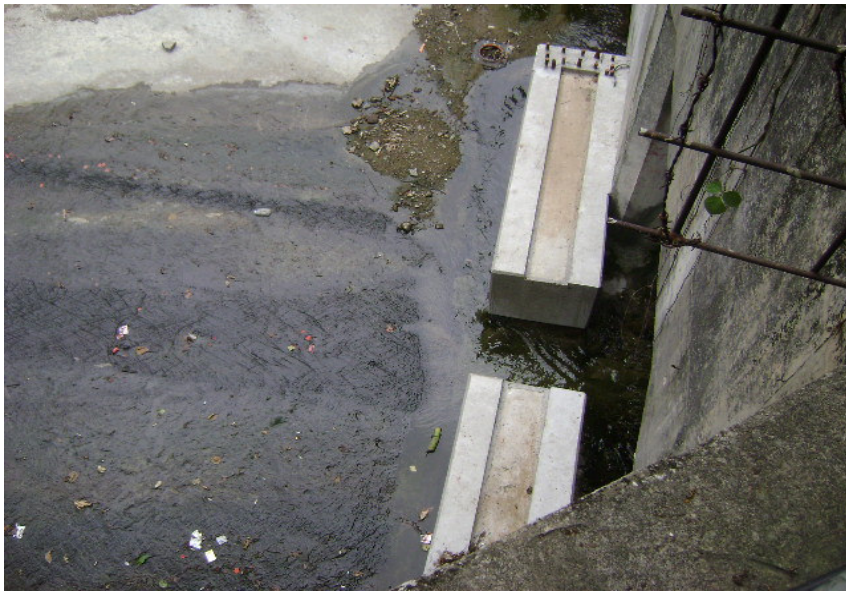
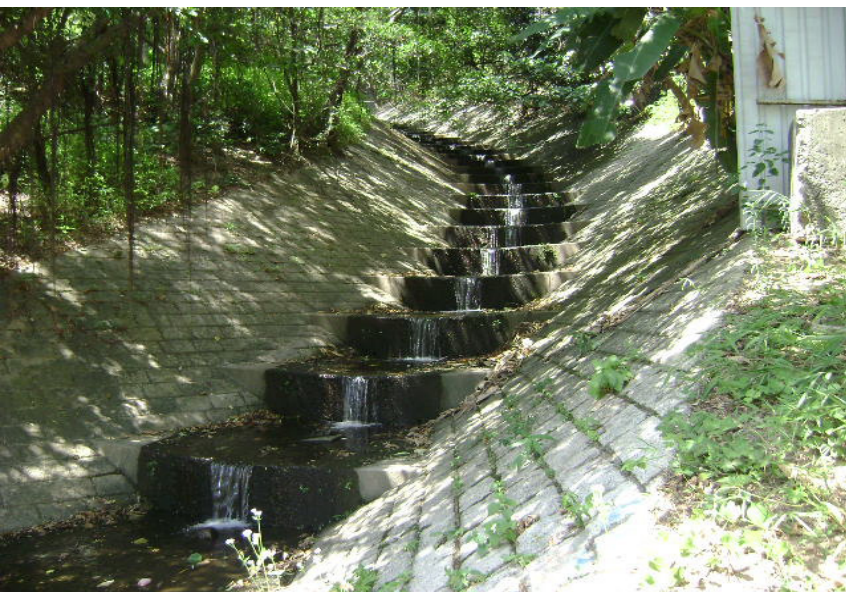
Photographic record for exceedance of Suspended Solid recorded at Sik Sik Yuen Ho Fung College (I-1) on 09-Jun-11

Site photo

Photo taken at I-1

Photo taken at I-1-C

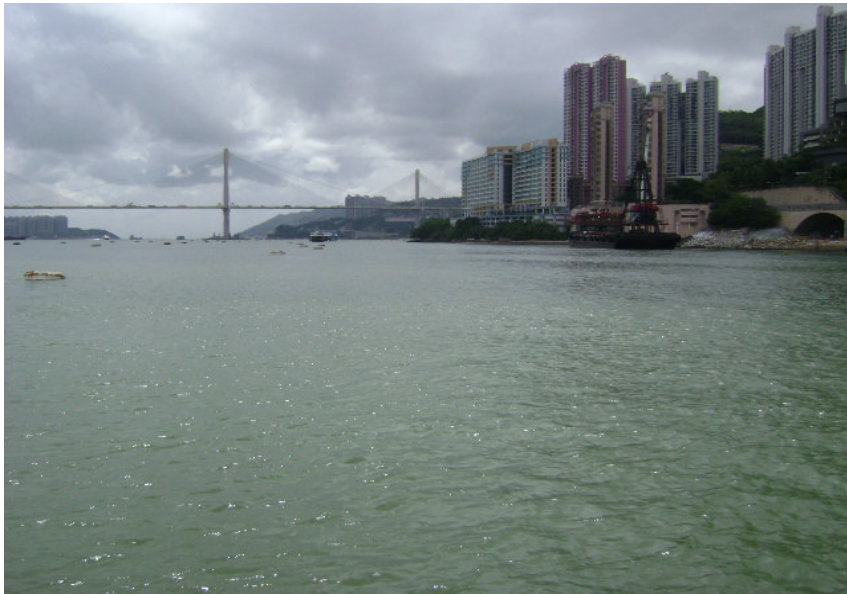
**Photographic record for exceedance of Dissolved Oxygen (marine surface) recorded at O-1(FT)
on 15-Jun-11**

Site photo
(Photo taken at location
near O-1-C(FT))

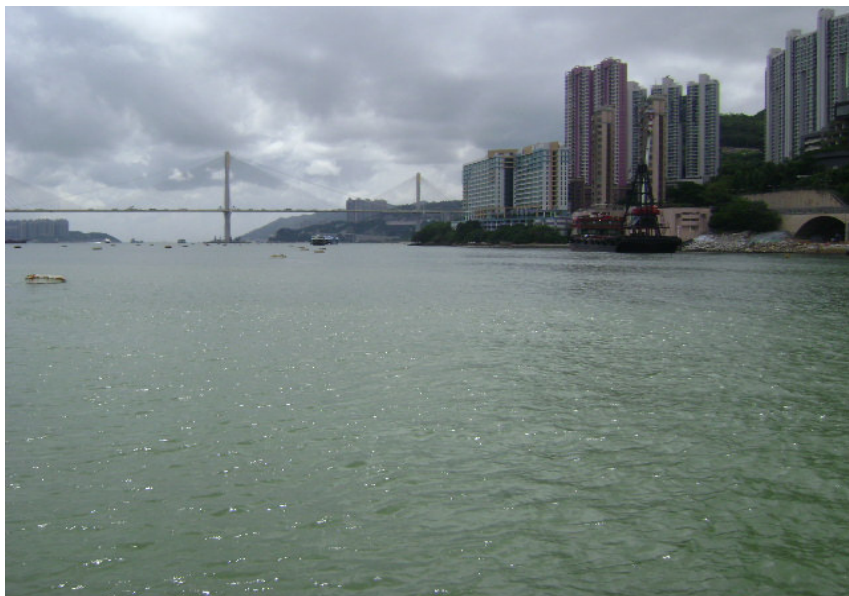
Photographic record for exceedance of Dissolved Oxygen (marine bottom) recorded at O-1(FT) on 15-Jun-11

Site photo
(Photo taken at location
near O-1-C(FT))

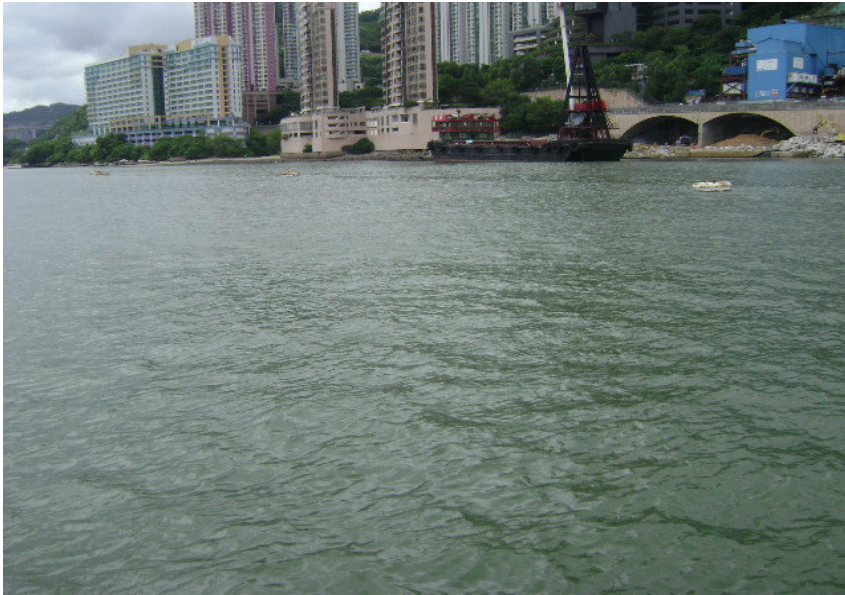
Photographic record for exceedance of Dissolved Oxygen (marine surface) recorded at O-1(ET) on 15-Jun-11

Site photo
(Photo taken at location
near the site)

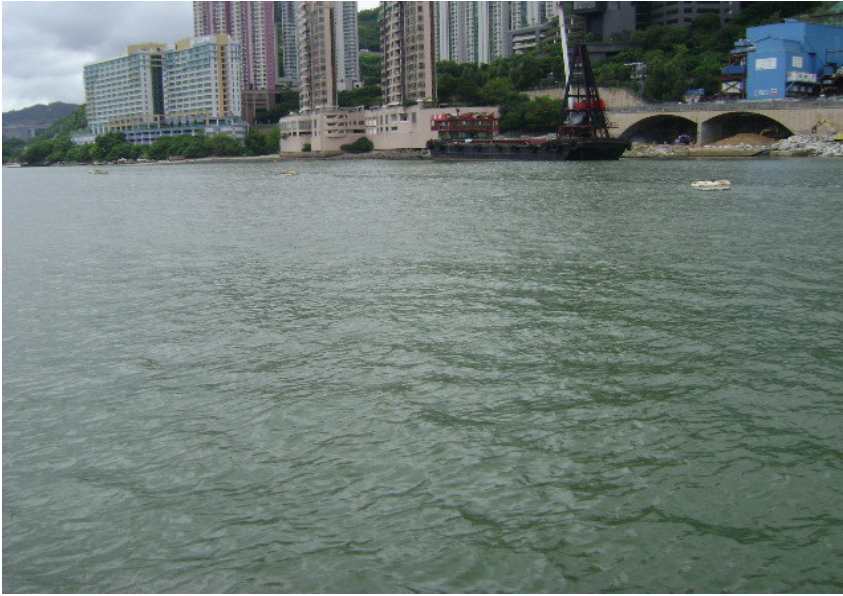
Photographic record for exceedance of Dissolved Oxygen (marine mid-depth) recorded at O-1(ET) on 15-Jun-11

Site photo
(Photo taken at location
near the site)

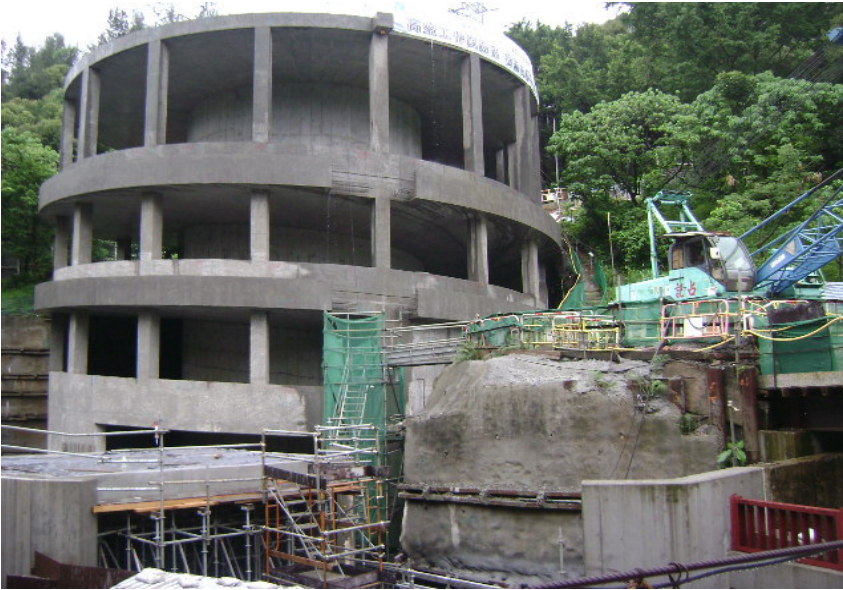
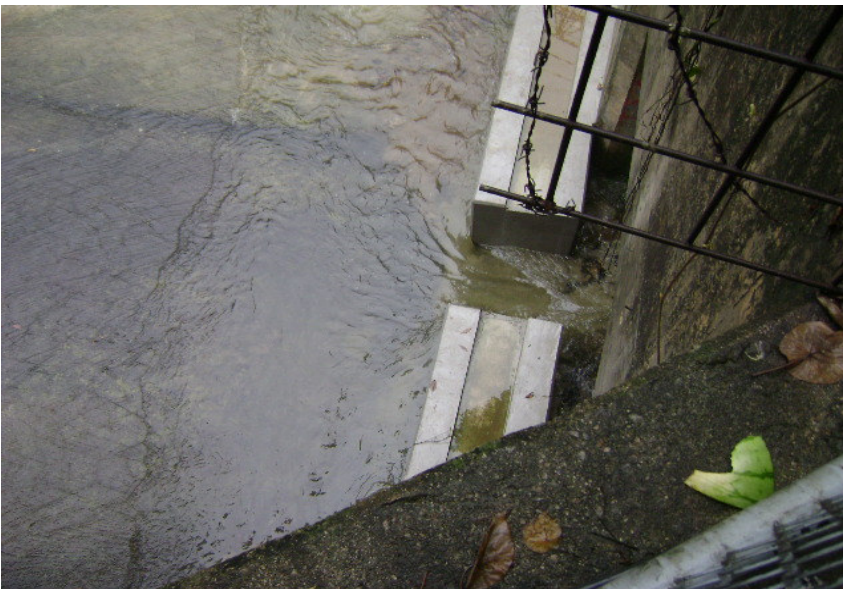
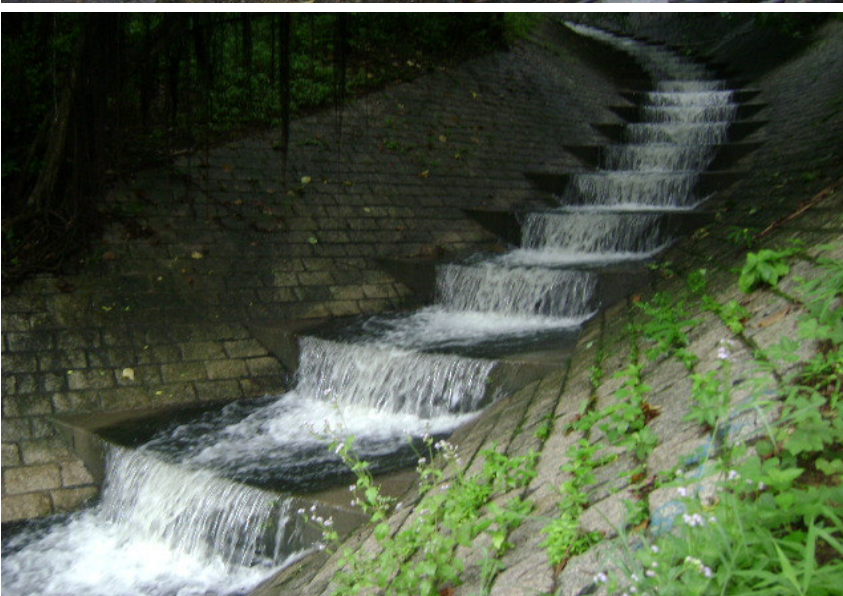
Photographic record for exceedance of Turbidity recorded at Sik Sik Yuen Ho Fung College (I-1)
on 17-Jun-11

Site photo

Photo taken at I-1

Photo taken at I-1-C

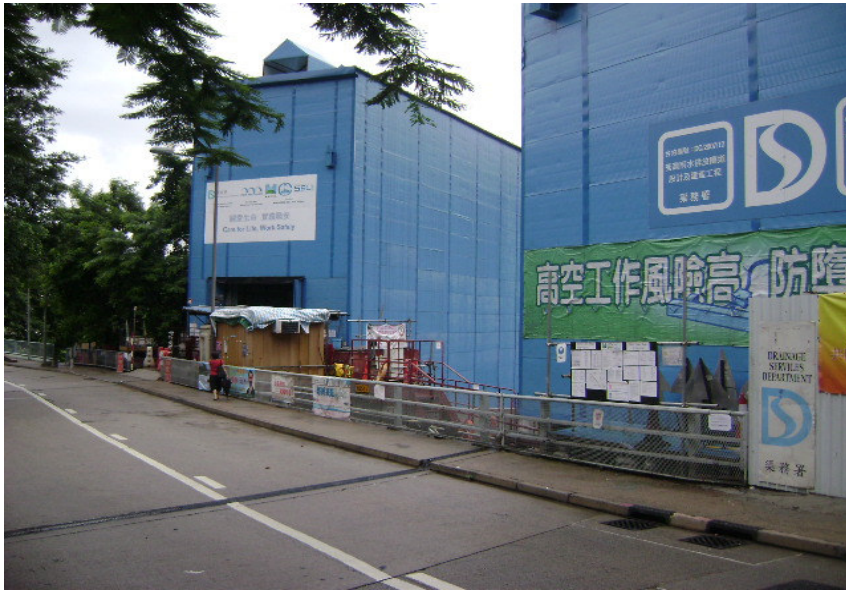
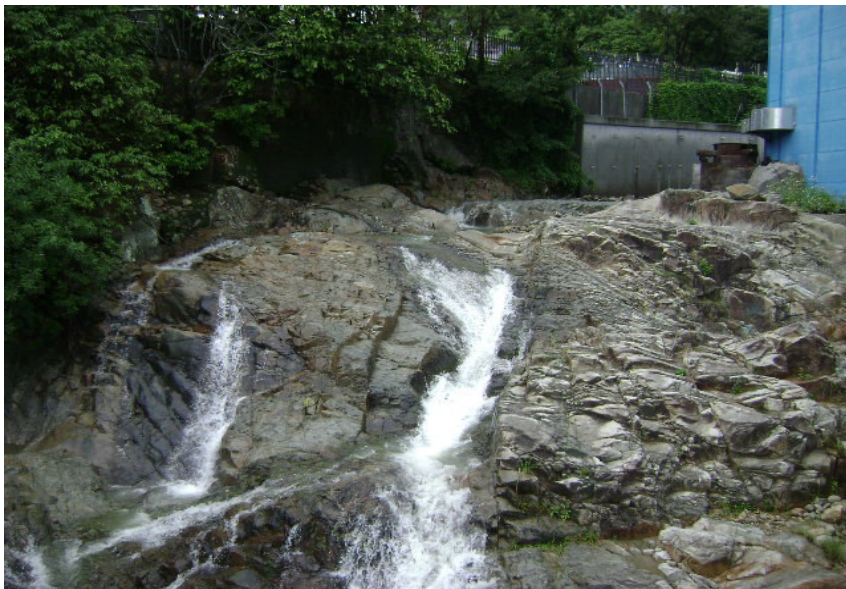
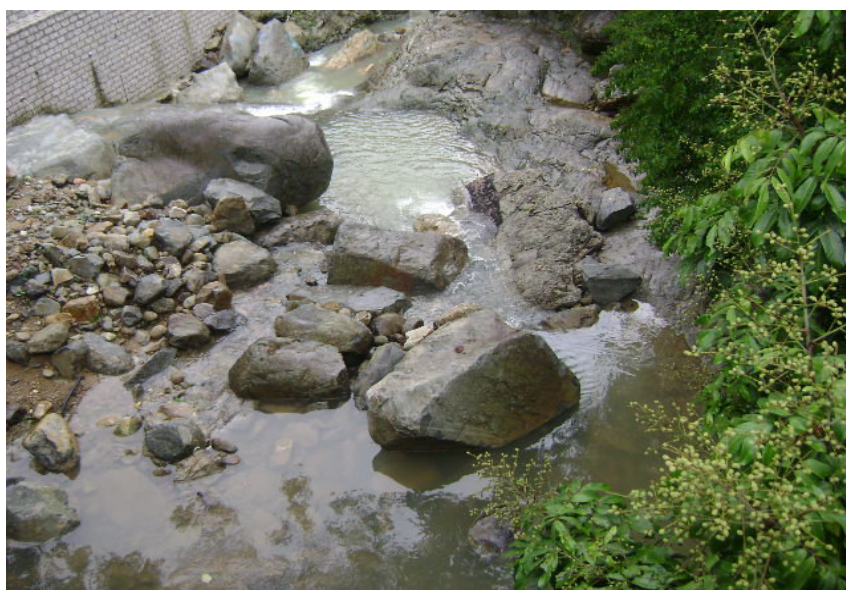
Photographic record for exceedance of Turbidity recorded at Hong Hoi Chee Hong Temple (I-2) on 17-Jun-11

Site photo

Photo taken at I-2

Photo taken at I-2-C

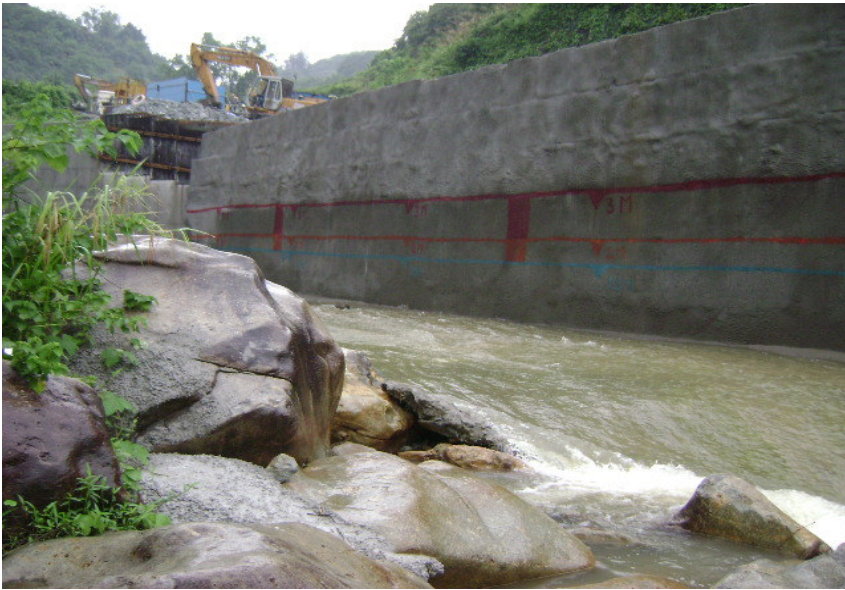
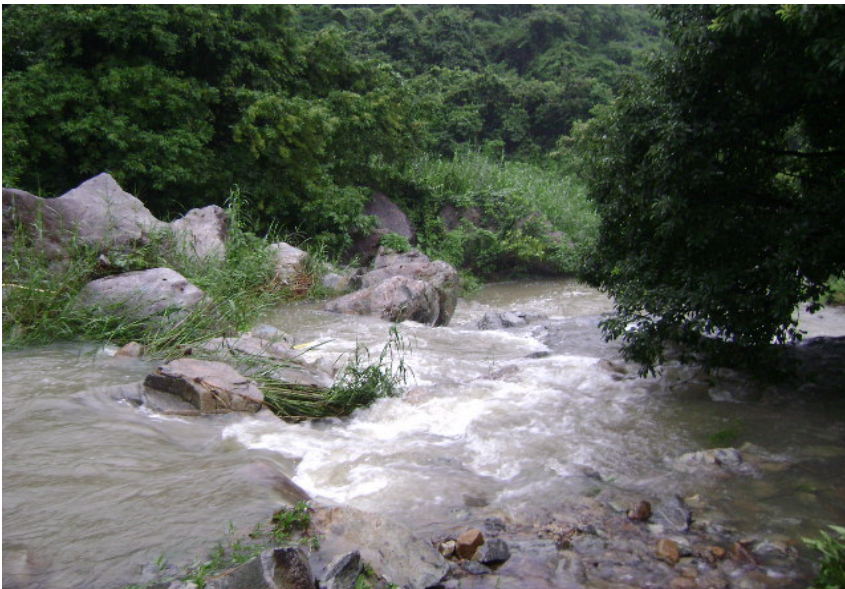
Photographic record for exceedance of Turbidity recorded at Squatters (I-3) on 17-Jun-11

Photo taken at I-3

Photo taken at I-3-C

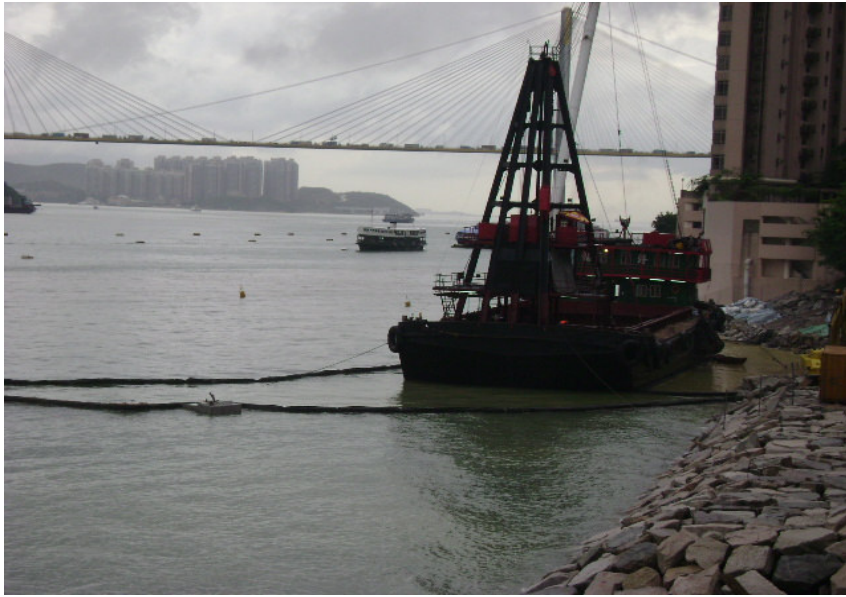
Photographic record for exceedance of Dissolved Oxygen (marine surface) recorded at O-1(FT) on 17-Jun-11

Site photo
