Interim Notification of Environmental Quality Limit Exceedance

Project	Tsuen Wan Drainage Tunnel
Date	01-Jun-11
Time	11:40 AM
Monitoring Location	O-1(ET)
Parameter	Dissolved Oxygen (marine mid-depth)
Action & Limit Levels (mg/L)	7.02 / 6.94
Measured Level (mg/L)	6.93
Control Station	O-1-C(ET)
Measured Level at the Control Station (mg/L)	7.00
Possible reason for Action or Limit Level Non-compliance	The measured DO level (marine mid-depth) of the monitoring station was slightly below the baseline limit level and the DO level at the corresponding control station. Relocation of C&D material to derrick barge was undertaken during monitoring and there was no other marine works conducted. Since the difference between the control station and impact monitoring was only 1%, the exceedance was considered contributed by natural variation and non-project related. Therefore, no further action was required.
Actions taken / to be taken	(1) Silt curtain was provided along the Portion E boundary line and extended from seawater level to the bottom of seabed; (2) floating type silt curtain was employed at the inner side; (3) sufficient slack of silt curtain was allowed to cope with the wave and tidal

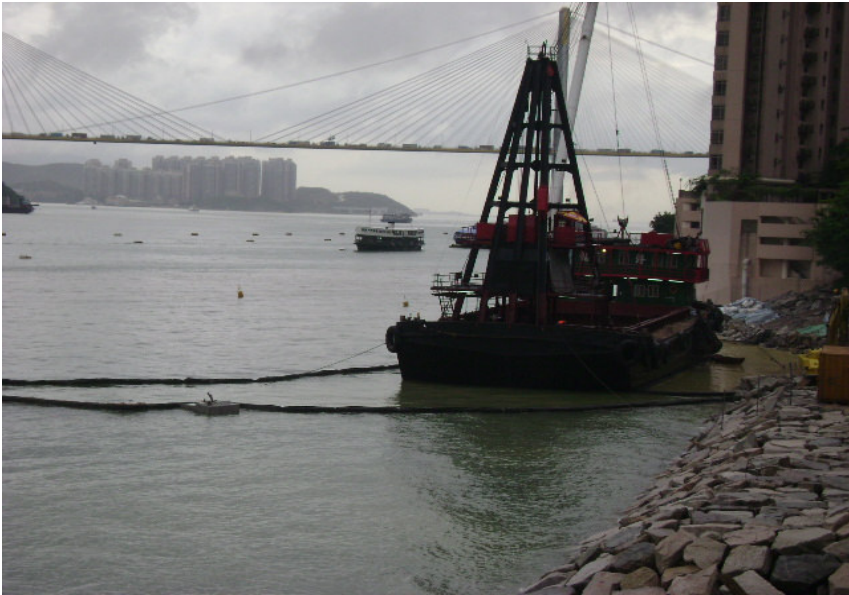
Photographic record for exceedance of Dissolved Oxygen (marine mid-depth) recorded at O-1(FT) on 17-Jun-11

Site photo

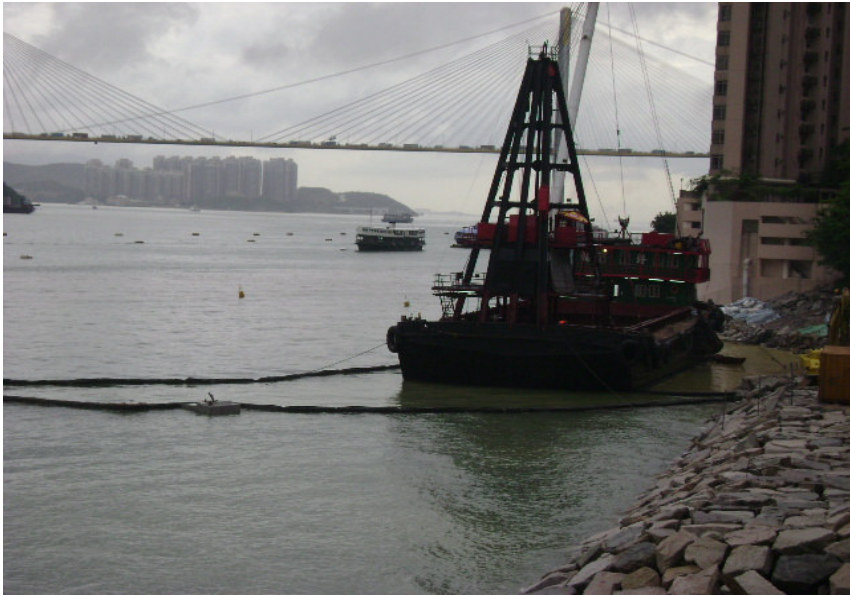
Photographic record for exceedance of Dissolved Oxygen (marine bottom) recorded at O-1(FT) on 17-Jun-11

Site photo

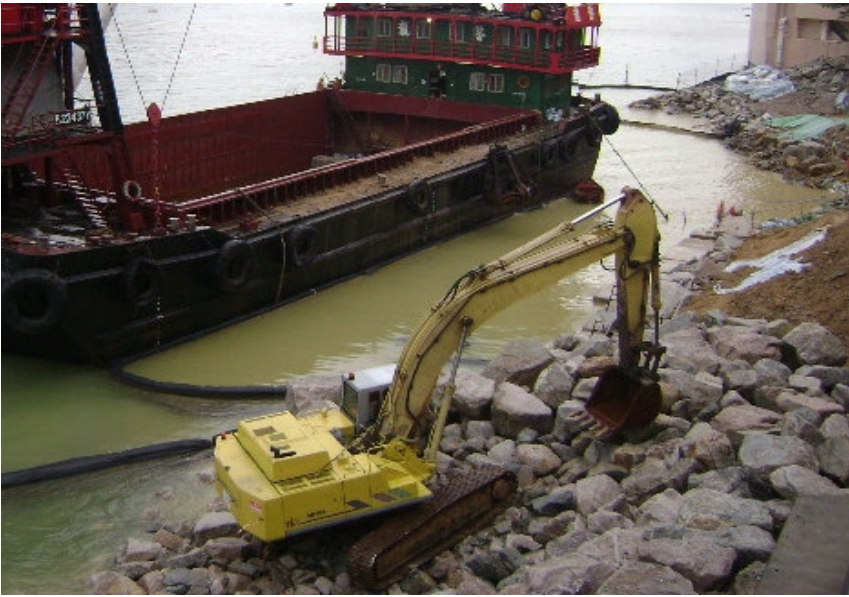
Photographic record for exceedance of Dissolved Oxygen (marine surface) recorded at O-1(ET) on 17-Jun-11

Site photo

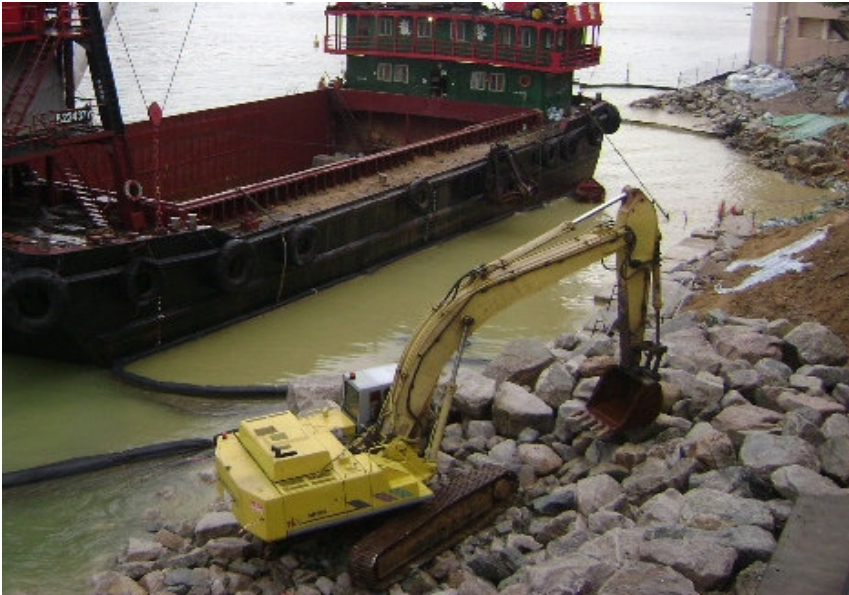
Photographic record for exceedance of Dissolved Oxygen (marine mid-depth) recorded at O-1(ET) on 17-Jun-11

Site photo

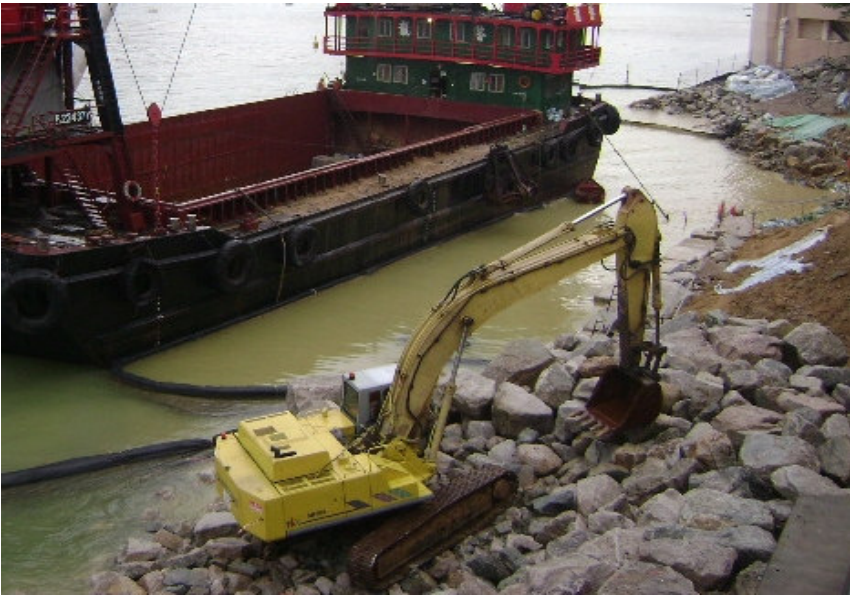
Photographic record for exceedance of Dissolved Oxygen (marine bottom) recorded at O-1(ET) on 17-Jun-11

Site photo

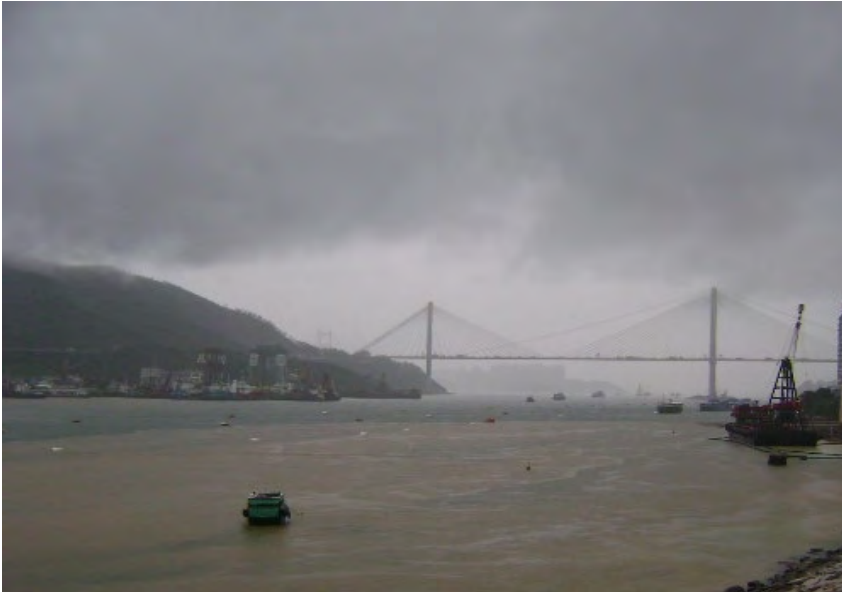
Photographic record for exceedance of Dissolved Oxygen (marine surface) recorded at O-1(FT) on 29-Jun-11

On 29 June 2011, 76.5 mm heavy rainfall was recorded. Huge amount of muddy water discharged from streams and drainage outfalls among the coast into marine water body was observed during afternoon on the monitoring day and caused turbid sea surface.

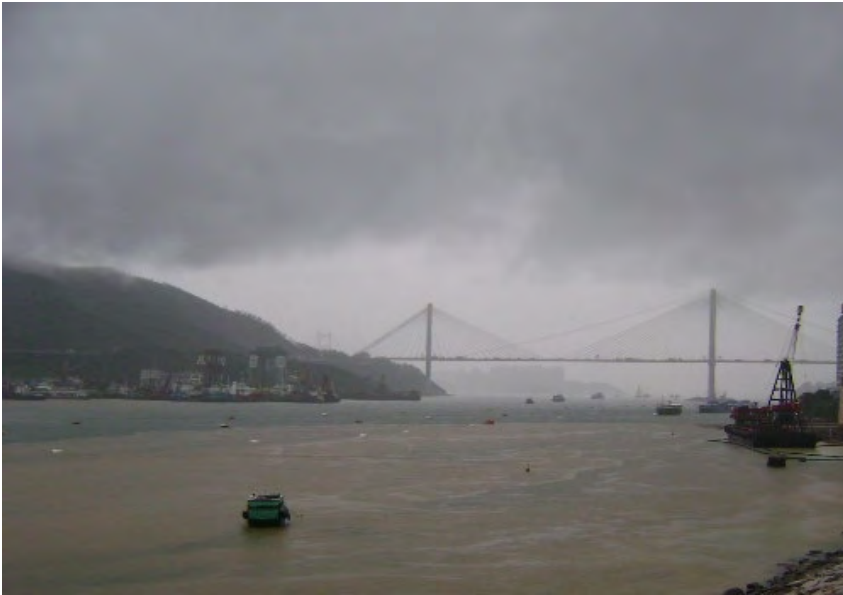
Photographic record for exceedance of Dissolved Oxygen (marine mid-depth) recorded at O-1(FT) on 29-Jun-11

On 29 June 2011, 76.5 mm heavy rainfall was recorded. Huge amount of muddy water discharged from streams and drainage outfalls among the coast into marine water body was observed during afternoon on the monitoring day and caused turbid sea surface.
