Interim Notification of Environmental Quality Limit Exceedance

Incident Report on Limit Level Non-compliance

Project	Tsuen Wan Drainage Tunnel
Date	02-Mar-12
Time	1:32 PM
Monitoring Location	O-1(FT)
Parameter	Dissolved Oxygen (marine mid-depth)
Action & Limit Levels (mg/L)	6.84 / 6.81
Measured Level (mg/L)	6.70
Control Station	O-1-C(FT)
Measured Level at the Control Station (mg/L)	6.66
Possible reason for Action or Limit Level Non-compliance	The measured DO level (marine mid-depth) at the monitoring station was below the baseline limit level, but higher than the DO level of the corresponding control station. Only trimming type II rock slope at west side was undertaken at the Outfall basin (Portion E) on the monitoring day. No other marine works was conducted. No direct disturbance was observed from the site. The exceedance was considered to be contributed by natural variation and non-project related. Therefore, no further action was required.
Actions taken / to be taken	(1) Silt curtain was provided along the Portion E boundary line and extended from the seawater level to the bottom of seabed; (2) sufficient slack of silt curtain was allowed to cope with the wave and tidal action

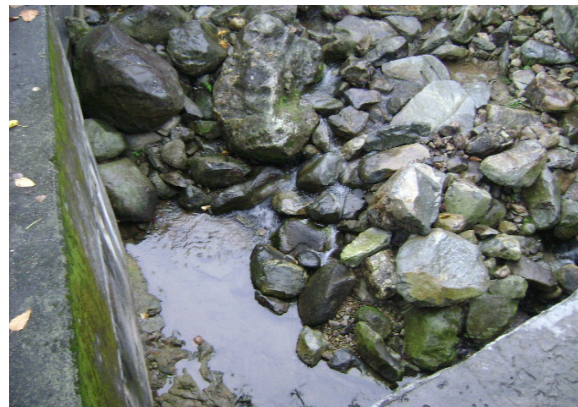
Photo taken at I-2-C

Project	Tsuen Wan Drainage Tunnel
Date	12-Mar-12
Time	4:40 PM
Monitoring Location	Hong Hoi Chee Hong Temple (I-2)
Parameter	Suspended Solids (SS)
Action & Limit Levels (mg/L)	7.68 / 8.34
Measured Level (mg/L)	2.50
Control Station	I-2-C
Measured Level at the Control Station (mg/L)	<2.00
Possible reason for Action or Limit Level Non-compliance	The measured SS level was well below the baseline action/limit level, but higher than 120% of the SS level of the control station (I-2-C). General site cleaning and housekeeping, mucking out and drilling holes for rock dowel and blast holes at main adit, rock mapping at de-aeration chamber, preparation works and carrying out blast no.102 at lower man access shaft (LMAS), erection of formwork for guide wall and housekeeping of L-shaped wall, and excavation and preparation works for placing blinding layer for trench of 1500 mm diameter drainage pipe from WS2 to SM1A (Stage 3) (construction area at Portion G next to the village house) were undertaken during the monitoring day. No direct disturbance was observed from the site. Therefore, the exceedance was considered to be contributed by natural variation. Since the exceedance was non-project related, no further action was required.

Photographic record for exceedance of Suspended Solids (SS) recorded at Hong Hoi Chee Hong Temple (I-2) on 12-Mar-12

Actions taken / to be taken	The following mitigation measures were provided on-site during monitoring: (1) wastewater was collected and diverted to waste water treatment plant prior to discharge; and (2) existing stream was diverted and banded by sand bags and sealed concrete block wall.
Remarks	None
