Interim Notification of Environmental Quality Limit Exceedance

Project	Tsuen Wan Drainage Tunnel
Date	06-Apr-11
Time	10:25 AM
Monitoring Location	Sik Sik Yuen Ho Fung College (I-1)
Parameter	Suspended Solids
Action & Limit Levels (mg/L)	8.85 / 10.17
Measured Level (mg/L)	10.95
Possible reason for Action or Limit Level Non-compliance	A high SS level of 10.60 mg/L was recorded at Control Station (I-1-C)
Actions taken / to be taken	The measured SS level was above the baseline limit level, but lower than 120% of SS level of the control station (I-1-C). General site cleaning, rebar fixing at cascade bay 1, dismantling of formwork at vehicle access, removal of hoarding and masonry wall and geotechnical instrumentation monitoring were undertaken during the measurement. No direct disturbance was observed from the site. Thus, the exceedance was considered to be contributed by high SS level at upstream location and natural variation. Therefore, no action was required.

Photographic record for exceedance of Suspended Solids recorded at Sik Sik Yuen Ho Fung College (I-1) on 06-Apr-11

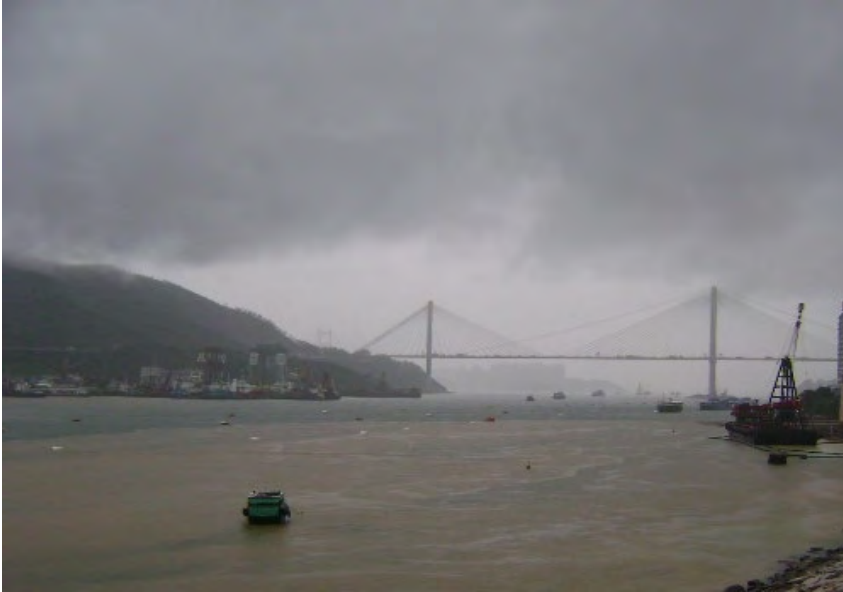
Site photo
(Photo taken at location
near Greenview Terrace)

On 29 June 2011, 76.5 mm heavy rainfall was recorded. Huge amount of muddy water discharged from streams and drainage outfalls among the coast into marine water body was observed during afternoon on the monitoring day and caused turbid sea surface.
