Interim Notifications of Environmental Quality Limits Exceedances

Incident Report on Action Level or Limit Level Non-compliance

Project	Tsuen Wan Drainage Tunnel
Date	02-Jul-10
Time	10:00 AM
Monitoring Location	Hong Hoi Chee Hong Temple (I-2)
Parameter	Suspended Solid
Action & Limit Levels	7.68 / 8.34
Measured Level	3.20 (higher than 120% of control station's SS)
Possible reason for Action or Limit Level Non-compliance	A low SS level of 2.50 is recorded at Control Station (I-2-C)
Actions taken / to be taken	The measured SS level was below baseline Action / Limit Level and was within the range of baseline SS concentration (1-8.5mg/L). General Site Cleaning and House Keeping; Erection of Noise Enclosure at Man Access Shaft; Excavation at Vortex Drop Shaft and Man Access Shaft; Pipe Jacking and Erection of working platform for mini-pile construction were undertaken during the measurement. No direct disturbance was observed from the site. Thus, the exceedance is considered to be contributed by natural variation and no action should be required.

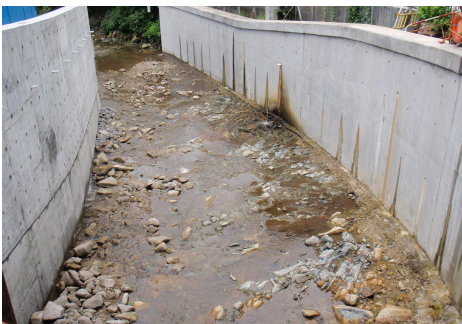
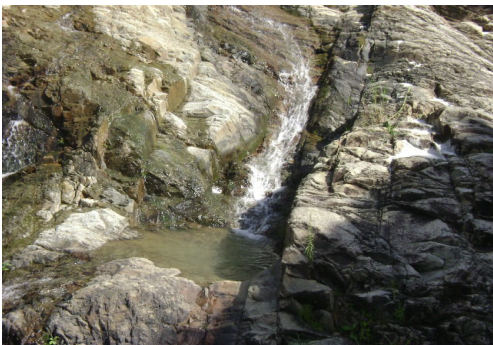
Photo taken at I-2

Project	Tsuen Wan Drainage Tunnel
Date	19-Jul-10
Time	9:40 AM
Monitoring Location	Hong Hoi Chee Hong Temple (I-2)
Parameter	Suspended Solid
Action & Limit Levels	7.68 / 8.34
Measured Level	4.00 (higher than 130% of control station's SS)
Possible reason for Action or Limit Level Non-compliance	A low SS level of 2.50 is recorded at Control Station (I-2-C)
Actions taken / to be taken	The measured SS level was below baseline Action / Limit Level and was within the range of baseline SS concentration (1-8.5mg/L). General site cleaning and house keeping; excavation at man access shaft; rock splitting at vortex drop shaft; extension of steel platform; pipe jacking and mini piling were undertaken during the measurement. No direct disturbance was observed from the site. Thus, the exceedance is considered to be contributed by natural variation and no action should be required.
Remarks	Following mitigation measures were provided: (1) Sedimentation tanks and wastewater treatment plant were in place for excavation works at the location of I-2. (2) A surface channel was used to collect wastewater generated from mini-pile construction to sedimentation tank and wastewater treatment plant at I-2.

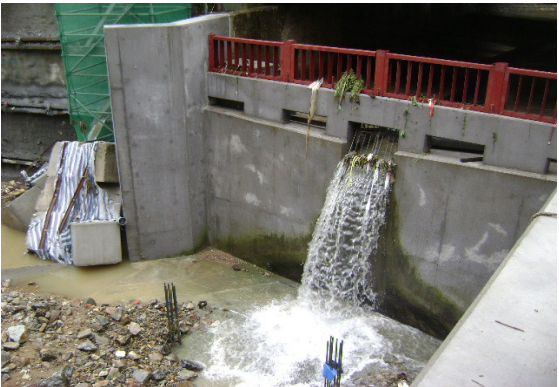
Photo taken at I-1

Project	Tsuen Wan Drainage Tunnel
Date	23-Jul-10
Time	9:00 AM
Monitoring Location	Sik Sik Yuen Ho Fung College (I-1)
Parameter	Turbidity
Action & Limit Levels	9.75 / 12.47
Measured Level	16.27
Possible reason for Action or Limit Level Non-compliance	A high turbidity level of 17.19 is recorded at Control Station (I-1-C).
Actions taken / to be taken	The measured turbidity level was above baseline Limit Level. It was also beyond the range of baseline turbidity concentration (3.13 - 13.15 NTU). Black storm signal was held on 22 July 2010. No construction activity was carried out on the following day. The exceedance is considered by natural variation. No action should be taken as the turbidity result at monitoring station was below the action and limit level of control station.
Remarks	Sand/silts removal facilities were installed for the treatment of wastewater at the location of I-1. However, other mitigation measures provided (e.g. sandbags) were found damaged by the heavy rainstorm.

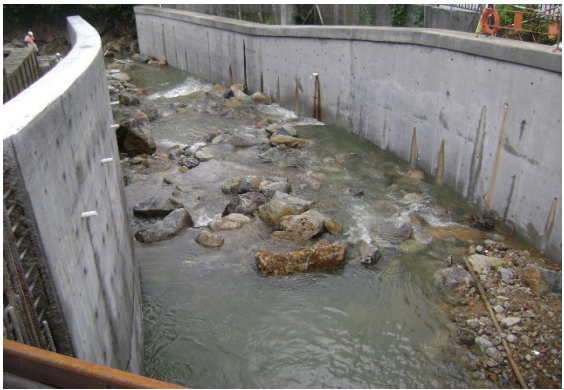
Photo taken at I-2

Project	Tsuen Wan Drainage Tunnel
Date	23-Jul-10
Time	10:35 AM
Monitoring Location	Hong Hoi Chee Hong Temple (I-2)
Parameter	Turbidity
Action & Limit Levels	6.63 / 6.99
Measured Level	10.13
Possible reason for Action or Limit Level Non-compliance	A high turbidity level of 10.76 is recorded at Control Station (I-2-C).
Actions taken / to be taken	The measured turbidity level was above baseline Limit Level. It was also beyond the range of baseline turbidity concentration (2.17 - 7.08 NTU). Black storm signal was held on 22 July 2010. No construction activity was carried out on the following day. The exceedance is considered by natural variation. No action should be taken as the turbidity result at monitoring station was below the action and limit level of control station.
Remarks	Sand/silts removal facilities were installed for the treatment of wastewater at the location of I-2. However, other mitigation measures provided (e.g. sandbags) were found damaged by the heavy rainstorm.

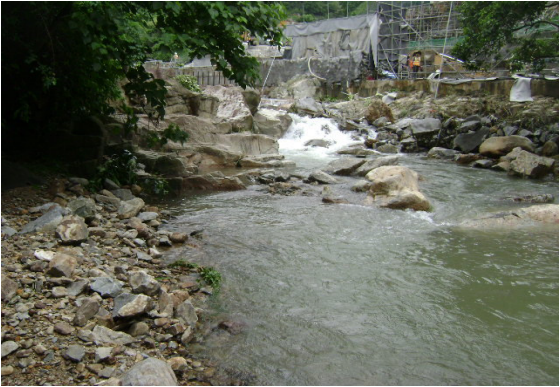
Photo taken at I-3

Project	Tsuen Wan Drainage Tunnel
Date	23-Jul-10
Time	11:10 AM
Monitoring Location	Squatters (I-3)
Parameter	Turbidity
Action & Limit Levels	3.99 / 4.18
Measured Level	8.79
Possible reason for Action or Limit Level Non-compliance	A high turbidity level of 8.72 is recorded at Control Station (I-3-C).
Actions taken / to be taken	The measured turbidity level was above baseline Limit Level. It was also beyond the range of baseline turbidity concentration (1.41 - 4.23 NTU). Black storm signal was held on 22 July 2010. No construction activity was carried out on the following day. The exceedance is considered by natural variation. No action should be taken as the turbidity result at monitoring station was below the action and limit level of control station.
Remarks	Sand/silts removal facilities were installed for the treatment of wastewater at the location of I-3. However, other mitigation measures provided (e.g. sandbags) were found damaged by the heavy rainstorm.

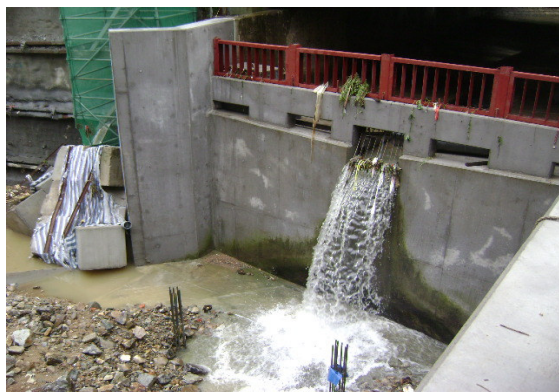
Photo taken at I-1

Project	Tsuen Wan Drainage Tunnel
Date	23-Jul-10
Time	9:00 AM
Monitoring Location	Sik Sik Yuen Ho Fung College (I-1)
Parameter	Suspended Solid
Action & Limit Levels	8.85 / 10.17
Measured Level	12.25
Possible reason for Action or Limit Level Non-compliance	SS level of 11.90 is recorded at Control Station (I-1-C).
Actions taken / to be taken	The measured SS level was above baseline Limit Level. It was also beyond the range of baseline SS concentration (1 - 10.5 mg/L). Black storm signal was held on 22 July 2010. No construction activity was carried out on the following day. The exceedance is considered by natural variation and no action should be required.
Remarks	Sand/silts removal facilities were installed for the treatment of wastewater at the location of I-1. However, other mitigation measures provided (e.g. sandbags) were found damaged by the heavy rainstorm.

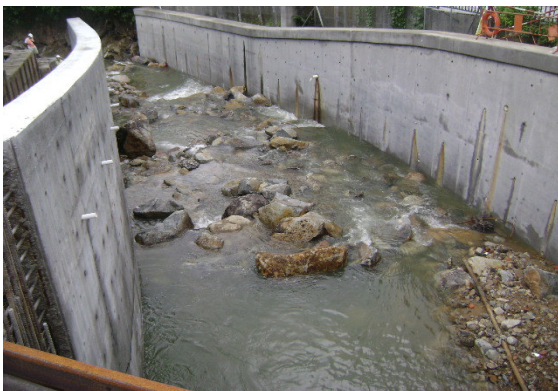
Photo taken at I-2

Project	Tsuen Wan Drainage Tunnel
Date	23-Jul-10
Time	10:35 AM
Monitoring Location	Hong Hoi Chee Hong Temple (I-2)
Parameter	Suspended Solid
Action & Limit Levels	7.68 / 8.34
Measured Level	6.35 (higher than 130% of control station's SS)
Possible reason for Action or Limit Level Non-compliance	A low SS level of 4.05 is recorded at Control Station (I-2-C).
Actions taken / to be taken	The measured SS level was below baseline Action / Limit Level and was within the range of baseline SS concentration (1-8.5mg/L). Black storm signal was held on 22 July 2010. No construction activity was carried out on the following day. The exceedance is considered by natural variation and no action should be required.
Remarks	Sand/silts removal facilities were installed for the treatment of wastewater at the location of I-2. However, other mitigation measures provided (e.g. sandbags) were found damaged by the heavy rainstorm.

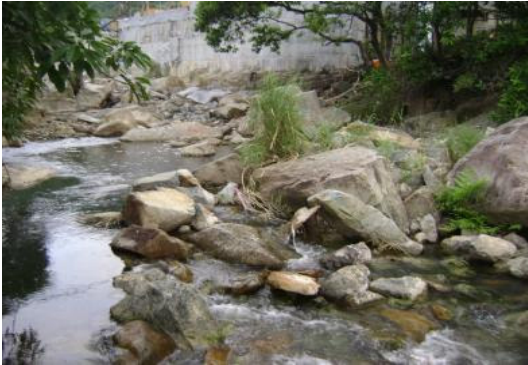
Photo taken at I-3

Project	Tsuen Wan Drainage Tunnel
Date	11-Aug-10
Time	9:27 AM
Monitoring Location	Squatters (I-3)
Parameter	Suspended Solid
Action & Limit Levels	6.13 / 7.23
Measured Level	3.15 (higher than 130% of control station's SS)
Possible reason for Action or Limit Level Non-compliance	A low SS level of 2.00 is recorded at Control Station (I-3-C)
Actions taken / to be taken	The measured SS level was within the range of baseline SS concentration (1-7.5mg/L). Drilling holes and breaking for spiral ramp excavation; Excavation for PB Wall working platform were undertaken during the measurement. No direct disturbance was observed from the site. Thus, the exceedance is considered not due to works and no action should be required.
Remarks	Following mitigation measures were provided: (1) Waste Water Treatment Plant was in-place to treat the waste water before discharge. (2) Bare slope surface was cover by tarpaulin sheet.

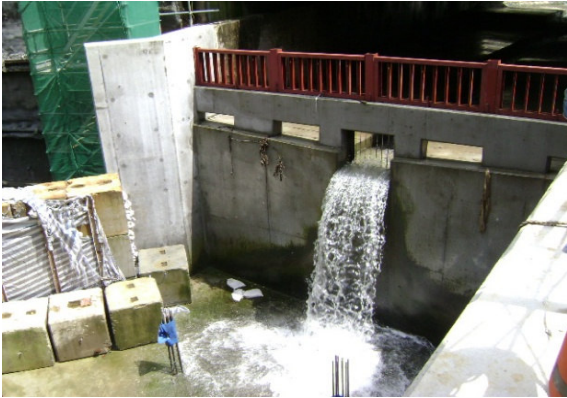
Photo taken at I-1

Site photo. As advised by Contractor, rocks and soil were found washed down to the stream from the upstream
