**Interim Notifications of Environmental Quality Limits Exceedances**

Incident Report on Action Level or Limit Level Non-compliance

Project	Tsuen Wan Drainage Tunnel
Date	15-Oct-10
Time	9:38 AM
Monitoring Location	Hong Hoi Chee Hong Temple (I-2)
Parameter	Turbidity
Action & Limit Levels	6.63/6.99
Measured Level	7.72
Possible reason for Action or Limit Level Non-compliance	A high turbidity level of 7.73 is recorded at Control Station (I-2-C)
Actions taken / to be taken	The measured turbidity level was above the Baseline Limit level and beyond the range of baseline turbidity concentration (2.17-7.08 NTU). Construction activities including General Site Cleaning & Housekeeping; Excavation and rock splitting at Vortex Drop Shaft; Excavation and rock splitting at Man Access Shaft; Pipe Jacking at Portion G; and Erect formwork and rebar fixing of pile caps at Portion G. No direct disturbance was observed from the site. Thus, the exceedance is considered to be natural variation and no action should be taken.
Remarks	Following mitigation measures were provided: (1) Waste water will be collected to Waste Water Treatment Plant and treat before discharge; (2) Existing Stream has been diverte

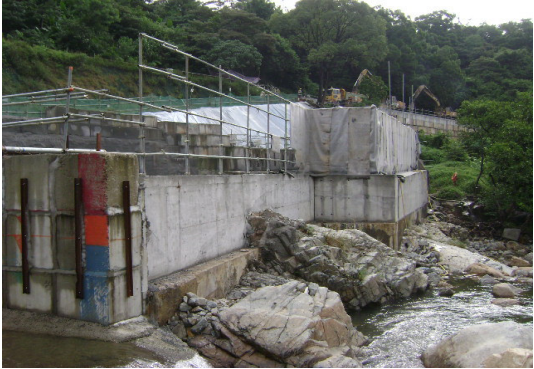
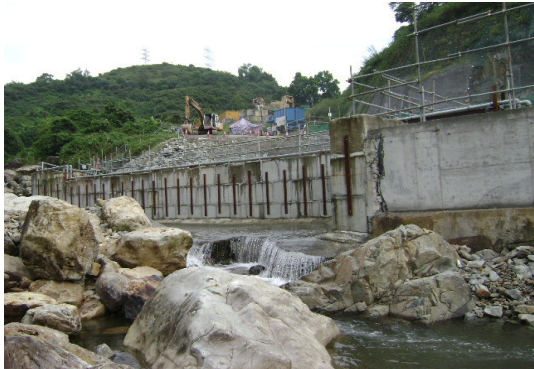
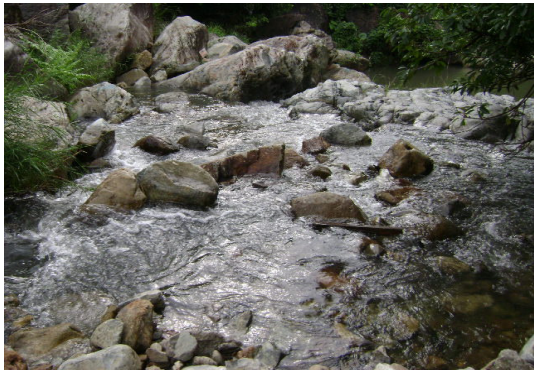
**Photographic record for exceedance of Turbidity recorded at Squatters (I-3) on 15-Oct-10**

Project	Tsuen Wan Drainage Tunnel
Date	15-Oct-10
Time	9:00 AM
Monitoring Location	Squatters (I-3)
Parameter	Turbidity
Action & Limit Levels	3.99 / 4.18
Measured Level	7.80
Possible reason for Action or Limit Level Non-compliance	A high turbidity level of 7.88 is recorded at Control Station (I-3-C).
Actions taken / to be taken	The measured turbidity level was above the Baseline Limit level and beyond the range of baseline turbidity concentration (1.41-4.23 NTU). Construction activities including General Site Cleaning & Housekeeping; Excavation of footpath, breaking existing wall and lay concrete blocks at PB Wall; Excavation of Shaft. No direct disturbance was observed from the site. Thus, the exceedance is considered to be natural variation and no action should be taken.
Remarks	Following mitigation measures were provided: 1) Waste water will be collected to Waste Water Treatment Plant and treat before discharge; 2) Existing Stream has been diverted and banded by sealed concrete block wall.

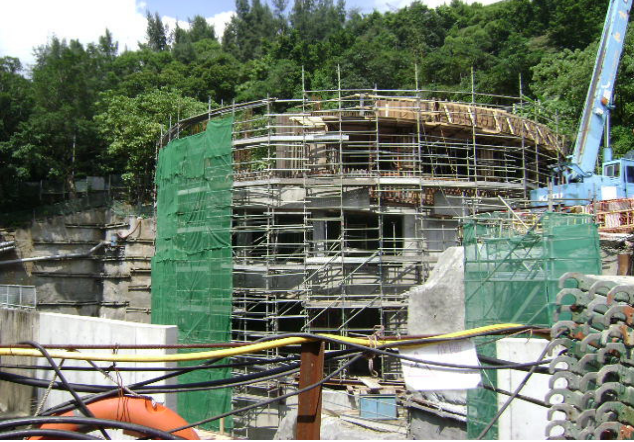
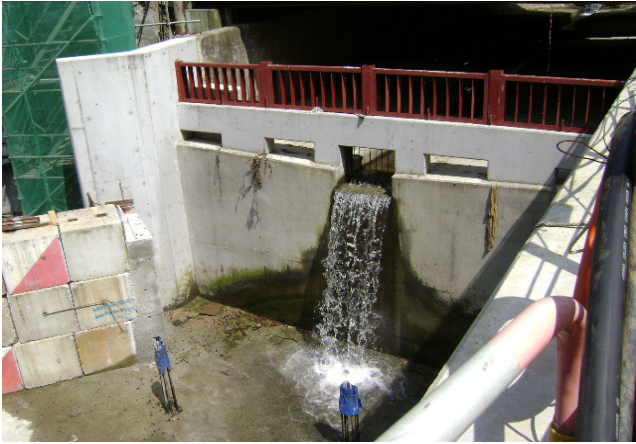
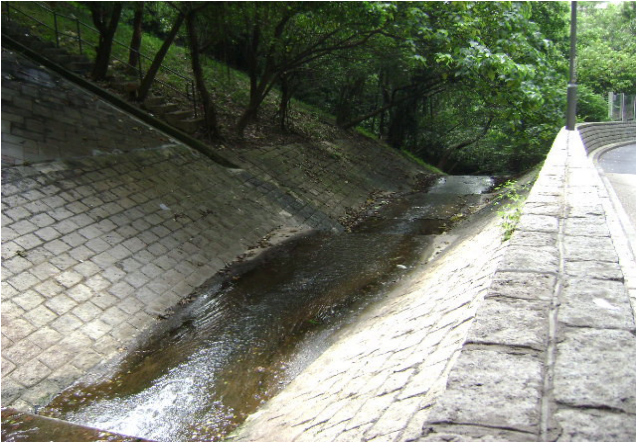
**Photographic record for exceedance of Suspended Solid recorded at Sik Sik Yuen Ho Fung College (I-1) on 13-Oct-10**

Project	Tsuen Wan Drainage Tunnel
Date	13-Oct-10
Time	11:27 AM
Monitoring Location	Sik Sik Yuen Ho Fung College (I-1)
Parameter	Suspended Solid
Action & Limit Levels	8.85 / 10.17
Measured Level	2.95 (higher than 130% of control station's SS)
Possible reason for Action or Limit Level Non-compliance	A low SS level of 2.05 was recorded at Control Station (I-1-C)
Actions taken / to be taken	The measured SS level was below baseline Action / Limit Level and was within the range of baseline SS concentration (1-10.5mg/L). General site cleaning and housekeeping; Formwork erection for Planter at Bay 18; Formwork erection for wall at Bay 19; and Set up Plant for horizontal drilling were undertaken during the measurement. No direct disturbance was observed from the site. Thus, the exceedance is considered to be contributed by natural variation and no action should be required.
Remarks	Following mitigation measures were provided: 1) Waste water will be collected to Waste Water Treatment Plant and treated before discharge; 2) Nullah and site had been separated by sealed concrete block wall.

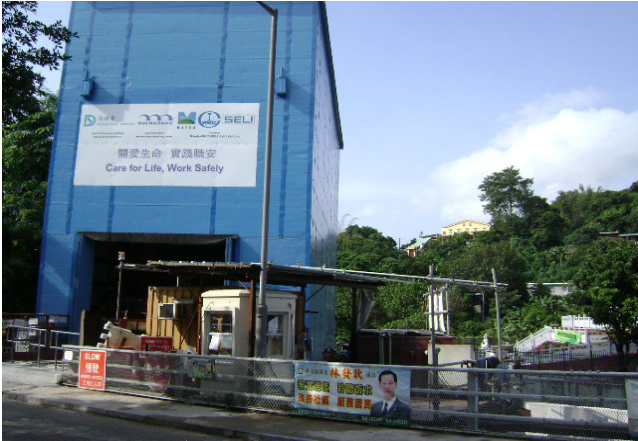
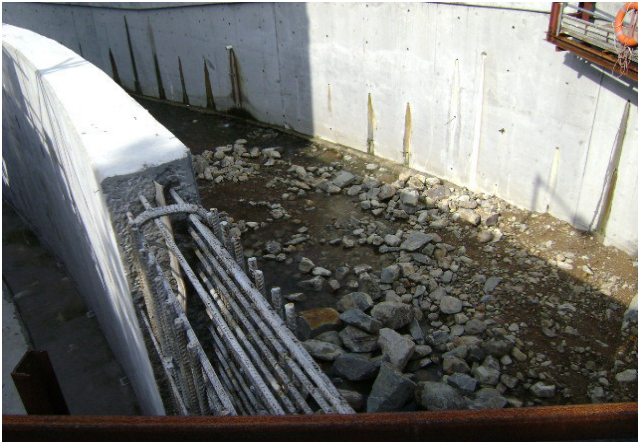
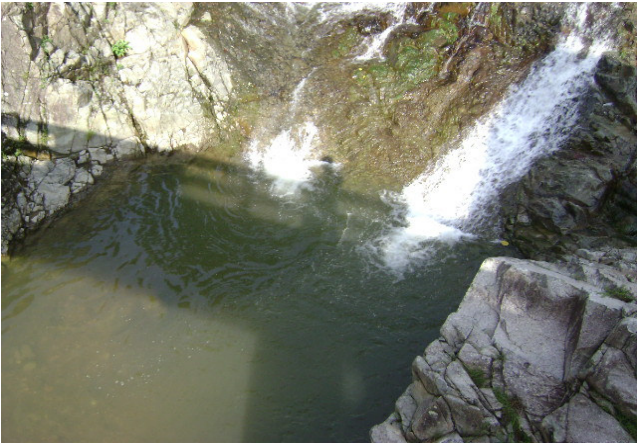
**Photographic record for exceedance of Suspended Solid recorded at Hong Hoi Chee Hong Temple (I-2) on 15-Oct-10**

Project	Tsuen Wan Drainage Tunnel
Date	15-Oct-10
Time	9:38 AM
Monitoring Location	Hong Hoi Chee Hong Temple (I-2)
Parameter	Suspended Solid
Action & Limit Levels	7.68 / 8.34
Measured Level	8.15
Possible reason for Action or Limit Level Non-compliance	A high SS level of 11.20 was recorded at Control Station (I-2-C)
Actions taken / to be taken	The measured SS level was above Baseline Action Level and beyond range of baseline SS concentration (1-8.5mg/L). General site cleaning and housekeeping; excavation, rock splitting and gantry repair at vortex drop shaft; pipe jacking at portion G; erect formwork and fix rebar pile caps at portion G were undertaken during the measurement. No direct disturbance was observed from the site. Thus, the exceedance is considered to be contributed by high SS level at control station and natural variation and no action should be required.
Remarks	Following mitigation measures were provided: 1) Waste water will be collected to waste water treatment plant and treated before discharge; 2) Existing stream has been diverted and bunded by sealed concrete block wall.

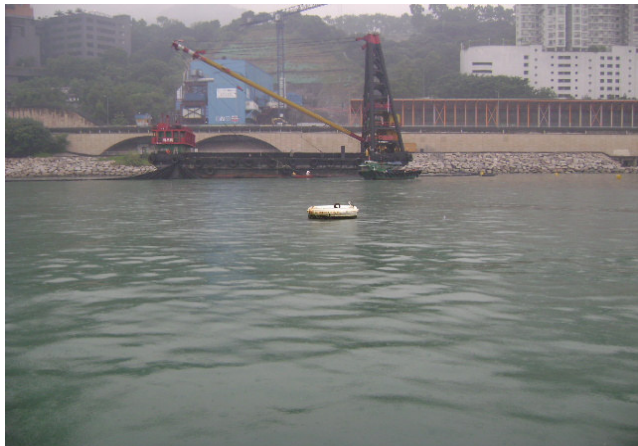
**Photographic record for exceedance of Suspended Solids (SS) recorded at O-1(FT) on 05-Nov-10**

Site photo

Actions taken / to be taken	(1) Silt curtains had been provided along the dredging boundary line and extended from the seawater level to the bottom of seabed; (2) Frame-type silt curtains had been employed for the derrick barge and all dredging operation was confined in the frame-type silt curtain; (3) Closed grab had been used and the daily dredging rate was less than 960 m <sup>3</sup> ; (4) Sufficient slacks of silt curtains were allowed to ensure the curtains rested on the seabed to cope with waves and tides; (5) Condition of silt curtains had been checked by the on-broad supervisor daily before any dredging activity; (6) Operator had been instructed to manoeuvre the grab with due care to prevent fast lifting out of the grab from the frame-type silt curtains.
Remarks	None

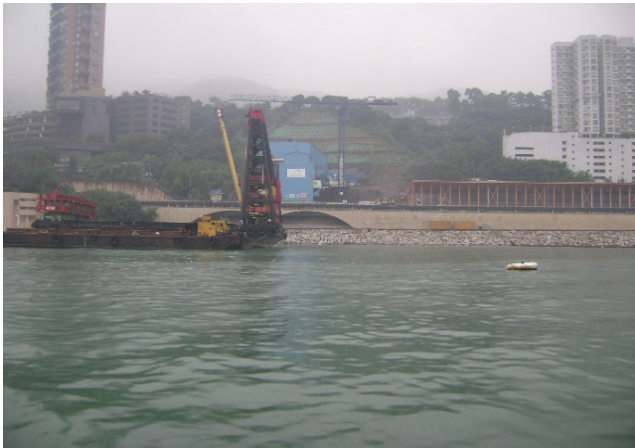
**Photographic record for exceedance of Suspended Solids (SS) recorded at O-1(ET) on 05-Nov-10**

Site photo

Actions taken / to be taken	(1) Silt curtains had been provided along the dredging boundary line and extended from the seawater level to the bottom of seabed; (2) Frame-type silt curtains had been employed for the derrick barge and all dredging operation was confined in the frame-type silt curtain; (3) Closed grab had been used and the daily dredging rate was less than 960 m <sup>3</sup> ; (4) Sufficient slacks of silt curtains were allowed to ensure the curtains rested on the seabed to cope with waves and tides; (5) Condition of silt curtains had been checked by the on-board supervisor daily before any dredging activity; (6) Operator had been instructed to manoeuvre the grab with due care to prevent fast lifting out of the grab from the frame-type silt curtains.
Remarks	None

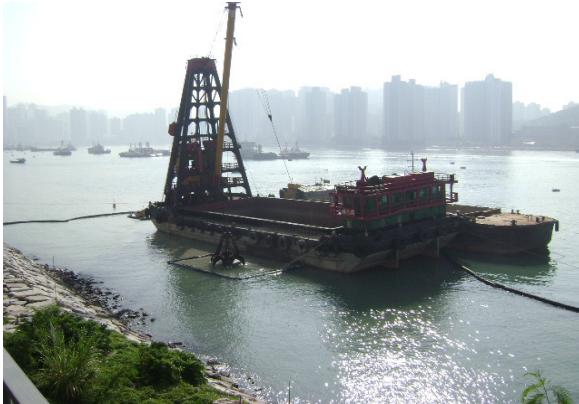
Photographic record for exceedance of Suspended Solids (SS) recorded at O-1(ET) on 08-Nov-10

Site photo

Actions taken / to be taken	(1) Silt curtains had been provided along the dredging boundary line and extended from the seawater level to the bottom of seabed; (2) Frame-type silt curtains had been employed for the derrick barge and all dredging operation was confined in the frame-type silt curtain; (3) Closed grab had been used and the daily dredging rate was less than 960 m <sup>3</sup> ; (4) Sufficient slacks of silt curtains were allowed to ensure the curtains rested on the seabed to cope with waves and tides; (5) Condition of silt curtains had been checked by the on-board supervisor daily before any dredging activity; (6) Operator had been instructed to manoeuvre the grab with due care to prevent fast lifting out of the grab from the frame-type silt curtains.
Remarks	None

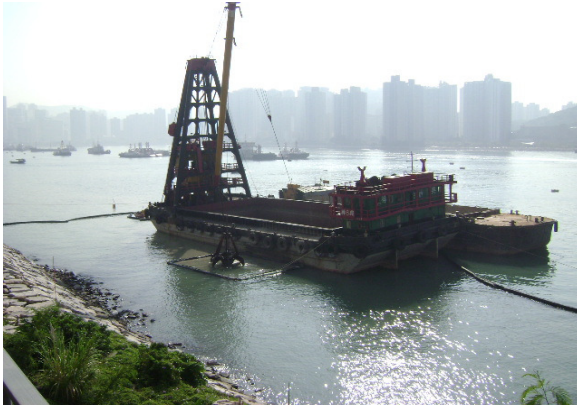
Photographic record for exceedance of Turbidity recorded at O-1(ET) on 08-Nov-10

Site photo

Actions taken / to be taken	(1) Silt curtains had been provided along the dredging boundary line and extended from the seawater level to the bottom of seabed; (2) Frame-type silt curtains had been employed for the derrick barge and all dredging operation was confined in the frame-type silt curtain; (3) Closed grab had been used and the daily dredging rate was less than 960 m <sup>3</sup> ; (4) Sufficient slacks of silt curtains were allowed to ensure the curtains rested on the seabed to cope with waves and tides; (5) Condition of silt curtains had been checked by the on-board supervisor daily before any dredging activity; (6) Operator had been instructed to manoeuvre the grab with due care to prevent fast lifting out of the grab from the frame-type silt curtains.
Remarks	None

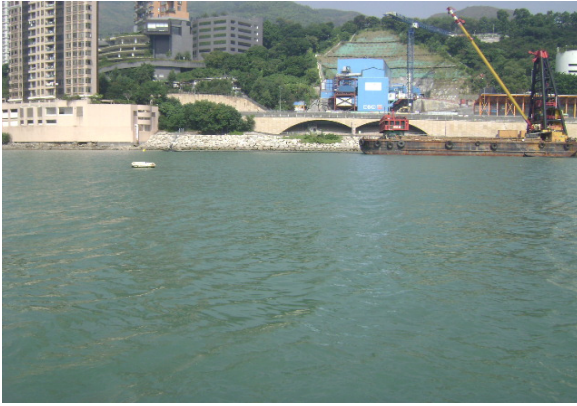
**Photographic record for exceedance of Suspended Solids (SS) recorded at O-1(ET) on 10-Nov-10**

Site photo

Actions taken / to be taken	(1) Silt curtains had been provided along the dredging boundary line and extended from the seawater level to the bottom of seabed; (2) Frame-type silt curtains had been employed for the derrick barge and all dredging operation was confined in the frame-type silt curtain; (3) Closed grab had been used and the daily dredging rate was less than 960 m <sup>3</sup> ; (4) Sufficient slacks of silt curtains were allowed to ensure the curtains rested on the seabed to cope with waves and tides; (5) Condition of silt curtains had been checked by the on-board supervisor daily before any dredging activity; (6) Operator had been instructed to manoeuvre the grab with due care to prevent fast lifting out of the grab from the frame-type silt curtains.
Remarks	None

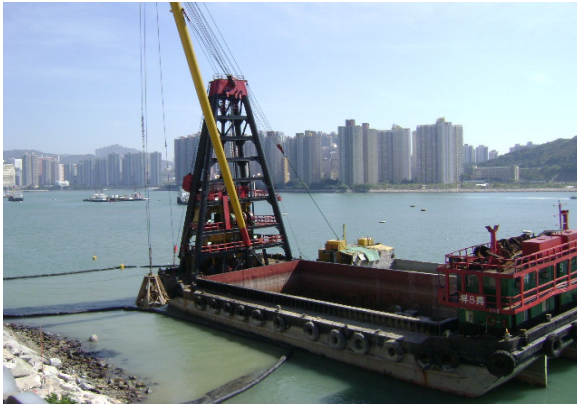
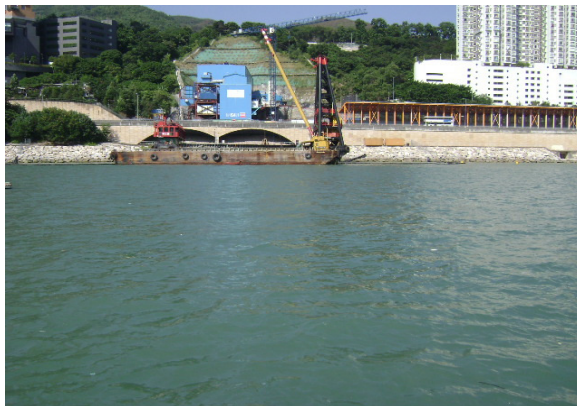
**Photographic record for exceedance of Suspended Solids (SS) recorded at O-1(ET) on 12-Nov-10**

Site photo

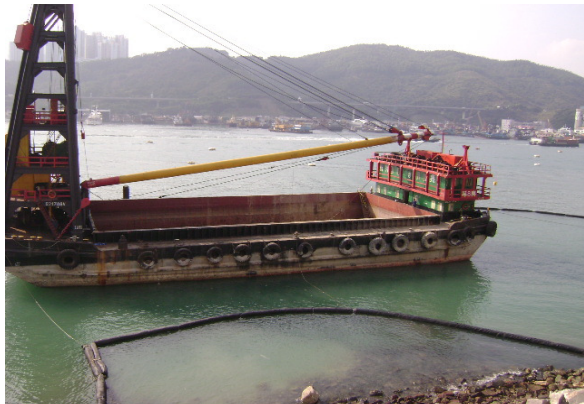
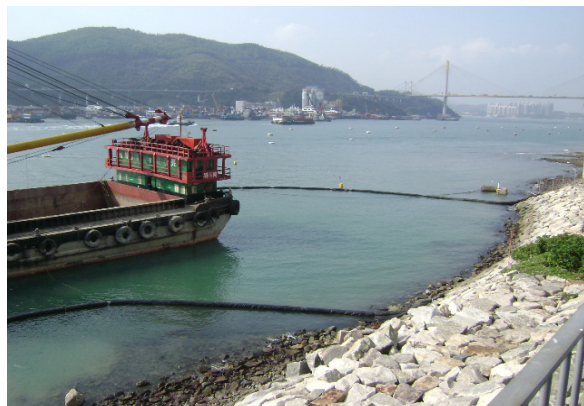
**Photographic record for exceedance of Suspended Solids (SS) recorded at O-1(ET) on 15-Nov-10**

Site photo

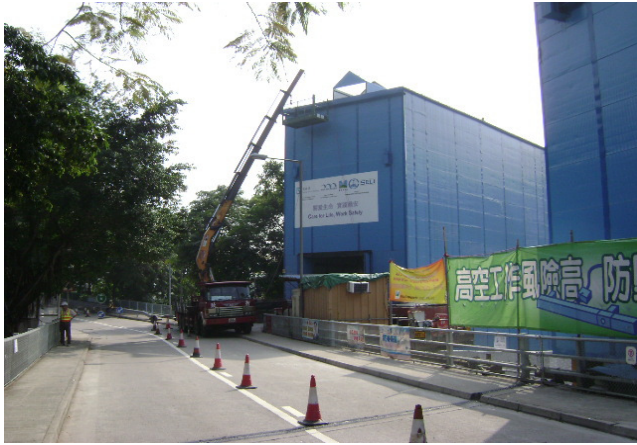
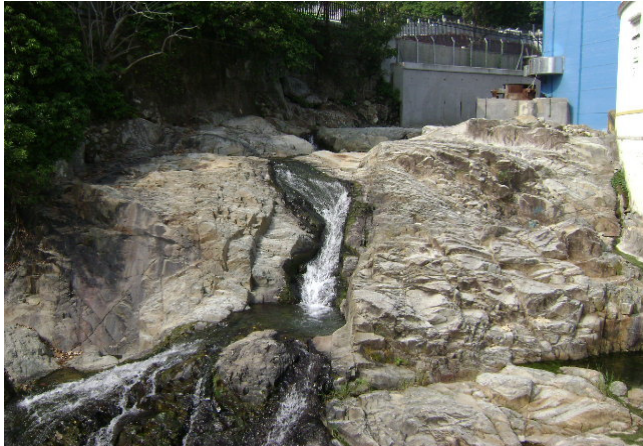
**Photographic record for exceedance of Suspended Solid recorded at Hong Hoi Chee Hong Temple (I-2) on 17-Nov-10**

Site photo

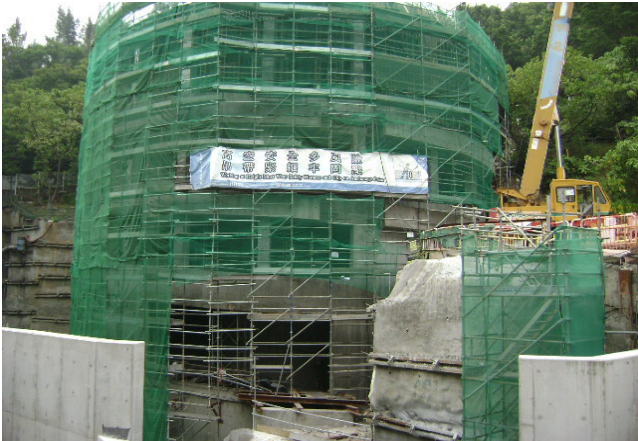
**Photographic record for exceedance of Suspended Solid recorded at Sik Sik Yuen Ho Fung College (I-1) on 01-Dec-10**

Site photo

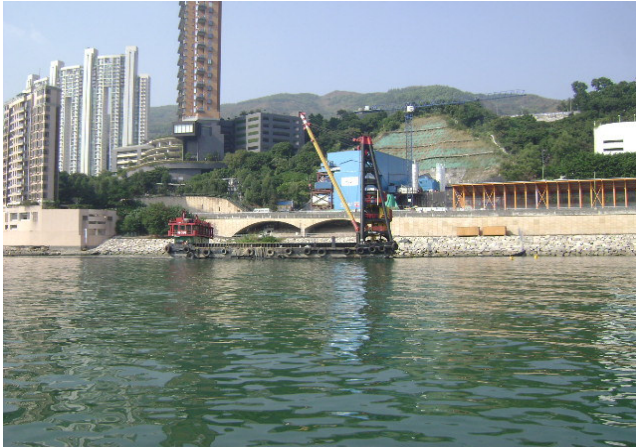
**Photographic record for exceedance of Suspended Solids (SS) recorded at O-1(FT) on 03-Dec-10**

Site photo

Actions taken / to be taken	(1) Silt curtain had been provided along the Portion E boundary line and extended from seawater level to the bottom of seabed; (2) Floating type silt curtain had been employed at the derrick barge; (3) Rock removal operation was confined in the inner (frame/floating type) silt curtain; (4) Sufficient slack of silt curtain was allowed to cope with the wave and tidal action to ensure the curtain was rested on seabed; (5) Condition of silt curtain had been checked by the on-board supervisor daily before the start of any marine works activity; (6) Operator had been instructed to handle with due care and prevent fast lifting out of the grab from the inner (frame/floating type) silt curtain; (7) Closed grab had been used for dredging operation; and (8) the daily dredging rate was limited to less than 960 m <sup>3</sup> .
Remarks	None

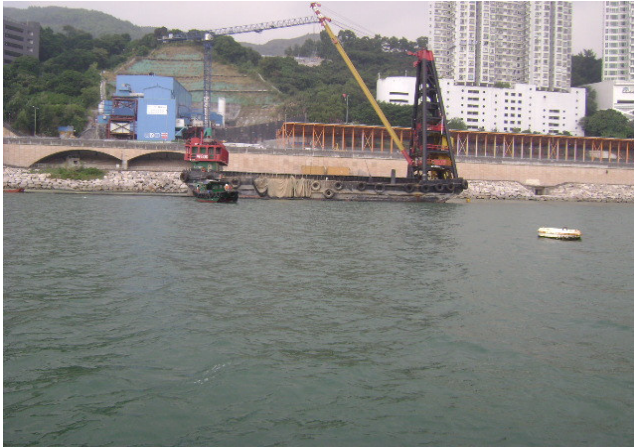
**Photographic record for exceedance of Suspended Solids (SS) recorded at O-1(FT) on 01-Dec-10**

Site photo

Actions taken / to be taken	(1) Silt curtain had been provided along the Portion E boundary line and extended from seawater level to the bottom of seabed; (2) Floating type silt curtain had been employed at the derrick barge; (3) Rock removal operation was confined in the inner (frame/floating type) silt curtain; (4) Sufficient slack of silt curtain was allowed to cope with the wave and tidal action to ensure the curtain was rested on seabed; (5) Condition of silt curtain had been checked by the on-board supervisor daily before the start of any marine works activity; (6) Operator had been instructed to handle with due care and prevent fast lifting out of the grab from the inner (frame/floating type) silt curtain; (7) Closed grab had been used for dredging operation; and (8) the daily dredging rate was limited to less than 960 m <sup>3</sup> .
Remarks	None

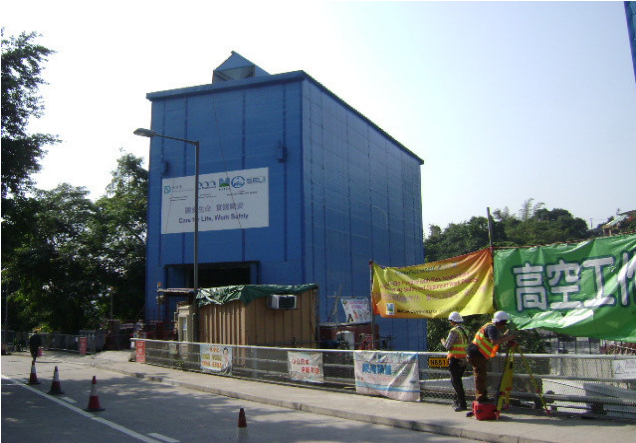
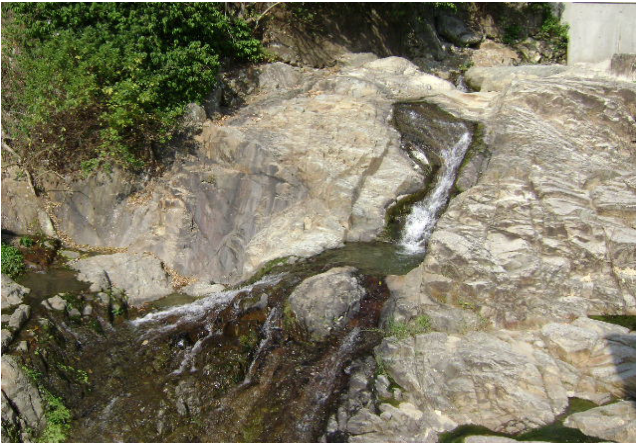
**Photographic record for exceedance of Suspended Solid recorded at Hong Hoi Chee Hong Temple (I-2) on 06-Dec-10**

Site photo
