Agreement No. MN 02/2013

Study and Site Trial on Biodiversity Improvement

of Drainage Channels through Rehabilitation of Habitats

Executive Summary

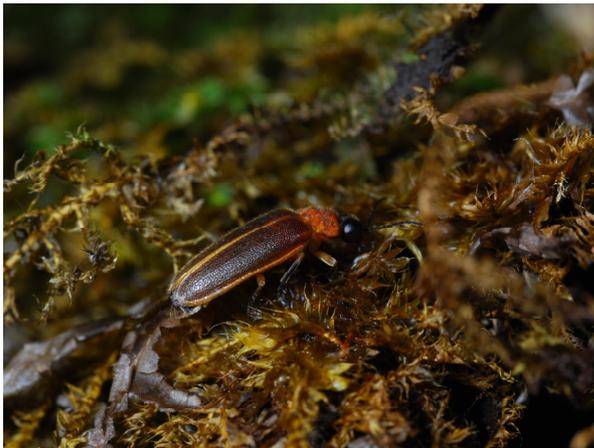
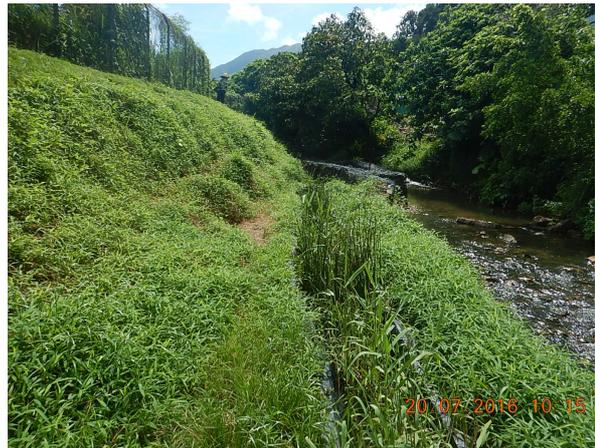
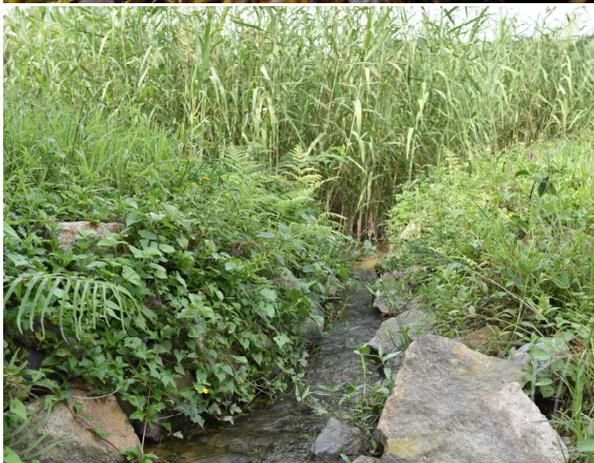
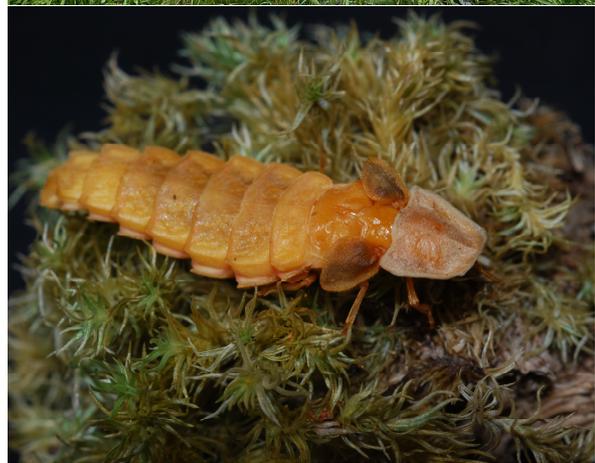
- 2. The study site and programme** – after some land search and preliminary investigation, three trial sites were selected for the biodiversity improvement works: Kam Tin River - KN2 (KaTR), Ping Yuen River (PYR) and Kwan Tei River (KwTR), shown in Figure 1 to Figure 3.

- 5. Results of Ecological Restoration**
 - a. Kwan Tei River**
 - i.** The river bank and bed of Kwan Tei River are constructed of rock gabions with little vegetation. Before restoration, slow water flow and direct sunlight heated up water body and raised the temperature to over 35°C.

- ii. Under the study, 3 eco-ponds were constructed to maintain sufficient water depth all year round. The eco-ponds were overlain with mud and large rocks. Mud offers an area for firefly to pupate while the rocks provide hiding space. A screen was put at the upstream area to prevent large fish entering the trial site and eating up all plants and aquatic organisms.

- iii. Local aquatic plants were planted on site under the study. Emergent plants such as common reed grass can filter water and absorb pollutants. Floating plants such as four-leaf fern can enhance the level of dissolved oxygen in the water. The root of plants can also create a complex environment for organisms to hide.

- ii. A 1-meter wide water channel was constructed under the study alongside with the main channel, which was transformed into an artificial surface flow wetland. Organic matters and pollutants can be settled and broken down by microorganisms. The plants can slow down water flow and enhance the biotic process by providing large surface area.

- i. The stream bed of the PYR site is fairly natural. The site is over-shadowed by bamboo. There is an inflatable dam upstream where occasional flush would aggravate soil erosion downstream.
- ii. The ecological restoration method employs the construction of refuge compartments by driving wooden piles into the river channel. Fauna and flora would be attracted into these refuge compartments.
- iii. The fauna species and numbers recorded at Ping Yuen River before and after rehabilitation are fairly similar, indicating that the biodiversity improvement brought about by the ecological improvement measures is insignificant. This is mainly due to the site dominated by bamboo plants, which hinder the flora growth in their vicinity, and the presence of Red Fire Ants in the vicinity. No herpetofauna and firefly species were recorded both before and after restoration.
