**Interim Notifications of Environmental Quality Limits Exceedances**

Incident Report on Action Level or Limit Level Non-compliance

**Photographic record for exceedance of Suspended Solid recorded at Hong Hoi Chee Hong Temple (I-2) on 05-Jun-09**

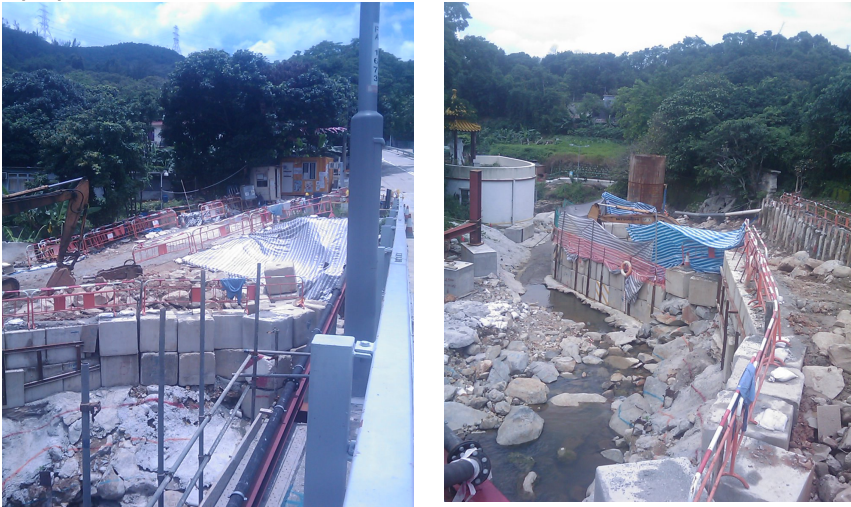
Site photo

Project	Tsuen Wan Drainage Tunnel
Date	05-Jun-09
Time	10:35 AM
Monitoring Location	Hong Hoi Chee Hong Temple (I-2)
Parameter	Suspended Solid
Action & Limit Levels	7.68 / 8.34
Measured Level	8.3 (higher than 130% of control station's SS)
Possible reason for Action or Limit Level Non-compliance	A low SS level of 3.7 is recorded at Control Station (I-2-C)
Actions taken / to be taken	The measured SS level was above Baseline Action Level but below Baseline Limit Level. However, the measured SS level was still within the range of baseline SS concentration (1-8.5mg/L). Site tidiness & cleanliness and disposal of C&D materials were undertaken during the measurement and no direct disturbance was observed from the site. Thus, the exceedance is considered to be contributed by natural variation and no action should be required.
Remarks	Following mitigation measures were provided: (1) exposed surfaces were covered by tarpaulin. (2) sandbags were used to avoid wastewater from site activities directly running down to the river of I-2. (3) sand/silts removal facilities was installed at the location of I-2.

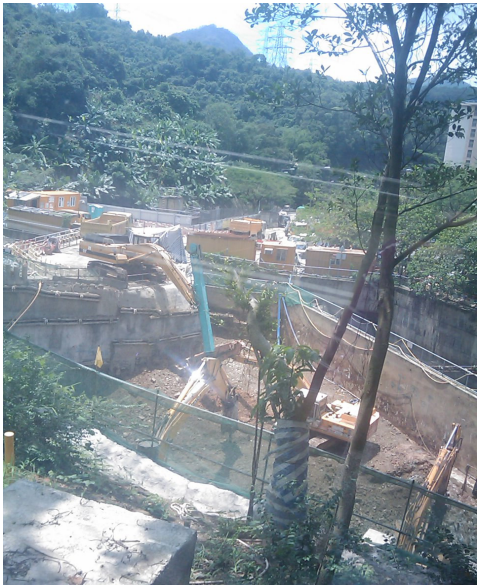
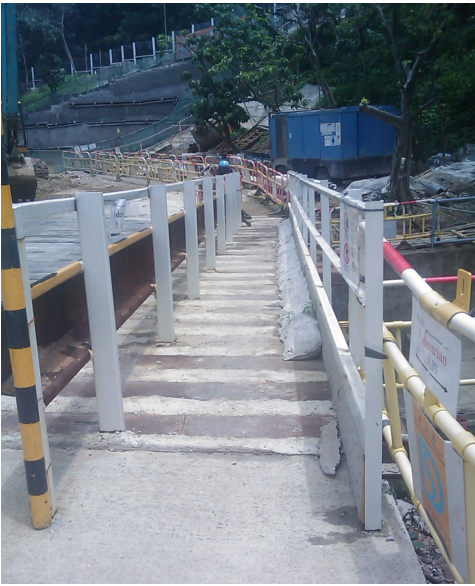
Site photo

Project	Tsuen Wan Drainage Tunnel
Date	10-Jun-09
Time	9:09 AM
Monitoring Location	Sik Sik Yuen Ho Fung College (I-1)
Parameter	Suspended Solid
Action & Limit Levels	8.85 / 10.17
Measured Level	4.2 (higher than 120% of control station's SS)
Possible reason for Action or Limit Level Non-compliance	A low SS level of 3.3 is recorded at Control Station (I-1-C)
Actions taken / to be taken	The measured SS level was below baseline Action / Limit Level and was within the range of baseline SS concentration (1- 10.5mg/L). Site cleanliness and tidiness, fabricate of temporary steel bridge, weld steel mesh and shotcrete to skin wall and no direct disturbance was observed from the site. Thus, the exceedance is considered to be contributed by natural variation and no action should be required.
Remarks	Following mitigation measures were provided: (1) sandbags were used at the gap of the bridge to avoid wastewater from site activities directly running down to the river of I-1. (2) The working site was segregated with a wall as shown in the following photo. (3) Sand/silts removal facilities was installed at the location of I-1.

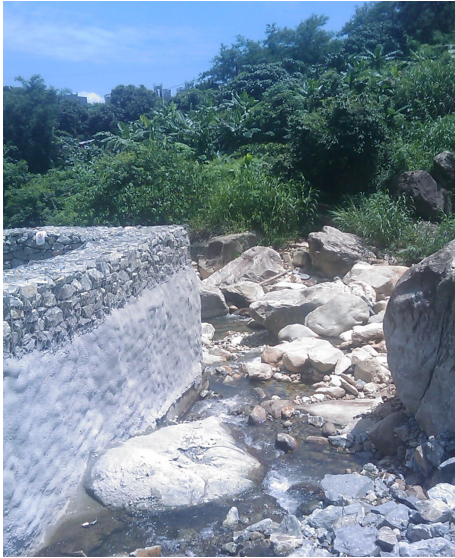
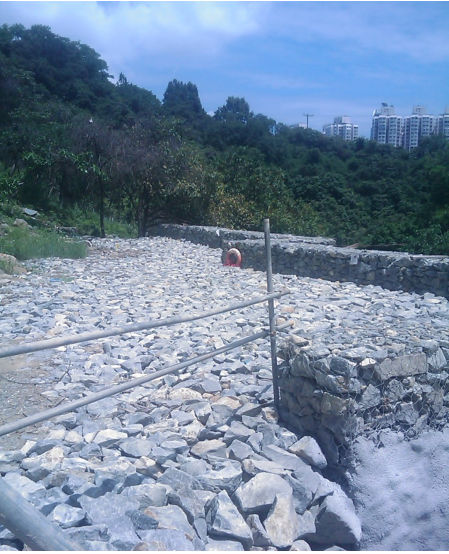
Site photo

Project	Tsuen Wan Drainage Tunnel
Date	10-Jun-09
Time	12:00 PM
Monitoring Location	Squatters (I-3)
Parameter	Suspended Solid
Action & Limit Levels	6.13 / 7.23
Measured Level	5.2 (higher than 130% of control station's SS)
Possible reason for Action or Limit Level Non-compliance	A low SS level of 3.8 is recorded at Control Station (I-3-C)
Actions taken / to be taken	The measured SS level was below baseline Action / Limit Level and was within the range of baseline SS concentration (1- 7.5mg/L). Site cleanliness and tidiness, erect formwork for skin wall and excavation, backfilling for access and no direct disturbance was observed from the site. Thus, the exceedance is considered to be contributed by natural variation and no action should be required.
Remarks	Following mitigation measures were provided: (1) Gabion wall has been constructed to avoid any water from rainstorm and from site activities directly running down to the river of I-3. (2) Sedimentation Pond and Sand/silts removal facilities was installed at the location of I-3.

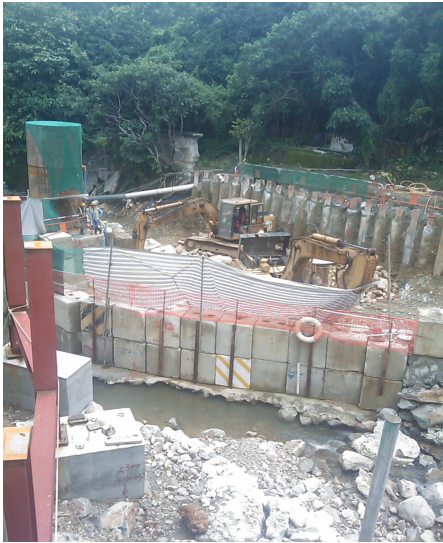
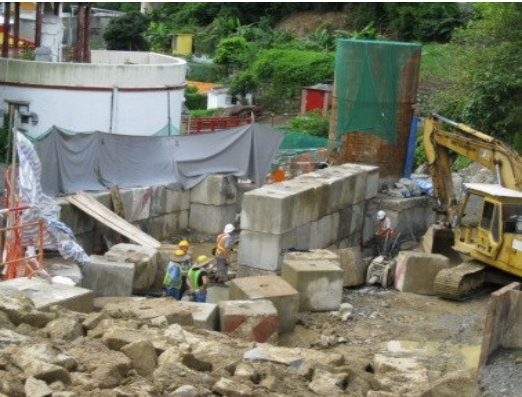
Site photo

Project	Tsuen Wan Drainage Tunnel
Date	26-Jun-09
Time	10:37 AM
Monitoring Location	Hong Hoi Chee Hong Temple (I-2)
Parameter	Suspended Solid
Action & Limit Levels	7.68 / 8.34
Measured Level	4.6 (higher than 130% of control station's SS)
Possible reason for Action or Limit Level Non-compliance	A low SS level of 3.3 is recorded at Control Station (I-2-C)
Actions taken / to be taken	The measured SS level was below baseline Action / Limit Level and was within the range of baseline SS concentration (1- 8.5mg/L). Site cleanliness and tidiness, installation of safe net and demolition of piling platform were carried out and no direct disturbance was observed from the site. Thus, the exceedance is considered to be contributed by natural variation and no action should be required.
Remarks	Following mitigation measures were provided: (1) exposed surfaces were covered by tarpaulin. (2) sandbags were used to avoid wastewater from site activities directly running down to the river of I-2. (3) sand/silts removal facilities was installed at the location of I-2.

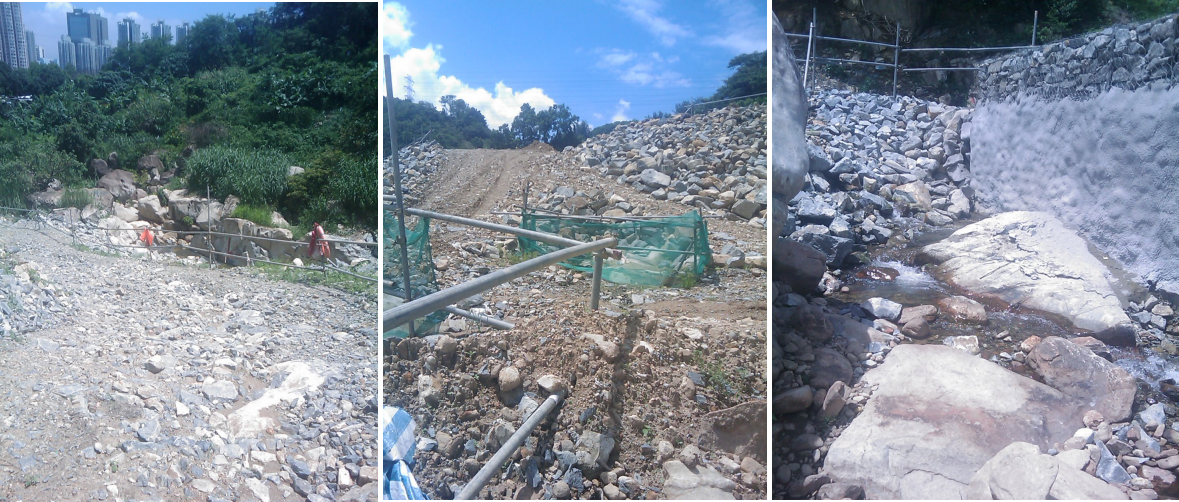
Site photo

Project	Tsuen Wan Drainage Tunnel
Date	26-Jun-09
Time	12:36 PM
Monitoring Location	Squatters (I-3)
Parameter	Suspended Solid
Action & Limit Levels	6.13 / 7.23
Measured Level	3.2 (higher than 130% of control station's SS)
Possible reason for Action or Limit Level Non-compliance	A low SS level of 2.0 is recorded at Control Station (I-3-C)
Actions taken / to be taken	The measured SS level was below baseline Action / Limit Level and was within the range of baseline SS concentration (1- 7.5mg/L). Site cleanliness and tidiness and formation of access road were carried out and no direct disturbance was observed from the site. Thus, the exceedance is considered to be contributed by natural variation and no action should be required.
Remarks	Following mitigation measures were provided: (1) gabion wall has been constructed to avoid any water from rainstorm and from site activities directly running down to the river of I-3. (2) Sedimentation pond and sand/silts removal facilities was installed at the location of I-3.
