Air Quality Impact Monitoring Results (1-Hour TSP)

Contract No. DC/2007/12 - Design and Construction of Tsuen Wan Drainage Tunnel

Noise Impact Monitoring Results

Water Quality Impact Monitoring Results

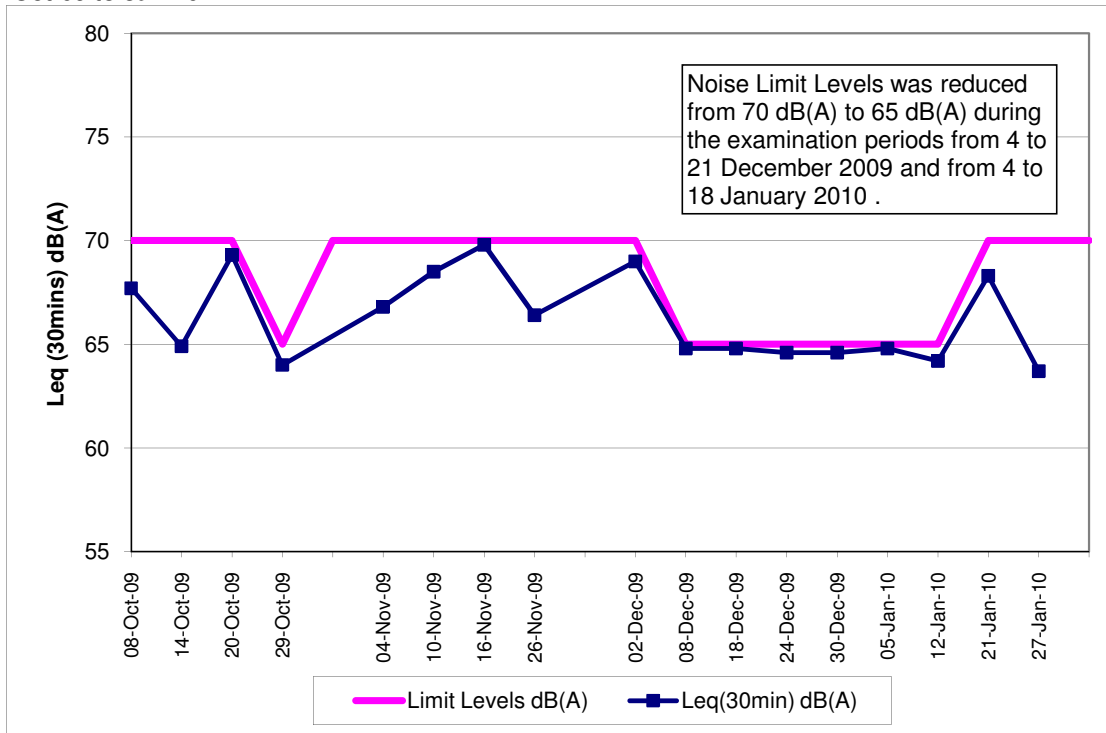
**Contract No. DC/2007/12 - Design and Construction of Tsuen Wan Drainage Tunnel
Noise Monitoring Results at Sik Sik Yuen Ho Fung College (NSR 1)
Oct-09 to Jan-10**

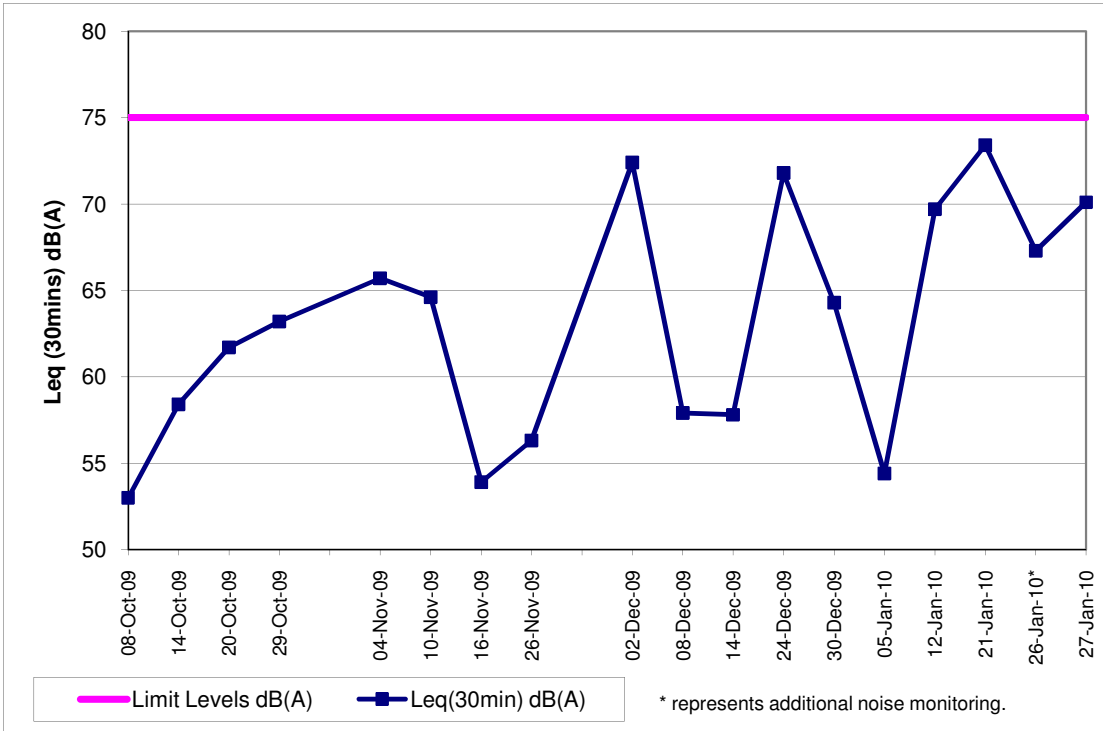
**Contract No. DC/2007/12 - Design and Construction of Tsuen Wan Drainage Tunnel
Noise Monitoring Results at Squatters (NSR 6)
Oct-09 to Jan-10**
