Interim Notifications of Environmental Quality Limits Exceedances

Incident Report on Action Level or Limit Level Non-compliance

Photographic record for exceedance of Suspended Solid recorded at Hong Hoi Chee Hong Temple (I-2) on 09-Jun-10

Photographic record for exceedance of Suspended Solid recorded at Sik Sik Yuen Ho Fung College (I-1) on 21-Jun-10

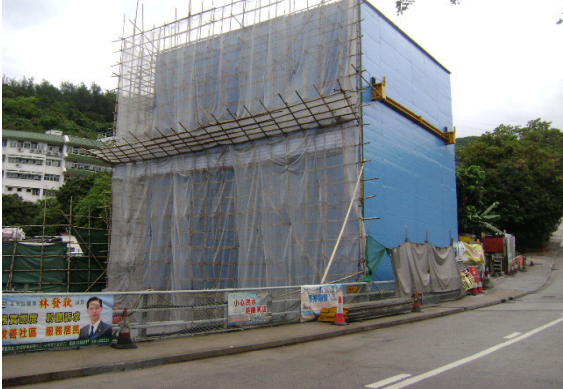
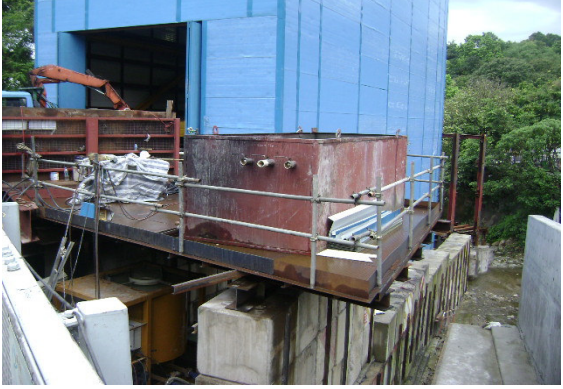
Site photo

Project	Tsuen Wan Drainage Tunnel
Date	09-Jun-10
Time	9:35 AM
Monitoring Location	Hong Hoi Chee Hong Temple (I-2)
Parameter	Suspended Solid
Action & Limit Levels	7.68 / 8.34
Measured Level	2.55 (higher than 120% of control station's SS)
Possible reason for Action or Limit Level Non-compliance	A low SS level of 2.00 is recorded at Control Station (I-2-C)
Actions taken / to be taken	The measured SS level was below baseline Action / Limit Level and was within the range of baseline SS concentration (1-8.5mg/L). Site cleaning & tidying, erection of noise enclosure at vortex drop shaft and man access shaft, excavation, erection of working platform for mini-pile and pipe jacking were undertaken during the measurement. No direct disturbance was observed from the site. Thus, the exceedance is considered to be contributed by natural variation and no action should be required.
Remarks	Following mitigation measures were provided: (1) Exposed surfaces were covered by tarpaulin. (2) Sandbags were used to avoid wastewater from site activities directly running down to the river of I-2. (3) Waste water treatment plant and sedimentation tanks were in place at the location of I-2.

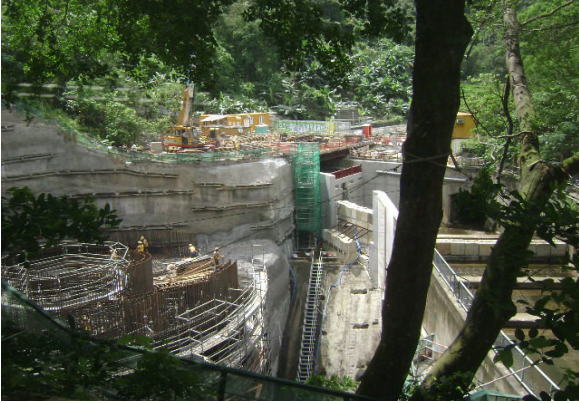
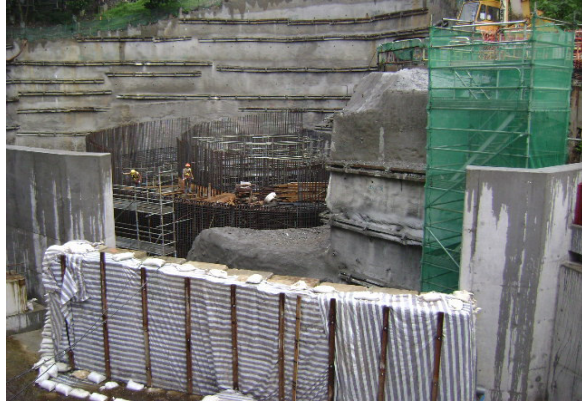
Site photo

Project	Tsuen Wan Drainage Tunnel
Date	21-Jun-10
Time	10:50 AM
Monitoring Location	Sik Sik Yuen Ho Fung College (I-1)
Parameter	Suspended Solid
Action & Limit Levels	8.85 / 10.17
Measured Level	10.35
Possible reason for Action or Limit Level Non-compliance	SS level of 6.50 is recorded at Control Station (I-1-C)
Actions taken / to be taken	The measured SS level was slightly above the Baseline Limit level and above the Control Limit Level. The measured value was still within the range of baseline SS concentration (1-10.5mg/L). Construction activities including general site cleaning and housekeeping; erect formwork for spiral ramp; strip off formwork for spiral ramp; rebar fixing for spiral ramp and erect scaffold working platform for spiral ramp were undertaken during the measurement and no direct disturbance was observed from the site. Thus, the exceedance is considered to be natural variation and no action should be taken.

Remarks	Following mitigation measures were provided: (1) existing stream has been diverted and banded by sealed concrete block wall and sand bag bund walls were also installed. No wastewater was observed down to the channel-I1. (2) Sand/silts removal facilities was installed at the location of I-1.
