Interim Notifications of Environmental Quality Limits Exceedances

Incident Report on Action Level or Limit Level Non-compliance

Project	Tsuen Wan Drainage Tunnel
Date	03-Jan-11
Time	11:10 AM
Monitoring Location	Sik Sik Yuen Ho Fung College (I-1)
Parameter	Turbidity
Action & Limit Levels	9.75 / 12.47
Measured Level	11.31
Possible reason for Action or Limit Level Non-compliance	A high turbidity level of 11.44 is recorded at Control Station (I-1-C).
Actions taken / to be taken	The measured turbidity level was above the baseline Action Level, but lower than the turbidity level of the control station (I-1-C) and within the range of baseline turbidity concentration (3.13 - 13.15 NTU). General site cleaning and housekeeping, filling TBM spoil into centre void, spatterdashing on spiral ramp, horizontal drilling and grouting, and geotechnical instrumentation monitoring were undertaken during the measurement. No direct disturbance was observed from the site. Thus, the exceedance was considered to be contributed by natural variation and no action was required.

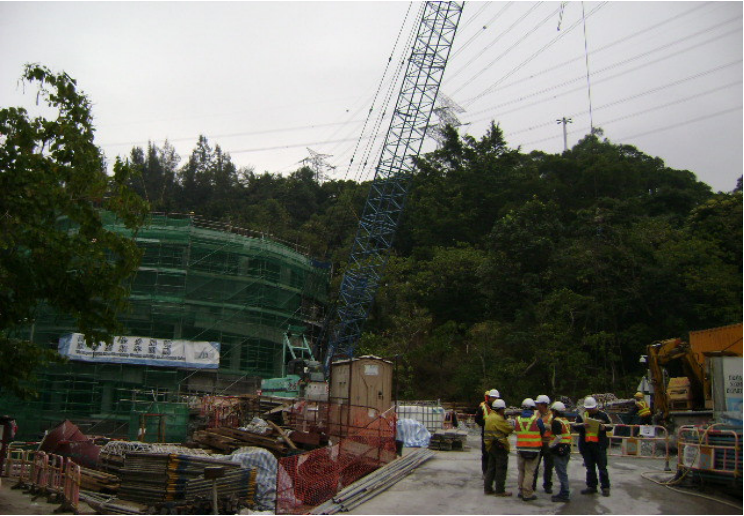
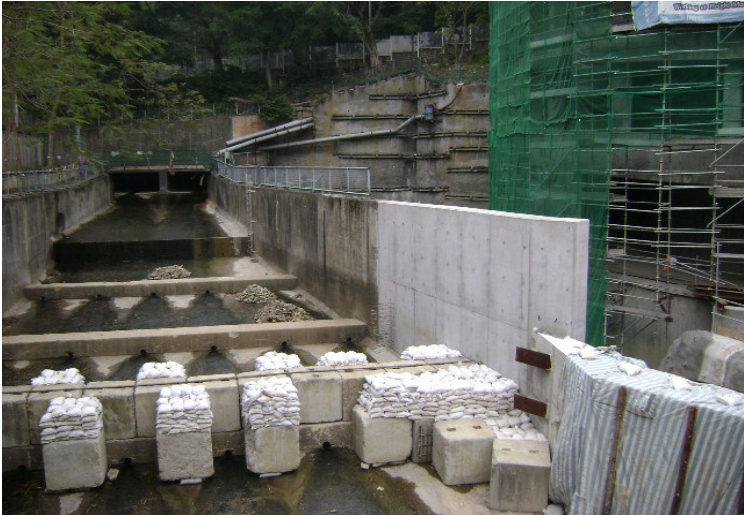
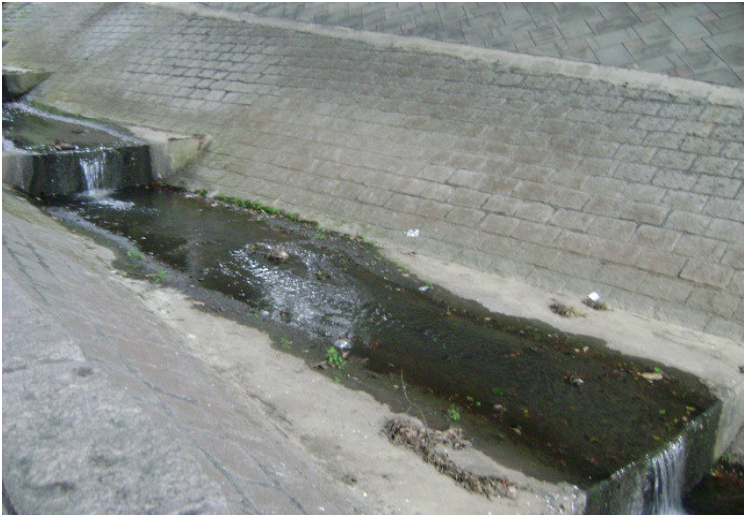
Photographic record for exceedance of Suspended Solid recorded at Sik Sik Yuen Ho Fung College (I-1) on 03-Jan-11

Project	Tsuen Wan Drainage Tunnel
Date	03-Jan-11
Time	11:10 AM
Monitoring Location	Sik Sik Yuen Ho Fung College (I-1)
Parameter	Suspended Solid
Action & Limit Levels (mg/L)	8.85 / 10.17
Measured Level (mg/L)	10.10
Possible reason for Action or Limit Level Non-compliance	A High SS level of 11.00 mg/L was recorded at Control Station (I-1-C)
Actions taken / to be taken	The measured SS level was above the baseline Action Level, but lower than the SS level of the control station (I-1-C) and within the range of baseline SS concentration (1 - 10.5 mg/L). General site cleaning and housekeeping, filling tunnel boring machine (TBM) spoil into centre void, spatterdashing on spiral ramp, horizontal drilling and grouting, and geotechnical instrumentation monitoring were undertaken during the measurement. No direct disturbance was observed from the site. Thus, the exceedance was considered to be contributed by natural variation and no action was required.

Remarks	The following mitigation measures were provided: (1) Waste water was collected and diverted to on-site waste water treatment plant for treatment before discharge; (2) Nullah and site area were separated by sealed concrete block wall and sandbags barrier.

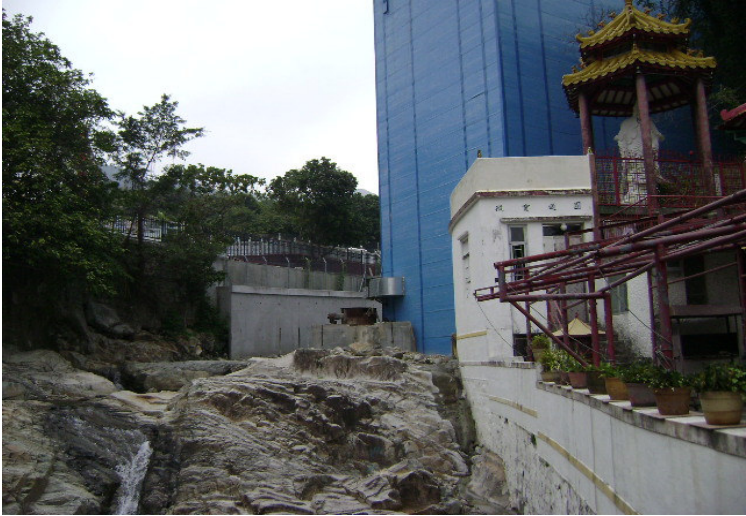
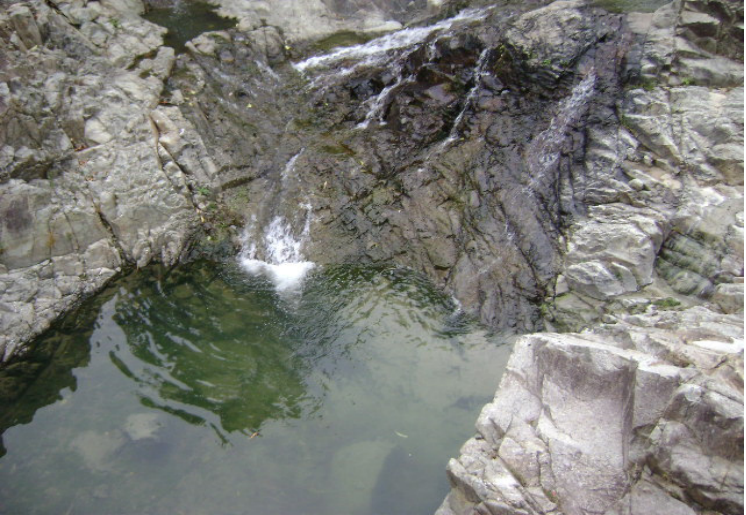
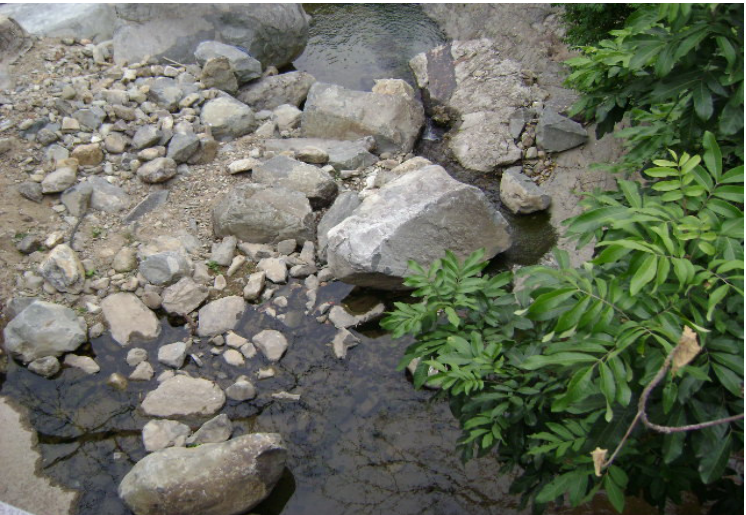
Photographic record for exceedance of Suspended Solid recorded at Hong Hoi Chee Hong Temple (I-2) on 03-Jan-11

Project	Tsuen Wan Drainage Tunnel
Date	03-Jan-11
Time	10:38 AM
Monitoring Location	Hong Hoi Chee Hong Temple (I-2)
Parameter	Suspended Solid
Action & Limit Levels (mg/L)	7.68 / 8.34
Measured Level (mg/L)	2.45
Possible reason for Action or Limit Level Non-compliance	A low SS level of 2.00 mg/L was recorded at Control Station (I-2-C)
Actions taken / to be taken	The measured SS level was below baseline Action / Limit Level and within the range of baseline SS concentration (1 - 8.5 mg/L) but was more than 120% of the SS level measured at the upstream control station (I-2-C). General site cleaning, housekeeping and temporary traffic arrangement (TTA), excavation (drilling holes) at vortex drop shaft, excavation (shotcreting and mucking) at man access shaft, closed formwork for dry flow channel, rock breaking for 16 th jacking pipe at Portion G; erection of 60 ton temporary steel platform at Portion G and excavation for 750 step channel (SC) and catchpit were undertaken during measurement. No direct disturbance was observed from the site. Thus, the exceedance was considered to be contributed by natural variation and no action was required.

Remarks	The following mitigation measures had been provided: (1) Waste water was collected to waste water treatment plant and treated before discharge; (2) existing stream has been diverted and bunded by sealed concrete block wall; and (3) existing stream had been bunded off by sand bag to prevent excavated material from washing out of the working area.

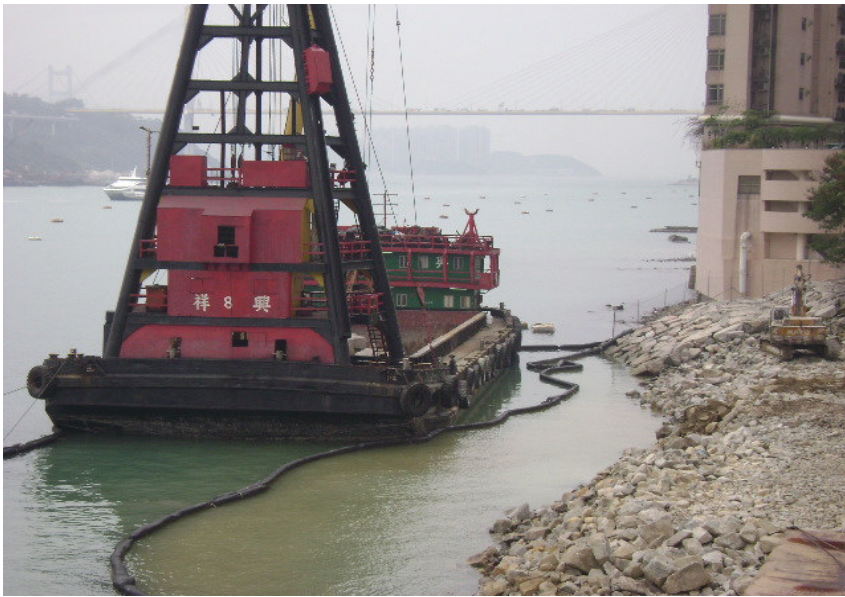
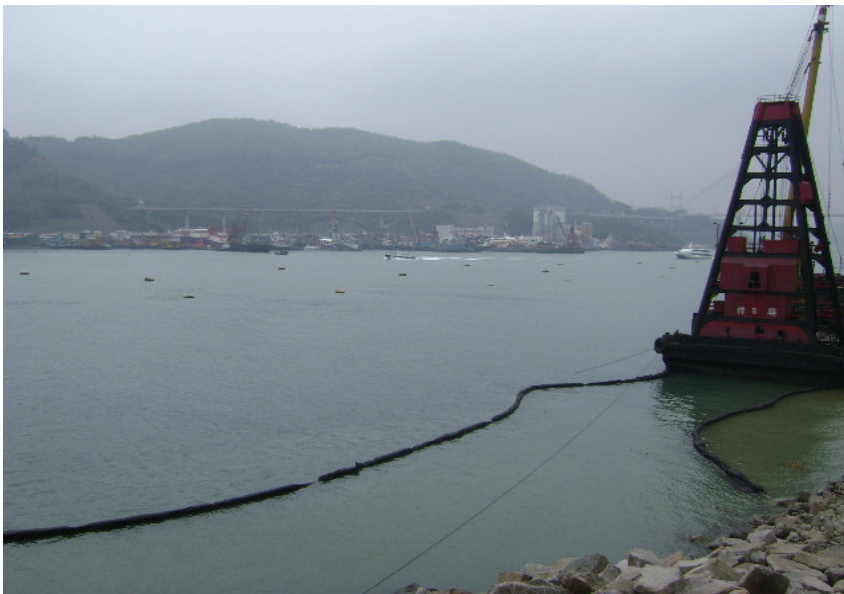
Photographic record for exceedance of Suspended Solids (SS) recorded at O-1(FT) on 05-Jan-11

Project	Tsuen Wan Drainage Tunnel
Date	05-Jan-11
Time	10:30 AM
Monitoring Location	O-1(FT)
Parameter	Suspended Solids (SS)
Action & Limit Levels (mg/L)	14.10 / 18.08 (derived from the baseline monitoring data)
Measured Level (depth-averaged) at Monitoring Location (mg/L)	10.55
Control Station	O-1-C(FT)
Measured Level (depth averaged) at Control Station (mg/L)	8.72
Possible reason for Action or Limit Level Non-compliance	The measured SS level (depth-averaged) at O-1(FT) was below the baseline Action/Limit Level but was higher than 120% of the control station's SS level (O-1-C(FT)) at the same tide of the same day. Only amour rock removal from the sea wall to the derrick barge at Portion E was undertaken during measurement. Silt curtain were deployed long the Portion E boundary line and extended from seawater level to seabed. Floating type silt curtain was also employed at the inner side. As such, the exceedance was considered to be contributed by natural variation and no further action was required.

Actions taken / to be taken	(1) Silt curtain had been provided along the Portion E boundary line and extended from seawater level to the bottom of seabed; (2) Floating type silt curtain had been employed at the inner side; (3) Sufficient slack of silt curtain was allowed to cope with the wave and tidal action to ensure the curtains (outer and inner) were rested on seabed; (4) Condition of silt curtains had been checked by the supervisor daily when marine works was undertaken.
Remarks	None

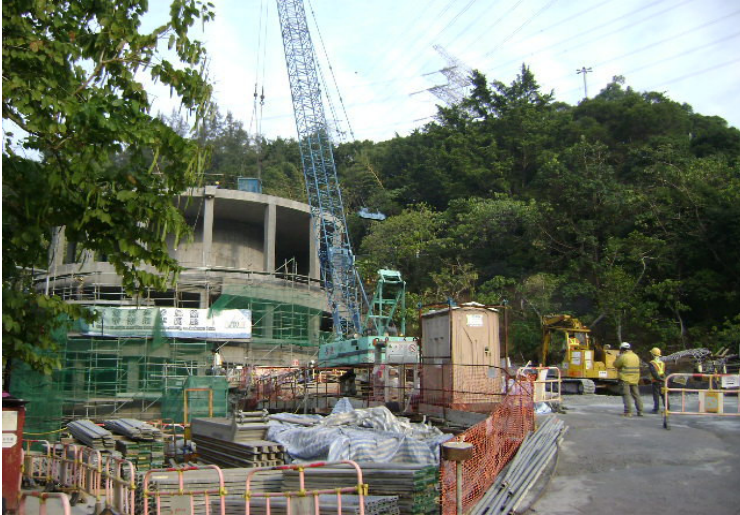
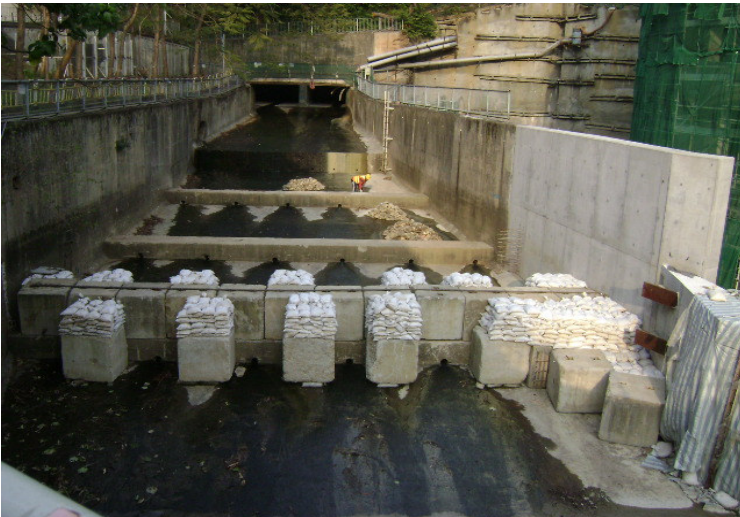
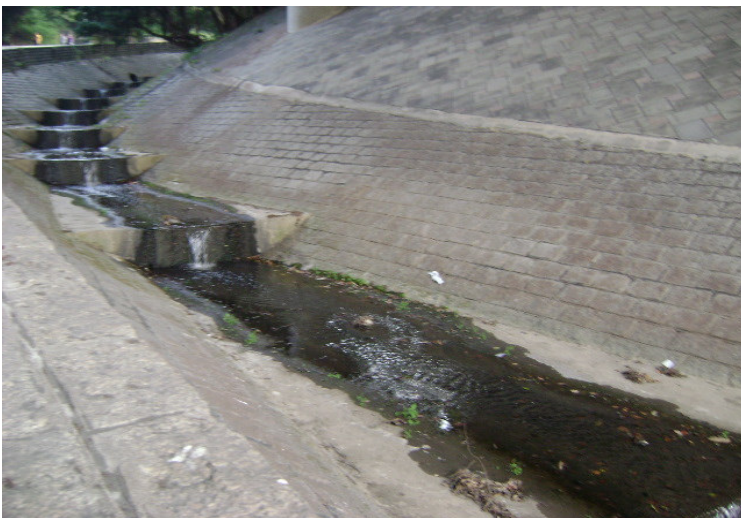
Photographic record for exceedance of Suspended Solid recorded at Sik Sik Yuen Ho Fung College (I-1) on 10-Jan-11

Project	Tsuen Wan Drainage Tunnel
Date	10-Jan-11
Time	9:54 AM
Monitoring Location	Sik Sik Yuen Ho Fung College (I-1)
Parameter	Suspended Solid
Action & Limit Levels (mg/L)	8.85 / 10.17
Measured Level (mg/L)	3.50
Possible reason for Action or Limit Level Non-compliance	A low SS level of 2.45 mg/L was recorded at control station (I-1-C).
Actions taken / to be taken	The measured SS level was below the baseline action level, but higher than 130% of the SS level of the control station (I-1-C) and within the range of baseline SS concentration (1 - 10.5 mg/L). General site cleaning and housekeeping, dismantling of facade platform, horizontal drilling and grouting, and geotechnical instrumentation monitoring were undertaken during measurement. No direct disturbance was observed from the site. Thus, the exceedance was considered to be contributed by natural variation and no action was required.
Remarks	The following mitigation measures were provided on-site during monitoring: (1) Waste water was diverted to waste water treatment plant and treated before discharge; and (2) Nullah and site area were separated by sealed concrete block.

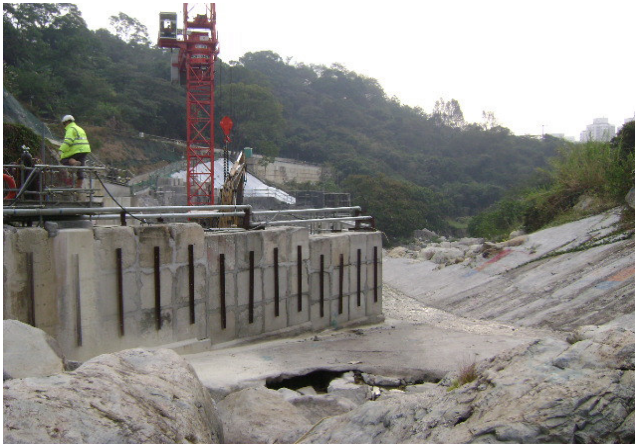
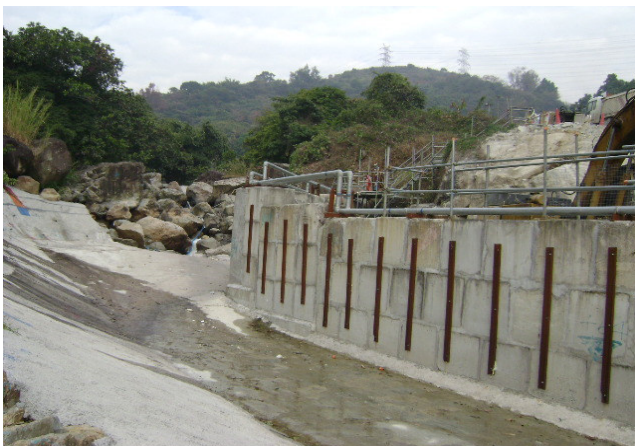
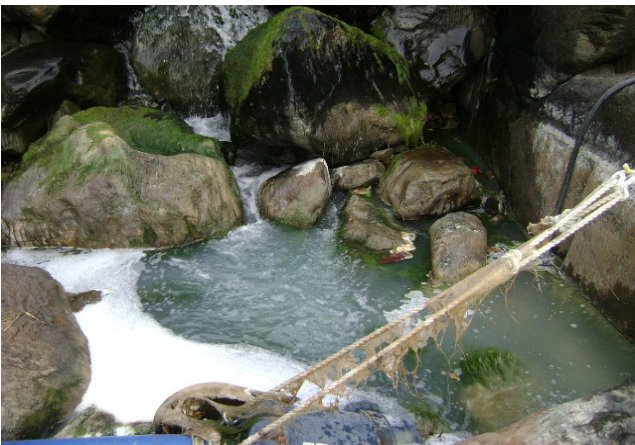
Photographic record for exceedance of Turbidity recorded at Squatters (I-3) on 14-Jan-11

Project	Tsuen Wan Drainage Tunnel
Date	14-Jan-11
Time	11:00 AM
Monitoring Location	Squatters (I-3)
Parameter	Turbidity
Action & Limit Levels (NTU)	3.99 / 4.18
Measured Level (NTU)	10.62
Possible reason for Action or Limit Level Non-compliance	A high turbidity 10.97 NTU was recorded at control station (I-3-C). Milky green polluted water discharged from others at upstream.
Actions taken / to be taken	The measured turbidity level was higher than baseline limit level, but lower than the turbidity level of the control station (I-3-C). General site cleaning and housekeeping, monitoring of deformation monitoring point (DMP), shotcreting at shaft, approach channel excavation – rock removal, rock breaking, pre-drilling, mesh installation, rock dowel drilling and grouting and peeling cement grout outside H-pile for PB wall were undertaken during measurement. No direct disturbance was observed from the site. Milky green colored water was found coming from upstream of the Intake I-3 works area, so the exceedance was considered to be contributed by pollution from upstream and not project related. As a result, no action was required.

Remarks	The following mitigation measures were provided on-site during monitoring: (1) All waste water were collected and diverted to waste water treatment plant prior to discharge; (2) Existing stream was diverted and banded by sealed concrete block wall; and (3) Excavated area had been banded and sealed by concrete block wall to prevent any excavated material runoff from working area.

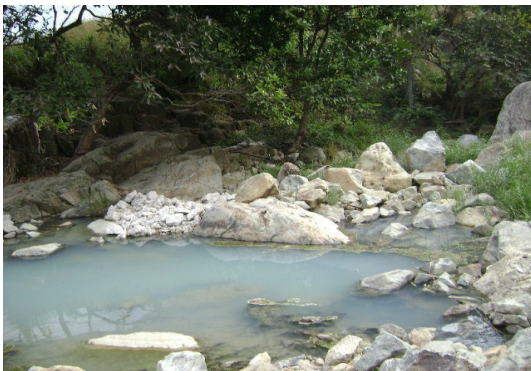
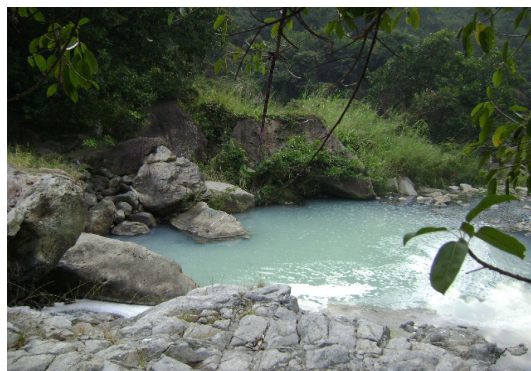
Milky Green Colored Water found at upstream location

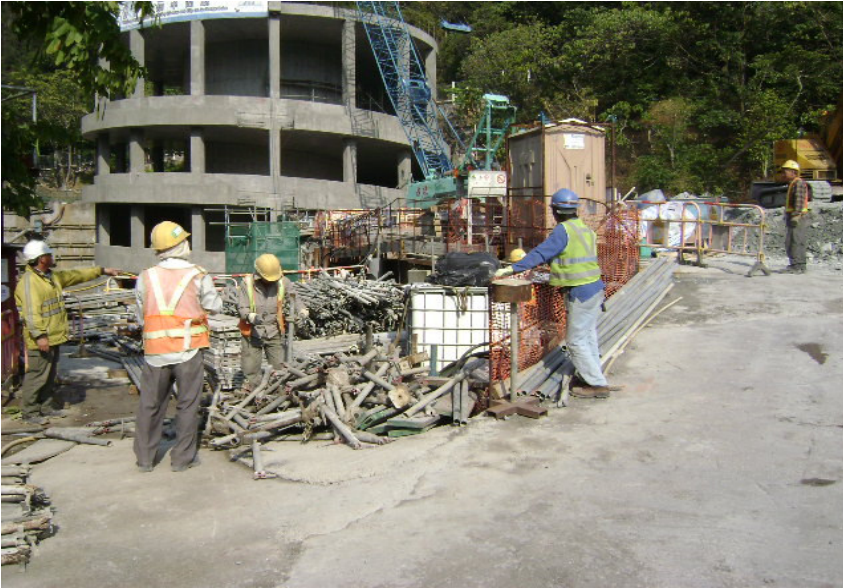
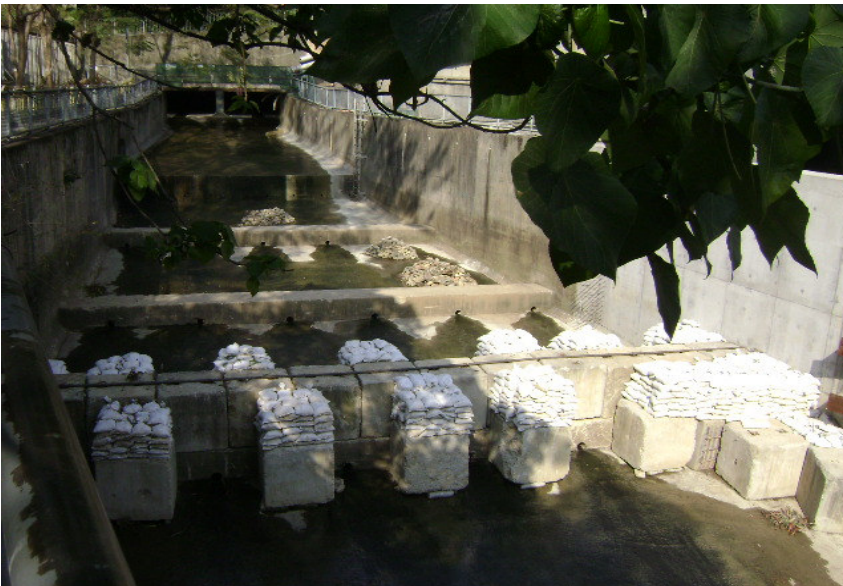
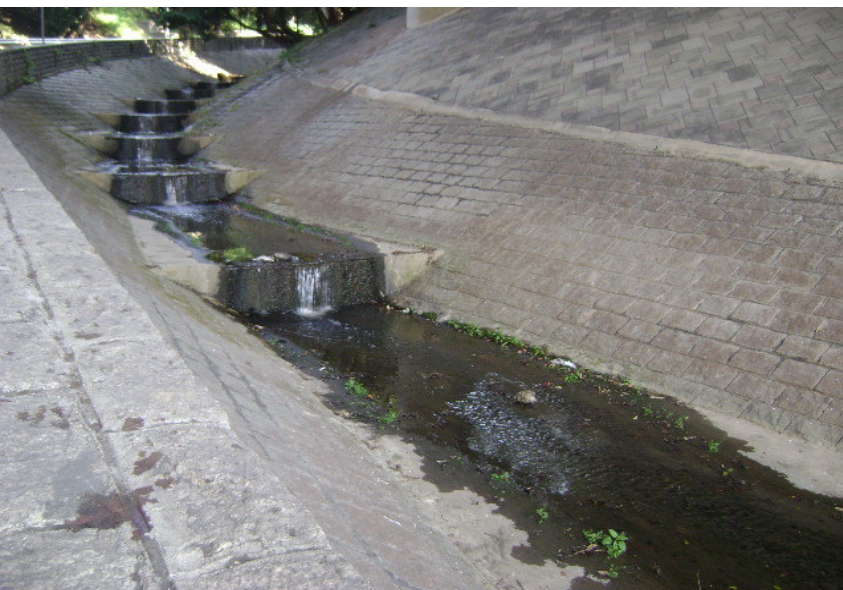
Photographic record for exceedance of Turbidity recorded at Sik Sik Yuen Ho Fung College (I-1)
on 19-Jan-11

Project	Tsuen Wan Drainage Tunnel
Date	19-Jan-11
Time	11:16 AM
Monitoring Location	Sik Sik Yuen Ho Fung College (I-1)
Parameter	Turbidity
Action & Limit Levels (NTU)	9.75 / 12.47
Measured Level (NTU)	13.70
Possible reason for Action or Limit Level Non-compliance	A high turbidity level of 13.88 NTU was recorded at the Control Station (I-1-C).
Actions taken / to be taken	The measured turbidity level was above the baseline limit level, but lower than the turbidity level of the control station (I-1-C). General site cleaning and tidy up works, filling the spoil of the tunnel boring machine (TBM) into spiral ramp, dismantling of steel working platform and geotechnical monitoring were undertaken during the measurement. No direct disturbance was observed from the site. Thus, the exceedance was considered to be contributed by high turbidity level of upstream location and natural variation. Since the exceedance was not project related, no action was required.

Remarks	The following mitigation measures were provided: (1) Waste water was collected to waste water treatment plant and treated before discharge; and (2) Nullah and site area were separated by sealed concrete block.

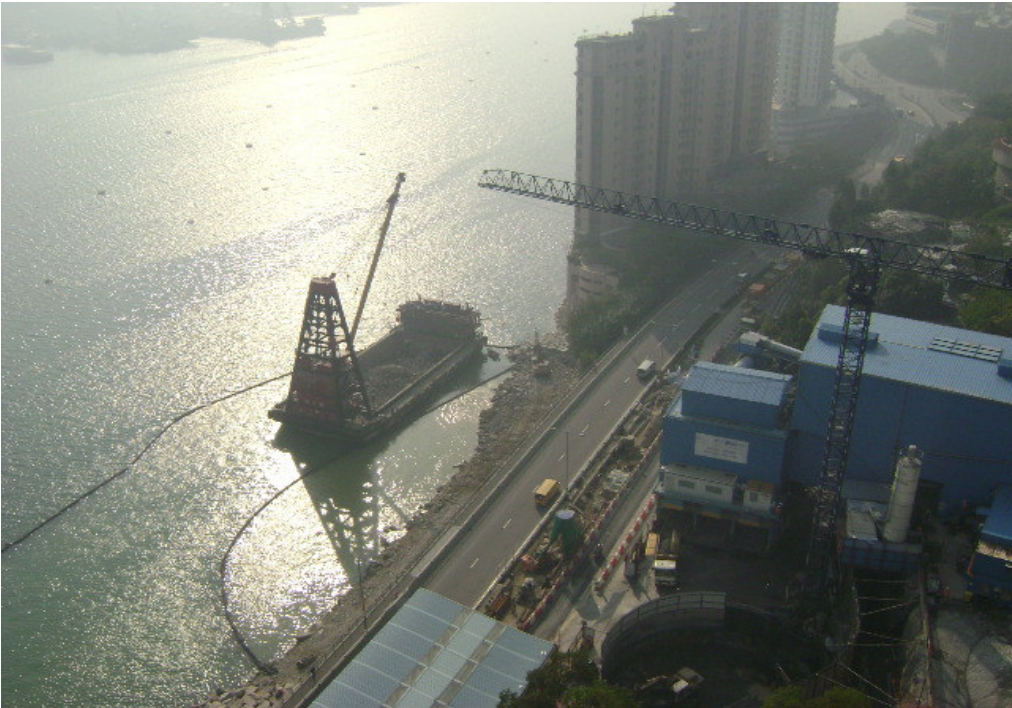
Photographic record for exceedance of Suspended Solids (SS) recorded at O-1(ET) on 14-Jan-11

Project	Tsuen Wan Drainage Tunnel
Date	14-Jan-11
Time	6:20 PM
Monitoring Location	O-1(ET)
Parameter	Suspended Solids (SS)
Action & Limit Levels (mg/L)	13.25 / 14.39 (derived from the baseline monitoring data)
Measured Level (depth-averaged) at Monitoring Location	5.10
Control Station	O-1-C(ET)
Measured Level (depth averaged) at Control Station (mg/L)	3.63
Possible reason for Action or Limit Level Non-compliance	The measured SS level (depth-averaged) at O-1(ET) was below the baseline Action/Limit Level but higher than 130% of the control station's SS level (O-1-C(ET)) at the same tide of the same day. Only removal of amour rock and placing them into derrick barge was undertaken during measurement and there was no other marine works. Silt curtains had been deployed along the dredging boundary line and extended from the seawater level to the seabed and floating type silt curtain had been employed at the inner side. As such, the exceedance was considered to be contributed by natural variation and no further action was required.

Actions taken / to be taken	(1) Silt curtain had been provided along the Portion E boundary line and extended from seawater level to the bottom of seabed; (2) Floating type silt curtain had been employed at the inner side; and (3) Sufficient slack of silt curtain was allowed to cope with the wave and tidal action to ensure the curtains (outer and inner) were rested on seabed.
Remarks	None

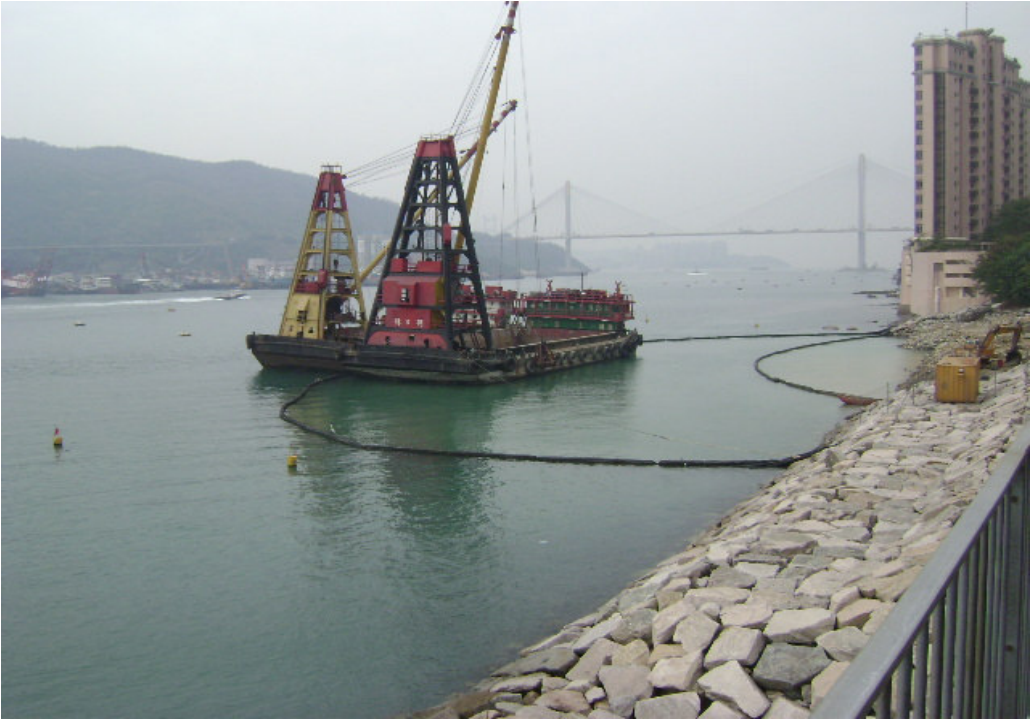
Photographic record for exceedance of Suspended Solids (SS) recorded at O-1(FT) on 17-Jan-11

Project	Tsuen Wan Drainage Tunnel
Date	17-Jan-11
Time	2:35 PM
Monitoring Location	O-1(FT)
Parameter	Suspended Solids (SS)
Action & Limit Levels (mg/L)	14.10 / 18.08 (derived from the baseline monitoring data)
Measured Level (depth-averaged) at Monitoring Location (mg/L)	5.10
Control Station	O-1-C(FT)
Measured Level (depth averaged) at Control Station (mg/L)	4.18
Possible reason for Action or Limit Level Non-compliance	The measured SS level (depth-averaged) at O-1(FT) was below the baseline Action/Limit Level but was higher than 120% of the control station's SS level (O-1-C(FT)) at the same tide of the same day. Only relocation of rock amour to another derrick barge for transportation to storage area was undertaken during measurement and there was no marine works. Silt curtain was deployed long the Portion E boundary line and extended from seawater level to seabed. Floating type silt curtain was also employed at the inner side. As such, the exceedance was considered to be contributed by natural variation and no further action was required.

Actions taken / to be taken	(1) Silt curtain had been provided along the Portion E boundary line and extended from seawater level to the bottom of seabed; (2) Floating type silt curtain had been employed at the inner side; (3) Sufficient slack of silt curtain was allowed to cope with the wave and tidal action to ensure the curtains (outer and inner) were rested on seabed.
Remarks	None

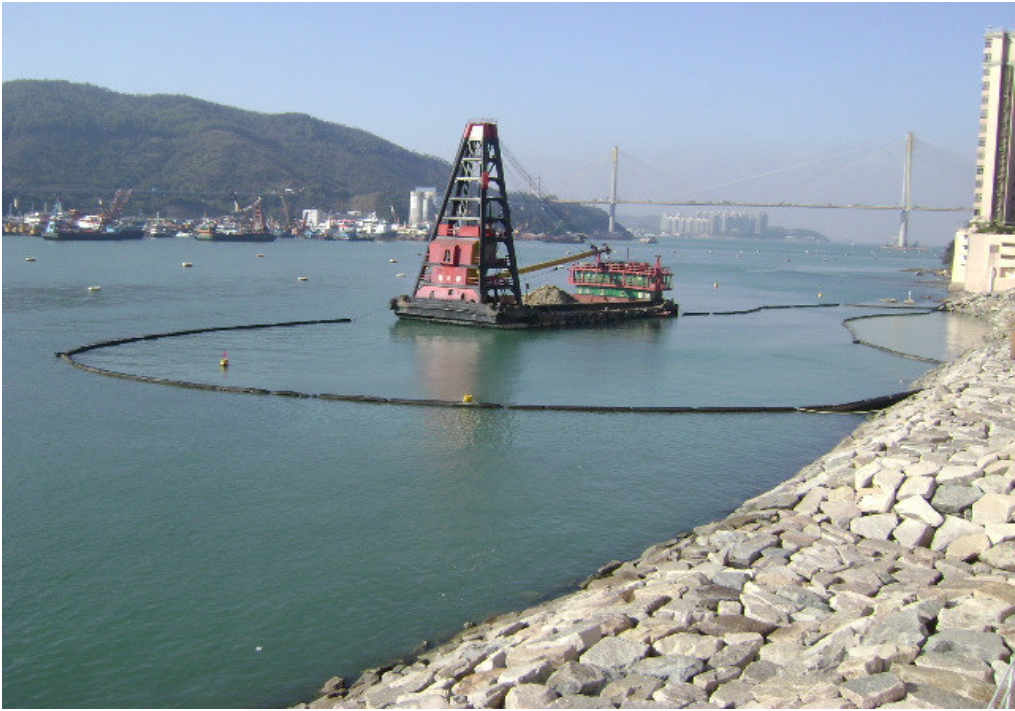
Photographic record for exceedance of Turbidity recorded at O-1(FT) on 21-Jan-11

Project	Tsuen Wan Drainage Tunnel
Date	21-Jan-11
Time	9:33 AM
Monitoring Location	O-1(FT)
Parameter	Turbidity
Action & Limit Levels (NTU)	10.35 / 13.15 (derived from the baseline monitoring data)
Measured Level (depth-averaged) at Monitoring Location (NTU)	12.61
Control Station	O-1-C(FT)
Measured Level (depth averaged) at Control Station (NTU)	14.57
Possible reason for Action or Limit Level Non-compliance	The measured SS level (depth-averaged) at O-1(FT) was above the baseline action level but was lower than the control station's SS level (O-1-C(FT)) at the same tide of the same day. No marine works was undertaken on that morning. Silt curtain was deployed along the Portion E boundary line and extended from seawater level to seabed. Floating type silt curtain was also employed at the inner side. As such, the exceedance was considered to be contributed by natural variation and no further action was required.

Actions taken / to be taken	(1) Silt curtain had been provided along the Portion E boundary line and extended from seawater level to the bottom of seabed; (2) Floating type silt curtain had been employed at the inner side; (3) Sufficient slack of silt curtain was allowed to cope with the wave and tidal action to ensure the curtains (outer and inner) were rested on seabed.
Remarks	None

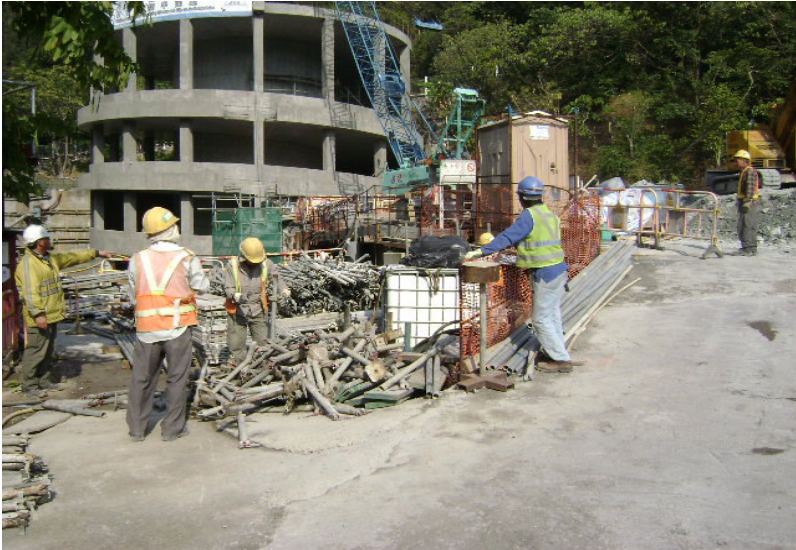
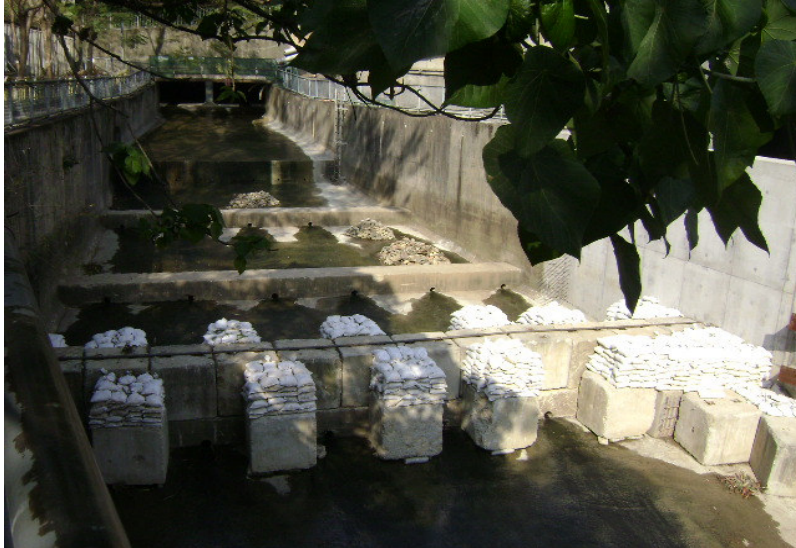
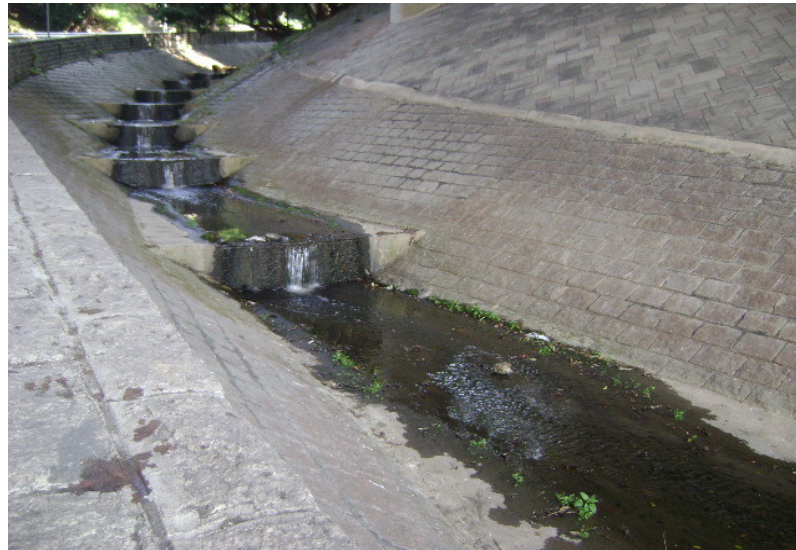
Photographic record for exceedance of Suspended Solid recorded at Sik Sik Yuen Ho Fung College (I-1) on 19-Jan-11

Project	Tsuen Wan Drainage Tunnel
Date	19-Jan-11
Time	11:16 AM
Monitoring Location	Sik Sik Yuen Ho Fung College (I-1)
Parameter	Suspended Solid
Action & Limit Levels (mg/L)	8.85 / 10.17
Measured Level (mg/L)	14.50
Possible reason for Action or Limit Level Non-compliance	A High SS level of 15.30 mg/L was recorded at Control Station (I-1-C)
Actions taken / to be taken	The measured SS level was above the baseline limit level, but lower than the SS level of the control station (I-1-C). General site cleaning and tidy up works, filling the spoil of the tunnel boring machine (TBM) into spiral ramp, dismantling of steel working platform and geotechnical monitoring were undertaken during the measurement. No direct disturbance was observed from the site. Thus, the exceedance was considered to be contributed by high SS level of upstream location and natural variation. Since the exceedance was not project related, no action was required.

Remarks	The following mitigation measures were provided: (1) Waste water was collected to waste water treatment plant and treated before discharge; and (2) Nullah and site area were separated by sealed concrete block.

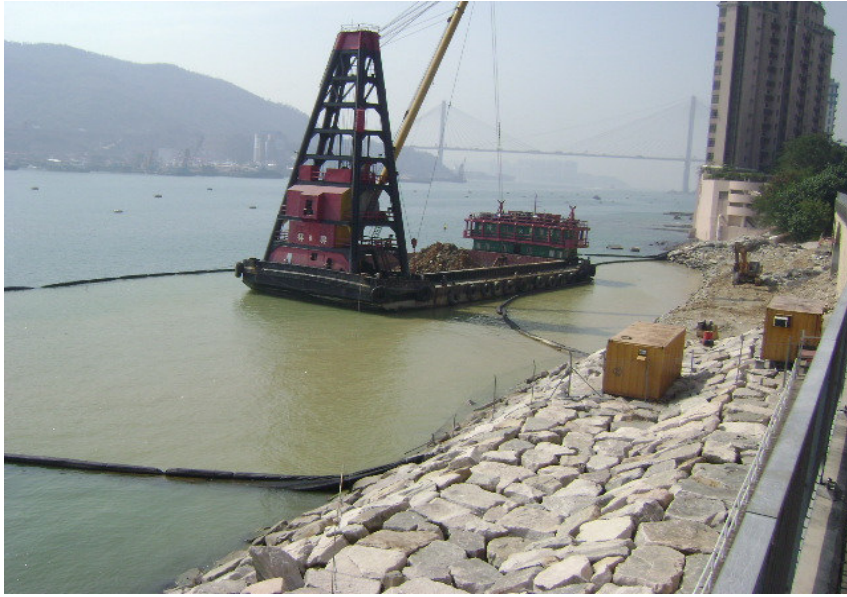
Photographic record for exceedance of Suspended Solids (SS) recorded at O-1(FT) on 19-Jan-11

Project	Tsuen Wan Drainage Tunnel
Date	19-Jan-11
Time	9:05 AM
Monitoring Location	O-1(FT)
Parameter	Suspended Solids (SS)
Action & Limit Levels (mg/L)	14.10 / 18.08 (derived from the baseline monitoring data)
Measured Level (depth-averaged) at Monitoring Location (mg/L)	7.52
Control Station	O-1-C(FT)
Measured Level (depth averaged) at Control Station (mg/L)	6.20
Possible reason for Action or Limit Level Non-compliance	The measured SS level (depth-averaged) at O-1(FT) was below the baseline Action/Limit Level but was higher than 120% of the control station's SS level (O-1-C(FT)) at the same tide of the same day. Only amour rock removal from seawall was undertaken and there was no other marine works during monitoring. Silt curtain was deployed along the Portion E boundary line and extended from seawater level to seabed. Floating type silt curtain was also employed at the inner side. As such, the exceedance was considered to be contributed by natural variation and no further action was required.

Actions taken / to be taken	(1) Silt curtain had been provided along the Portion E boundary line and extended from seawater level to the bottom of seabed; (2) Floating type silt curtain had been employed at the inner side; (3) Sufficient slack of silt curtain was allowed to cope with the wave and tidal action to ensure the curtains (outer and inner) were rested on seabed.
Remarks	None

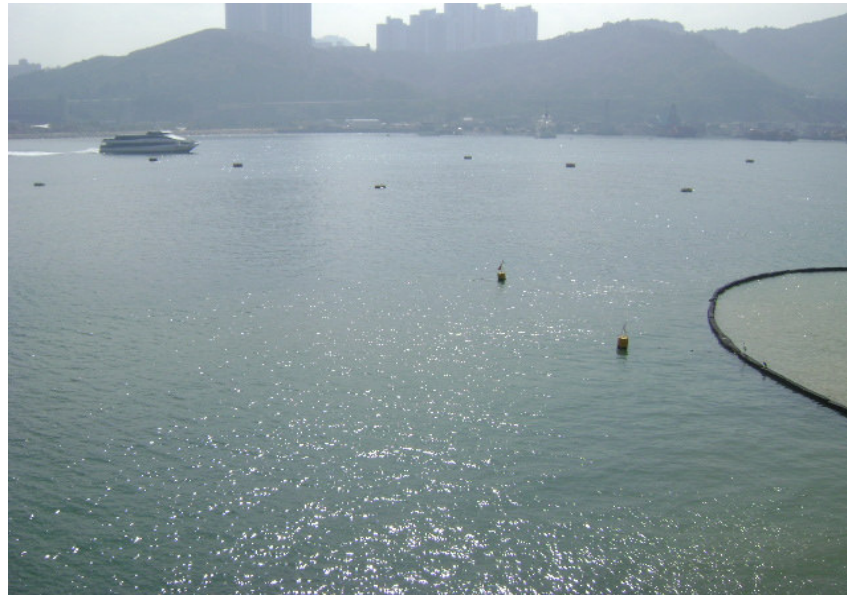
A photo showing slit curtain was functioning properly to prevent suspended solids dispersed away from the site

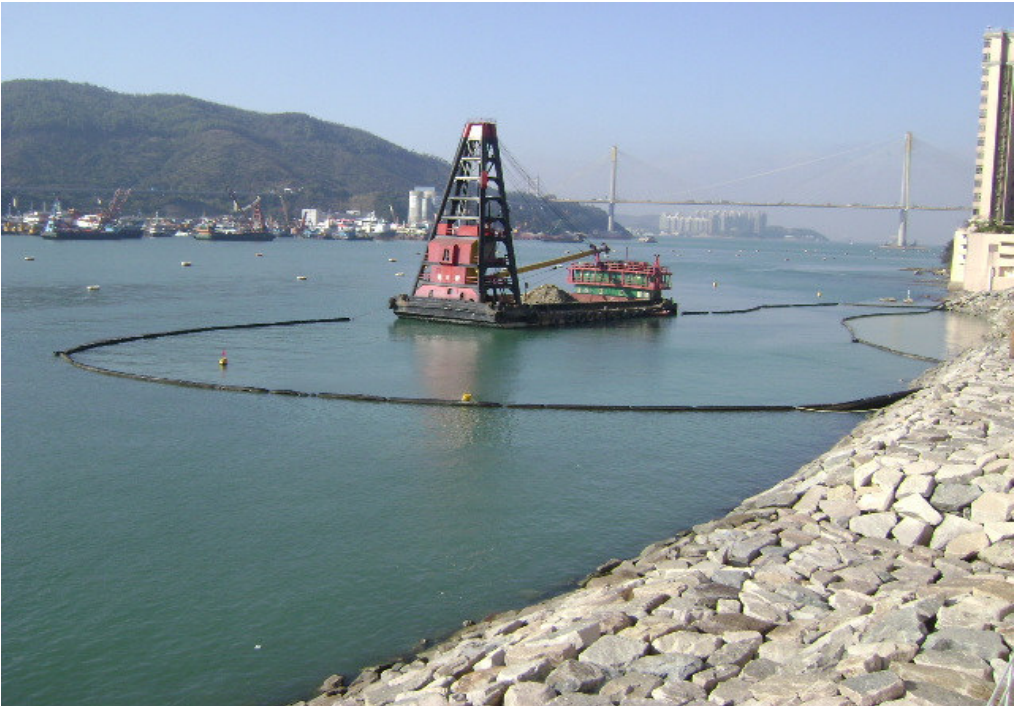
Photographic record for exceedance of Suspended Solids (SS) recorded at O-1(FT) on 21-Jan-11

Project	Tsuen Wan Drainage Tunnel
Date	21-Jan-11
Time	9:33 AM
Monitoring Location	O-1(FT)
Parameter	Suspended Solids (SS)
Action & Limit Levels (mg/L)	14.10 / 18.08 (derived from the baseline monitoring data)
Measured Level (depth-averaged) at Monitoring Location (mg/L)	19.27
Control Station	O-1-C(FT)
Measured Level (depth averaged) at Control Station (mg/L)	16.85
Possible reason for Action or Limit Level Non-compliance	The measured SS level (depth-averaged) at O-1(FT) was above the baseline limit level and the control station's SS level (O-1-C(FT)) at the same tide of the same day. No marine works was undertaken on that morning. Silt curtain was deployed along the Portion E boundary line and extended from seawater level to seabed. Floating type silt curtain was also employed at the inner side. As such, the exceedance was considered to be contributed by natural variation and no further action was required.

Actions taken / to be taken	(1) Silt curtain had been provided along the Portion E boundary line and extended from seawater level to the bottom of seabed; (2) Floating type silt curtain had been employed at the inner side; (3) Sufficient slack of silt curtain was allowed to cope with the wave and tidal action to ensure the curtains (outer and inner) were rested on seabed.
Remarks	None

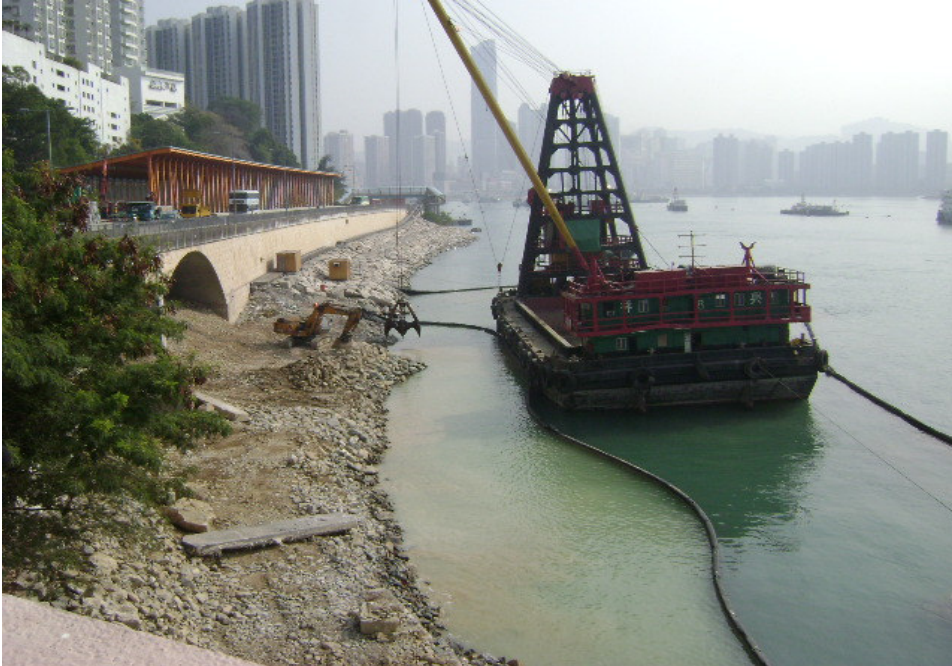
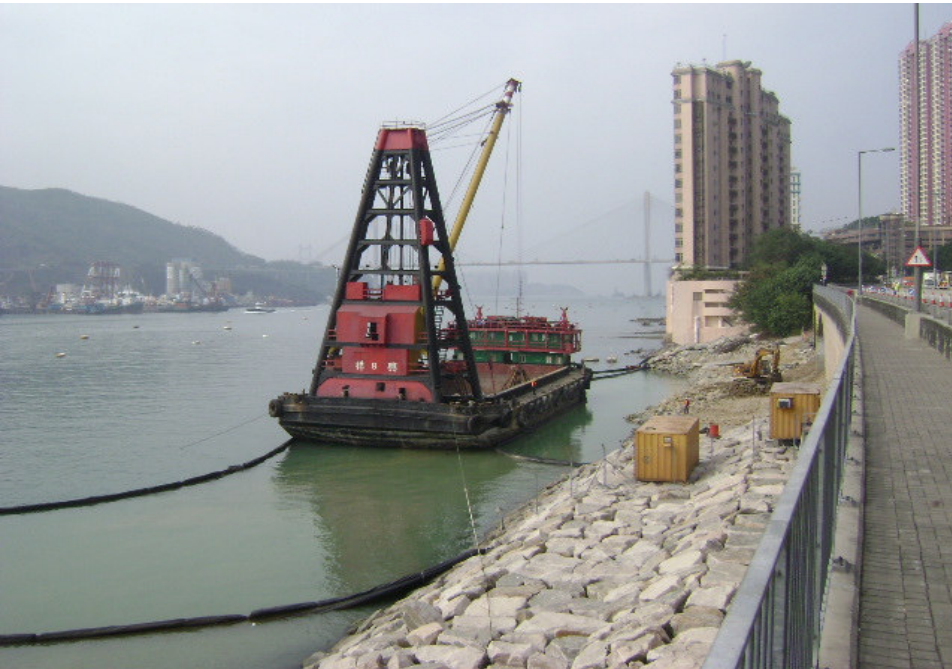
Photographic record for exceedance of Suspended Solids (SS) recorded at O-1(ET) on 24-Jan-11

Project	Tsuen Wan Drainage Tunnel
Date	24-Jan-11
Time	3:27 PM
Monitoring Location	O-1(ET)
Parameter	Suspended Solids (SS)
Action & Limit Levels (mg/L)	13.25 / 14.39 (derived from the baseline monitoring data)
Measured Level (depth-averaged) at Monitoring Location	5.68
Control Station	O-1-C(ET)
Measured Level (depth averaged) at Control Station (mg/L)	3.75
Possible reason for Action or Limit Level Non-compliance	The measured SS level (depth-averaged) at O-1(ET) was below the baseline Action/Limit Level but higher than 130% of the control station's SS level (O-1-C(ET)) at the same tide of the same day. Only removal of amour rock from seawall and placing them into derrick barge was undertaken during measurement and there was no other marine works. Silt curtains had been deployed along the dredging boundary line and extended from the seawater level to the seabed. Floating type silt curtain had been employed at the inner side. As such, the exceedance was considered to be contributed by natural variation and no further action was required.

Actions taken / to be taken	(1) Silt curtain had been provided along the Portion E boundary line and extended from seawater level to the bottom of seabed; (2) Floating type silt curtain had been employed at the inner side; and (3) Sufficient slack of silt curtain was allowed to cope with the wave and tidal action to ensure the curtains (outer and inner) were rested on seabed.
Remarks	None

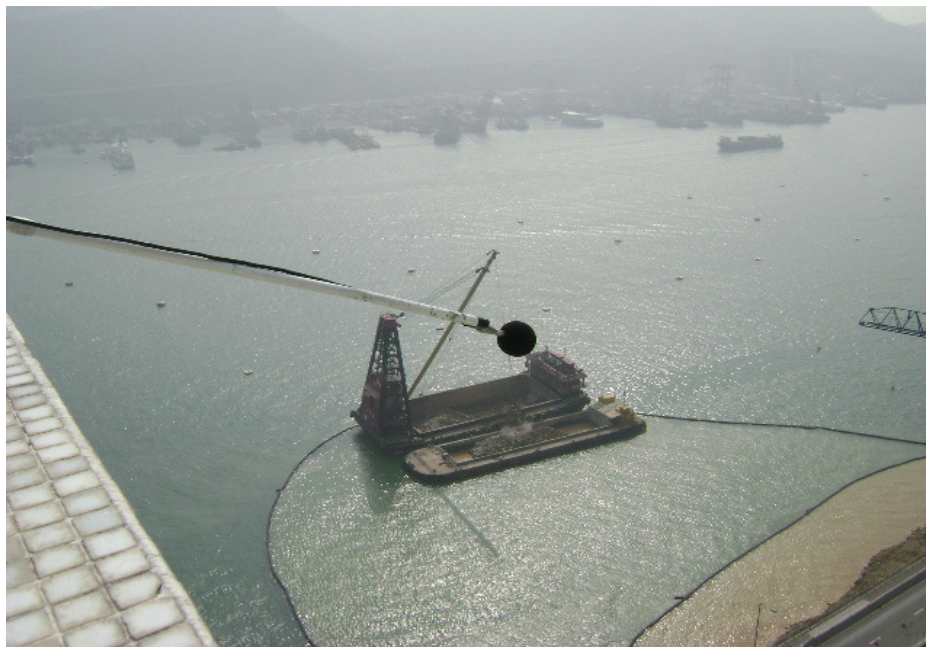
Photographic record for exceedance of Suspended Solids (SS) recorded at O-1(ET) on 26-Jan-11

Project	Tsuen Wan Drainage Tunnel
Date	26-Jan-11
Time	5:30 PM
Monitoring Location	O-1(ET)
Parameter	Suspended Solids (SS)
Action & Limit Levels (mg/L)	13.25 / 14.39 (derived from the baseline monitoring data)
Measured Level (depth-averaged) at Monitoring Location (mg/L)	6.68
Control Station	O-1-C(ET)
Measured Level (depth averaged) at Control Station (mg/L)	4.65
Possible reason for Action or Limit Level Non-compliance	The measured SS level (depth-averaged) at O-1(ET) was below the baseline Action/Limit Level but higher than 130% of the control station's SS level (O-1-C(ET)) at the same tide of the same day. Only transfer of excavated materials from derrick barge to split barge was undertaken during measurement. Silt curtains had been deployed along the dredging boundary line and extended from the seawater level to the seabed. Floating type silt curtain had been employed at the inner side. As such, the exceedance was considered to be contributed by natural variation and no further action was required.

Actions taken / to be taken	(1) Silt curtain had been provided along the Portion E boundary line and extended from seawater level to the bottom of seabed; (2) Floating type silt curtain had been employed at the inner side; and (3) Sufficient slack of silt curtain was allowed to cope with the wave and tidal action to ensure the curtains (outer and inner) were rested on seabed.
Remarks	None

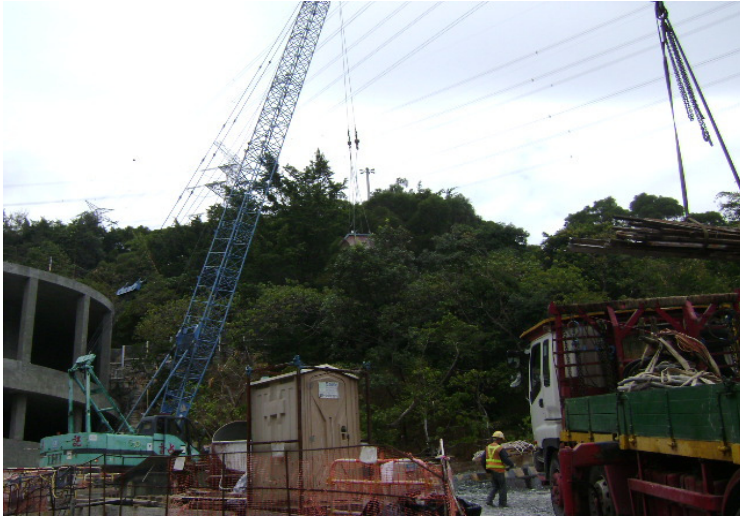
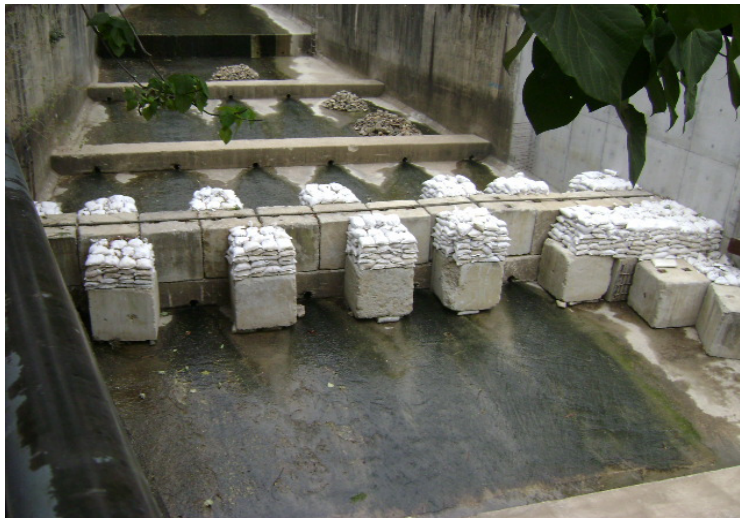
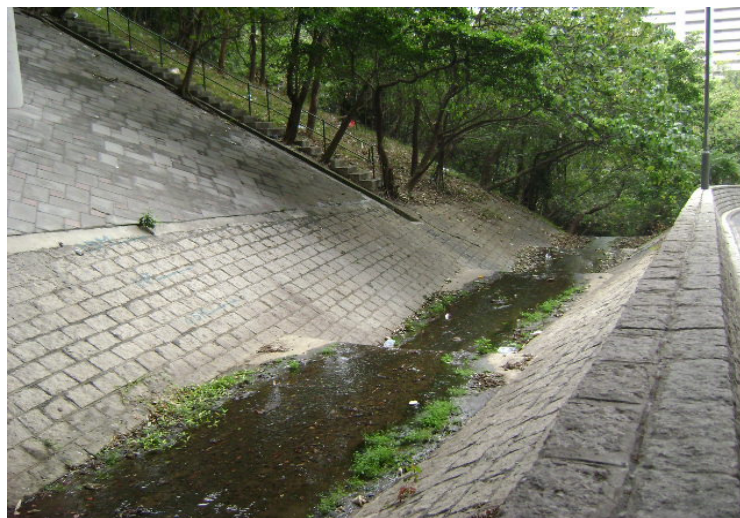
Photographic record for exceedance of Suspended Solid recorded at Sik Sik Yuen Ho Fung College (I-1) on 28-Jan-11

Project	Tsuen Wan Drainage Tunnel
Date	28-Jan-11
Time	2:18 PM
Monitoring Location	Sik Sik Yuen Ho Fung College (I-1)
Parameter	Suspended Solid
Action & Limit Levels (mg/L)	8.85 / 10.17
Measured Level (mg/L)	10.25
Possible reason for Action or Limit Level Non-compliance	A High SS level of 10.90 mg/L was recorded at Control Station (I-1-C)
Actions taken / to be taken	The measured SS level was above the baseline limit level, but lower than the SS level of the control station (I-1-C). General site cleaning, filling the spoil of the tunnel boring machine (TBM) into spiral ramp, breaking shear key for cascade construction and geotechnical instrumentation monitoring were undertaken during the measurement. No direct disturbance was observed from the site. Thus, the exceedance was considered to be contributed by high SS level of upstream location and natural variation. Since the exceedance was not project related, no action was required.

Remarks	The following mitigation measures were provided: (1) Waste water was collected to waste water treatment plant and treated before discharge; and (2) Existing nullah and site area were separated by sealed concrete block.
