Interim Notification of Environmental Quality Limit Exceedance

Incident Report on Limit Level Non-compliance

Project	Tsuen Wan Drainage Tunnel
Date	11-Jun-12
Time	4:20 PM
Monitoring Location	Squatters (I-3)
Parameter	Turbidity
Action & Limit Levels (NTU)	3.99 / 4.18
Measured Level (NTU)	4.58
Control Station	I-3-C
Measured Level at the Control Station (NTU)	4.71
Possible reason for Action or Limit Level Non-compliance	The measured turbidity level was higher than the baseline limit level, but lower than the turbidity level of the control station (I-3-C). General site cleaning and housekeeping, shuttering and concreting for precast staircase, drilling holes for rock breaking for main adit (CH10.5-12), mucking out for 80 degree cut slope access road, excavation for 350mm U-channel and excavation for 900mm drainage pipe for access road, erecting scaffold and installing precast staircase for man access shaft (MAS), excavation and concreting formwork for 375mm U-channel for access road, dismantling of internal formwork of deaeration chamber crown, and tree planting at hairpin curve and shrubs planting behind PA wall were undertaken during the monitoring day. No direct disturbance was ob

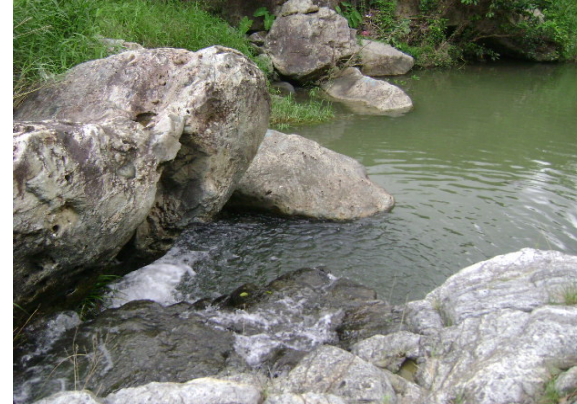
Photo taken at I-3

Photographic record for exceedance of Turbidity recorded at Squatters (I-3) on 11-Jun-12

Actions taken / to be taken	The following mitigation measures were provided on-site during monitoring: (1) wastewater was collected and diverted to waste water treatment plant prior to discharge; and (2) site area and existing stream were separated by sealed concrete block wall.
Remarks	None

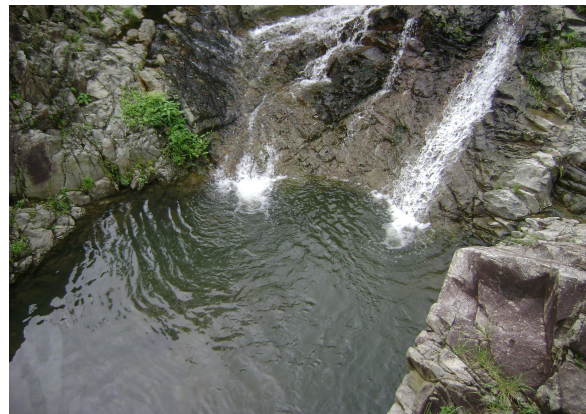
Photo taken at I-2

Project	Tsuen Wan Drainage Tunnel
Date	13-Jun-12
Time	2:15 PM
Monitoring Location	Hong Hoi Chee Hong Temple (I-2)
Parameter	Turbidity
Action & Limit Levels (NTU)	6.63 / 6.99
Measured Level (NTU)	8.69
Control Station	I-2-C
Measured Level at the Control Station (NTU)	9.00
Possible reason for Action or Limit Level Non-compliance	The measured turbidity level was higher than the baseline limit level, but lower than the turbidity level of the control station (I-2-C). General site cleaning and housekeeping, mucking out and drilling blast holes at main adit (MA), removing lining formwork at upper man access adit, erection of formwork for de-aeration chamber (DC), placing concrete for launch for SM1A at portion G, inserting starter bar at 1500 step channel at portion G, and chipping of defect concrete at SM2 at Portion G were undertaken during the monitoring day. No direct disturbance was observed from the site. Raining was observed on the monitoring day and about 22.5 mm rainfall was recorded by the Hong Kong Observatory on the monitoring day. Therefore, the exceedance was considered to be contributed by heavy rainfall and high turbidity level at upstream location. Since the exceedance was non-project related, no further action was required.

Photographic record for exceedance of Turbidity recorded at Hong Hoi Chee Hong Temple (I-2) on 13-Jun-12

Actions taken / to be taken	The following mitigation measures were provided on-site during monitoring: (1) wastewater was collected and diverted to waste water treatment plant prior to discharge; and (2) existing stream was banded by sealed concrete block wall.
Remarks	None

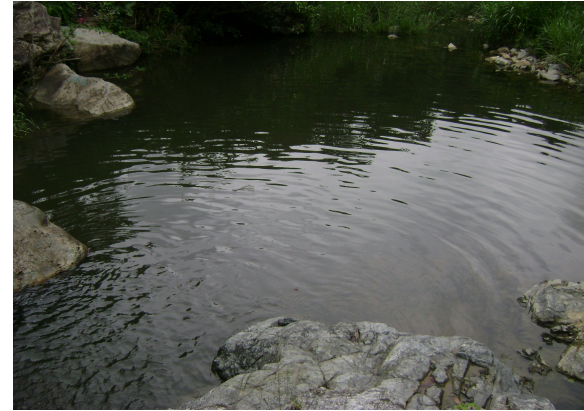
Photo taken at I-3

Project	Tsuen Wan Drainage Tunnel
Date	13-Jun-12
Time	2:45 PM
Monitoring Location	Squatters (I-3)
Parameter	Turbidity
Action & Limit Levels (NTU)	3.99 / 4.18
Measured Level (NTU)	4.13
Control Station	I-3-C
Measured Level at the Control Station (NTU)	4.19
Possible reason for Action or Limit Level Non-compliance	The measured turbidity level was higher than the baseline action level, but lower than the turbidity level of the control station (I-3-C). General site cleaning and housekeeping, rock breaking and drilling holes for main adit, excavation for 80 degrees cut slope and excavation for 350mm U-channel, dismantling formwork for precast staircase, erecting scaffold and installing precast staircase at man access shaft, dismantling forwork for deaeration chamber crown, planting shrubs behind PB wall, and excavation, formwork erecting and concreting for 375mm U-channel were undertaken during the monitoring day. No direct disturbance was observed from the site. Raining was observed on the monitoring day and about 22.5 mm rainfall was recorded by the Hong Kong Observatory on the monitoring day. Therefore, the exceedance was considered to be contributed by heavy rainfall and high turbidity level at upstream location. Since the exceedance was non-project related, no further action was required.

Photographic record for exceedance of Turbidity recorded at Squatters (I-3) on 13-Jun-12

Actions taken / to be taken	The following mitigation measures were provided on-site during monitoring: (1) wastewater was collected and diverted to waste water treatment plant prior to discharge; and (2) site area and existing stream were separated by sealed concrete block wall.
Remarks	None

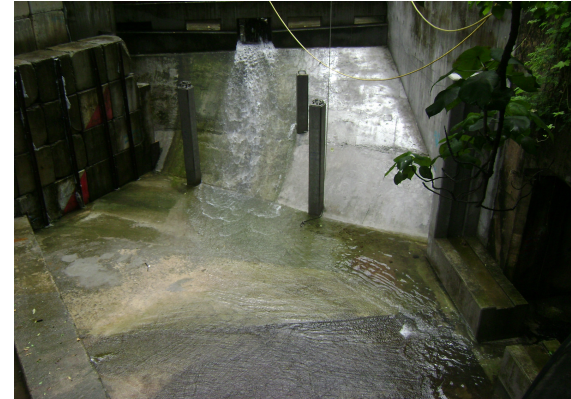
Photo taken at I-1

Project	Tsuen Wan Drainage Tunnel
Date	18-Jun-12
Time	1:58 PM
Monitoring Location	Sik Sik Yuen Ho Fung College (I-1)
Parameter	Turbidity
Action & Limit Levels (NTU)	9.75 / 12.47
Measured Level (NTU)	12.99
Control Station	I-1-C
Measured Level at the Control Station (NTU)	13.21
Possible reason for Action or Limit Level Non-compliance	The measured turbidity level was higher than the baseline limit level, but lower than the turbidity level of the control station (I-1-C). General housekeeping and site cleaning were undertaken during the monitoring day. No direct disturbance was observed from the site. Raining was observed on the monitoring day and about 17.7 mm rainfall was recorded by the Hong Kong Observatory on the monitoring day. Therefore, the exceedance was considered to be contributed by heavy rainfall and high turbidity level at upstream location. Since the exceedance was non-project related, no further action was required.

Photographic record for exceedance of Turbidity recorded at Sik Sik Yuen Ho Fung College (I-1) on 18-Jun-12

Actions taken / to be taken	The following mitigation measures were provided on-site during monitoring: (1) wastewater was collected to waste water treatment plant for treatment before discharge; and (2) nullah and site area were separated by sealed concrete blocks.
Remarks	None

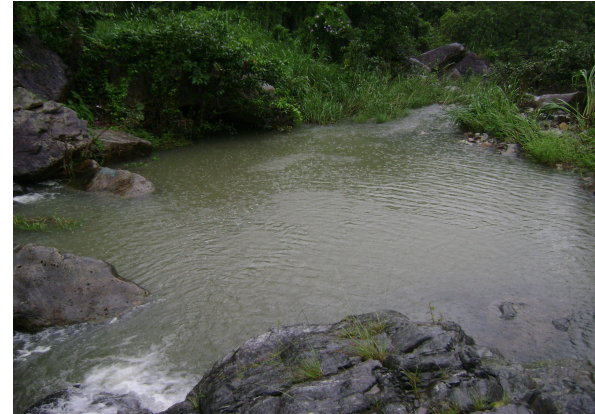
Photo taken at I-3

Project	Tsuen Wan Drainage Tunnel
Date	18-Jun-12
Time	2:45 PM
Monitoring Location	Squatters (I-3)
Parameter	Turbidity
Action & Limit Levels (NTU)	3.99 / 4.18
Measured Level (NTU)	16.60
Control Station	I-3-C
Measured Level at the Control Station (NTU)	16.48
Possible reason for Action or Limit Level Non-compliance	The measured turbidity level was higher than the baseline limit level, but lower than 120% of the turbidity level of the control station (I-3-C). General site cleaning and housekeeping, rock breaking and drilling holes for main adit, excavation for 80 degrees cut slope, excavation for 350mm U-channel and 900 drainage pipe at access road, erecting internal formwork for vortex draft shaft, shuttering end shutter formwork and rebar fixing at deaeration chamber crown, planting shrubs behind PB Wall, and excavation, formwork erecting and concreting for 375mm U-channel were undertaken during the monitoring day. No direct disturbance was observed from the site. Raining was observed on the monitoring day and about 17.7 mm rainfall was recorded by the Hong Kong Observatory on the monitoring day. Therefore, the exceedance was considered to be contributed by heavy rainfall and high turbidity level at upstream location. Since the exceedance was non-project related, no further action was required.

Photographic record for exceedance of Turbidity recorded at Squatters (I-3) on 18-Jun-12

Actions taken / to be taken	The following mitigation measures were provided on-site during monitoring: (1) wastewater was collected and diverted to waste water treatment plant prior to discharge; and (2) site area and existing stream were separated by sealed concrete block wall.
Remarks	None

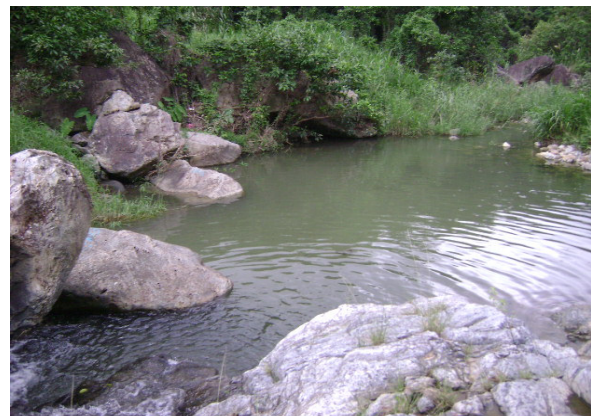
Photo taken at I-3

Project	Tsuen Wan Drainage Tunnel
Date	11-Jun-12
Time	4:20 PM
Monitoring Location	Squatters (I-3)
Parameter	Suspended Solids (SS)
Action & Limit Levels (mg/L)	6.13 / 7.23
Measured Level (mg/L)	6.20
Control Station	I-3-C
Measured Level at the Control Station (mg/L)	6.05
Possible reason for Action or Limit Level Non-compliance	The measured SS level was higher than the baseline action level, but lower than 120% of the SS level of the control station (I-3-C). General site cleaning and housekeeping, shuttering and concreting for precast staircase, drilling holes for rock breaking for main adit (CH10.5-12), mucking out for 80 degrees cut slope access road, excavation for 350mm U-channel and excavation for 900mm drainage pipe for access road, erecting scaffold and installing precast staircase for man access shaft (MAS), excavation and concreting formwork for 375mm U-channel for access road, dismantling of internal formwork of deaeration chamber crown, and tree planting at hairpin curve and shrubs planting behind PA wall were undertaken during the monitoring day. No direct disturbance was observed from the site. Therefore, the exceedance was considered to be contributed by high SS level at upstream location. Since the exceedance was non-project related, no further action was required.

Photographic record for exceedance of Suspended Solids (SS) recorded at Squatters (I-3) on 11-Jun-12

Actions taken / to be taken	The following mitigation measures were provided on-site during monitoring: (1) wastewater was collected and diverted to waste water treatment plant prior to discharge; and (2) site area and existing stream were separated by sealed concrete block wall.
Remarks	None

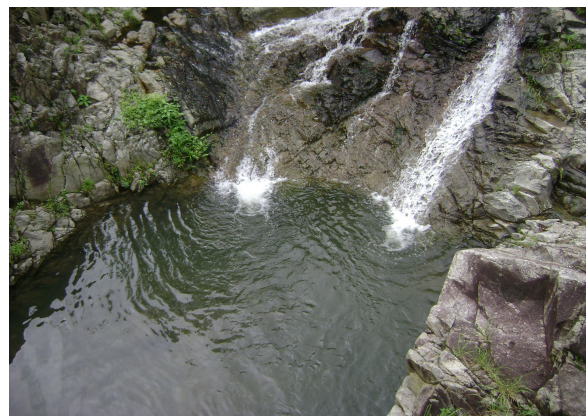
Photo taken at I-2

Project	Tsuen Wan Drainage Tunnel
Date	13-Jun-12
Time	2:15 PM
Monitoring Location	Hong Hoi Chee Hong Temple (I-2)
Parameter	Suspended Solids (SS)
Action & Limit Levels (mg/L)	7.68 / 8.34
Measured Level (mg/L)	7.95
Control Station	I-2-C
Measured Level at the Control Station (mg/L)	8.05
Possible reason for Action or Limit Level Non-compliance	The measured SS level was higher than the baseline action level, but lower than the SS level of the control station (I-2-C). General site cleaning and housekeeping, mucking out and drilling blast holes at main adit (MA), removing lining formwork at upper man access adit, erection of formwork for de-aeration chamber (DC), placing concrete for launch for SM1A at portion G, inserting starter bar at 1500 step channel at portion G, and chipping of defect concrete at SM2 at Portion G were undertaken during the monitoring day. No direct disturbance was observed from the site. Raining was observed on the monitoring day and about 22.5 mm rainfall was recorded by the Hong Kong Observatory on the monitoring day. Therefore, the exceedance was considered to be contributed by heavy rainfall and high SS level at upstream location. Since the exceedance was non-project related, no further action was required.

Photographic record for exceedance of Suspended Solids (SS) recorded at Hong Hoi Chee Hong Temple (I-2) on 13-Jun-12

Actions taken / to be taken	The following mitigation measures were provided on-site during monitoring: (1) wastewater was collected and diverted to waste water treatment plant prior to discharge; and (2) existing stream was banded by sealed concrete block wall.
Remarks	None

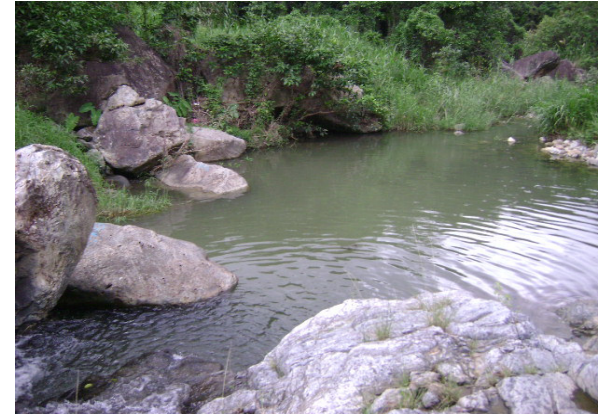
Photo taken at I-3

Project	Tsuen Wan Drainage Tunnel
Date	13-Jun-12
Time	2:45 PM
Monitoring Location	Squatters (I-3)
Parameter	Suspended Solids (SS)
Action & Limit Levels (mg/L)	6.13 / 7.23
Measured Level (mg/L)	3.10
Control Station	I-3-C
Measured Level at the Control Station (mg/L)	2.25
Possible reason for Action or Limit Level Non-compliance	The measured SS level was lower than the baseline action/limit level, but higher than 130% of the SS level of the control station (I-3-C). General site cleaning and housekeeping, rock breaking and drilling holes for main adit, excavation for 80 degrees cut slope and excavation for 350mm U-channel, dismantling formwork for precast staircase, erecting scaffold and installing precast staircase at man access shaft, dismantling forwork for deaeration chamber crown, planting shrubs behind PB wall, and excavation, formwork erecting and concreting for 375mm U-channel were undertaken during the monitoring day. No direct disturbance was observed from the site. Therefore, the exceedance was considered to be contributed by natural variation. Since the exceedance was non-project related, no further action was required.

Photographic record for exceedance of Suspended Solids (SS) recorded at Squatters (I-3) on 13-Jun-12

Actions taken / to be taken	The following mitigation measures were provided on-site during monitoring: (1) wastewater was collected and diverted to waste water treatment plant prior to discharge; and (2) site area and existing stream were separated by sealed concrete block wall.
Remarks	None

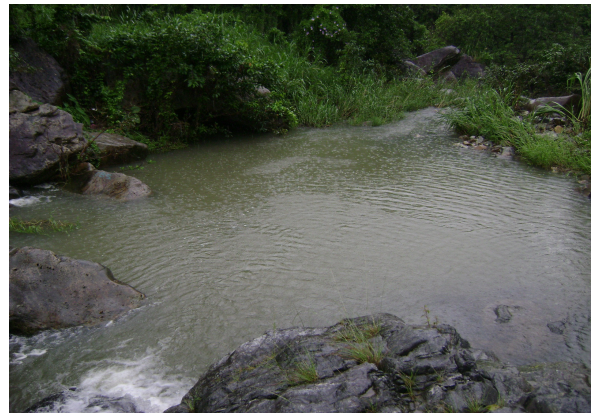
Photo taken at I-3

Project	Tsuen Wan Drainage Tunnel
Date	18-Jun-12
Time	2:45 PM
Monitoring Location	Squatters (I-3)
Parameter	Suspended Solids (SS)
Action & Limit Levels (mg/L)	6.13 / 7.23
Measured Level (mg/L)	7.05
Control Station	I-3-C
Measured Level at the Control Station (mg/L)	6.30
Possible reason for Action or Limit Level Non-compliance	The measured SS level was higher than the baseline action level, but lower than 120% of the SS level of the control station (I-3-C). General site cleaning and housekeeping, rock breaking and drilling holes for main adit, excavation for 80 degrees cut slope, excavation for 350mm U-channel and 900 drainage pipe at access road, erecting internal formwork for vortex draft shaft, shuttering end shutter formwork and rebar fixing at deaeration chamber crown, planting shrubs behind PB Wall, and excavation, formwork erecting and concreting for 375mm U-channel were undertaken during the monitoring day. No direct disturbance was observed from the site. Raining was observed on the monitoring day and about 17.7 mm rainfall was recorded by the Hong Kong Observatory on the monitoring day. Therefore, the exceedance was considered to be contributed by heavy rainfall and high SS level at upstream location. Since the exceedance was non-project related, no further action was required.

Photographic record for exceedance of Suspended Solids (SS) recorded at Squatters (I-3) on 18-Jun-12

Actions taken / to be taken	The following mitigation measures were provided on-site during monitoring: (1) wastewater was collected and diverted to waste water treatment plant prior to discharge; and (2) site area and existing stream were separated by sealed concrete block wall.
Remarks	None

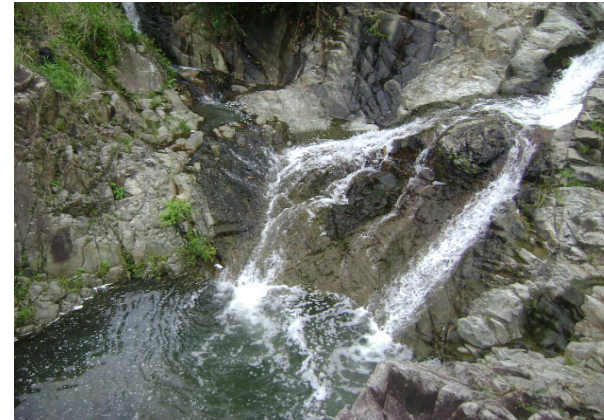
Photo taken at I-2

Project	Tsuen Wan Drainage Tunnel
Date	20-Jun-12
Time	9:49 AM
Monitoring Location	Hong Hoi Chee Hong Temple (I-2)
Parameter	Suspended Solids (SS)
Action & Limit Levels (mg/L)	7.68 / 8.34
Measured Level (mg/L)	3.30
Control Station	I-2-C
Measured Level at the Control Station (mg/L)	2.55
Possible reason for Action or Limit Level Non-compliance	The measured SS level was lower than the baseline action/limit level, but higher than 120% of the SS level of the control station (I-2-C). General site cleaning and housekeeping, curing and removing formwork for Wall A at de-aeration chamber (DC), fixing rebar for Wall B and Wall C of DC, formwork shuttering for Wall C of DC, drilling holes for wall-tie at Wall B and Wall C of DC, grouting to tie-rods at Wall B and Wall C of DC, excavation and mucking out to bottom level of base slab at upper man access shaft (UMAS), erecting formwork for Wall C of DC, cutting and bending rebar for side wall of DC & UMAS, erecting formwork for modification of 1500mm step-channel (SC) outlet at portion G, and formwork shuttering for SM1A at portion G were undertaken during the monitoring day. No direct disturbance was observed from the site. Therefore, the exceedance was considered to be contributed by natural variation. Since the exceedance was non-project related, no further action was required.

Photographic record for exceedance of Suspended Solids (SS) recorded at Hong Hoi Chee Hong Temple (I-2) on 20-Jun-12

Actions taken / to be taken	The following mitigation measures were provided on-site during monitoring: (1) wastewater was collected and diverted to waste water treatment plant prior to discharge; and (2) existing stream was banded by sealed concrete block wall.
Remarks	None

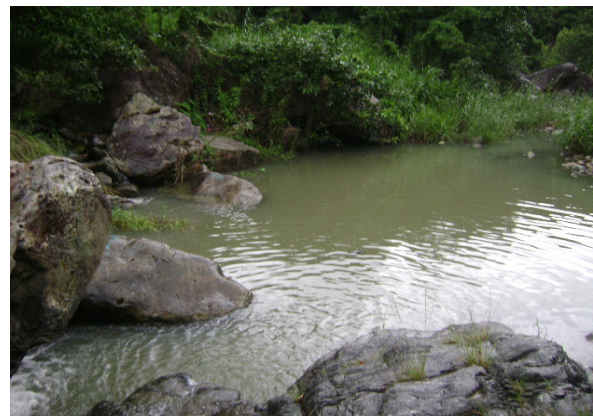
Photo taken at I-3

Project	Tsuen Wan Drainage Tunnel
Date	22-Jun-12
Time	4:25 PM
Monitoring Location	Squatters (I-3)
Parameter	Turbidity
Action & Limit Levels (NTU)	3.99 / 4.18
Measured Level (NTU)	15.87
Control Station	I-3-C
Measured Level at the Control Station (NTU)	16.16
Possible reason for Action or Limit Level Non-compliance	The measured turbidity level was higher than the baseline limit level, but lower than the turbidity level of the control station (I-3-C). General site cleaning and housekeeping, mucking out for 80 degrees cut slope, excavation for 350mm U-channel and 900mm drainage pipe at access road, installation of internal formwork and modification of scaffold for vortex drop shaft (VDS), excavating, erecting formwork and concreting for 375mm U-channel at internal curve, concreting at de-aeration chamber (DAC) base slab, and planting and planting shrubs at PA Wall and behind PB Wall were undertaken during the monitoring day. No direct disturbance was observed from the site. Raining was observed on the monitoring day and about 16.0 mm rainfall was recorded by the Hong Kong Observatory on the monitoring day. Therefore, the exceedance was considered to be contributed by heavy rainfall and high turbidity level at upstream location. Since the exceedance was non-project related, no further action was required.

Photographic record for exceedance of Turbidity recorded at Squatters (I-3) on 22-Jun-12

Actions taken / to be taken	The following mitigation measures were provided on-site during monitoring: (1) wastewater was collected and diverted to waste water treatment plant prior to discharge; and (2) site area and existing stream were separated by sealed concrete block wall.
Remarks	None

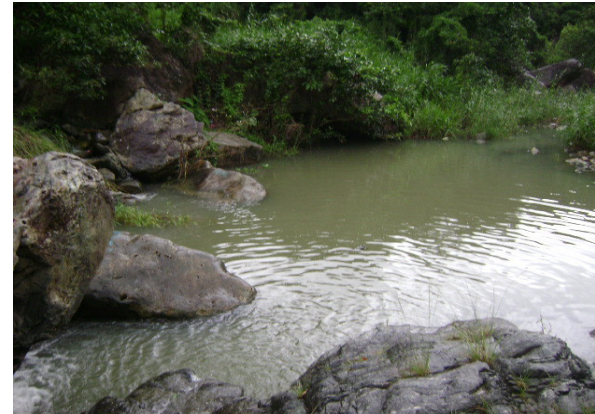
Photo taken at I-3

Project	Tsuen Wan Drainage Tunnel
Date	22-Jun-12
Time	4:25 PM
Monitoring Location	Squatters (I-3)
Parameter	Suspended Solids (SS)
Action & Limit Levels (mg/L)	6.13 / 7.23
Measured Level (mg/L)	6.60
Control Station	I-3-C
Measured Level at the Control Station (mg/L)	5.65
Possible reason for Action or Limit Level Non-compliance	The measured SS level was higher than the baseline action level, but lower than 120% of the SS level of the control station (I-3-C). General site cleaning and housekeeping, mucking out for 80 degrees cut slope, excavation for 350mm U-channel and 900mm drainage pipe at access road, installation of internal formwork and modification of scaffold for vortex drop shaft (VDS), excavating, erecting formwork and concreting for 375mm U-channel at internal curve, concreting at de-aeration chamber (DAC) base slab, and planting and planting shrubs at PA Wall and behind PB Wall were undertaken during the monitoring day. No direct disturbance was observed from the site. Raining was observed on the monitoring day and about 16.0 mm rainfall was recorded by the Hong Kong Observatory on the monitoring day. Therefore, the exceedance was considered to be contributed by heavy rainfall and high SS level at upstream location. Since the exceedance was non-project related, no further action was required.

Photographic record for exceedance of Suspended Solids (SS) recorded at Squatters (I-3) on 22-Jun-12

Actions taken / to be taken	The following mitigation measures were provided on-site during monitoring: (1) wastewater was collected and diverted to waste water treatment plant prior to discharge; and (2) site area and existing stream were separated by sealed concrete block wall.
Remarks	None
