Interim Notifications of Environmental Quality Limits Exceedances

Incident Report on Action Level or Limit Level Non-compliance

Project	Tsuen Wan Drainage Tunnel
Date	9-Jan-09
Time	10:20 AM
Monitoring Location	Hong Hoi Chee Hong Temple (I-2)
Parameter	Suspended Solid
Action & Limit Levels	7.68 / 8.34
Measured Level	5.2 (higher than 120% of control station's SS)
Possible reason for Action or Limit Level Non-compliance	A low SS level of 4.2 is recorded at Control Station (I-2-C)
Actions taken / to be taken	The measured SS level was below baseline Action / Limit Level and was within the range of baseline SS concentration (1-8.5mg/L). Site tidiness and cleanliness and drilling hole for air vent shaft construction were undertaken during the measurement and no direct disturbance was observed. Thus, the exceedance is considered to be contributed by natural variation and no action should be required.
Remarks

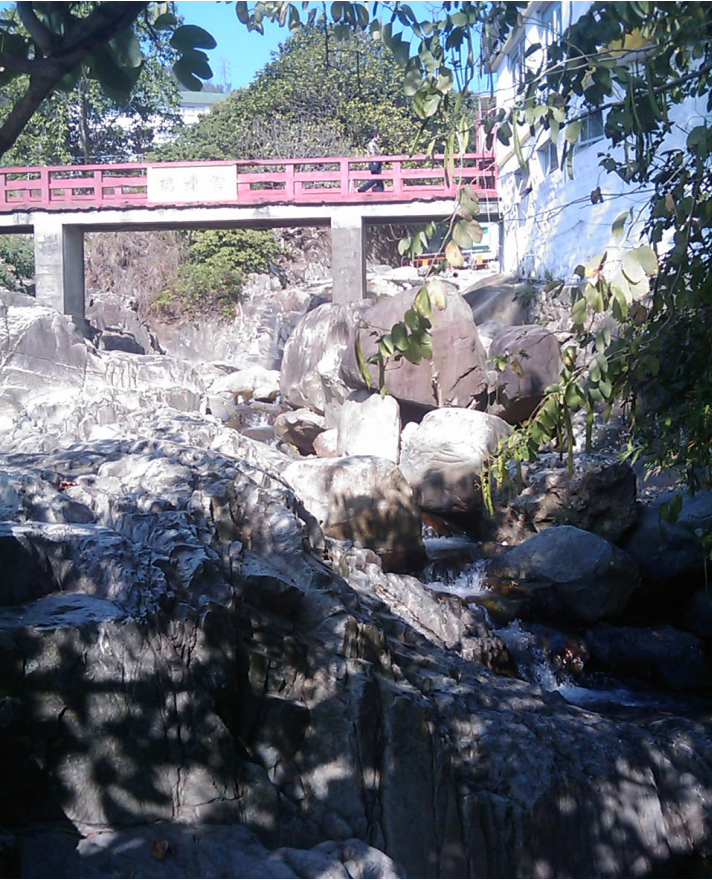
Photo taken at I-2

Photographic record for exceedance of Suspended Solid recorded at Hong Hoi Chee Hong Temple (I-2) on 09-Jan-09

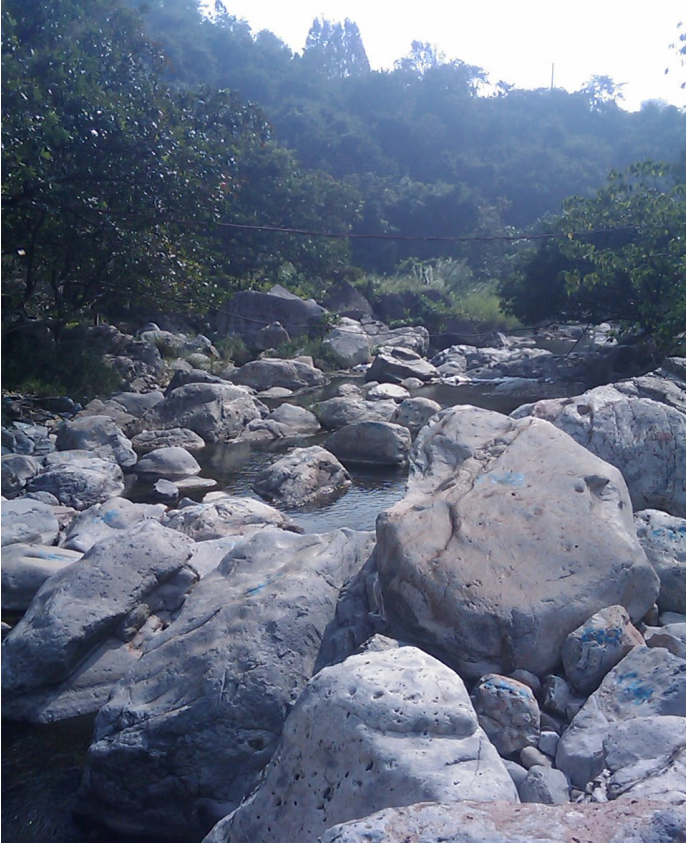
Photo taken at I-3

Project	Tsuen Wan Drainage Tunnel
Date	9-Jan-09
Time	11:50 AM
Monitoring Location	Squatters (I-3)
Parameter	Suspended Solid
Action & Limit Levels	6.13 / 7.23
Measured Level	2.5 (higher than 120% of control station's SS)
Possible reason for Action or Limit Level Non-compliance	A low SS level of 2.0 is recorded at Control Station (I-3-C)
Actions taken / to be taken	The measured SS level was below baseline Action / Limit Level and was within the range of baseline SS concentration (1- 7.5mg/L). Site tidiness and cleanliness, drilling pre-bore H-pile and installation of H-pile and grout pre-bore H-pile were undertaken during the measurement and no direct disturbance was observed. Thus, the exceedance is considered to be contributed by natural variation and no action should be required.
Remarks

Photographic record for exceedance of Suspended Solid recorded at Squatters (I-3) on 09-Jan-09
