Interim Notification of Environmental Quality Limit Exceedance

Project	Tsuen Wan Drainage Tunnel
Date	06-Apr-11
Time	10:25 AM
Monitoring Location	Sik Sik Yuen Ho Fung College (I-1)
Parameter	Suspended Solids
Action & Limit Levels (mg/L)	8.85 / 10.17
Measured Level (mg/L)	10.95
Possible reason for Action or Limit Level Non-compliance	A high SS level of 10.60 mg/L was recorded at Control Station (I-1-C)
Actions taken / to be taken	The measured SS level was above the baseline limit level, but lower than 120% of SS level of the control station (I-1-C). General site cleaning, rebar fixing at cascade bay 1, dismantling of formwork at vehicle access, removal of hoarding and masonry wall and geotechnical instrumentation monitoring were undertaken during the measurement. No direct disturbance was observed from the site. Thus, the exceedance was considered to be contributed by high SS level at upstream location and natural variation. Therefore, no action was required.

Photographic record for exceedance of Suspended Solids recorded at Sik Sik Yuen Ho Fung College (I-1) on 06-Apr-11

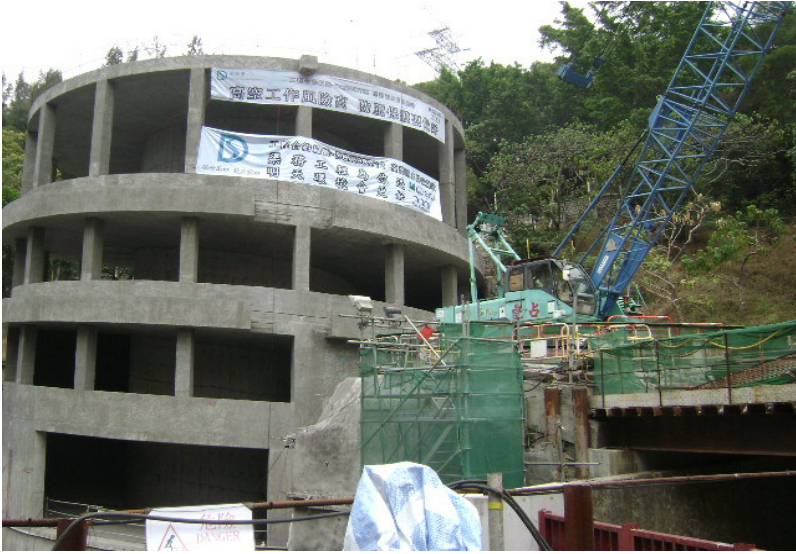
Site photo

Photographic record for exceedance of Suspended Solids recorded at Sik Sik Yuen Ho Fung College (I-1) on 08-Apr-11

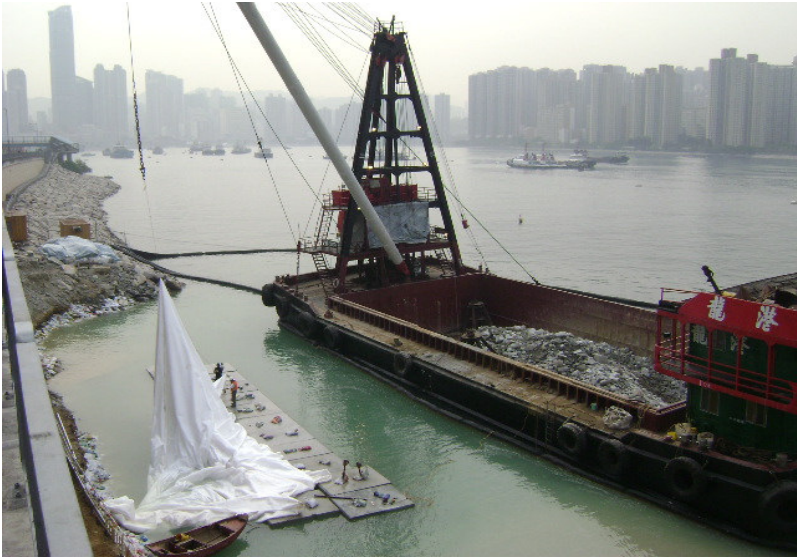
Site photo

Photographic record for exceedance of Suspended Solids (SS) recorded at O-1(FT) on 08-Apr-11

Actions taken / to be taken	(1) Silt curtain had been provided along the Portion E boundary line and extended from seawater level to the bottom of seabed; (2) Floating type silt curtain had been employed at the inner side; (3) Sufficient slack of silt curtain was allowed to cope with the wave and tidal action to ensure the curtains (outer and inner) were rested on seabed; (4) condition of silt curtain was checked by the supervisor daily; (5) and seawall blocks installation was undertaken within the inner silt curtain area only.
Remarks	None

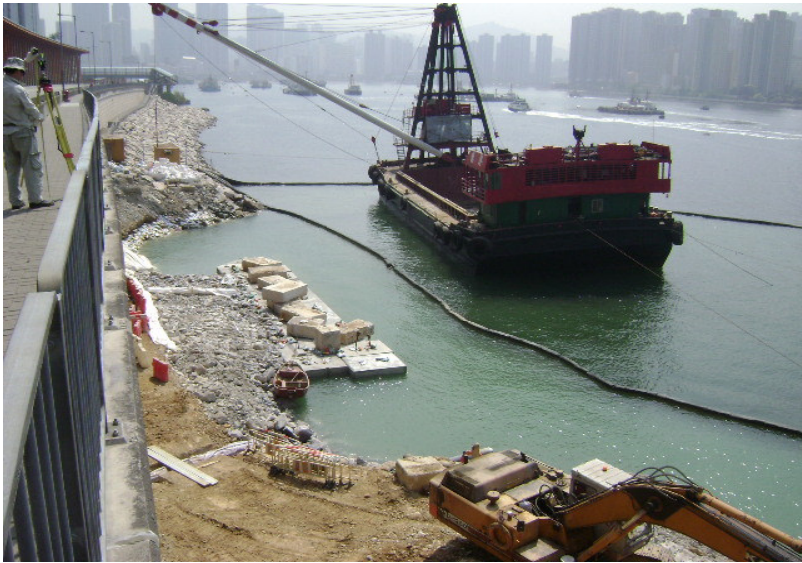
Site photo

Photographic record for exceedance of Suspended Solids (SS) recorded at O-1(FT) on 11-Apr-11

Actions taken / to be taken	(1) Silt curtain had been provided along the Portion E boundary line and extended from seawater level to the bottom of seabed; (2) Floating type silt curtain had been employed at the inner side; (3) Sufficient slack of silt curtain was allowed to cope with the wave and tidal action to ensure the curtains (outer and inner) were rested on seabed; (4) condition of silt curtain was checked by the supervisor daily; (5) and seawall blocks installation was undertaken within the inner silt curtain area only.
Remarks	None

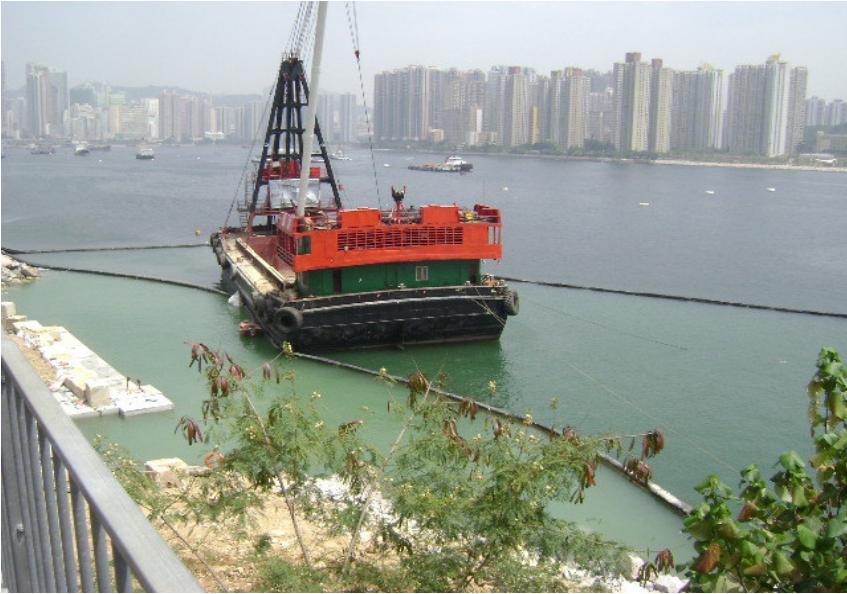
Site photo

Photographic record for exceedance of Suspended Solids (SS) recorded at O-1(FT) on 13-Apr-11

Actions taken / to be taken	(1) Silt curtain had been provided along the Portion E boundary line and extended from seawater level to the bottom of seabed; (2) floating type silt curtain had been employed at the inner side; (3) sufficient slack of silt curtain was allowed to cope with the wave and tidal action to ensure the curtains (outer and inner) were rested on seabed; (4) condition of silt curtain was checked by the supervisor daily; (5) and seawall blocks installation was undertaken within the inner silt curtain area only.
Remarks	None

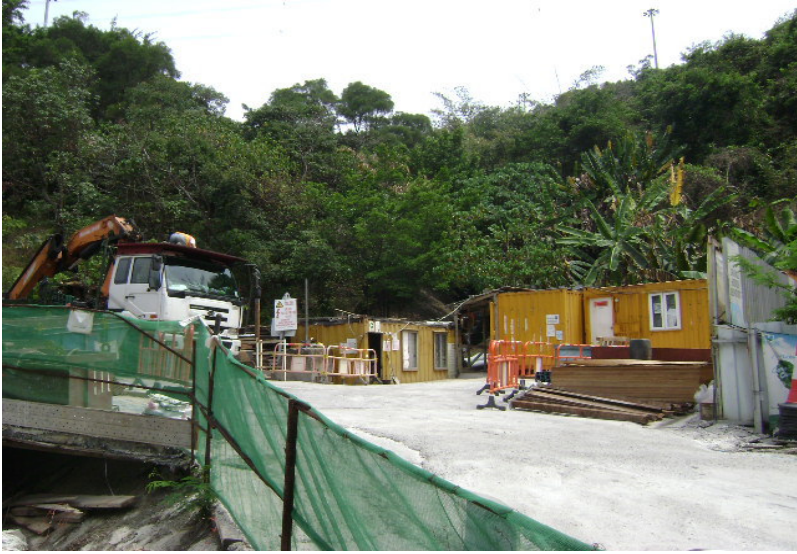
Site photo

Photographic record for exceedance of Suspended Solids recorded at Sik Sik Yuen Ho Fung College (I-1) on 18-Apr-11

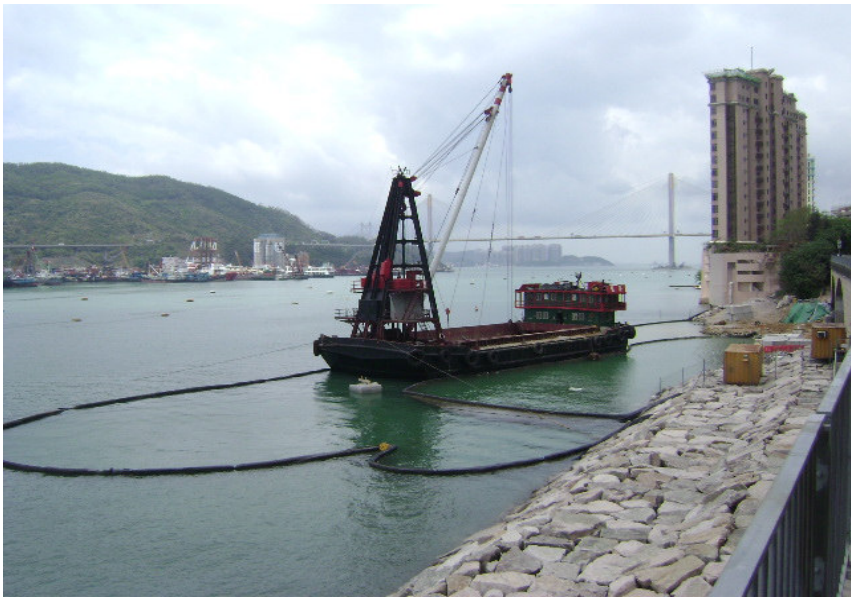
Site photo

Photographic record for exceedance of Dissolved Oxygen (marine surface) recorded at O-1(FT) on 07-May-11

Actions taken / to be taken	(1) Silt curtain was provided along the Portion E boundary line and extended from seawater level to the bottom of seabed; (2) floating type silt curtain was employed at the inner side; (3) sufficient slack of silt curtain was allowed to cope with the wave and tidal action to ensure the curtains (outer and inner) were rested on seabed; (4) condition of silt curtains was checked by the supervisor daily; and (5) seawall blocks installation was undertaken within the inner silt curtain area only.
Remarks	None

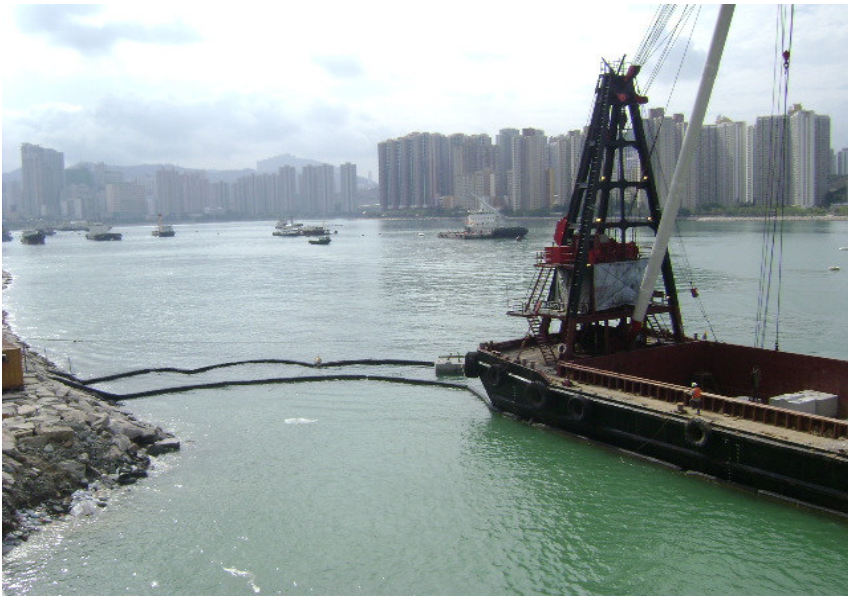
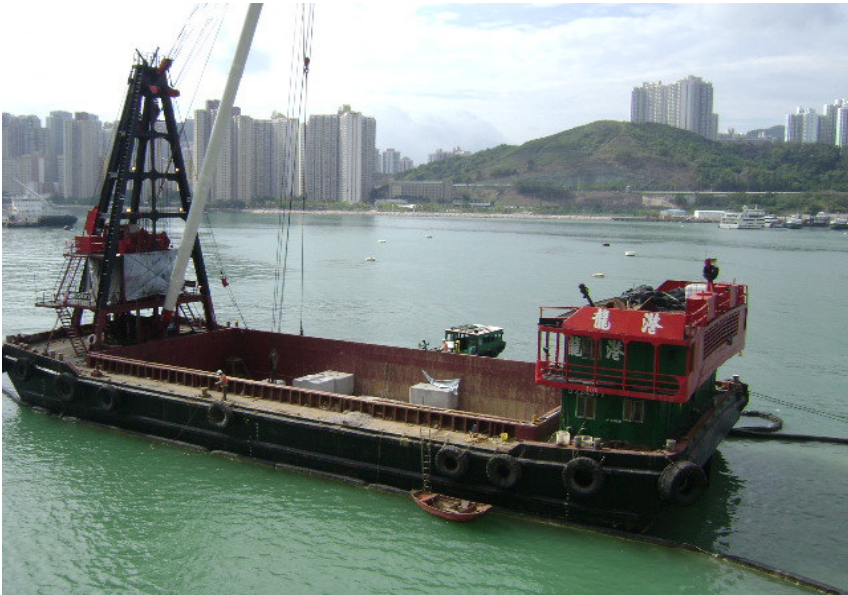
Site photo

Photographic record for exceedance of Dissolved Oxygen (marine mid-depth) recorded at O-1(ET) on 07-May-11

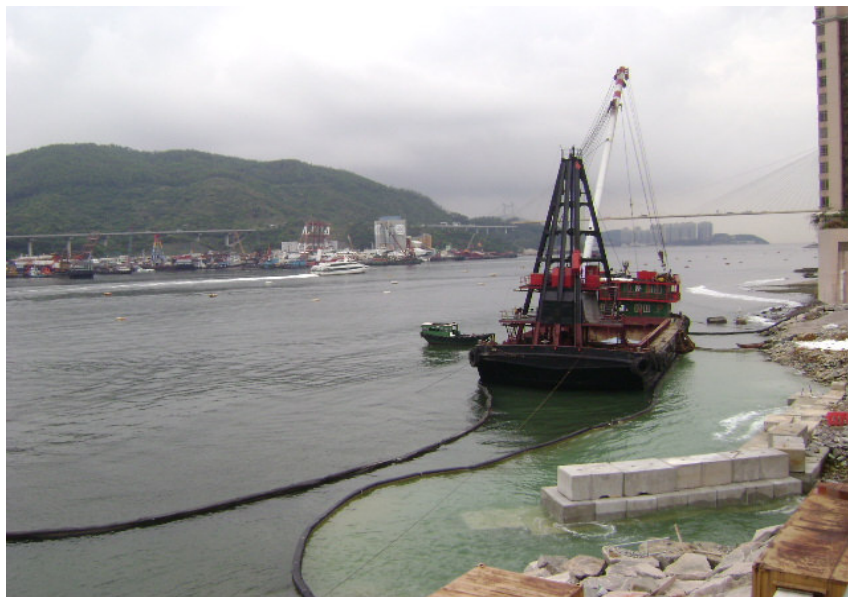
Site photo

Photographic record for exceedance of Dissolved Oxygen (marine bottom) recorded at O-1(FT) on 13-May-11

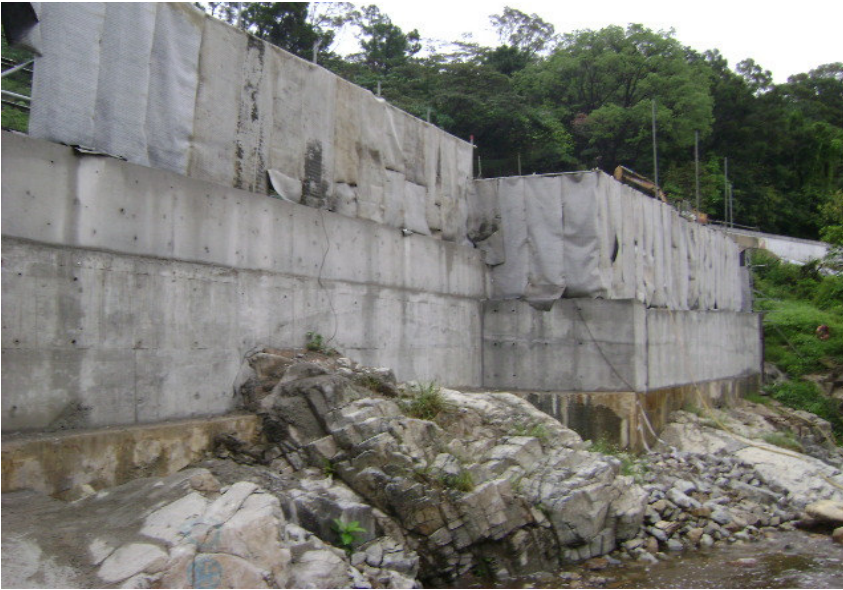
Site photo

Photographic record for exceedance of Suspended Solid recorded at Squatters (I-3) on 13-May-11

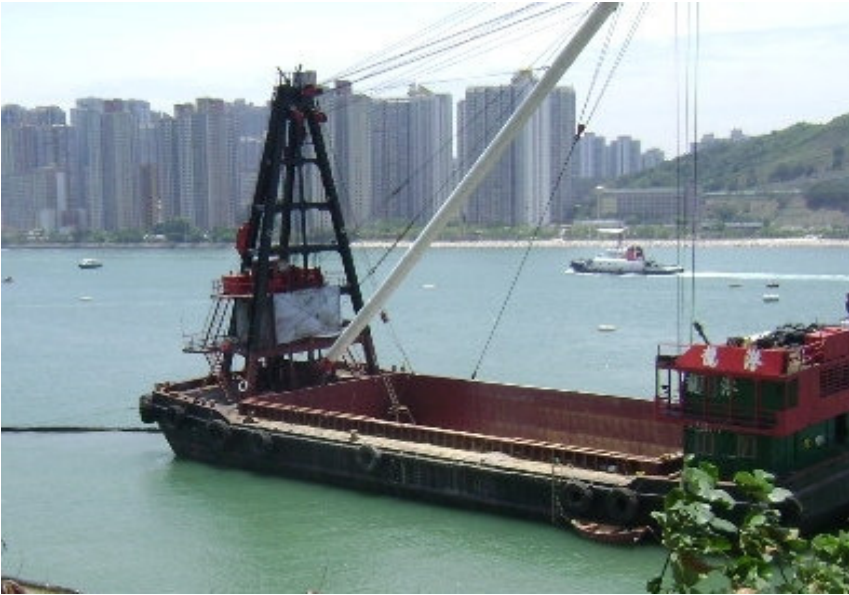
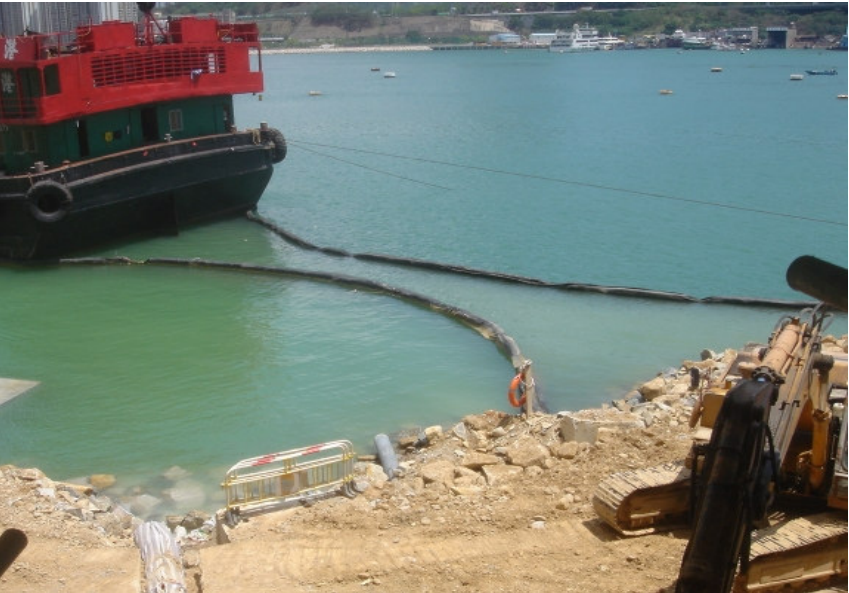
Site photo

Photographic record for exceedance of Suspended Solids recorded at O-1(ET) on 18-May-11

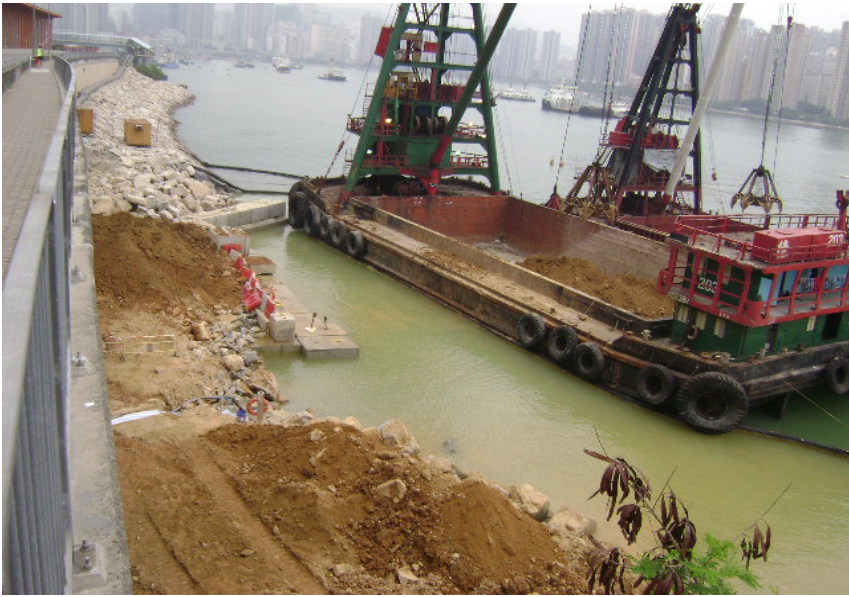
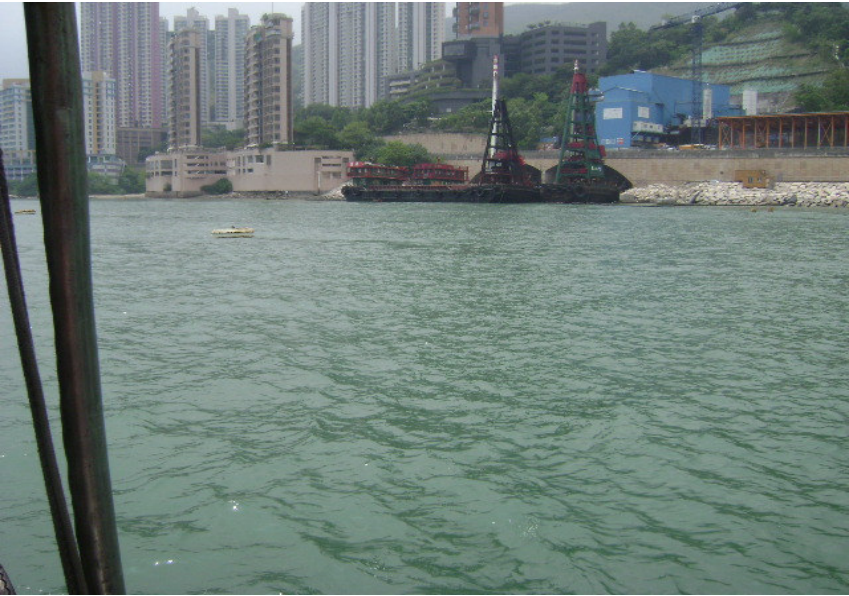
Site photo

Photographic record for exceedance of Dissolved Oxygen (marine surface) recorded at O-1(ET) on 03-Jun-11

Actions taken / to be taken	(1) Silt curtain was provided along the Portion E boundary line and extended from seawater level to the bottom of seabed; (2) floating type silt curtain was employed at the inner side; (3) sufficient slack of silt curtain was allowed to cope with the wave and tidal action to ensure the curtains (outer and inner) were rested on seabed; (4) condition of silt curtains was checked by the supervisor daily; and (5) seawall blocks installation was undertaken within the inner silt curtain area only.
Remarks	None

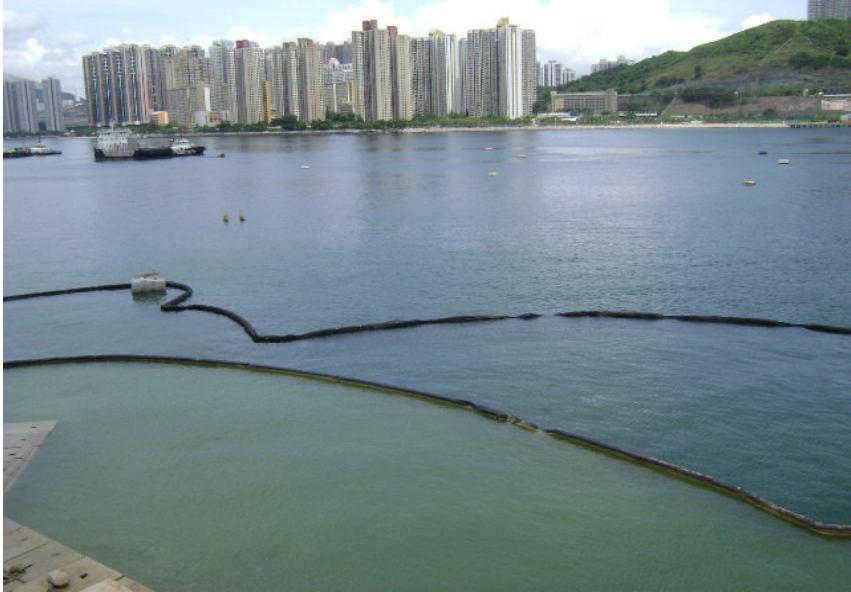
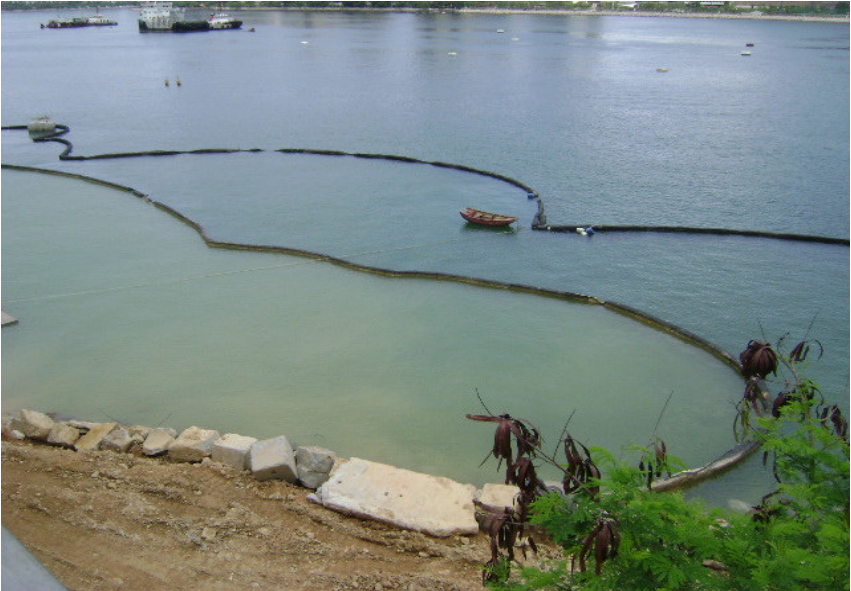
Site photo

Photographic record for exceedance of Dissolved Oxygen (marine surface) recorded at O-1(ET) on 07-Jun-11

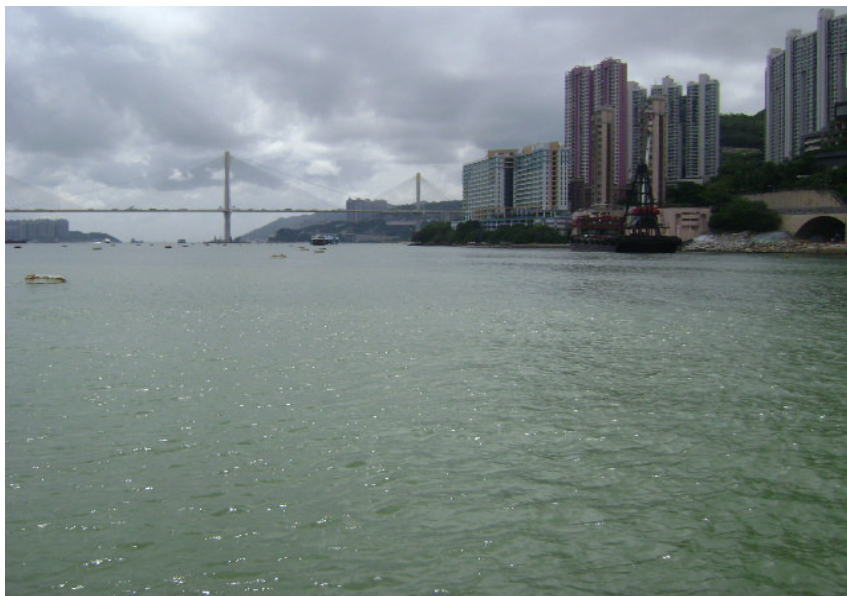
Photographic record for exceedance of Dissolved Oxygen (marine bottom) recorded at O-1(FT) on 15-Jun-11

Site photo
(Photo taken at location
near O-1-C(FT))

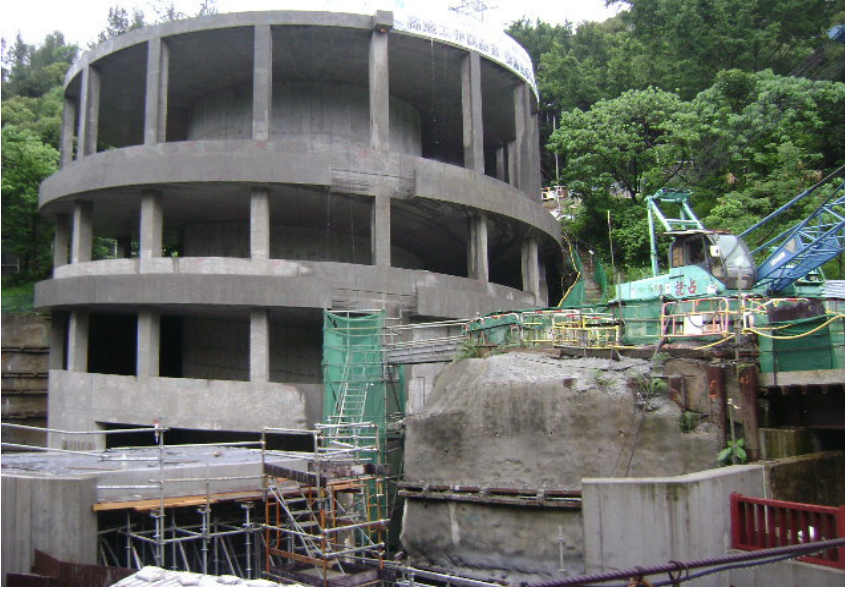
Site photo

Photographic record for exceedance of Turbidity recorded at Sik Sik Yuen Ho Fung College (I-1)
on 17-Jun-11

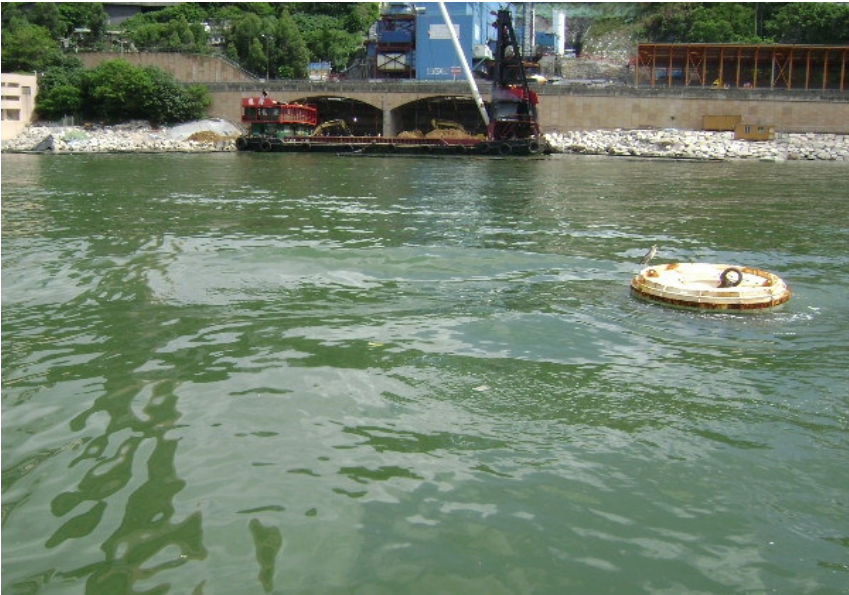
Site photo

Photographic record for exceedance of Dissolved Oxygen (marine surface) recorded at O-1(FT) on 20-Jun-11

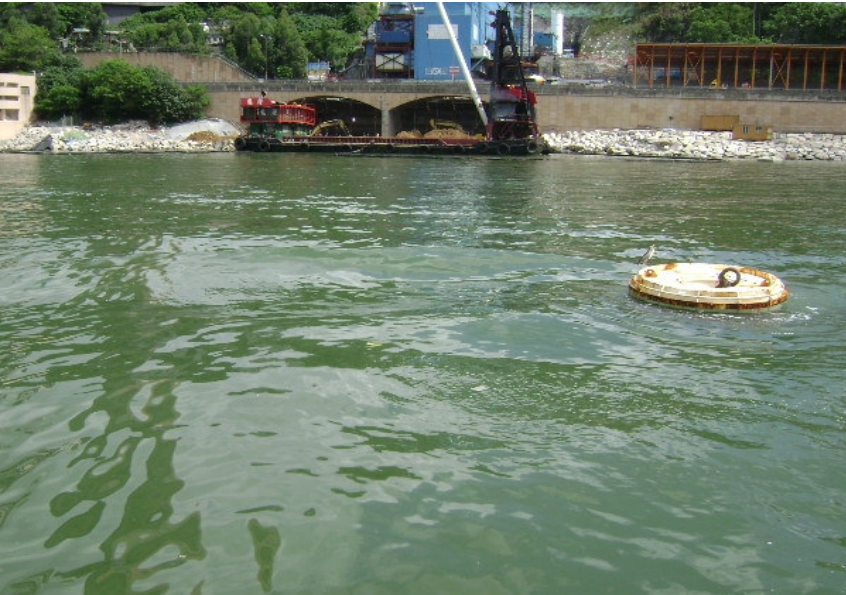
Site photo

Photographic record for exceedance of Dissolved Oxygen (marine mid-depth) recorded at O-1(FT) on 20-Jun-11

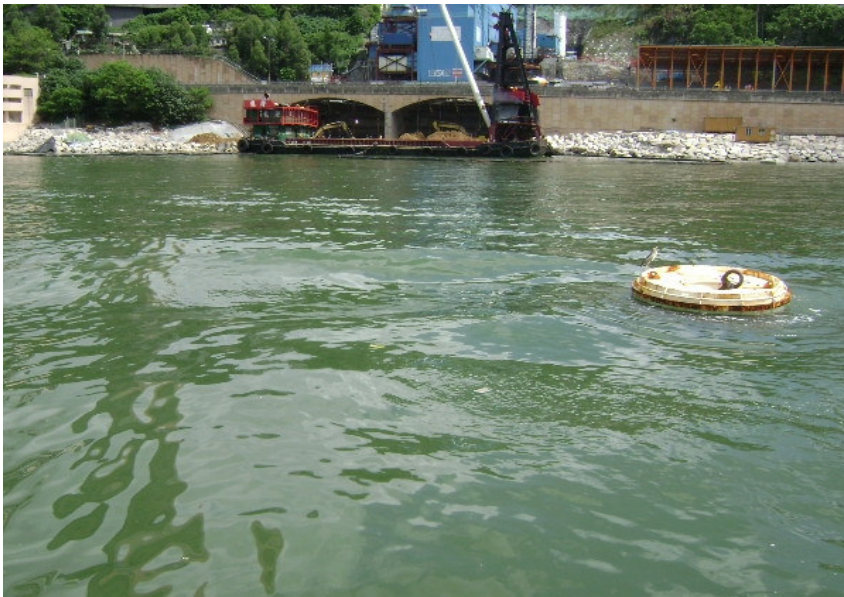
Site photo

Photographic record for exceedance of Dissolved Oxygen (marine bottom) recorded at O-1(FT) on 20-Jun-11

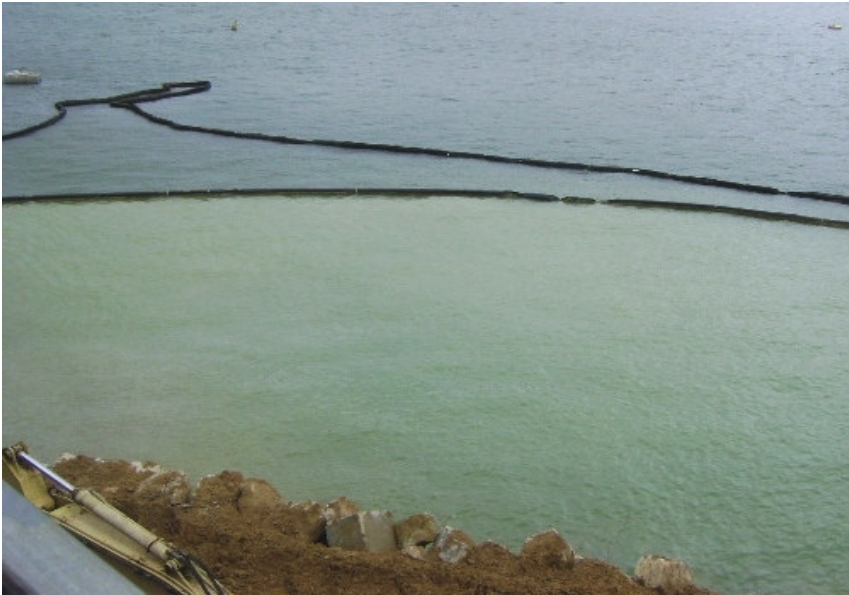
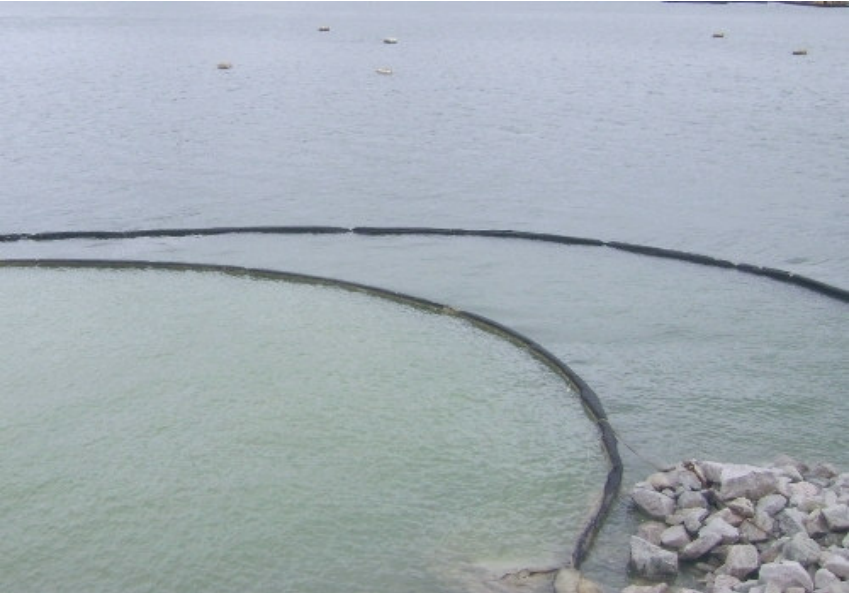
Site photo

Photographic record for exceedance of Dissolved Oxygen (marine surface) recorded at O-1(ET) on 20-Jun-11

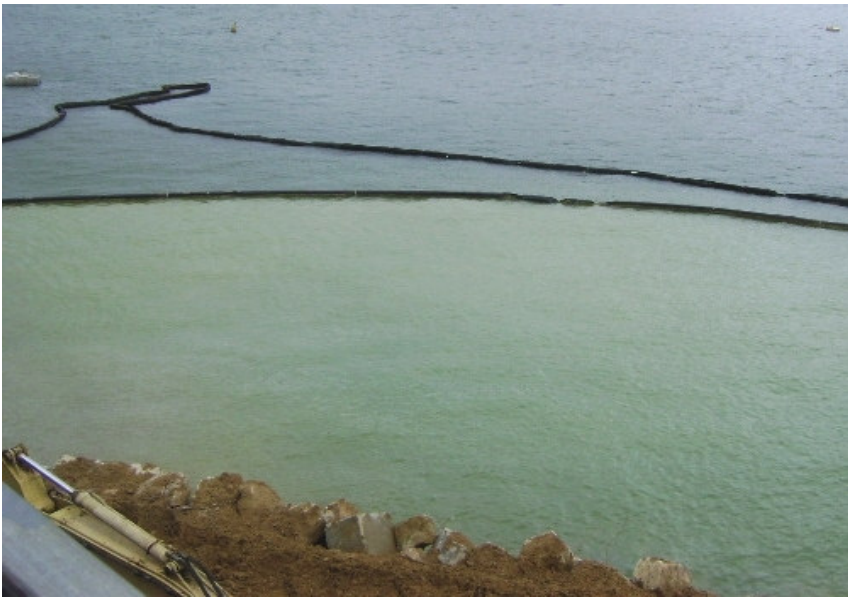
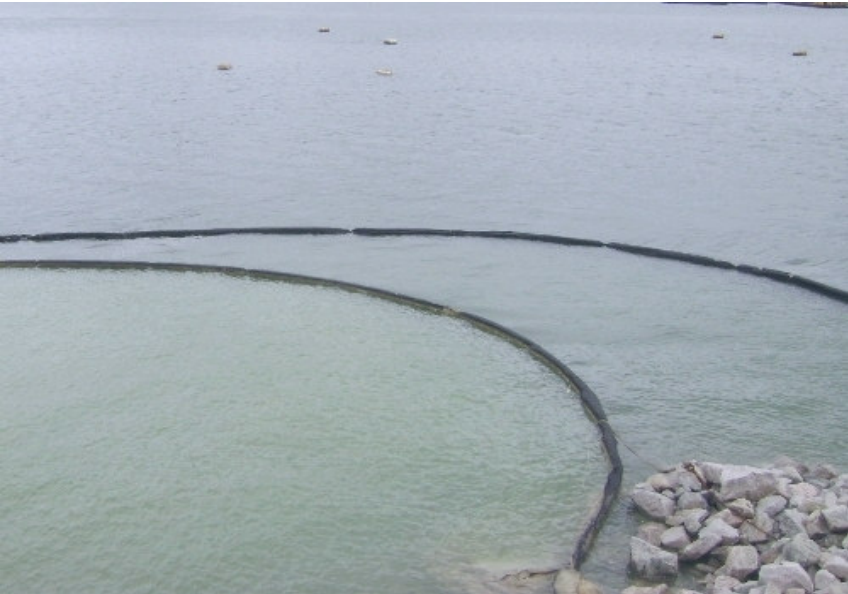
Site photo

Photographic record for exceedance of Dissolved Oxygen (marine mid-depth) recorded at O-1(ET) on 20-Jun-11

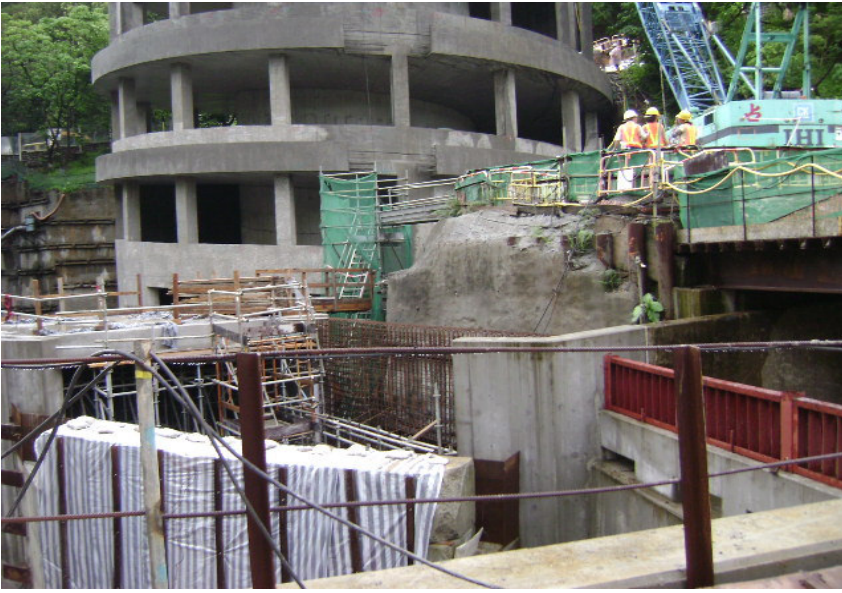
Site photo

Photographic record for exceedance of Turbidity recorded at Sik Sik Yuen Ho Fung College (I-1)
on 22-Jun-11

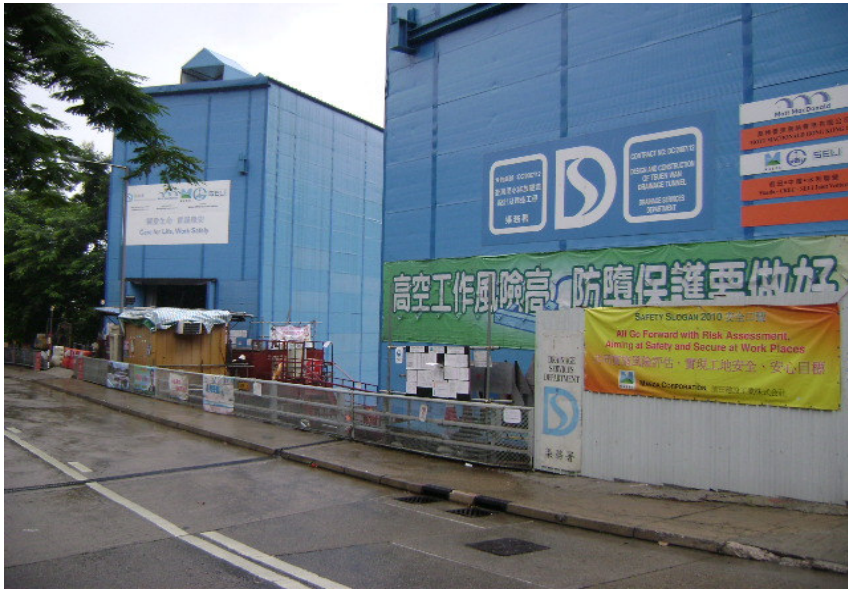
Site photo

Photographic record for exceedance of Turbidity recorded at Hong Hoi Chee Hong Temple (I-2) on 22-Jun-11

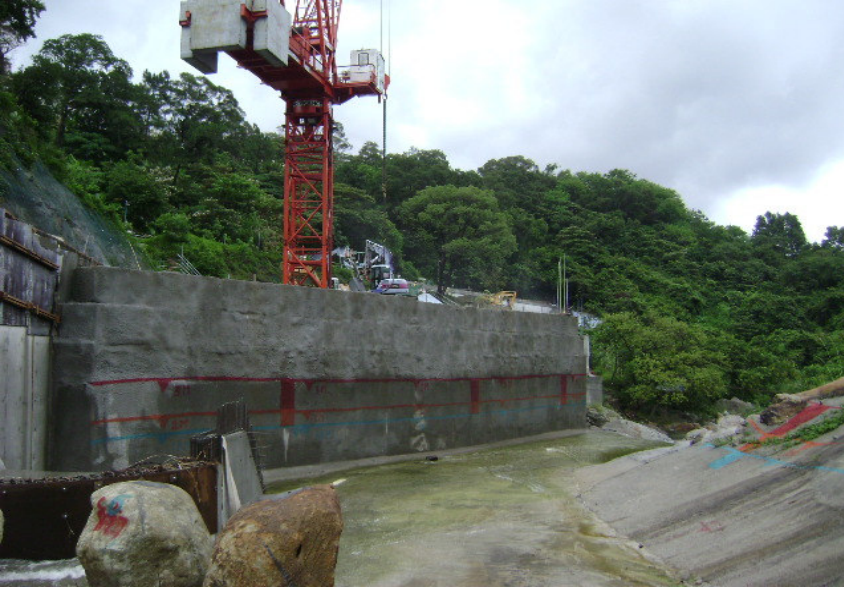
Photo taken at I-3

Photographic record for exceedance of Turbidity recorded at Squatters (I-3) on 22-Jun-11

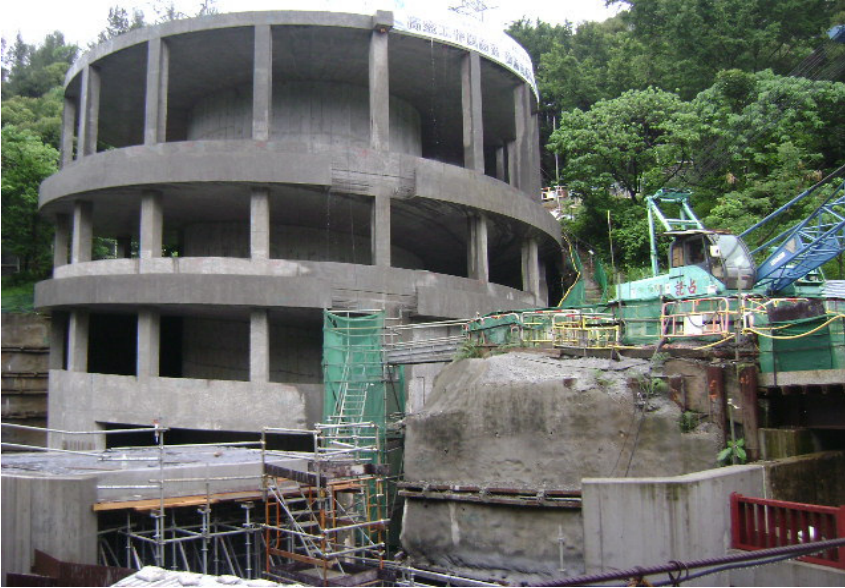
Site photo

Photographic record for exceedance of Suspended Solids (SS) recorded at Sik Sik Yuen Ho Fung College (I-1) on 17-Jun-11

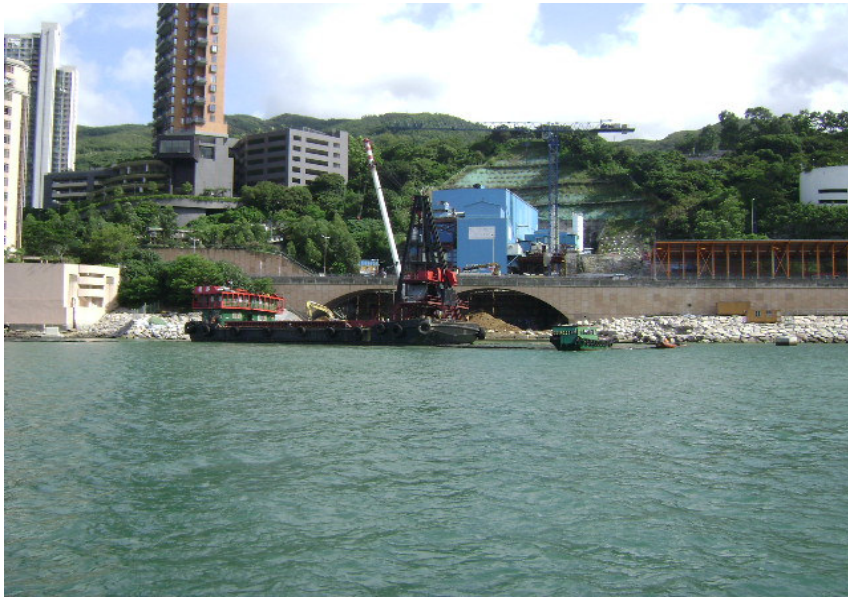
Photographic record for exceedance of Dissolved Oxygen (marine surface) recorded at O-1(ET) on 24-Jun-11

Site photo (Photo taken at location near O-1(ET))
